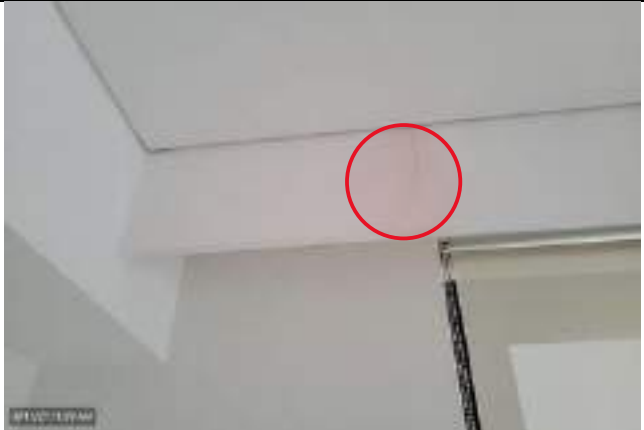
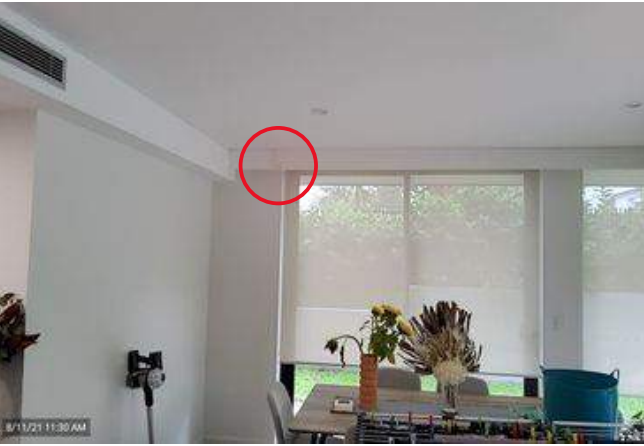
| ITEM | COMMENTARY | PHOTOGRAPH(S) |
|---|--|---|
| 2-G05 | | |

| ITEM | COMMENTARY | PHOTOGRAPH(S) |
|---|--|---|
| A | <p>Location & Description Living area - Pelmet</p> <p>The Author has observed that the patch repair to the pelmet in the living area is incomplete and significant damage to the pelmet on the eastern side of living area.</p> <p>The Author is of the view, that the defect originated at the time of construction and that the Builder has not completed the repair works, and that the pelmet to the eastern side of the living area will need to be replaced.</p> | <p>A photograph of a living area showing a white pelmet on the ceiling. A red circle highlights a defect on the eastern side of the pelmet. A timestamp '8/11/21 11:30 AM' is visible in the bottom left corner.</p> |
| B | <p>Cause(s)</p> <ul style="list-style-type: none"> • Failure of Builder to complete the repair works. • <i>Building contract – Defect liability period</i> | |
| C | <p>Breach(es) <i>Failure to comply with the following:</i></p> <ul style="list-style-type: none"> ▪ <i>Home Building Act 1989 (NSW) under Section 18B Clauses 1 (a);</i> ▪ <i>Incomplete contract works</i> | <p>A photograph of a living area showing a white pelmet on the ceiling. A red circle highlights a defect on the eastern side of the pelmet. A timestamp '8/11/21 11:30 AM' is visible in the bottom left corner.</p> |

| ITEM | COMMENTARY | PHOTOGRAPH(S) |
|---|--|---|
| D | <p>Proposed Rectification Scope of Works Allow to:</p> <ol style="list-style-type: none"> 1. Provide site supervision. Supervisor to coordinate access and facilitate the works throughout the whole process. 2. Gain access to required areas in accordance with Safework requirements. 3. Labour to complete paint repair to affected area 4. Supply paint ancillaries 5. Cover and protect adjacent surfaces during the rectification work. 6. Make good any surfaces affected as part of the works, to their prior condition. 7. Clean site and leave in a tidy condition upon completion of work | |

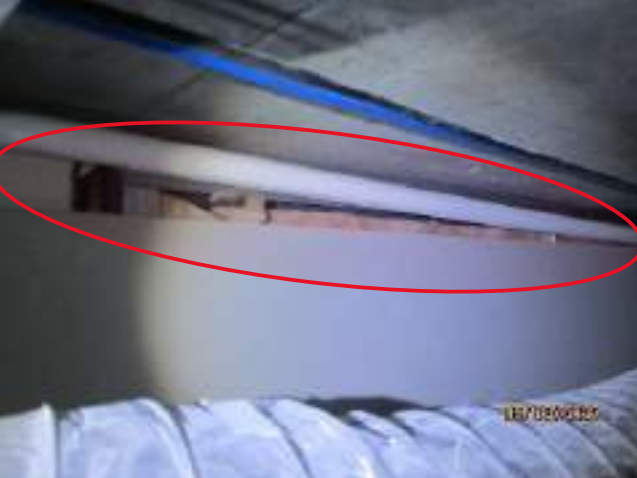
| ITEM | COMMENTARY | PHOTOGRAPH(S) |
|---|--|--|
| 3-G05 | | |

| ITEM | COMMENTARY | PHOTOGRAPH(S) |
|---|--|--|
| A | <p>Location & Description Party wall – Fire Separation</p> <p>The Author has observed that the sections of the common wall adjoining unit G06 fire protection is missing. The Author is of the view that the works to not conform to the requirements under C2.7(b)(i) Separation by fire walls of the NCC Vol 1 2016. For clarity, please refer to following extract before mentioned - Extract NCC Volume 1 2016 C2.7(b)(i) Separation by fire walls -</p> <p>The fire wall extends through all storeys and spaces in the nature of storeys that are common to that part and any adjoining part of the building.</p> <p>The Author noted issue was identified in TCA (Giaouris) report Attachment F Defect schedule U G05.1</p> <p>The Author is of the view that the work has not been carried out accordance with relevant requirements of the NCC, and that the defect originated from poor workmanship employed by the Builder at the time of construction.</p> | <p>Images showing missing fire separation to common wall to east of location from ceiling access</p> |
| B | <p>Cause(s)</p> <ul style="list-style-type: none"> Poor workmanship employed by the Builder at the time of construction. | |
| C | <p>Breach(es) <i>Failure to comply with the following:</i></p> <ul style="list-style-type: none"> Home Building Act 1989 (NSW) under Section 18B Clauses 1 (a); NCC Volume 1 2016 C2.7(b)(i) Separation by fire walls | |

| ITEM | COMMENTARY | PHOTOGRAPH(S) |
|---|--|--|
| D | <p>Proposed Rectification Scope of Works Allow to:</p> <ol style="list-style-type: none"> Provide site supervision. Supervisor to coordinate access and facilitate the works throughout the whole process. Gain access to required areas in accordance with Safework requirements. Cover and protect adjacent surfaces during the rectification work. Labour to isolate electrical services to make safe Labour to demolish and remove ceiling linings to provide access to rectify defective works | |

6. Labour to install fire rated materials in accordance with NCC
7. Labour repair and reinstate plasterboard linings and finishes
8. Labour to paint ceiling and affected finishes
9. Labour to restore electrical service and commission
10. Supply fire rated material, plasterboard, paint and ancillaries
11. Make good any surfaces affected as part of the works, to their prior condition.
12. Clean site and leave in a tidy condition upon completion of work
13. Waste disposal

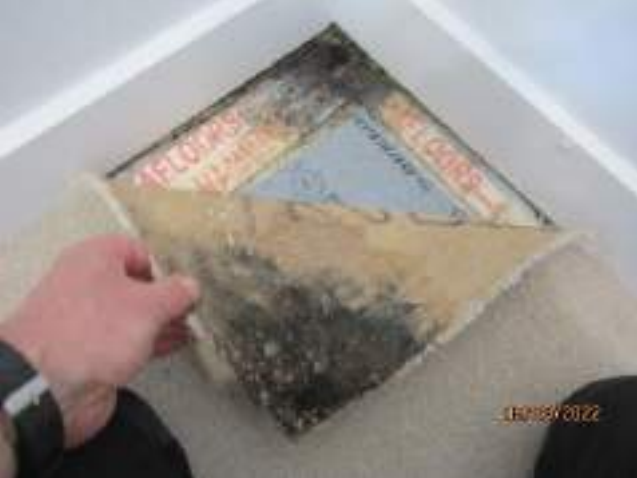
| ITEM | COMMENTARY | PHOTOGRAPH(S) |
|---|--|---|
| 4-G05 | | |

| ITEM | COMMENTARY | PHOTOGRAPH(S) |
|---|--|---|
| A | <p>Location & Description Bedroom 2 – Rainwater penetration</p> <p>The Author has observed moisture penetration, damage, and high levels of moisture indicated to the southeast corner and western side sliding door to bedroom 2.</p> <p>The Author noted issue was identified in TCA (Giaouris) report Attachment F Defect schedule U G05.20</p> <p>The Author observed that –</p> <ul style="list-style-type: none"> the cavity drainage (weep hole) at concrete slab level above the eastern side of sliding door has been painted over. No water stop has been provided to the sliding door <p>The Author conducted moisture test to the exterior wall at the main entry ramp adjoining bedroom 2 and observed high level of moisture indicated.</p> <p>The Author is of the view that –</p> <ol style="list-style-type: none"> Rainwater is penetrating the western end of the sliding door due the Builders failure to provide a water stop in accordance with AS4654.2. Moisture penetrating the southeast corner of bedroom 2 has originated due the Builders failure to provide weep drainage to the HEBEL wall system in accordance with the manufacturers guidelines. The has failure to adequately weatherproof the parapet wall above as identified in Item C-2 of this report. | <p>Moisture penetration, mould and damage to southeast corner of bedroom 2</p> |
| B | <p>Cause(s)</p> <ul style="list-style-type: none"> Poor workmanship employed by the Builder at the time of construction. Failure of the Builder to carry out the works in accordance with the NCC, relevant Australian standards and manufacturers guidelines. | |

| <p>C</p> | <p>Breach(es) <i>Failure to comply with the following:</i></p> <ul style="list-style-type: none"> ▪ Home Building Act 1989 (NSW) under Section 18B Clauses 1 (a); ▪ National Construction Code 2016 Vol1 FP1.4 Weatherproofing ▪ AS4654.2:2012 ▪ Manufacturers guidelines ▪ Contract plans and specifications | |

| <p>D</p> | <p>Proposed Rectification Scope of Works Allow to: IN CONJUNCTION WITH RECTIFICATION WORKS IN RELATION TO ITEM C-2</p> <ol style="list-style-type: none"> 1. Provide site supervision. Supervisor to coordinate access and facilitate the works throughout the whole process. 2. Gain access to required areas in accordance with Safework requirements. 3. Cover and protect adjacent surfaces during the rectification work 4. Labour to remove sliding door and store in a secure location 5. Labour to clean down existing waterproofing, reactivate waterproofing, install new waterproofing waterstop angle behind sliding door, aluminium angle colour matched to aluminium frame, Install new waterproofing, angle and fillet to hob and waterstop 6. Labour to reinstall sliding door suite, finishes, sealant to vertical and horizontal tile junction, Install storm moulds to sliding door frame 7. Labour to complete paint repair affected finishes 8. Supply paint ancillaries 9. Remove damage carpet, supply and install new carpet 10. Make good any surfaces affected as part of the works, to their prior condition. 11. Clean site and leave in a tidy condition upon completion of work 12. Waste disposal | |

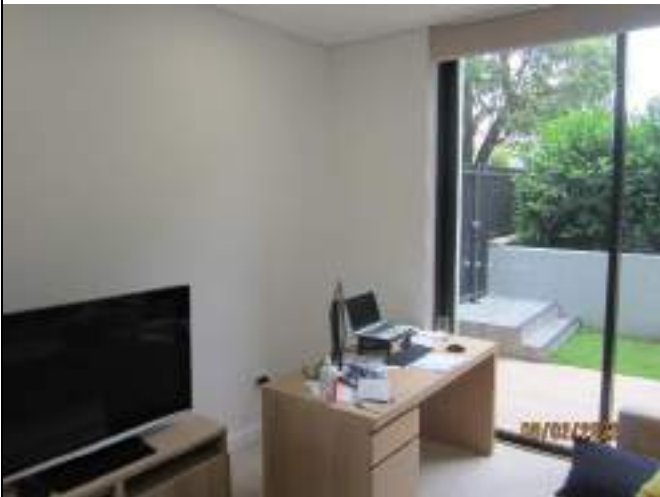
Bedroom 2 southeast corner

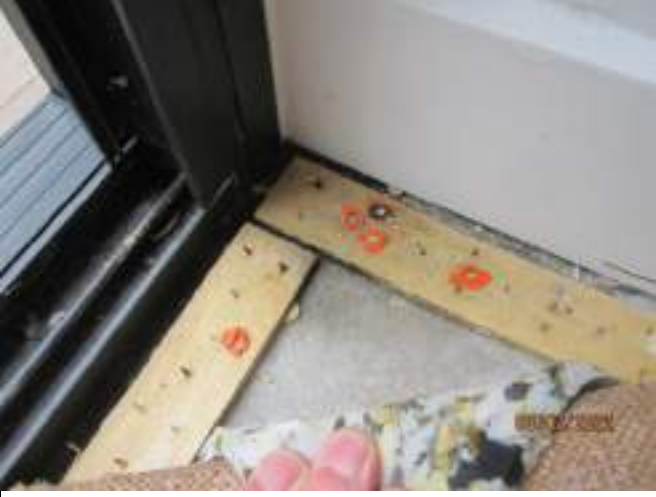
Moisture from rain penetrating interior to western side of sliding door bedroom 2

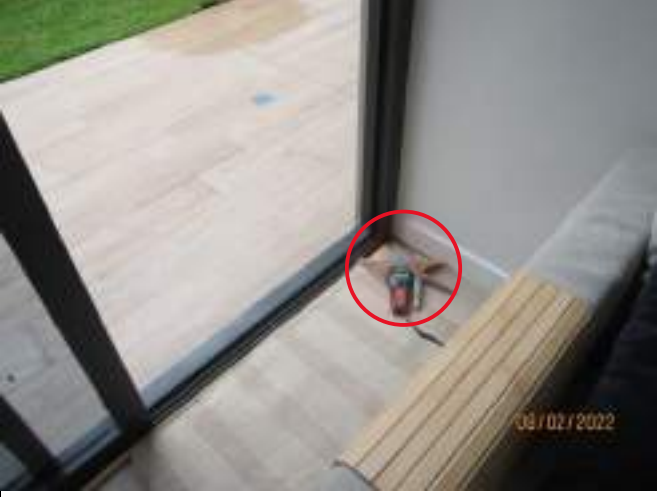
Location of rainwater penetration to western side of sliding door bedroom 2

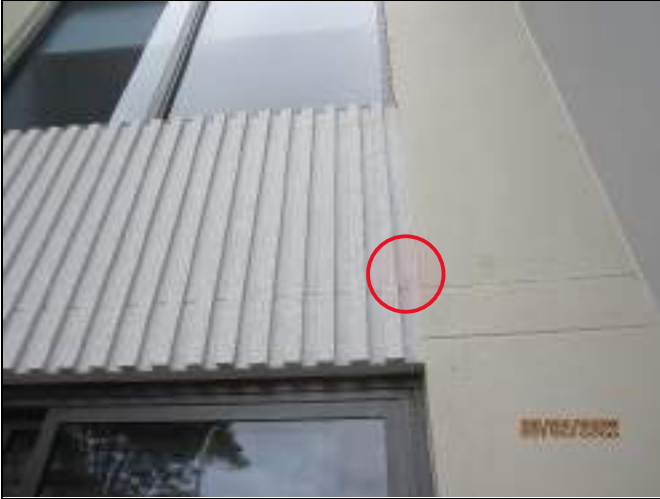
Weep hole drainage painted over above sliding door to bedroom2 Unit G05

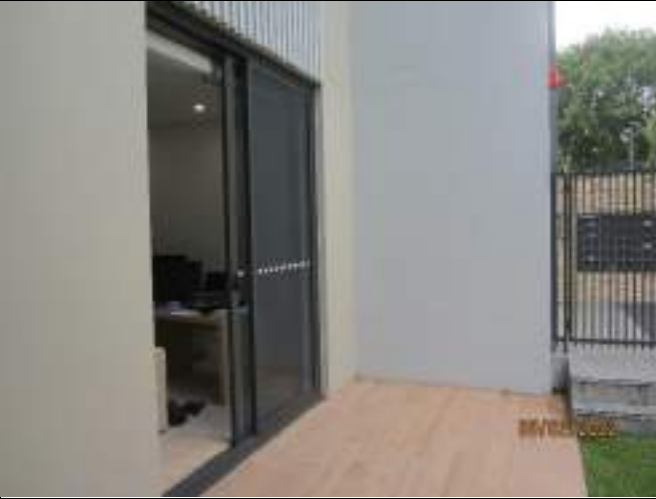
Location of bedroom 2 sliding door Unit G05 looking east and light weight wall adjoining main entry ramp

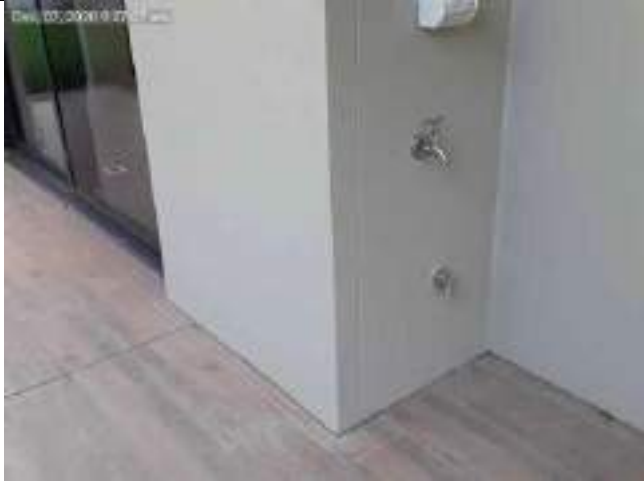
| ITEM | COMMENTARY | PHOTOGRAPH(S) |
|---|---|---|
| 5-G05 | | |

| ITEM | COMMENTARY | PHOTOGRAPH(S) |
|---|---|---|
| A | <p>Location & Description Southern facade – Hebel cladding installation</p> <p>The Author has observed no Pressure Equalisation PE/weep hole drainage outlets have been provided to the southern façade of unit G05.</p> <p>The Author noted that the defective works had been identified in Section 10.6 and 8.26 of Mr Giaouris report dated 7 December 2020. However, the Author noted that Hebel installation guidelines referenced by Mr Giaouris states PE/drainage slots to be located no greater than 3 metre spacing. Therefore, the Author is of the view that work is defective in the locations where the spacing exceed or do not conform to the manufacturers guidelines.</p> <p>To clarify, please refer to extract from Section 8.26.3 of Mr Giaouris report -</p> <p>Pressure Equalisation Slots</p> <div style="border: 1px solid red; border-radius: 10px; padding: 5px; margin: 10px 0;"> <p>PE Slots (Weepa) allow pressure equalisation to the wall cavity and permit drainage of any water from the cavity. Ideally located at control joints (CJ) and at no greater than 3 metre spacing.</p> </div> <p>The Author noted issue was specifically identified to unit G05 in TCA (Giaouris) report Attachment F Defect schedule U G05.27</p> <p>The Author is of the view that where the works have not been carried out in accordance with manufacturers guidelines that the works are defective and the defect originated due to poor workmanship employed by the Builder at the time of construction.</p> | <p>No pressure equalisation slots or cavity drainage provide to southern façade of Unit G05HEBEL cladding system</p> |
| B | <p>Cause(s)</p> <ul style="list-style-type: none"> Poor workmanship employed by the Builder at the time of construction. | |

| D | Proposed Rectification Scope of Works Allow to: <ol style="list-style-type: none">1. Provide site supervision. Supervisor to coordinate access and facilitate the works throughout the whole process.2. Gain access to required areas in accordance with Safework requirements.3. Cover and protect adjacent surfaces during the rectification work.4. Labour to cut slot in Hebel panel to install Weepa protector, install Weepa protectors and patch and repair affected finishes in accordance with manufacturers guidelines.5. Labour to repair render and paint façade to provide even finish6. Supplier Weepa protectors7. Supply Dulux render system materials, paint and ancillaries8. Make good any surfaces affected as part of the works, to their prior condition.9. Clean site and leave in a tidy condition upon completion of work10. Waste disposal | |

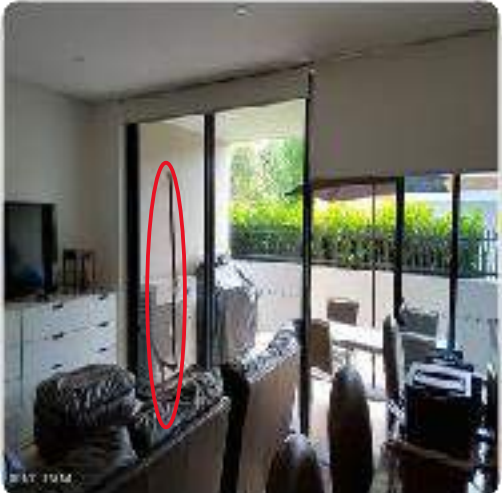
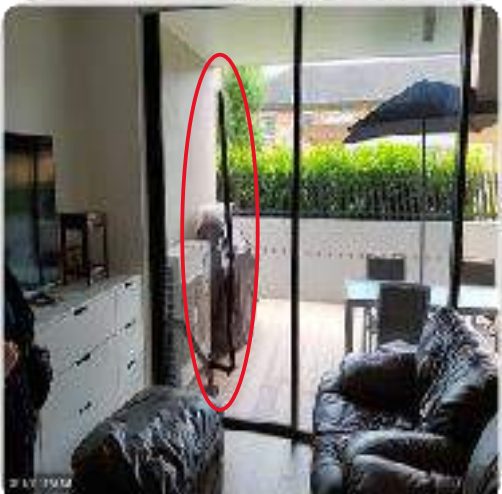
| ITEM | COMMENTARY | PHOTOGRAPH(S) |
|---|--|---|
| 1-G06 | | |

| ITEM | COMMENTARY | PHOTOGRAPH(S) |
|---|--|---|
| A | <p>Location & Description Living area – Sliding door</p> <p>The Author has observed the northwestern fixed glass panel to the sliding door in the living area is broken. It was reported to the Author by the occupants at the time of inspection that the damage originated at the time of construction.</p> <p>The Author has assumed that the occupants statement is true and correct.</p> | |
| B | <p>Cause(s)</p> <ul style="list-style-type: none"> • Damage originating at the time of construction. | |
| C | <p>Breach(es) <i>Failure to comply with the following:</i></p> <ul style="list-style-type: none"> ▪ Home Building Act 1989 (NSW) under Section 18B Clauses 1(a) ▪ Building contract – Defect liability period | <p data-bbox="1496 1281 2051 1310">Location of damage glass panel to living sliding door</p> |

| ITEM | COMMENTARY | PHOTOGRAPH(S) |
|---|--|---|
| D | <p>Proposed Rectification Scope of Works Allow to:</p> <ol style="list-style-type: none"> 1. Provide site supervision. Supervisor to coordinate access and facilitate the works throughout the whole process. 2. Gain access to required areas in accordance with Safework requirements. 3. Cover and protect adjacent surfaces during the rectification work. 4. Remove existing glass, supply and install new equivalent glass panel with indicator motif 5. Dispose of building waste 6. Make good any surfaces affected as part of the works, to their prior condition. 7. Clean site and leave in a tidy condition upon completion of work | |

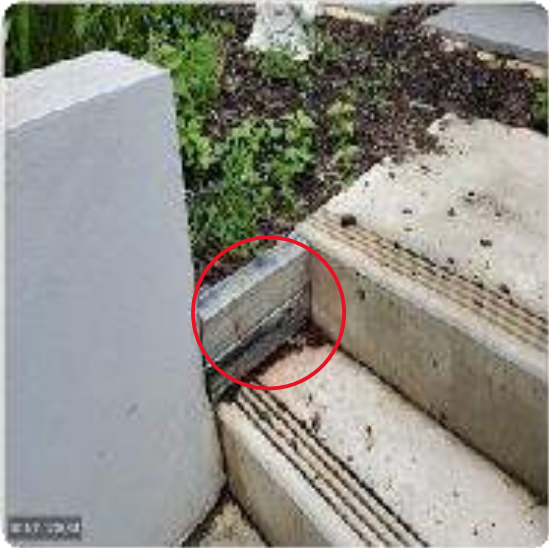
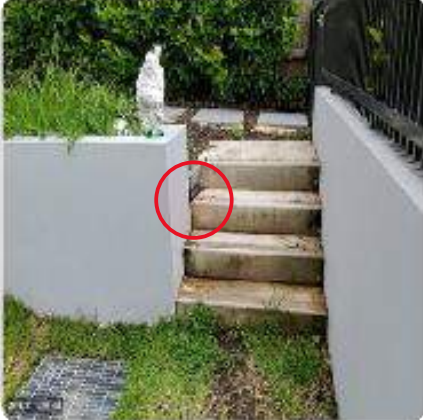
| ITEM | COMMENTARY | PHOTOGRAPH(S) |
|---|---|---|
| 2-G06 | | |

| ITEM | COMMENTARY | PHOTOGRAPH(S) |
|---|---|---|
| A | <p>Location & Description Northwestern exterior -Landscaping</p> <p>The Author has observed there is a gap between the retaining wall and top of stairs to the northwestern exterior and that timber used to close gap and retain soft landscaping reported by the occupants at the time of inspection, had been placed by the occupants to retain soil and landscaping.</p> <p>The Author is of the view, that the defect originated from poor workmanship employed by the Builder at the time of construction.</p> | |
| B | <p>Cause(s)</p> <ul style="list-style-type: none"> Poor workmanship employed by Builder at the time of construction | |
| D | <p>Proposed Rectification Scope of Works Allow to:</p> <ol style="list-style-type: none"> Provide site supervision. Supervisor to coordinate access and facilitate the works throughout the whole process. Gain access to required areas in accordance with Safework requirements. Labour to install treated pine sleeper retaining Supply H4 treated pine sleeper Make good any surfaces affected as part of the works, to their prior condition. Clean site and leave in a tidy condition upon completion of work | <p>Location of gap on stairs to northwest corner of exterior</p> |

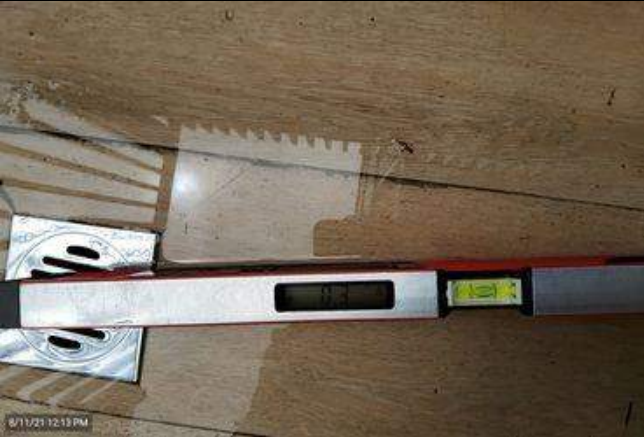
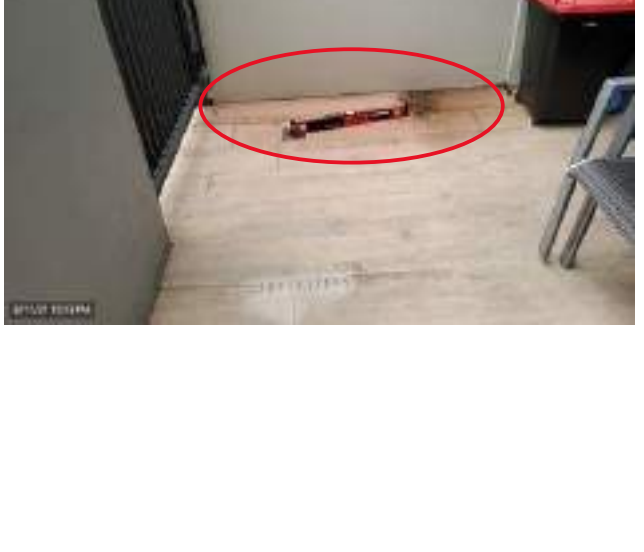
| ITEM | COMMENTARY | PHOTOGRAPH(S) |
|---|---|--|
| 3-G06 | | |

| ITEM | COMMENTARY | PHOTOGRAPH(S) |
|---|---|--|
| A | <p>Location & Description Northeastern exterior -Tiling</p> <p>The Author has observed there was water ponding at the southern side of the floor waste to the northeastern exterior. The Author conducted test using a digital level and found there was insufficient fall to the tiled surface.</p> <p>The Author is of the view, that the defect originated at the time of construction.</p> | |
| B | <p>Cause(s)</p> <ul style="list-style-type: none"> Poor workmanship employed by Builder at the time of construction; | <p>Surface fall on southern side of floor indicted 0.3%</p> |
| C | <p>Breach(es) <i>Failure to comply with the following:</i></p> <ul style="list-style-type: none"> Home Building Act 1989 (NSW) under Section 18B Clauses 1(a) Failure of Builder to carry out the works in accordance with AS3958.1:2007 Part 1: Guide to the installation of ceramic tiles Building contract specifications | |

| ITEM | COMMENTARY | PHOTOGRAPH(S) |
|---|---|--|
| D | <p>Proposed Rectification Scope of Works Allow to:</p> <ol style="list-style-type: none"> Provide site supervision. Supervisor to coordinate access and facilitate the works throughout the whole process. Gain access to required areas in accordance with Safework requirements. Cover and protect adjacent surfaces during the rectification work. Labour to demolish and remove defective tiling Labour to repair tile screed and provide tile screed to direct fall to inlet in accordance with AS3958.2:2007 Part 1: Guide to the installation of ceramic tiles Labour to fix new tiling, apply grout to joins and provide flexible joint at wall junction or movement joint to affected area. Supply sand, cement, tile adhesive, tiles, grout and flexible sealant. Make good any surfaces affected as part of the works, to their prior condition. Clean site and leave in a tidy condition upon completion of work | |

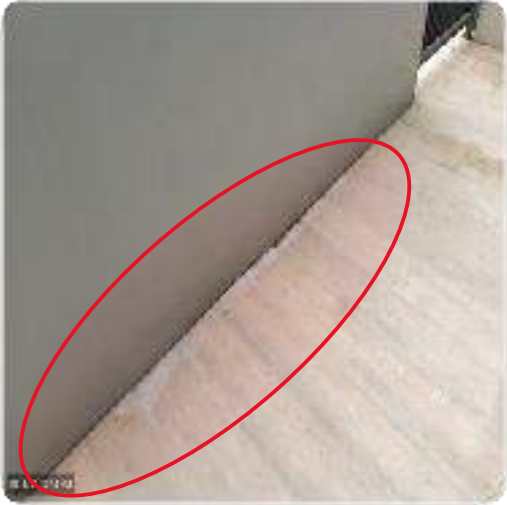
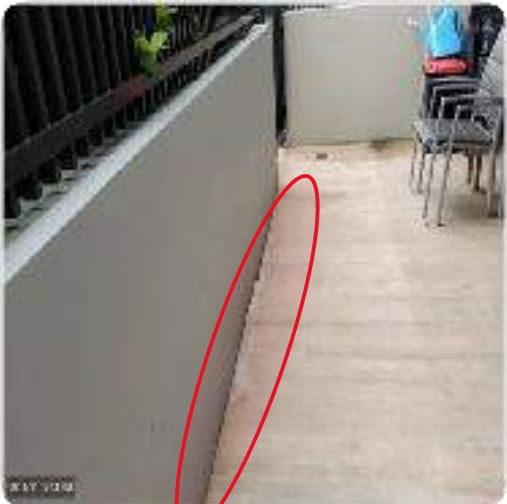
| ITEM | COMMENTARY | PHOTOGRAPH(S) |
|---|--|--|
| 4-G06 | | |

| ITEM | COMMENTARY | PHOTOGRAPH(S) |
|---|--|--|
| A | <p>Location & Description Northern exterior – Efflorescence</p> <p>The Author has observed efflorescent staining on the floor tiles to the northern exterior of the alfresco area. The occupants report to the Author at the time of inspection, that the efflorescence was identified on handover.</p> <p>The Author is of the view that the efflorescence migrated from the northern rendered wall and has assumed the occupants statement is true and correct.</p> | |
| B | <p>Cause(s)</p> <ul style="list-style-type: none"> • Efflorescence migrating from the northern rendered wall. | |
| C | <p>Breach(es) <i>Failure to comply with the following:</i></p> <ul style="list-style-type: none"> ▪ NSW standards & tolerances 2017 – 14.8 Calcification and efflorescence associated with decks and balconies Calcification or efflorescence caused by water coming from a deck or balcony that occurs on walls below or beside the deck or balcony, or that appears in the mortar joints of the deck or balcony tiling, may be considered a defect if it is due to defective or missing flashings, membrane, a damp proof course DPC or faulty design and needs to be investigated to identify the cause. | |

| ITEM | COMMENTARY | PHOTOGRAPH(S) |
|---|--|--|
| D | <p>Proposed Rectification Scope of Works Allow to:</p> <ol style="list-style-type: none"> 1. Provide site supervision. Supervisor to coordinate access and facilitate the works throughout the whole process. 2. Gain access to required areas in accordance with Safework requirements. 3. Cover and protect adjacent surfaces during the rectification work. 4. Labour to remove efflorescence staining 5. Cleaning chemical product 6. Make good any surfaces affected as part of the works, to their prior condition. 7. Clean site and leave in a tidy condition upon completion of work | <p>Location of efflorescence staining on court yard tiles</p> |

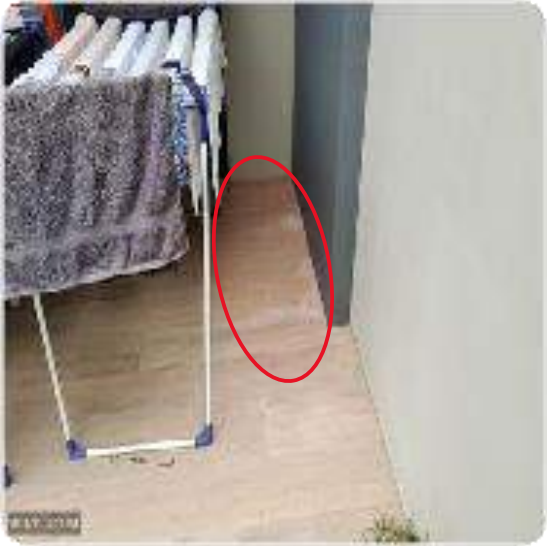
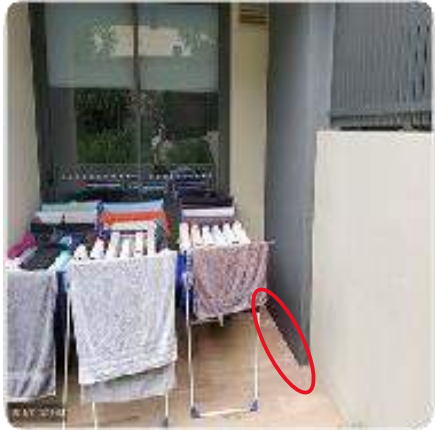
| ITEM | COMMENTARY | PHOTOGRAPH(S) |
|---|--|--|
| 6-G06 | | |

| ITEM | COMMENTARY | PHOTOGRAPH(S) |
|---|--|--|
| A | <p>Location & Description</p> <p>Southeastern exterior – Efflorescence</p> <p>The Author has observed efflorescent staining on the floor tiles to the southeastern end of the exterior. The occupants reported to the Author at the time of inspection, that the efflorescence was identified on handover.</p> <p>The Author is of the view that the efflorescence migrated from the eastern rendered wall and has assumed the occupants statement is true and correct.</p> | |
| B | <p>Cause(s)</p> <ul style="list-style-type: none"> • Efflorescence migrating from the eastern rendered wall | |
| C | <p>Breach(es)</p> <p><i>Failure to comply with the following:</i></p> <ul style="list-style-type: none"> ▪ NSW standards & tolerances 2017 – 14.8 Calcification and efflorescence associated with decks and balconies <p>Calcification or efflorescence caused by water coming from a deck or balcony that occurs on walls below or beside the deck or balcony, or that appears in the mortar joints of the deck or balcony tiling, may be considered a defect if it is due to defective or missing flashings, membrane, a damp proof course DPC or faulty design and needs to be investigated to identify the cause.</p> | |

| ITEM | COMMENTARY | PHOTOGRAPH(S) |
|---|--|--|
| D | <p>Proposed Rectification Scope of Works</p> <p>Allow to:</p> <ol style="list-style-type: none"> 1. facilitate the works throughout the whole process. 2. Gain access to required areas in accordance with Safework requirements. 3. Cover and protect adjacent surfaces during the rectification work. 4. Labour to remove efflorescence staining 5. Cleaning chemical product 6. Make good any surfaces affected as part of the works, to their prior condition. 7. Clean site and leave in a tidy condition upon completion of work | |

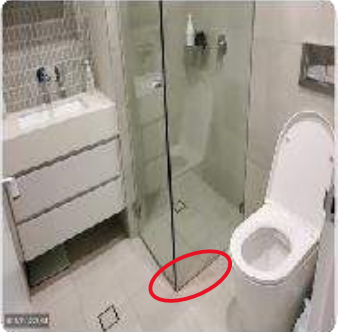
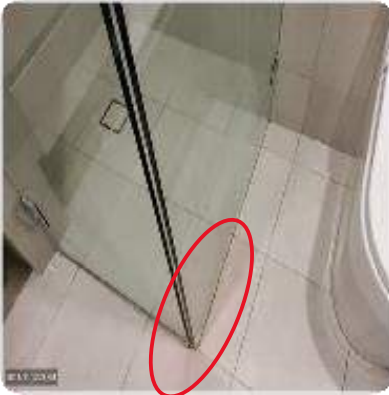
| ITEM | COMMENTARY | PHOTOGRAPH(S) |
|---|--|---|
| 7-G06 | | |

| ITEM | COMMENTARY | PHOTOGRAPH(S) |
|---|--|---|
| A | <p>Location & Description Main bathroom and ensuite – Shower screens</p> <p>The Author has observed that the main bathroom and ensuite fixed shower screen panel is out of alignment and silicone sealant fixing is loose at base of shower screen.</p> <p>The Author is of the view, that the defect originated due to poor workmanship employed by the Builder at the time of construction. As the fixing of the base of glass panel is reliant on the flexible sealant being applied to adequately secure the shower screen and provide a waterproof seal at the water stop angle.</p> | |
| B | <p>Cause(s)</p> <ul style="list-style-type: none"> Poor workmanship employed by Builder at the time of construction | |
| C | <p>Breach(es) Failure to comply with the following:</p> <ul style="list-style-type: none"> Home Building Act 1989 (NSW) under Section 18B Clauses (a) & (c); Building contract - Defect liability period – Product warranty | |

| ITEM | COMMENTARY | PHOTOGRAPH(S) |
|---|--|---|
| D | <p>Proposed Rectification Scope of Works Allow to:</p> <ol style="list-style-type: none"> Provide site supervision. Supervisor to coordinate access and facilitate the works throughout the whole process. Gain access to required areas in accordance with Safework requirements. Cover and protect adjacent surfaces during the rectification work. Labour to apply construction adhesive waterproofing sealant Supply construction adhesive waterproofing sealant Make good any surfaces affected as part of the works, to their prior condition. Clean site and leave in a tidy condition upon completion of work | |

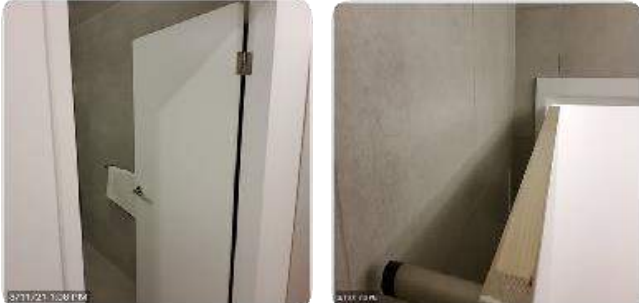
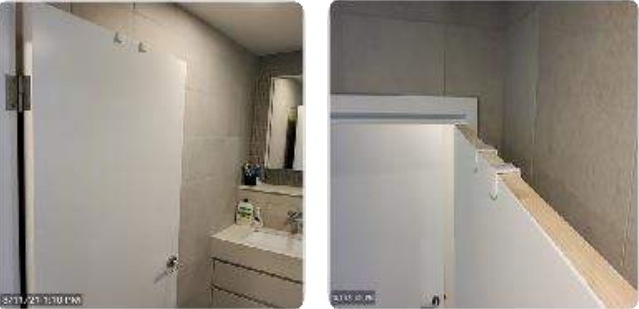
| ITEM | COMMENTARY | PHOTOGRAPH(S) |
|---|---|---|
| 1-102 | | |

| ITEM | COMMENTARY | PHOTOGRAPH(S) |
|---|---|---|
| A | <p>Location & Description Main bathroom and ensuite – Painting to doors</p> <p>The Author has observed that the main bathroom and ensuite doors have not been fully sealed.</p> <p>The Author is of the view, that the defect originated from poor workmanship employed by the Builder at the time of construction.</p> | |
| B | <p>Cause(s)</p> <ul style="list-style-type: none"> • Poor workmanship employed by Builder at the time of construction; | |
| C | <p>Breach(es) <i>Failure to comply with the following:</i></p> <ul style="list-style-type: none"> ▪ Home Building Act 1989 (NSW) under Section 18B Clauses 1(a) &(b) ▪ AS/NZS2311:2009 'Guide to Painting of Buildings' ▪ NSW Guide to standards & tolerances 2017-9.6 Sealing of doors | |
| D | <p>Proposed Rectification Scope of Works Allow to:</p> <ol style="list-style-type: none"> 1. Provide site supervision. Supervisor to coordinate access and facilitate the works throughout the whole process. 2. Gain access to required areas in accordance with Safework requirements. 3. Cover and protect adjacent surfaces during the rectification work. 4. Labour to remove and reinstall doors following repair 5. Labour to apply paint system in accordance with AS2311:2009 'Guide to Painting of Buildings' 6. Supply paint and ancillaries 7. Make good any surfaces affected as part of the works, to their prior condition. 8. Clean site and leave in a tidy condition upon completion of work | <p>Images showing bathroom and ensuite doors not fully sealed</p> |

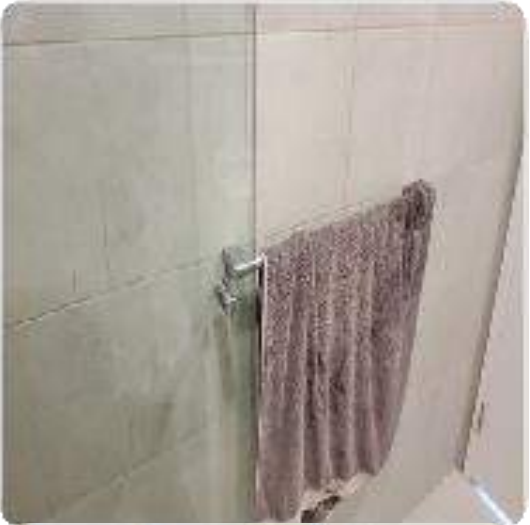
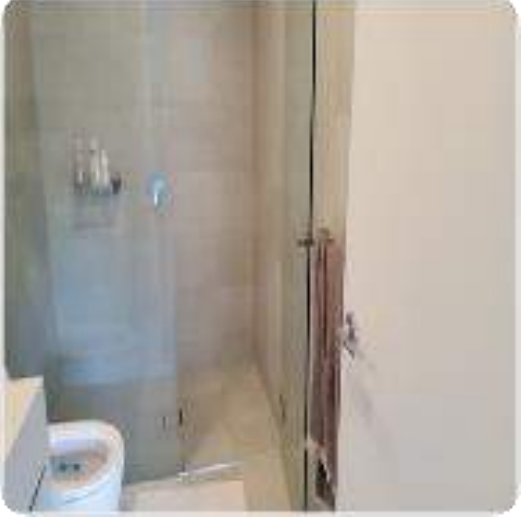
| ITEM | COMMENTARY | PHOTOGRAPH(S) |
|---|---|--|
| 1-103 | | |

| ITEM | COMMENTARY | PHOTOGRAPH(S) |
|---|---|--|
| A | <p>Location & Description Main bathroom and ensuite – Towel rail</p> <p>The Author has observed that the bathroom shower screen door is striking the wall mounted metal towel rail.</p> <p>The Author is of the view, that there is a possibility that the shower rail may impact with glass and cause the glass to break creating a safety hazard to the occupants. The National Construction Code requires that a wet area be constructed to avoid the likelihood of the creation of any unhealthy or dangerous conditions.</p> <p>For clarity, please refer to the following extract from the National Construction Code 2016 Vol.2 F2.4.1</p> <p>F2.4.1 Wet areas A building is to be constructed to avoid the likelihood of—</p> <ul style="list-style-type: none"> (a) the creation of any unhealthy or dangerous conditions; or (b) damage to building elements, | |
| B | <p>Cause(s)</p> <ul style="list-style-type: none"> • Failure of the Builder to carry out the works with due care and skill | |
| C | <p>Breach(es) Failure to comply with the following:</p> <ul style="list-style-type: none"> ▪ Home Building Act 1989 (NSW) under Section 18B Clauses 1(a) ▪ National Construction Code 2016 Vol.2 F2.4.1 | |
| D | <p>Proposed Rectification Scope of Works Allow to:</p> <ol style="list-style-type: none"> 1. Provide site supervision. Supervisor to coordinate access and facilitate the works throughout the whole process. 2. Gain access to required areas in accordance with Safework requirements. 3. Cover and protect adjacent surfaces during the rectification work. 4. Labour to remove towel rail store in a secure location, demolish and remove tiles to provide for relocation of towel rail. 5. Labour to prepare substrate and fix new tiles and apply grout to match existing finishes in accordance with AS3958.1:2007 Part 1: Guide to the installation of | <p>Ensuite shower screen door is striking metal towel rail</p> |

6. Following tile repair provide labour to reinstall existing towel rail clear of possible contact with shower screen door
7. Make good any surfaces affected as part of the works, to their prior condition.
8. Clean site and leave in a tidy condition upon completion of work

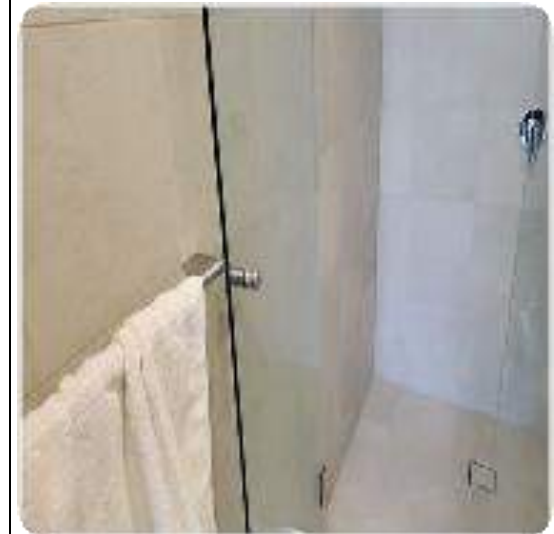
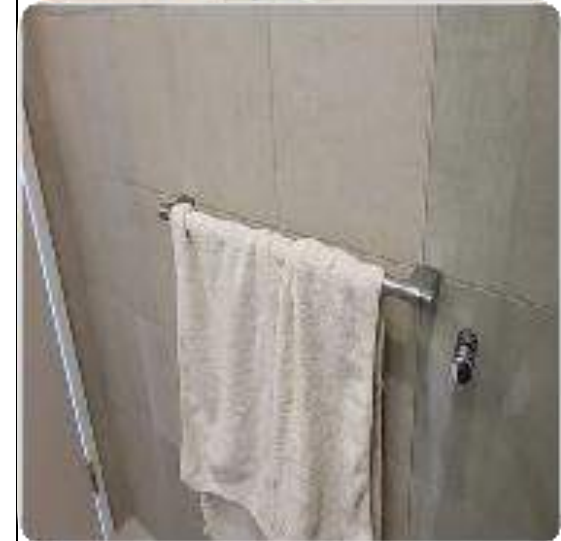
Ensuite shower screen door is striking metal towel rail

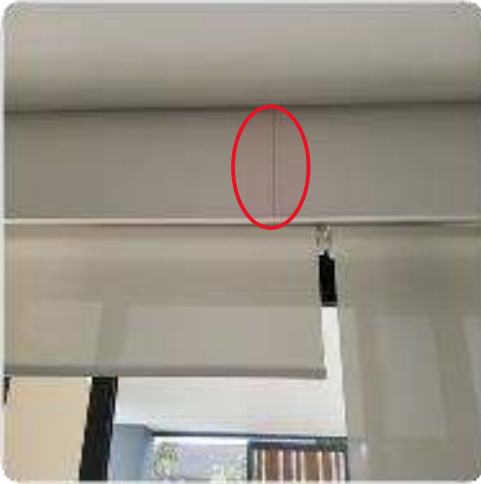
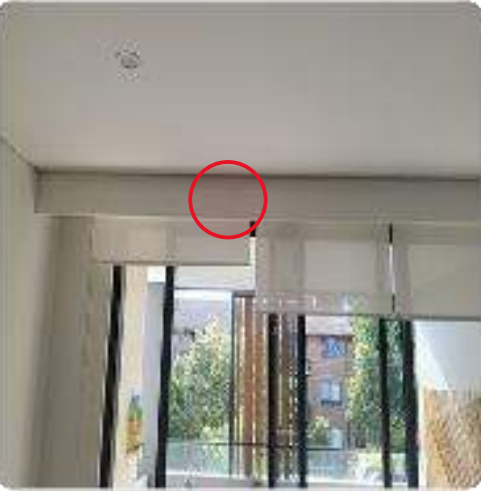
| ITEM | COMMENTARY | PHOTOGRAPH(S) |
|---|--|--|
| 2-103 | | |

| ITEM | COMMENTARY | PHOTOGRAPH(S) |
|---|--|--|
| A | <p>Location & Description Living room - Pelmet</p> <p>The Author has observed the paint repair to the living pelmet has not been completed.</p> <p>The Author is of the view, that the Builder has failure to complete the rectifications works.</p> | |
| B | <p>Cause(s)</p> <ul style="list-style-type: none"> • Failure of Builder to complete the rectifications works | |
| C | <p>Breach(es) <i>Failure to comply with the following:</i></p> <ul style="list-style-type: none"> ▪ Home Building Act 1989 (NSW) under Section 18B Clauses 1(a) ▪ Building contract – Defect liability period | |

| ITEM | COMMENTARY | PHOTOGRAPH(S) |
|---|--|--|
| D | <p>Proposed Rectification Scope of Works Allow to:</p> <ol style="list-style-type: none"> 1. Provide site supervision. Supervisor to coordinate access and facilitate the works throughout the whole process. 2. Gain access to required areas in accordance with Safework requirements. 3. Labour to complete paint repair to affected area 4. Supply paint ancillaries 5. Cover and protect adjacent surfaces during the rectification work. 6. Make good any surfaces affected as part of the works, to their prior condition. 7. Clean site and leave in a tidy condition upon completion of work | |

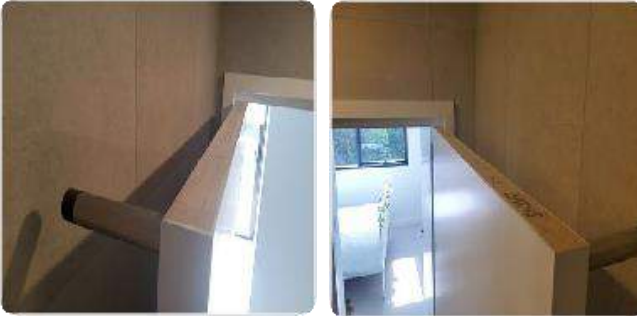
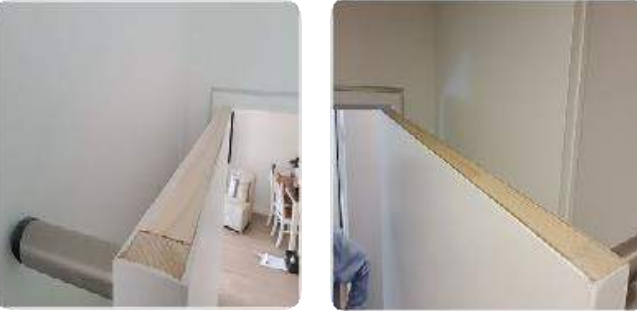
| ITEM | COMMENTARY | PHOTOGRAPH(S) |
|---|--|--|
| 3-103 | | |

| ITEM | COMMENTARY | PHOTOGRAPH(S) |
|---|--|--|
| A | <p>Location & Description Interior door throughout – Painting</p> <p>The Author has observed that the interior doors throughout have not been fully sealed.</p> <p>The Author is of the view, that the defect originated from poor workmanship employed by the Builder at the time of construction.</p> | |
| B | <p>Cause(s)</p> <ul style="list-style-type: none"> • Poor workmanship employed by Builder at the time of construction; | |
| C | <p>Breach(es) Failure to comply with the following:</p> <ul style="list-style-type: none"> ▪ Home Building Act 1989 (NSW) under Section 18B Clauses 1(a) &(b) ▪ AS/NZS2311:2009 'Guide to Painting of Buildings' ▪ NSW Guide to standards & tolerances 2017-9.6 Sealing of doors | |
| D | <p>Proposed Rectification Scope of Works Allow to:</p> <ol style="list-style-type: none"> 1. Provide site supervision. Supervisor to coordinate access and facilitate the works throughout the whole process. 2. Gain access to required areas in accordance with Safework requirements. 3. Cover and protect adjacent surfaces during the rectification work. 4. Labour to remove and reinstall doors following repair 5. Labour to apply paint system in accordance with AS2311:2009 'Guide to Painting of Buildings' 6. Supply paint and ancillaries 7. Make good any surfaces affected as part of the works, to their prior condition. 8. Clean site and leave in a tidy condition upon completion of work | <p>Images showing interior doors throughout have not fully sealed</p> |

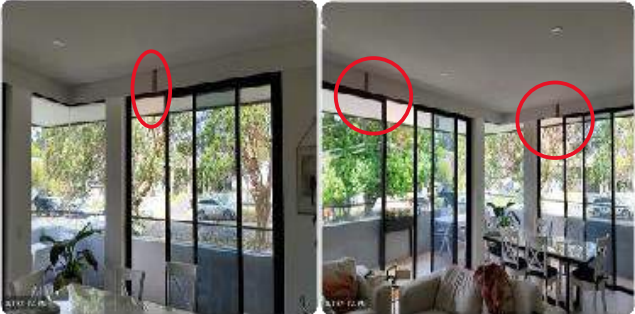
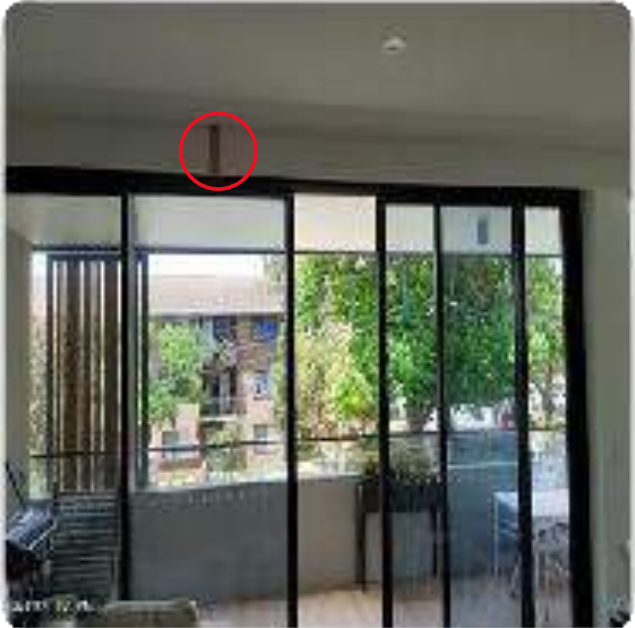
| ITEM | COMMENTARY | PHOTOGRAPH(S) |
|---|--|--|
| 1-104 | | |

| ITEM | COMMENTARY | PHOTOGRAPH(S) |
|---|--|--|
| A | <p>Location & Description Living room – Pelmet</p> <p>The Author has observed the paint repair to the living pelmet has not been completed.</p> <p>The Author is of the view, that the Builder has failure to complete the rectifications works.</p> | |
| B | <p>Cause(s)</p> <ul style="list-style-type: none"> • Failure of Builder to complete the rectifications works | |
| C | <p>Breach(es) <i>Failure to comply with the following:</i></p> <ul style="list-style-type: none"> ▪ Home Building Act 1989 (NSW) under Section 18B Clauses 1(a) ▪ Building contract – Defect liability period | |

| ITEM | COMMENTARY | PHOTOGRAPH(S) |
|---|--|--|
| D | <p>Proposed Rectification Scope of Works Allow to:</p> <ol style="list-style-type: none"> 1. Provide site supervision. Supervisor to coordinate access and facilitate the works throughout the whole process. 2. Gain access to required areas in accordance with Safework requirements. 3. Labour to complete paint repair to affected area 4. Supply paint ancillaries 5. Cover and protect adjacent surfaces during the rectification work. 6. Make good any surfaces affected as part of the works, to their prior condition. 7. Clean site and leave in a tidy condition upon completion of work | |

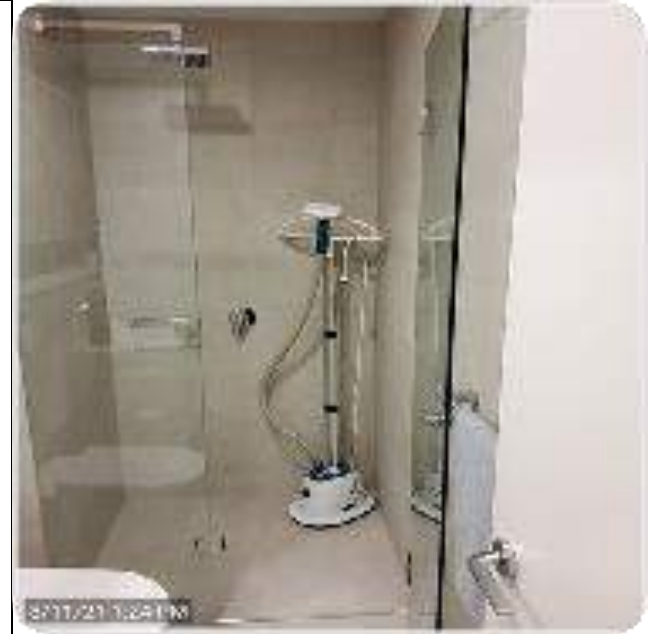
| ITEM | COMMENTARY | PHOTOGRAPH(S) |
|---|---|---|
| 2-104 | | |

| ITEM | COMMENTARY | PHOTOGRAPH(S) |
|---|---|---|
| A | <p>Location & Description Main bathroom – Towel rail</p> <p>The Author has observed that the bathroom shower screen door is striking the wall mounted metal towel rail.</p> <p>The Author is of the view, that there is a possibility that the shower rail may impact with glass and cause the glass to break creating a safety hazard to the occupants. The National Construction Code requires that a wet area be constructed to avoid the likelihood of the creation of any unhealthy or dangerous conditions.</p> <p>For clarity, please refer to the following extract from the National Construction Code 2016 Vol.2 F2.4.1</p> <div style="background-color: #fff9c4; padding: 5px;"> <p>F2.4.1 Wet areas A building is to be constructed to avoid the likelihood of—</p> <ul style="list-style-type: none"> (a) the creation of any unhealthy or dangerous conditions; or (b) damage to building elements, </div> | |
| B | <p>Cause(s)</p> <ul style="list-style-type: none"> • Failure of the Builder to carry out the works with due care and skill | |
| C | <p>Breach(es) Failure to comply with the following:</p> <ul style="list-style-type: none"> ▪ Home Building Act 1989 (NSW) under Section 18B Clauses 1(a) ▪ National Construction Code 2016 Vol.2 F2.4.1 | |

6. Following tile repair provide labour to reinstall existing towel rail clear of possible contact with shower screen door
7. Make good any surfaces affected as part of the works, to their prior condition.
8. Clean site and leave in a tidy condition upon completion of work

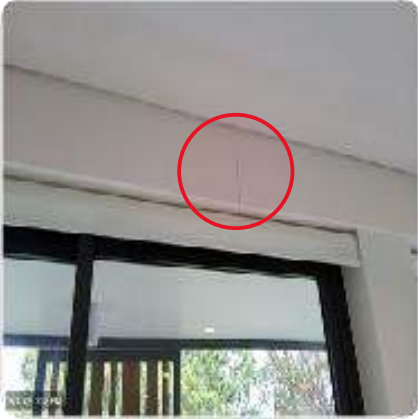
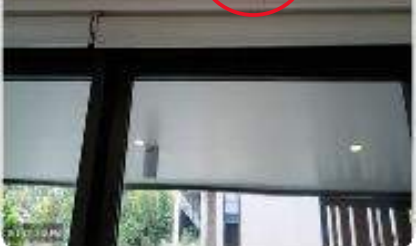
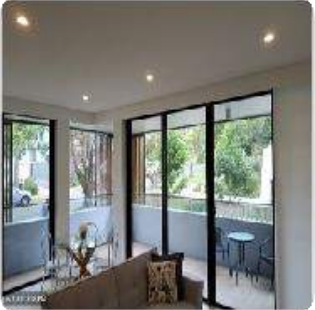
| ITEM | COMMENTARY | PHOTOGRAPH(S) |
|---|--|---|
| 1-105 | | |

| ITEM | COMMENTARY | PHOTOGRAPH(S) |
|---|--|---|
| A | <p>Location & Description Living room - Pelmet</p> <p>The Author has observed paint repair to the living pelmet has not been completed.</p> <p>The Author is of the view, that the Builder has failure to complete the rectifications works.</p> | |
| B | <p>Cause(s)</p> <ul style="list-style-type: none"> • Failure of Builder to complete the rectifications works | |
| C | <p>Breach(es) <i>Failure to comply with the following:</i></p> <ul style="list-style-type: none"> ▪ Home Building Act 1989 (NSW) under Section 18B Clauses 1(a) ▪ Building contract – Defect liability period | |

| ITEM | COMMENTARY | PHOTOGRAPH(S) |
|---|--|---|
| D | <p>Proposed Rectification Scope of Works Allow to:</p> <ol style="list-style-type: none"> 1. Provide site supervision. Supervisor to coordinate access and facilitate the works throughout the whole process. 2. Gain access to required areas in accordance with Safework requirements. 3. Labour to complete paint repair to affected area 4. Supply paint ancillaries 5. Cover and protect adjacent surfaces during the rectification work. 6. Make good any surfaces affected as part of the works, to their prior condition. 7. Clean site and leave in a tidy condition upon completion of work | |

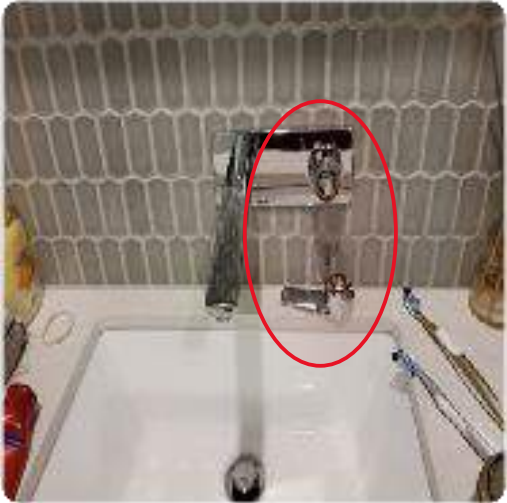
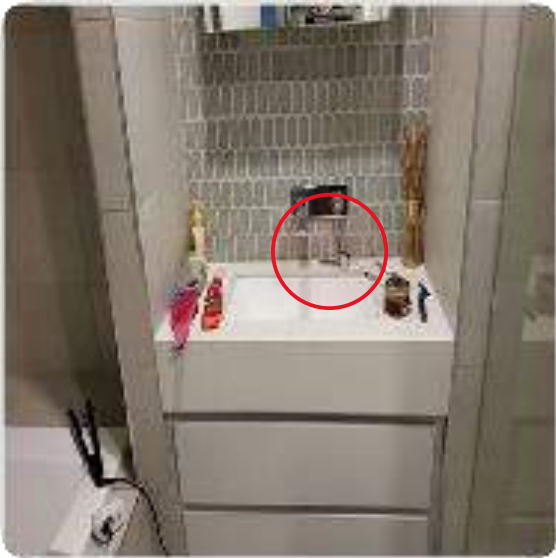
| ITEM | COMMENTARY | PHOTOGRAPH(S) |
|---|---|--|
| 1-106 | | |

| ITEM | COMMENTARY | PHOTOGRAPH(S) |
|---|---|--|
| A | <p>Location & Description Ensuite mixer tap handle</p> <p>The Author has observed that the ensuite mixer tap handle is loose.</p> <p>The Author is of the view, that the defect is the responsibility of the Builder under the building contract maintenance period and under Section 18E(1)(b) of the Home Building Act 1989.</p> | |
| B | <p>Cause(s)</p> <ul style="list-style-type: none"> Poor workmanship employed by Builder at the time of construction; | |
| C | <p>Breach(es) Failure to comply with the following:</p> <ul style="list-style-type: none"> Home Building Act 1989 (NSW) under Section 18B Clauses 1 (a) Building contract – Defect liability period | |

| ITEM | COMMENTARY | PHOTOGRAPH(S) |
|---|---|--|
| D | <p>Proposed Rectification Scope of Works Allow to:</p> <ol style="list-style-type: none"> Provide site supervision. Supervisor to coordinate access and facilitate the works throughout the whole process. Gain access to required areas in accordance with Safework requirements. Cover and protect adjacent surfaces during the rectification work. Labour to fix loose mixer tap handle Make good any surfaces affected as part of the works, to their prior condition. Clean site and leave in a tidy condition upon completion of work | |

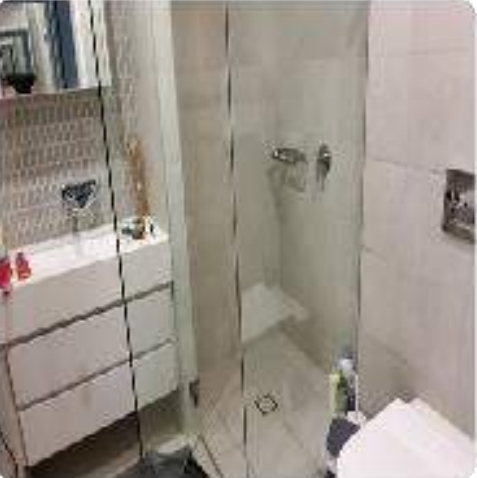
| ITEM | COMMENTARY | PHOTOGRAPH(S) |
|---|--|--|
| 2-106 | | |

| ITEM | COMMENTARY | PHOTOGRAPH(S) |
|---|--|--|
| A | <p>Location & Description Ensuite – Soap holder</p> <p>The Author has observed the soap holder in the shower is loose.</p> <p>The Author is of the view, that the defect is the responsibility of the Builder under the building contract maintenance period and under Section 18E(1)(b) of the Home Building Act 1989.</p> | |
| B | <p>Cause(s)</p> <ul style="list-style-type: none"> • Poor workmanship employed by Builder at the time of construction; | |
| C | <p>Breach(es)</p> <p><i>Failure to comply with the following:</i></p> <ul style="list-style-type: none"> ▪ Home Building Act 1989 (NSW) under Section 18B Clauses 1(a) ▪ Building contract – Defect liability period | |

| ITEM | COMMENTARY | PHOTOGRAPH(S) |
|---|--|--|
| D | <p>Proposed Rectification Scope of Works</p> <p>Allow to:</p> <ol style="list-style-type: none"> 1. Provide site supervision. Supervisor to coordinate access and facilitate the works throughout the whole process. 2. Gain access to required areas in accordance with Safework requirements. 3. Cover and protect adjacent surfaces during the rectification work. 4. Labour to fix loose soap holder 5. Make good any surfaces affected as part of the works, to their prior condition. 6. Clean site and leave in a tidy condition upon completion of work | |

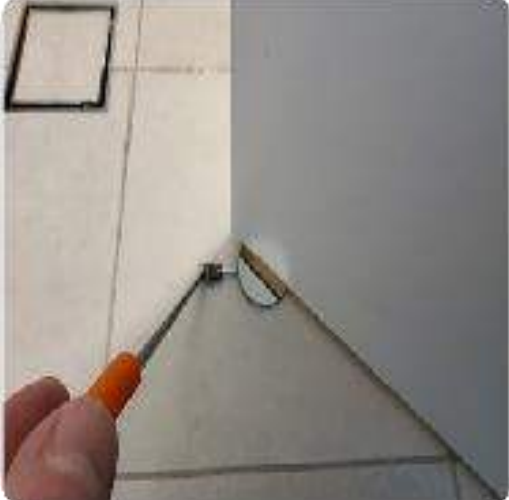
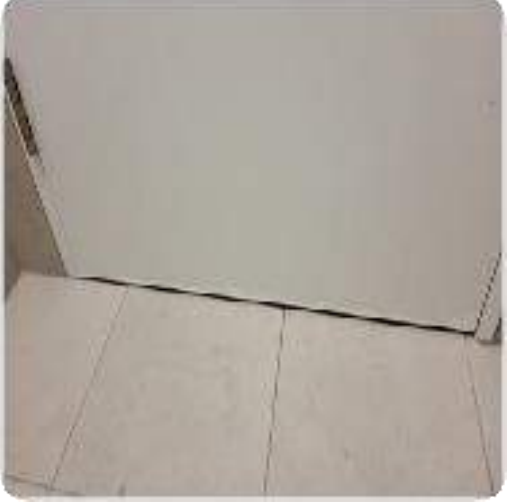
| ITEM | COMMENTARY | PHOTOGRAPH(S) |
|---|--|--|
| 3-106 | | |

| ITEM | COMMENTARY | PHOTOGRAPH(S) |
|---|--|--|
| A | <p>Location & Description Laundry door – Painting and moisture damage</p> <p>The Author has observed the laundry door is not fully sealed and the door leaf is swollen and distorted at top and bottom of door.</p> <p>The Author is of the view, defect originated due to poor workmanship employed by the Builder at the of construction and that the moisture damage is so significant the door requires replacement.</p> | |
| B | <p>Cause(s)</p> <ul style="list-style-type: none"> • Poor workmanship employed by Builder at the time of construction; • Failure of Builder to carry out the AS2311:2017 Guide to the painting of buildings | |
| C | <p>Breach(es) <i>Failure to comply with the following:</i></p> <ul style="list-style-type: none"> ▪ Home Building Act 1989 (NSW) under Section 18B Clauses (a) & (c); ▪ Building contract – Defect liability period ▪ AS2311:2017 Guide to the painting of buildings | |

| ITEM | COMMENTARY | PHOTOGRAPH(S) |
|---|--|--|
| D | <p>Proposed Rectification Scope of Works Allow to:</p> <ol style="list-style-type: none"> 1. Provide site supervision. Supervisor to coordinate access and facilitate the works throughout the whole process. 2. Gain access to required areas in accordance with Safework requirements. 3. Cover and protect adjacent surfaces during the rectification work. 4. Supply new door to replace defective door 5. Labour to remove defective door, install new door and existing door furniture 6. Labour to paint new door in accordance with AS2311:2017 Guide to the painting of buildings 7. Make good any surfaces affected as part of the works, to their prior condition. 8. Clean site and leave in a tidy condition upon completion of work 9. Dispose of building waste | |
