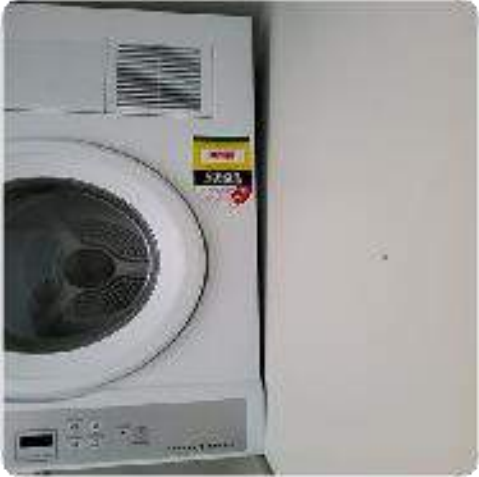
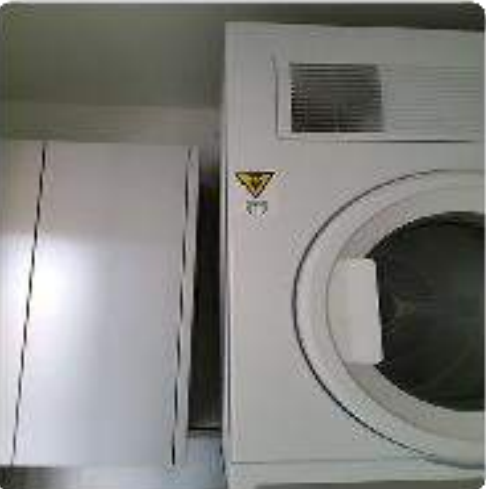
| ITEM | COMMENTARY | PHOTOGRAPH(S) |
|---|---|--|
| 4-106 | | |

| ITEM | COMMENTARY | PHOTOGRAPH(S) |
|---|---|--|
| A | <p>Location & Description Laundry – Dryer installation</p> <p>The Author has observed the clothes dryer has been installed out of level.</p> <p>The Author is of the view, The Author is of the view, that the defect is the responsibility of the Builder under the building contract maintenance period and under Section 18E(1)(b) of the Home Building Act 1989.</p> | |
| B | <p>Cause(s)</p> <ul style="list-style-type: none"> Poor workmanship employed by Builder at the time of construction | |
| C | <p>Breach(es) <i>Failure to comply with the following:</i></p> <ul style="list-style-type: none"> Home Building Act 1989 (NSW) under Section 18B Clauses 1 (a) Building contract – Annexure Part P_PPR_DOC-11134 pg.56 6.6.4 Laundry | |

| ITEM | COMMENTARY | PHOTOGRAPH(S) |
|---|---|--|
| D | <p>Proposed Rectification Scope of Works Allow to:</p> <ol style="list-style-type: none"> Provide site supervision. Supervisor to coordinate access and facilitate the works throughout the whole process. Gain access to required areas in accordance with Safework requirements. Cover and protect adjacent surfaces during the rectification work. Labour to remove clothes dryer, adjust wall fixture as required to make level and reinstall clothes dryer Make good any surfaces affected as part of the works, to their prior condition. Clean site and leave in a tidy condition upon completion of work | |

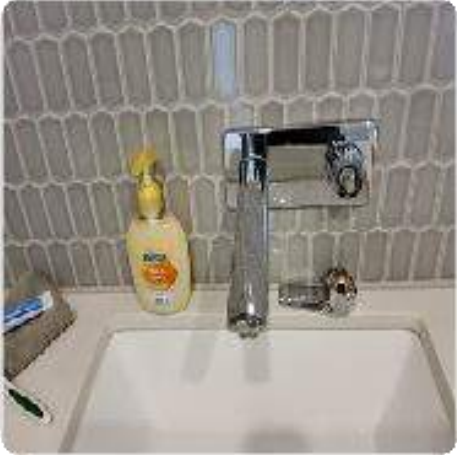
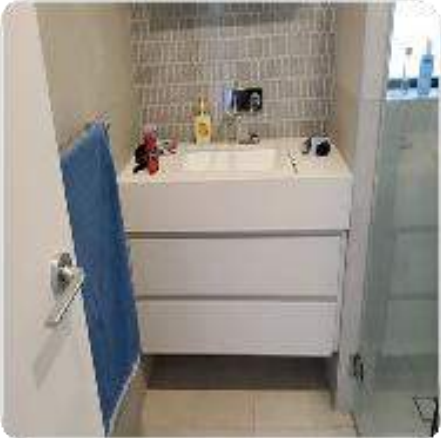
| ITEM | COMMENTARY | PHOTOGRAPH(S) |
|---|--|--|
| 5-106 | | |

| ITEM | COMMENTARY | PHOTOGRAPH(S) |
|---|--|--|
| A | <p>Location & Description Bathroom mixer tap handle</p> <p>The Author has observed the kitchen and ensuite mixer tap handles are loose.</p> <p>The Author is of the view, The Author is of the view, that the defect is the responsibility of the Builder under the building contract maintenance period and under Section 18E(1)(b) of the Home Building Act 1989.</p> | |
| B | <p>Cause(s)</p> <ul style="list-style-type: none"> Poor workmanship employed by Builder at the time of construction; | |
| C | <p>Breach(es) <i>Failure to comply with the following:</i></p> <ul style="list-style-type: none"> Home Building Act 1989 (NSW) under Section 18B Clauses 1 (a) Building contract – Defect liability period | |

| ITEM | COMMENTARY | PHOTOGRAPH(S) |
|---|--|--|
| D | <p>Proposed Rectification Scope of Works Allow to:</p> <ol style="list-style-type: none"> Provide site supervision. Supervisor to coordinate access and facilitate the works throughout the whole process. Gain access to required areas in accordance with Safework requirements. Cover and protect adjacent surfaces during the rectification work. Labour to fix loose mixer tap handle Make good any surfaces affected as part of the works, to their prior condition. Clean site and leave in a tidy condition upon completion of work | |

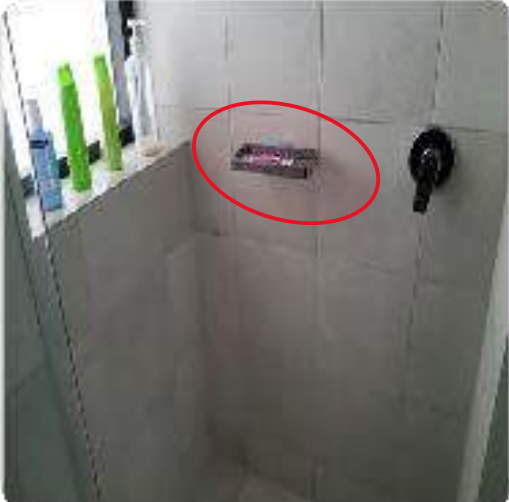
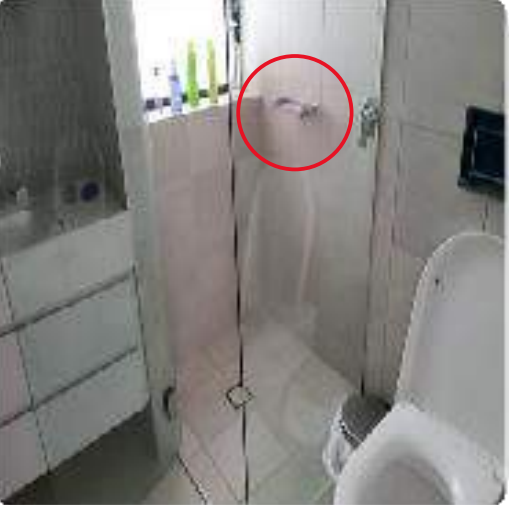
| ITEM | COMMENTARY | PHOTOGRAPH(S) |
|---|--|--|
| 6-106 | | |

| ITEM | COMMENTARY | PHOTOGRAPH(S) |
|---|--|--|
| A | <p>Location & Description Bathroom – Soap holder</p> <p>The Author has observed the soap holder in the shower is loose.</p> <p>The Author is of the view, that the defect is the responsibility of the Builder under the building contract maintenance period and under Section 18E(1)(b) of the Home Building Act 1989.</p> | |
| B | <p>Cause(s)</p> <ul style="list-style-type: none"> • Failure of Builder to that the Builder has failed to complete the works in accordance with building contract specifications. | |
| C | <p>Breach(es) <i>Failure to comply with the following:</i></p> <ul style="list-style-type: none"> ▪ Home Building Act 1989 (NSW) under Section 18B Clauses 1(a) ▪ Building contract – Defect liability period | |

| ITEM | COMMENTARY | PHOTOGRAPH(S) |
|---|--|--|
| D | <p>Proposed Rectification Scope of Works Allow to:</p> <ol style="list-style-type: none"> 1. Provide site supervision. Supervisor to coordinate access and facilitate the works throughout the whole process. 2. Gain access to required areas in accordance with Safework requirements. 3. Cover and protect adjacent surfaces during the rectification work. 4. Labour to fix loose soap holder 5. Make good any surfaces affected as part of the works, to their prior condition. 6. Clean site and leave in a tidy condition upon completion of work | |

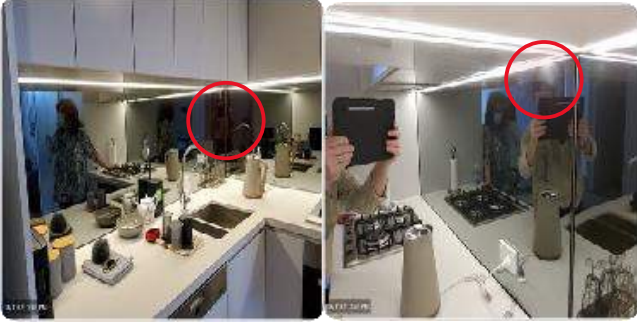
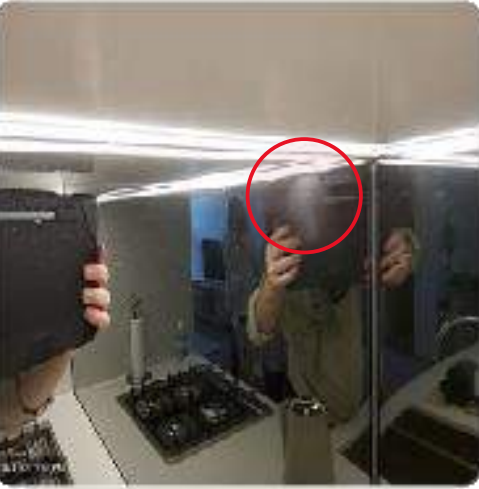
| ITEM | COMMENTARY | PHOTOGRAPH(S) |
|---|---|--|
| 1-107 | | |

| ITEM | COMMENTARY | PHOTOGRAPH(S) |
|---|---|--|
| A | <p>Location & Description</p> <p>Kitchen splash back – Damage</p> <p>The occupant reported to the Author at the time of inspection, that there was blemish mark to the glass splash back at the southwest corner that originated from repairs carried out by the Builder to rectify damage identified prior to handover.</p> <p>The Author has assumed that the occupants statement is true and correct.</p> | |
| B | <p>Cause(s)</p> <ul style="list-style-type: none"> Poor workmanship employed by Builder at the time of construction | |
| C | <p>Breach(es)</p> <p>Failure to comply with the following:</p> <ul style="list-style-type: none"> Home Building Act 1989 (NSW) under Section 18B Clauses 1(a) NSW standards & tolerances 2017 – Damage by Builder | |

| ITEM | COMMENTARY | PHOTOGRAPH(S) |
|---|---|--|
| D | <p>Proposed Rectification Scope of Works</p> <p>Allow to:</p> <ol style="list-style-type: none"> Provide site supervision. Supervisor to coordinate access and facilitate the works throughout the whole process. Gain access to required areas in accordance with Safework requirements. Cover and protect adjacent surfaces during the rectification work. Supply and install new splash back Make good any surfaces affected as part of the works, to their prior condition. Clean site and leave in a tidy condition upon completion of work | |

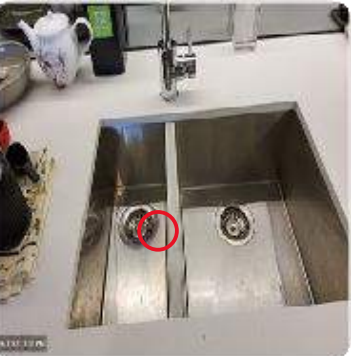
| ITEM | COMMENTARY | PHOTOGRAPH(S) |
|---|---|--|
| A | <p>Location & Description Kitchen sink – Damage</p> <p>The lot owner reported to the Author at the time of inspection, that the dint to the side of drain in the kitchen sink was reported to the Builder prior to hand over.</p> <p>The Author has assumed that the lot owners statement is true and correct.</p> | |
| B | <p>Cause(s)</p> <ul style="list-style-type: none"> Poor workmanship employed by Builder at the time of construction; | |
| C | <p>Breach(es) Failure to comply with the following:</p> <ul style="list-style-type: none"> Home Building Act 1989 (NSW) under Section 18B Clauses 1 (a) NSW Guide to Standards & Tolerances 2017 G – Responsibility to rectify – Builders are liable to repair damage caused to property in the course of completing their building work. | |

| ITEM | COMMENTARY | PHOTOGRAPH(S) |
|---|---|--|
| D | <p>Proposed Rectification Scope of Works Allow to:</p> <ol style="list-style-type: none"> Provide site supervision. Supervisor to coordinate access and facilitate the works throughout the whole process. Gain access to required areas in accordance with Safework requirements. Cover and protect adjacent surfaces during the rectification work. Labour to remove and install new kitchen sink Supply new kitchen sink Make good any surfaces affected as part of the works, to their prior condition. Clean site and leave in a tidy condition upon completion of work | |

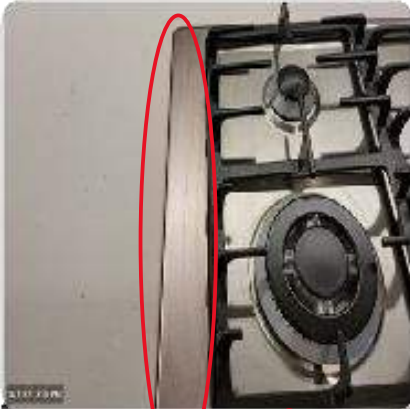
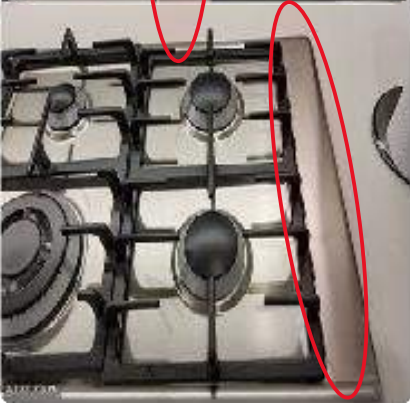
| ITEM | COMMENTARY | PHOTOGRAPH(S) |
|---|--|---|
| 4-107 | | |

| ITEM | COMMENTARY | PHOTOGRAPH(S) |
|---|--|---|
| A | <p>Location & Description</p> <p>Kitchen - Stainless steel cook top</p> <p>It was reported to the Author by the lot owners at the time of inspection, that the cooktop had scratchers identified prior to handover.</p> <p>The Author has assumed that the lot owners statement is true and correct.</p> | |
| B | <p>Cause(s)</p> <ul style="list-style-type: none"> Poor workmanship employed by Builder at the time of construction; | |
| C | <p>Breach(es)</p> <p><i>Failure to comply with the following:</i></p> <ul style="list-style-type: none"> <i>Home Building Act 1989 (NSW) under Section 18B Clauses 1 (a)</i> <i>NSW Guide to Standards & Tolerances 2017 G – Responsibility to rectify – Builders are liable to repair damage caused to property in the course of completing their building work.</i> | |

| ITEM | COMMENTARY | PHOTOGRAPH(S) |
|---|--|---|
| D | <p>Proposed Rectification Scope of Works</p> <p>Allow to:</p> <ol style="list-style-type: none"> Provide site supervision. Supervisor to coordinate access and facilitate the works throughout the whole process. Gain access to required areas in accordance with Safework requirements. Cover and protect adjacent surfaces during the rectification work. Labour to remove and install new cooktop Supply new cook top Make good any surfaces affected as part of the works, to their prior condition. Clean site and leave in a tidy condition upon completion of work | |

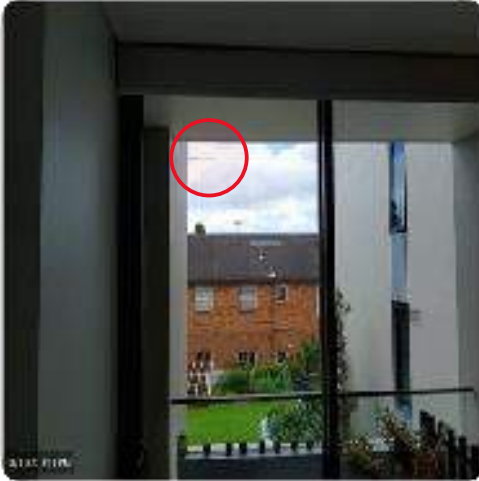
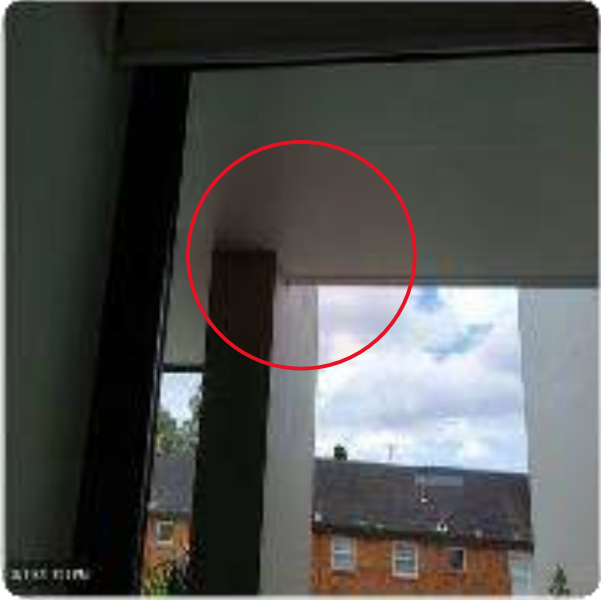
| ITEM | COMMENTARY | PHOTOGRAPH(S) |
|---|---|--|
| 5-107 | | |

| ITEM | COMMENTARY | PHOTOGRAPH(S) |
|---|---|--|
| A | <p>Location & Description Bedroom sliding door The Author observed at the time of inspection, scratches, and blemishes to the upper the glass panel to the western sliding sash in the bedroom.</p> <p>The lot owner reported to the Author at the inspection, the damage originated during repairs carried out by the Builder on other items identified prior to handover.</p> <p>The Author has assumed to the lot owners statement are true and correct.</p> | |
| B | <p>Cause(s)</p> <ul style="list-style-type: none"> Poor workmanship employed by Builder to carry out repairs | |
| C | <p>Breach(es) <i>Failure to comply with the following:</i></p> <ul style="list-style-type: none"> Home Building Act 1989 (NSW) under Section 18B Clauses 1(a) NSW Guide to Standards & Tolerances 2017 G – Responsibility to rectify – Builders are liable to repair damage caused to property in the course of completing their building work. | |

| ITEM | COMMENTARY | PHOTOGRAPH(S) |
|---|---|--|
| D | <p>Proposed Rectification Scope of Works Allow to:</p> <ol style="list-style-type: none"> Provide site supervision. Supervisor to coordinate access and facilitate the works throughout the whole process. Gain access to required areas in accordance with Safework requirements. Cover and protect adjacent surfaces during the rectification work. Remove existing glass, supply and install new equivalent glass panel with indicator motif Dispose of building waste Make good any surfaces affected as part of the works, to their prior condition. Clean site and leave in a tidy condition upon completion of work | |

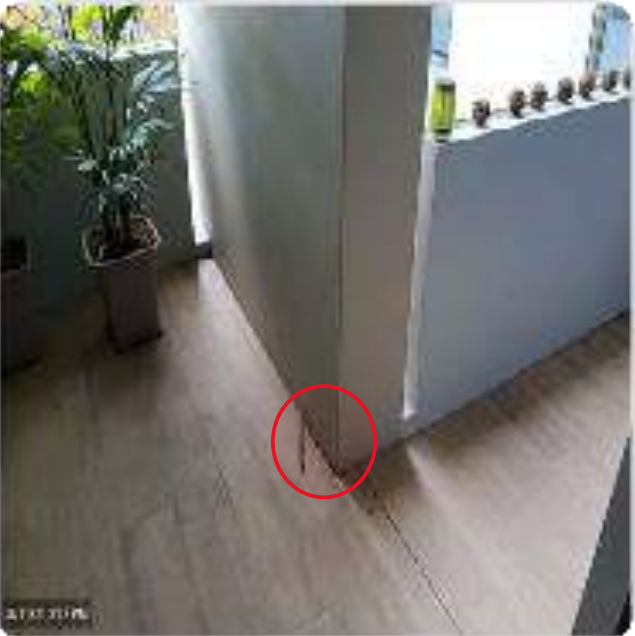
| ITEM | COMMENTARY | PHOTOGRAPH(S) |
|---|--|---|
| 6-107 | | |

| ITEM | COMMENTARY | PHOTOGRAPH(S) |
|---|--|---|
| A | <p>Location & Description Balcony – Waterproofing</p> <p>The lot owner reported to the Author at the time of inspection, flexible sealant removed at the base at the floor tile junction to the western side of the rendered column at the centre of the balcony, was removed by the Builder to carry out invasive testing to investigate the cause of moisture damage to the light weight rendered column that extends to the ground floor below and to the levels above.</p> <p>On inspection the Author found no evidence that the waterproofing membrane to the balcony floor return and terminated at a level above the tiled surface.</p> <p>In the Authors view, further investigation should be undertaken to determine if the waterproofing membrane has been terminated above the tiles surface and if possible whether moisture migration has been caused by a failure to install the waterproofing to the balcony in accordance with AS4654.2</p> <p>The Author has determined the proposed scope of works in relation to this item on an 'if found basis' and has included to conduct an invasive testing to investigate the cause of the defect.</p> | |
| B | <p>Cause(s)</p> <ul style="list-style-type: none"> • Poor workmanship employed by Builder at the time of construction; • Failure of Builder to carry out the waterproofing in accordance with AS4654.2 | |
| C | <p>Breach(es) <i>Failure to comply with the following:</i></p> <ul style="list-style-type: none"> ▪ Home Building Act 1989 (NSW) under Section 18B Clauses (a) & (c); ▪ AS4654.2:2012 Waterproofing membranes for external above-ground use Part 2: Design and installation | |

| D | <p>Proposed Rectification Scope of Works</p> <p>Allow to:</p> <p>If found waterproofing is defective</p> <ol style="list-style-type: none">1. Provide site supervision. Supervisor to coordinate access and facilitate the works throughout the whole process.2. Gain access to required areas in accordance with Safework requirements.3. Labour to demolish and remove tiling, tile bed (screed) to nearest junction4. Labour to expose concrete slab substrate, remove demolition waste and place in waste bin for disposal5. Labour to grind concrete surface and prepare surface for new waterproofing system6. Labour to apply waterproofing system in accordance with AS4654.1&2 to affected area and as to building contract specifications7. Labour to repair render8. Supply Dulux render materials9. Labour to place sand and cement tile screed and provide positive falls to drainage inlets in accordance with AS3958.1 and in accordance with building contract specifications10. Labour to mix sand and cement for tile screed and assist trades11. Supply sand and cement for tile screed12. Supply 'Efflock' to prevent efflorescence13. Supply and apply waterproofing system on top of tile bed to prevent efflorescence as to building contract specifications14. Supply and install preformed tile movement joint in accordance with AS3958.1 and building contract specifications if required15. Supply and fix new selected tiles and grout in accordance with AS3958.1:2007 and building contract specifications16. Supply 'Efflock' for tile adhesive and grouts to prevent efflorescence17. Labour to repair paint work to affected finishes18. Supply paint and ancillaries19. Remove and dispose of all building waste20. Make good any surfaces affected as part of the works, to their prior condition.21. Clean site and leave in a tidy condition upon completion of work | |

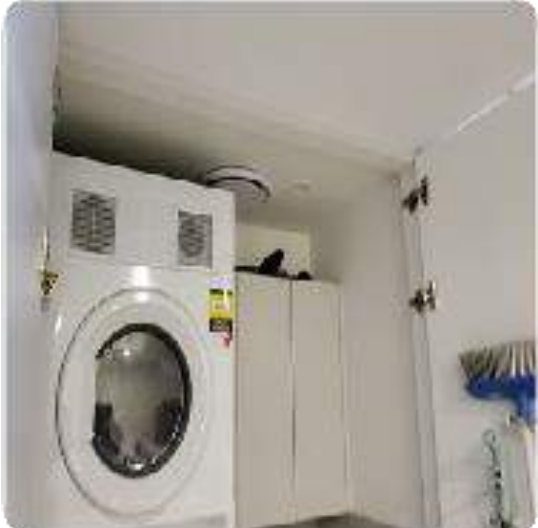
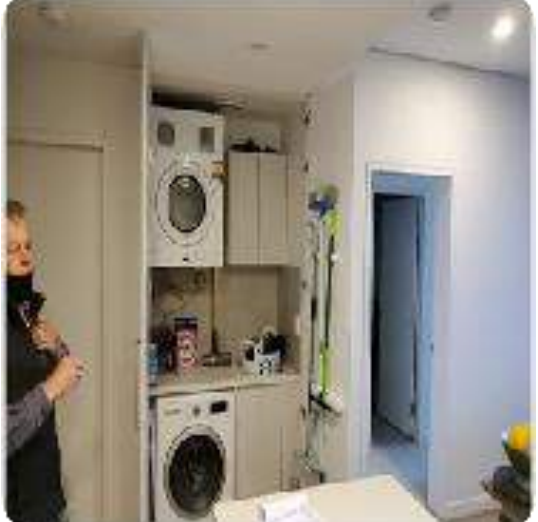
| ITEM | COMMENTARY | PHOTOGRAPH(S) |
|---|---|--|
| 2-201 | | |

| ITEM | COMMENTARY | PHOTOGRAPH(S) |
|---|---|--|
| A | <p>Location & Description Laundry – Mechanical ventilation</p> <p>The occupant reported to the Author at the time of inspection, that the exhaust fan in the laundry area was discharge from the from the bathroom when the shower bathroom fan is in use and condensation forms within the laundry cabinet</p> <p>The Author is of the view, the Builder has failure to carry out the works in accordance with AS1668.2 Mechanical ventilation for acceptable air quality, and that the issue in relation to the ducting of the exhaust requires investigation by a suitably qualified contract to determine the cause.</p> | |
| B | <p>Cause(s)</p> <ul style="list-style-type: none"> • Poor workmanship employed by Builder at the time of construction; • Failure of Builder to carry out the works in accordance with AS1668.2 Mechanical ventilation for acceptable air quality. • Failure of the Builder to carry out the works in accordance with the National Construction Code 2016 Vol1 F4.5 Ventilation of rooms | |
| C | <p>Breach(es) <i>Failure to comply with the following:</i></p> <ul style="list-style-type: none"> ▪ Home Building Act 1989 (NSW) under Section 18B Clauses (a) & (c); ▪ AS1668.2 Mechanical ventilation for acceptable air quality ▪ National Construction Code 2016 Vol1 F4.5 Ventilation of rooms | |

| ITEM | COMMENTARY | PHOTOGRAPH(S) |
|---|---|--|
| D | <p>Proposed Rectification Scope of Works Allow to:</p> <ol style="list-style-type: none"> 1. Provide site supervision. Supervisor to coordinate access and facilitate the works throughout the whole process. 2. Gain access to required areas in accordance with Safework requirements. 3. Cover and protect adjacent surfaces during the rectification work. 4. Labour to investigate cause of defect 5. Make good any surfaces affected as part of the works, to their prior condition. 6. Clean site and leave in a tidy condition upon completion of work | |

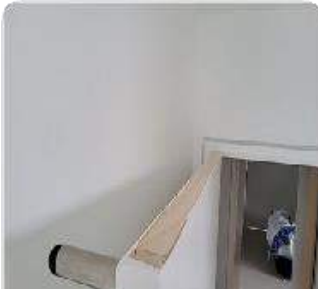
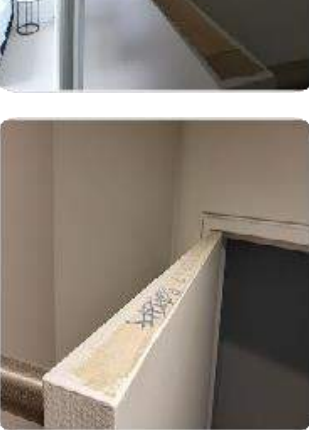
| ITEM | COMMENTARY | PHOTOGRAPH(S) | |
|---|--|--|---|
| 1-202 | | | |

| ITEM | COMMENTARY | PHOTOGRAPH(S) | |
|---|--|--|---|
| A | <p>Location & Description Doors throughout interior – Painting</p> <p>The Author has observed doors throughout have not been fully sealed.</p> <p>The Author is of the view, that the defect originated due to poor workmanship employed by the Builder at the time of construction.</p> | | |
| B | <p>Cause(s)</p> <ul style="list-style-type: none"> Poor workmanship employed by Builder at the time of construction | | |
| C | <p>Breach(es)</p> <p><i>Failure to comply with the following:</i></p> <ul style="list-style-type: none"> Home Building Act 1989 (NSW) under Section 18B Clauses (a) & (c); NSW standards & tolerances 2017 – Painting AS2311:2017 Guide to the painting of buildings | | |

| ITEM | COMMENTARY | PHOTOGRAPH(S) | |
|---|--|--|---|
| D | <p>Proposed Rectification Scope of Works</p> <p>Allow to:</p> <ol style="list-style-type: none"> Provide site supervision. Supervisor to coordinate access and facilitate the works throughout the whole process. Gain access to required areas in accordance with Safework requirements. Cover and protect adjacent surfaces during the rectification work. Labour to remove and reinstall doors following repair Labour to apply paint system in accordance with AS2311:2009 'Guide to Painting of Buildings' Supply paint and ancillaries Make good any surfaces affected as part of the works, to their prior condition. Clean site and leave in a tidy condition upon completion of work | | |

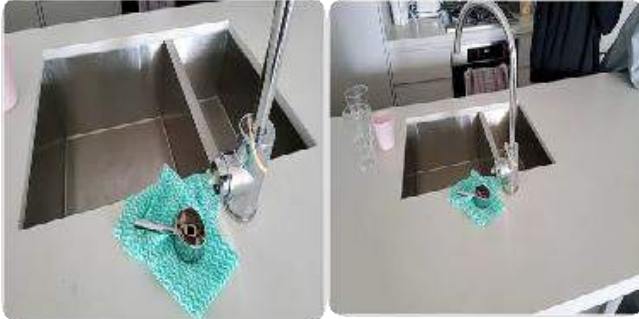
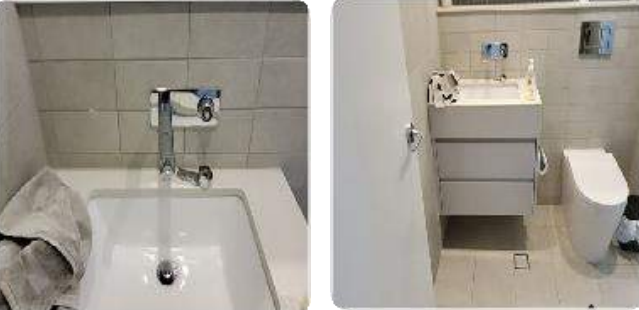
| ITEM | COMMENTARY | PHOTOGRAPH(S) |
|---|---|---|
| 2-202 | | |

| ITEM | COMMENTARY | PHOTOGRAPH(S) |
|---|---|---|
| A | <p>Location & Description Kitchen and ensuite mixer tap handles</p> <p>The Author has observed the kitchen and ensuite mixer tap handles are loose.</p> <p>The Author is of the view, The Author is of the view, that the defect is the responsibility of the Builder under the building contract maintenance period and under Section 18E(1)(b) of the Home Building Act 1989.</p> | |
| B | <p>Cause(s)</p> <ul style="list-style-type: none"> • Poor workmanship employed by Builder at the time of construction; • Failure of Builder to carry out the • | |
| C | <p>Breach(es) Failure to comply with the following:</p> <ul style="list-style-type: none"> ▪ Home Building Act 1989 (NSW) under Section 18B Clauses 1 (a) ▪ Building contract – Defect liability period | |

| ITEM | COMMENTARY | PHOTOGRAPH(S) |
|---|---|---|
| D | <p>Proposed Rectification Scope of Works Allow to:</p> <ol style="list-style-type: none"> 1. Provide site supervision. Supervisor to coordinate access and facilitate the works throughout the whole process. 2. Gain access to required areas in accordance with Safework requirements. 3. Cover and protect adjacent surfaces during the rectification work. 4. Labour to fix loose mixer tap handle 5. Make good any surfaces affected as part of the works, to their prior condition. 6. Clean site and leave in a tidy condition upon completion of work | |

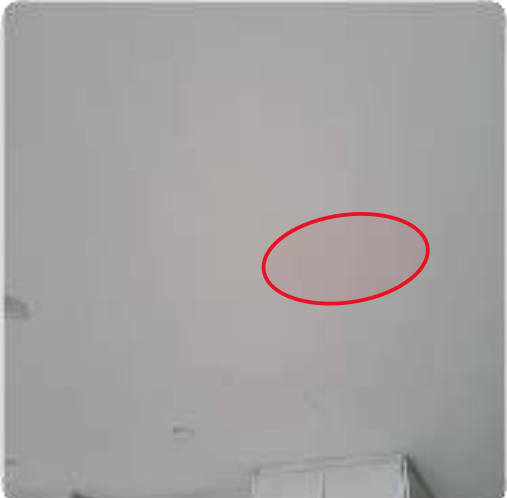
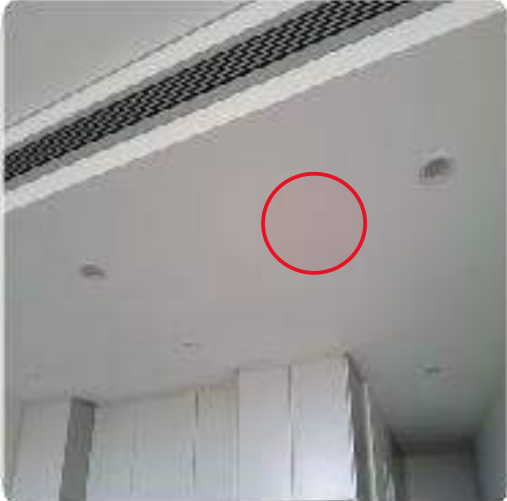
| ITEM | COMMENTARY | PHOTOGRAPH(S) |
|---|--|--|
| 3-202 | | |

| ITEM | COMMENTARY | PHOTOGRAPH(S) |
|---|--|--|
| A | <p>Location & Description Kitchen ceiling – Painting</p> <p>The Author observed at the time of inspection, blisters to the paint finish on the ceiling in the kitchen.</p> <p>The Author is of the view, that the defect originated due to poor workmanship employed by the Builder at the time of construction.</p> | |
| B | <p>Cause(s)</p> <ul style="list-style-type: none"> Poor workmanship employed by Builder at the time of construction; | |
| C | <p>Breach(es) Failure to comply with the following:</p> <ul style="list-style-type: none"> Home Building Act 1989 (NSW) under Section 18B Clauses (a) & (c); AS2311:2017 Guide to the painting of buildings NSW standards & tolerances 2017 – 13.2 Surface finish of paintwork Paintwork is defective if the application has blemishes such as paint runs, paint sags, wrinkling, dust, bare or starved painted areas, colour variations, surface cracks, irregular and coarse brush marks, sanding marks, blistering, non-uniformity of gloss level and other irregularities in the surface that are visible from a normal viewing position. (Highlighting added) | |

| ITEM | COMMENTARY | PHOTOGRAPH(S) |
|---|--|--|
| D | <p>Proposed Rectification Scope of Works Allow to:</p> <ol style="list-style-type: none"> Provide site supervision. Supervisor to coordinate access and facilitate the works throughout the whole process. Gain access to required areas in accordance with Safework requirements. Cover and protect adjacent surfaces during the rectification work. Labour to patch and repair paint finish in accordance with AS2311:2017 Guide to the painting of buildings Supply paint and ancillaries Make good any surfaces affected as part of the works, to their prior condition. Clean site and leave in a tidy condition upon completion of work | |

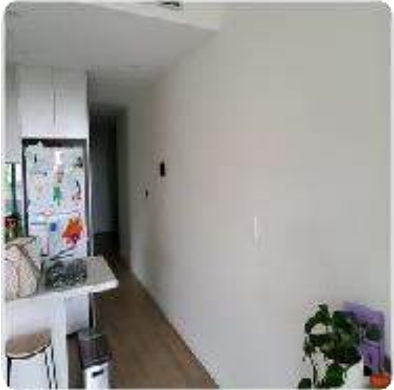
| ITEM | COMMENTARY | PHOTOGRAPH(S) |
|---|--|--|
| A | <p>Location & Description Main hallway northern wall – Painting</p> <p>The Author has observed the main entry hallway northern wall has uneven paint cover.</p> <p>The Author is of the view, that the defect originated from poor workmanship employed by the Builder at the time of construction.</p> | |
| B | <p>Cause(s)</p> <ul style="list-style-type: none"> • Poor workmanship employed by Builder at the time of construction | |
| C | <p>Breach(es) <i>Failure to comply with the following:</i></p> <ul style="list-style-type: none"> ▪ Home Building Act 1989 (NSW) under Section 18B Clauses (a) & (c); ▪ AS2311:2017 Guide to the painting of buildings ▪ NSW standards & tolerances 2017 – 13.2 Surface finish of paintwork <p><i>Paintwork is defective if the application has blemishes such as paint runs, paint sags, wrinkling, dust, bare or starved painted areas, colour variations, surface cracks, irregular and coarse brush marks, sanding marks, blistering, non-uniformity of gloss level and other irregularities in the surface that are visible from a normal viewing position. (Highlighting added)</i></p> | |

| ITEM | COMMENTARY | PHOTOGRAPH(S) |
|---|--|--|
| D | <p>Proposed Rectification Scope of Works Allow to:</p> <ol style="list-style-type: none"> 1. Provide site supervision. Supervisor to coordinate access and facilitate the works throughout the whole process. 2. Gain access to required areas in accordance with Safework requirements. 3. Cover and protect adjacent surfaces during the rectification work. 4. Labour to patch, repair and apply paint in accordance with AS2311:2017 Guide to the painting of buildings 5. Supply paint and ancillaries 6. Make good any surfaces affected as part of the works, to their prior condition. 7. Clean site and leave in a tidy condition upon completion of work | |

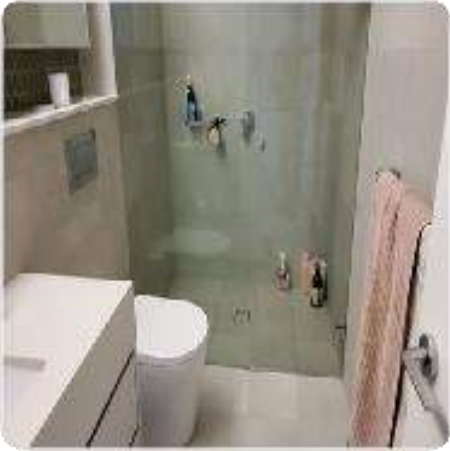
| ITEM | COMMENTARY | PHOTOGRAPH(S) |
|---|--|--|
| 2-204 | | |

| ITEM | COMMENTARY | PHOTOGRAPH(S) |
|---|--|--|
| A | <p>Location & Description Ensuite shower screen</p> <p>The Author has observed water leaks at the bottom of the fixed shower screen in the ensuite, the silicone to the bottom of the shower screen towards the door has gaps</p> <p>The Author is of the view, that the defect originated from poor workmanship employed by the Builder at the time of construction.</p> | |
| B | <p>Cause(s)</p> <ul style="list-style-type: none"> Poor workmanship employed by Builder at the time of construction | |
| C | <p>Breach(es) Failure to comply with the following:</p> <ul style="list-style-type: none"> Home Building Act 1989 (NSW) under Section 18B Clauses 1 (a) Building contract - Defect liability period – Product warranty | |

| ITEM | COMMENTARY | PHOTOGRAPH(S) |
|---|--|--|
| D | <p>Proposed Rectification Scope of Works Allow to:</p> <ol style="list-style-type: none"> Provide site supervision. Supervisor to coordinate access and facilitate the works throughout the whole process. Gain access to required areas in accordance with Safework requirements. Cover and protect adjacent surfaces during the rectification work. Labour to apply construction adhesive waterproofing sealant Supply construction adhesive waterproofing sealant Make good any surfaces affected as part of the works, to their prior condition. Clean site and leave in a tidy condition upon completion of work | |

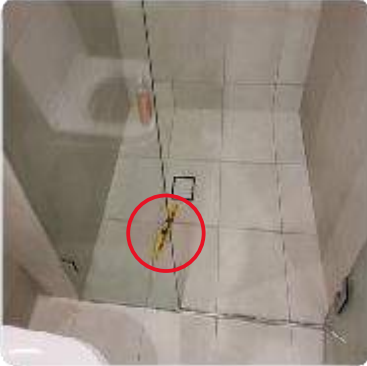
| ITEM | COMMENTARY | PHOTOGRAPH(S) | |
|---|--|---|--|
| 3-204 | | | |

| ITEM | COMMENTARY | PHOTOGRAPH(S) | |
|---|--|---|--|
| A | <p>Location & Description Main bathroom shower floor tiling</p> <p>The Author has observed water is ponding on the eastern side of the drain the main bathroom shower. The Author conducted testing with a spirit level and found there was insufficient fall on the tile surface to the eastern side of the drain.</p> <p>The Author is of the view, that the defect originated due to poor workmanship employed by the Builder at the time of construction.</p> | | |
| B | <p>Cause(s)</p> <ul style="list-style-type: none"> • Poor workmanship employed by Builder at the time of construction • Failure of Builder to carry out the tiling in accordance with AS3958.1:2007 and in accordance with building contract specifications | | |
| C | <p>Breach(es) Failure to comply with the following:</p> <ul style="list-style-type: none"> ▪ Home Building Act 1989 (NSW) under Section 18B Clauses (a) & (c); ▪ AS3958.1 Fall in floor finishes D1 General – Falls in floor finishes is to ensure water does not remain on the finish floor in a manner that can adversely affect the health or amenity of the occupants or deteriorate building elements. ▪ The Builder has failed to carry out the works in accordance with the building contract specifications | | |

| ITEM | COMMENTARY | PHOTOGRAPH(S) | |
|---|--|---|--|
| D | <p>Proposed Rectification Scope of Works Allow to:</p> <ol style="list-style-type: none"> 1. Provide site supervision. Supervisor to coordinate access and facilitate the works throughout the whole process. 2. Gain access to required areas in accordance with Safework 3. Cover and protect adjacent surfaces during the rectification work 4. Labour to remove shower screen and store in a secure location 5. Labour to demolish floor and wall tiling to provide access for rectification of defective tiling 6. Labour to demolish and remove tile screed and waterproofing membrane and prepare substrate for new waterproofing system and tile screed 7. Supply water resistant fibre cement wall linings same size as existing | | |

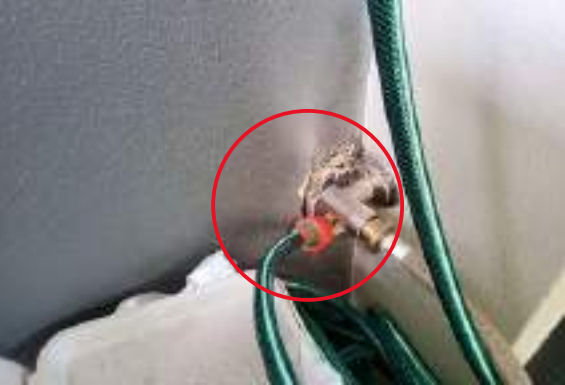
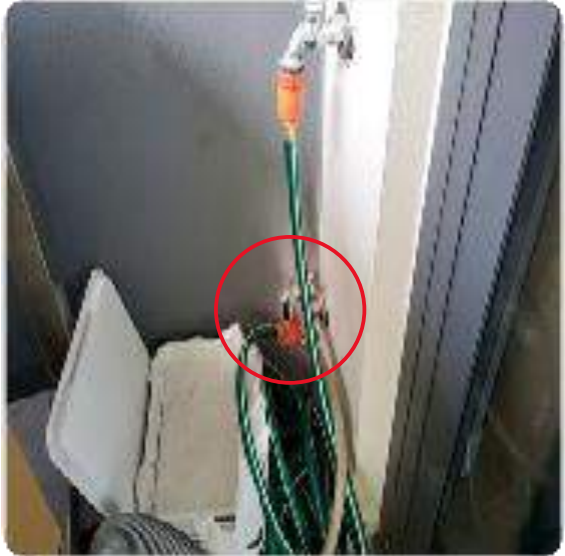
| ITEM | COMMENTARY | PHOTOGRAPH(S) |
|---|---|--|
| 2-205 | | |

| ITEM | COMMENTARY | PHOTOGRAPH(S) |
|---|---|--|
| A | <p>Location & Description Western side of balcony – Damage</p> <p>The Author has observed the gas barbecue points repair work that the occupant reported at the time of inspection was carried out by the Builder has damaged the balcony party wall.</p> <p>The Author is of the view, that the damage originated due to poor workmanship employed by the Builder to carry out repairs.</p> | |
| B | <p>Cause(s)</p> <ul style="list-style-type: none"> Poor workmanship employed by Builder at the time of construction | |
| C | <p>Breach(es)</p> <p><i>Failure to comply with the following:</i></p> <ul style="list-style-type: none"> <i>Home Building Act 1989 (NSW) under Section 18B Clauses 1 (a);</i> <i>NSW Guide to Standards & Tolerances 2017 G – Responsibility to rectify – Builders are liable to repair damage caused to property in the course of completing their building work.</i> | |

| ITEM | COMMENTARY | PHOTOGRAPH(S) |
|---|---|--|
| D | <p>Proposed Rectification Scope of Works</p> <p>Allow to:</p> <ol style="list-style-type: none"> Provide site supervision. Supervisor to coordinate access and facilitate the works throughout the whole process. Gain access to required areas in accordance with Safework requirements. Cover and protect adjacent surfaces during the rectification work. Labour to patch and repair wall lining and render finish in accordance with Dulux render system Supply Dulux render materials and ancillaries Make good any surfaces affected as part of the works, to their prior condition. Clean site and leave in a tidy condition upon completion of work | |

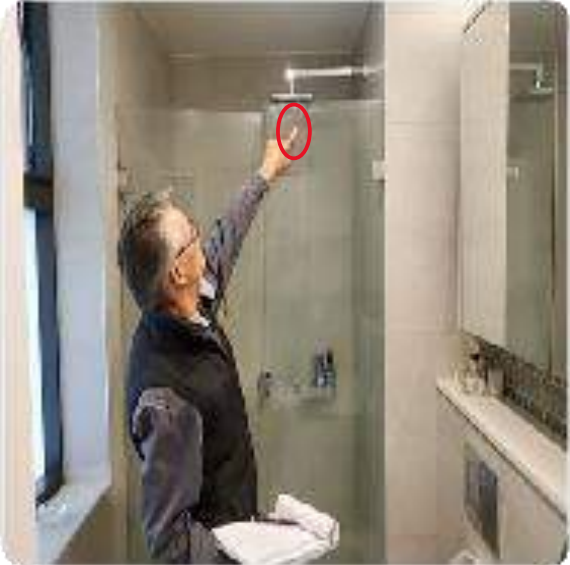
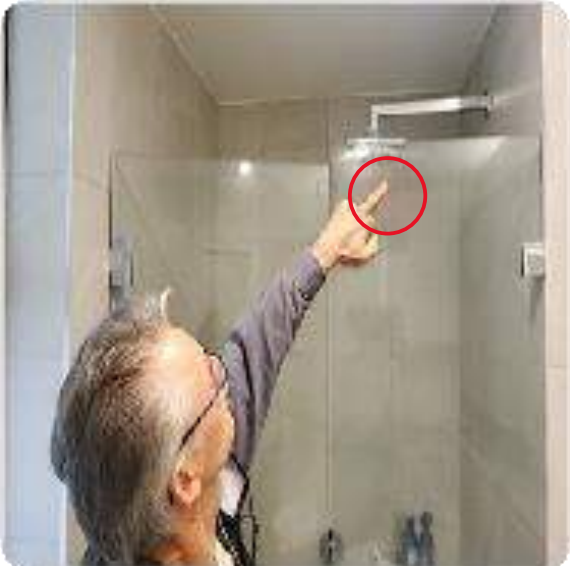
| ITEM | COMMENTARY | PHOTOGRAPH(S) |
|---|--|--|
| 3-205 | | |

| ITEM | COMMENTARY | PHOTOGRAPH(S) |
|---|--|--|
| A | <p>Location & Description Ensuite shower screen</p> <p>The Author has observed fixed panel to shower screen there is evidence of scratches to the glass to the upper section of the panel at adjacent to the door. The occupant reported to the Author at the time of construction that the defect was identified at handover.</p> <p>The Author is of the view, that the occupants statements are true and correct and that the defect originated at the time of construction.</p> | |
| B | <p>Cause(s)</p> <ul style="list-style-type: none"> • Damage originating at the time of construction | |
| C | <p>Breach(es)</p> <p><i>Failure to comply with the following:</i></p> <ul style="list-style-type: none"> ▪ Home Building Act 1989 (NSW) under Section 18B Clauses 1(a); ▪ NSW standards & tolerances 2017 19.4 - Scratches, fractures, chips or surface blemishes on glazing and mirrors are defective if they exist at handover and can be seen from a normal viewing position. | |

| ITEM | COMMENTARY | PHOTOGRAPH(S) |
|---|--|--|
| D | <p>Proposed Rectification Scope of Works</p> <p>Allow to:</p> <ol style="list-style-type: none"> 1. Provide site supervision. Supervisor to coordinate access and facilitate the works throughout the whole process. 2. Gain access to required areas in accordance with Safework requirements. 3. Cover and protect adjacent surfaces during the rectification work. 4. Labour to remove defective shower screen, install new shower screen and seal all junctions to make watertight. 5. Supply new shower screen 6. Dispose of building waste 7. Make good any surfaces affected as part of the works, to their prior condition. 8. Clean site and leave in a tidy condition upon completion of work | |

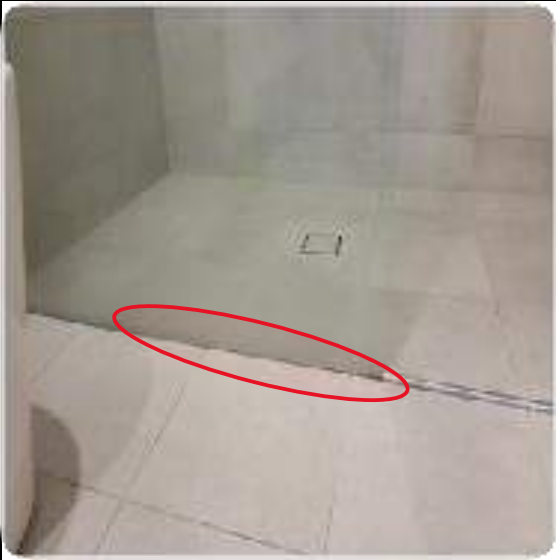
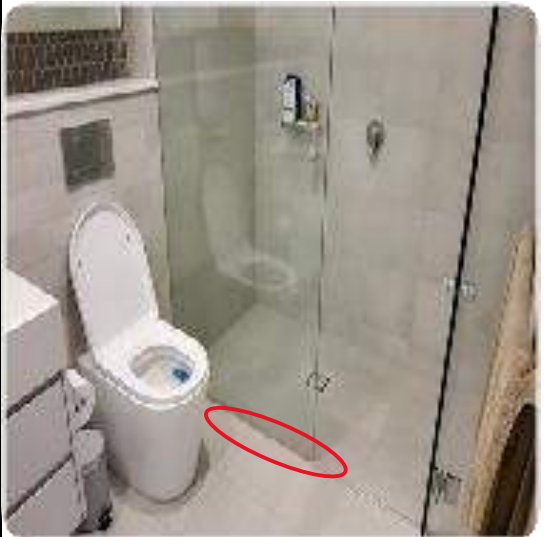
| ITEM | COMMENTARY | PHOTOGRAPH(S) |
|---|--|--|
| 1-207 | | |

| ITEM | COMMENTARY | PHOTOGRAPH(S) |
|---|--|--|
| A | <p>Location & Description Main bathroom – Shower screen</p> <p>The Author has observed fixed shower screen panel on the Eastern side sealant fixing is loose and there are gaps in the sealant.</p> <p>The Author is of the view, that the defect originated due to poor workmanship employed by the Builder at the time of construction.</p> | |
| B | <p>Cause(s)</p> <ul style="list-style-type: none"> Poor workmanship employed by Builder at the time of construction | |
| C | <p>Breach(es) Failure to comply with the following:</p> <ul style="list-style-type: none"> Home Building Act 1989 (NSW) under Section 18B Clauses 1 (a) Building contract - Defect liability period – Product warranty | |

| ITEM | COMMENTARY | PHOTOGRAPH(S) |
|---|--|--|
| D | <p>Proposed Rectification Scope of Works Allow to:</p> <ol style="list-style-type: none"> Provide site supervision. Supervisor to coordinate access and facilitate the works throughout the whole process. Gain access to required areas in accordance with Safework requirements. Cover and protect adjacent surfaces during the rectification work. Labour to apply construction adhesive waterproofing sealant Supply construction adhesive waterproofing sealant Make good any surfaces affected as part of the works, to their prior condition. Clean site and leave in a tidy condition upon completion of work | |

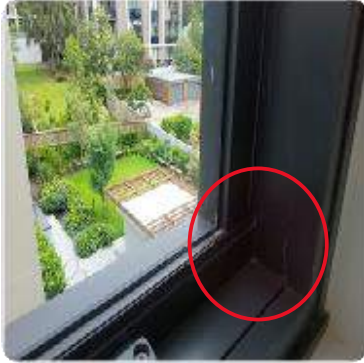
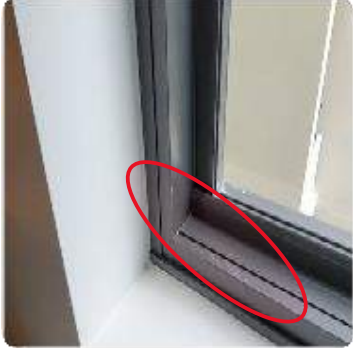
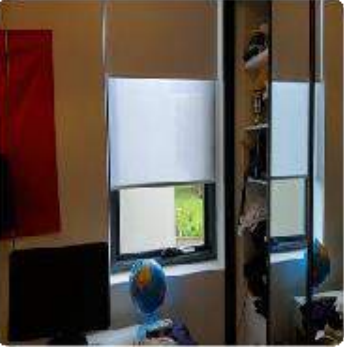
| ITEM | COMMENTARY | PHOTOGRAPH(S) |
|---|--|--|
| 1-301 | | |

| ITEM | COMMENTARY | PHOTOGRAPH(S) |
|---|--|--|
| A | <p>Location & Description Bedroom 2 – Window</p> <p>The occupant reported to the Author at the time of inspection, that the metal window frame had been scratched from repair work carried out by Builder. The Author observed evidence of damage to the to the northern lower and southern lower sections of the metal window frame.</p> <p>The Author has assumed that the occupants statement is true and correct.</p> <p>The Author is of the view, that the damaged originated due to poor workmanship employed by the Builder to carry out repair work.</p> | |
| B | <p>Cause(s)</p> <ul style="list-style-type: none"> • Poor workmanship employed by Builder to carry out repair work. | |
| C | <p>Breach(es) <i>Failure to comply with the following:</i></p> <ul style="list-style-type: none"> ▪ <i>Home Building Act 1989 (NSW) under Section 18B Clauses 1(a);</i> ▪ <i>NSW Guide to Standards & Tolerances 2017 G – Responsibility to rectify – Builders are liable to repair damage caused to property in the course of completing their building work.</i> | |

| ITEM | COMMENTARY | PHOTOGRAPH(S) |
|---|--|--|
| D | <p>Proposed Rectification Scope of Works Allow to:</p> <ol style="list-style-type: none"> 1. Provide site supervision. Supervisor to coordinate access and facilitate the works throughout the whole process. 2. Gain access to required areas in accordance with Safework requirements. 3. Cover and protect adjacent surfaces during the rectification work. 4. Specialist labour to repair to damaged window frame 5. Make good any surfaces affected as part of the works, to their prior condition. 6. Clean site and leave in a tidy condition upon completion of work | |

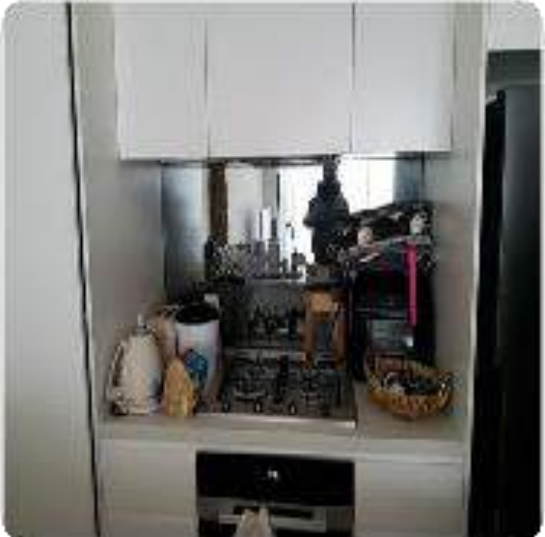
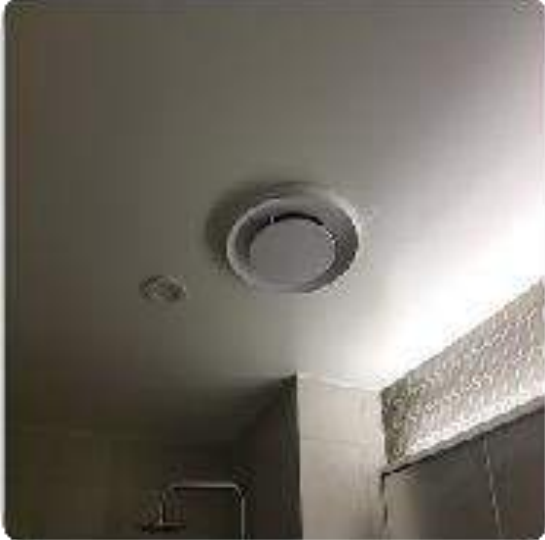
| ITEM | COMMENTARY | PHOTOGRAPH(S) |
|---|--|--|
| 2-301 | | |

| ITEM | COMMENTARY | PHOTOGRAPH(S) |
|---|--|--|
| A | <p>Location & Description Bathroom – Mechanical ventilation</p> <p>The occupant reported to the Author at the time of inspection, that when the shower is used in the main bathroom that the mechanical ventilation causes the glass splash back in the kitchen behind the cooktop to fog up.</p> <p>The Author conducted testing, by running shower and exhaust fan for a several minutes and observed fog forming on the kitchen glass splash back.</p> <p>The Author is of the view, that the presents of fog on the glass indicates that the ventilation duct is not fully sealed allowing moist air to leak and dispel into the ceiling space and wall where the glass splash back is located.</p> <p>The Author is of the view, that the defect originated due to poor workmanship employed by the Builder at the time of construction.</p> | |
| B | <p>Cause(s)</p> <ul style="list-style-type: none"> Poor workmanship employed by Builder at the time of construction; | |
| C | <p>Breach(es) <i>Failure to comply with the following:</i></p> <ul style="list-style-type: none"> Home Building Act 1989 (NSW) under Section 18B Clauses 1 (a) & (c); Failure of the Builder to carry out the works in accordance with the National Construction Code 2016 Vol1 F4.5 Ventilation of rooms | |

| ITEM | COMMENTARY | PHOTOGRAPH(S) |
|---|--|--|
| D | <p>Proposed Rectification Scope of Works Allow to:</p> <ol style="list-style-type: none"> Provide site supervision. Supervisor to coordinate access and facilitate the works throughout the whole process. Gain access to required areas in accordance with Safework requirements. Cover and protect adjacent surfaces during the rectification work. Labour to repair ducting to exhaust fan Make good any surfaces affected as part of the works, to their prior condition. Clean site and leave in a tidy condition upon completion of work | |

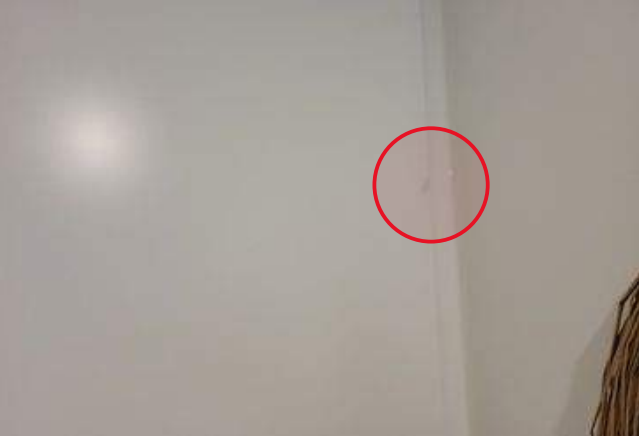
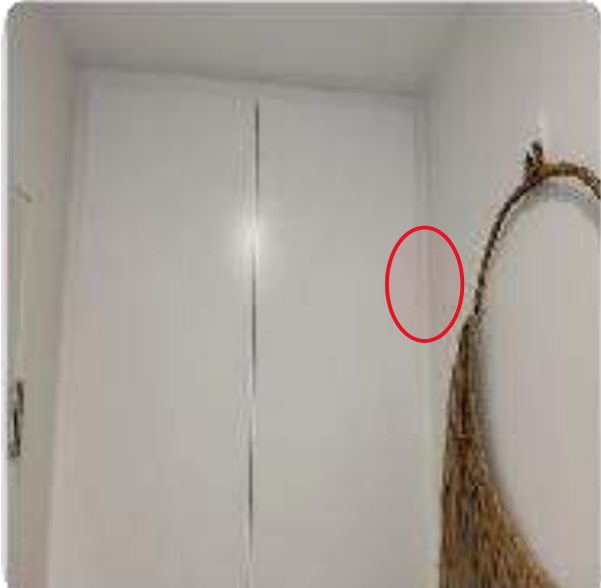
| ITEM | COMMENTARY | PHOTOGRAPH(S) |
|---|---|--|
| 4-301 | | |

| ITEM | COMMENTARY | PHOTOGRAPH(S) |
|---|---|--|
| A | <p>Location & Description Linen bed hallway - Damage</p> <p>The Author has observed damage to the linen door to right hand side and upper right, the occupant reported to the Author at the time of inspection, that the damage was identified prior to handover.</p> <p>The Author has assumed that the occupants statement is true and correct.</p> <p>The Author is of the view, that the defect originated due to poor workmanship employed by the Builder at the time of construction.</p> | |
| B | <p>Cause(s)</p> <ul style="list-style-type: none"> Poor workmanship employed by Builder at the time of construction; | |
| C | <p>Breach(es) <i>Failure to comply with the following:</i></p> <ul style="list-style-type: none"> <i>Home Building Act 1989 (NSW) under Section 18B Clauses (a) & (c);</i> <i>NSW Guide to Standards & Tolerances 2017 G – Responsibility to rectify – Builders are liable to repair damage caused to property in the course of completing their building work.</i> | |

| ITEM | COMMENTARY | PHOTOGRAPH(S) |
|---|---|--|
| D | <p>Proposed Rectification Scope of Works Allow to:</p> <ol style="list-style-type: none"> Provide site supervision. Supervisor to coordinate access and facilitate the works throughout the whole process. Gain access to required areas in accordance with Safework requirements. Cover and protect adjacent surfaces during the rectification work. Labour to remove damaged door and transport to door supplier for repair Labour to return with door and install following repair Make good any surfaces affected as part of the works, to their prior condition. Clean site and leave in a tidy condition upon completion of work | |

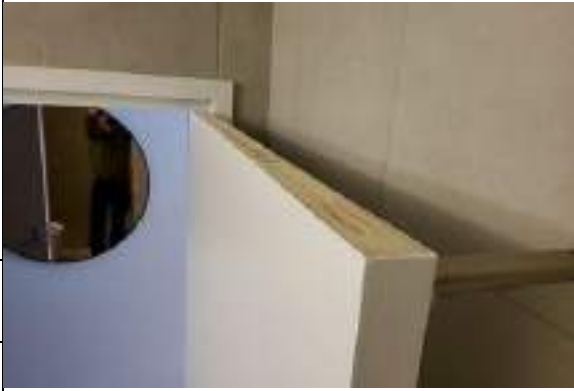
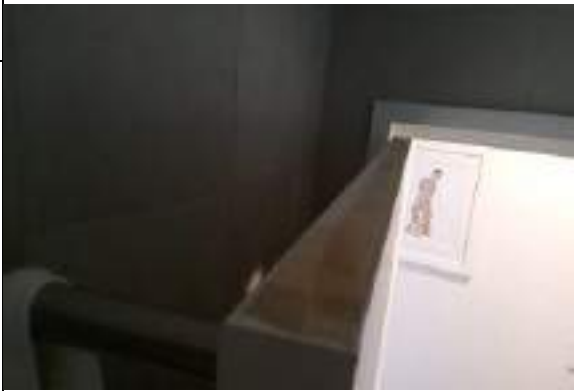
| ITEM | COMMENTARY | PHOTOGRAPH(S) |
|---|--|--|
| 5-301 | | |

| ITEM | COMMENTARY | PHOTOGRAPH(S) |
|---|--|--|
| A | <p>Location & Description Main bathroom and ensuite doors – Painting</p> <p>The Author has observed main bathroom and ensuite doors are not fully sealed.</p> <p>The Author is of the view, that the defect originated due to poor workmanship employed by the Builder at the time of construction</p> | |
| B | <p>Cause(s)</p> <ul style="list-style-type: none"> Poor workmanship employed by Builder at the time of construction | |
| C | <p>Breach(es) Failure to comply with the following:</p> <ul style="list-style-type: none"> Home Building Act 1989 (NSW) under Section 18B Clauses (a) & (c); NSW standards & tolerances 2017 – Painting AS2311:2017 Guide to the painting of buildings | |

| ITEM | COMMENTARY | PHOTOGRAPH(S) |
|---|--|--|
| D | <p>Proposed Rectification Scope of Works Allow to:</p> <ol style="list-style-type: none"> Provide site supervision. Supervisor to coordinate access and facilitate the works throughout the whole process. Gain access to required areas in accordance with Safework requirements. Cover and protect adjacent surfaces during the rectification work. Labour to remove and reinstall doors following repair Labour to apply paint system in accordance with AS2311:2009 'Guide to Painting of Buildings' Supply paint and ancillaries Make good any surfaces affected as part of the works, to their prior condition. Clean site and leave in a tidy condition upon completion of work | |

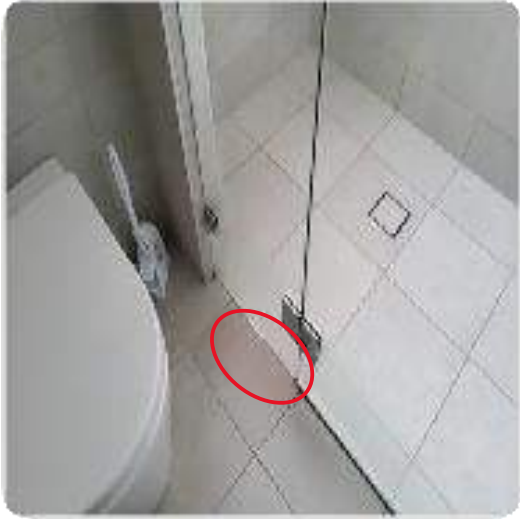
| ITEM | COMMENTARY | PHOTOGRAPH(S) |
|---|--|--|
| 1-302 | | |

| ITEM | COMMENTARY | PHOTOGRAPH(S) |
|---|--|--|
| A | <p>Location & Description Main bathroom – Shower screen</p> <p>The Author has observed fixed shower screen panel is loose and there are gaps in the sealant fixing.</p> <p>The Author is of the view, that the defect originated due to poor workmanship employed by the Builder at the time of construction.</p> | |
| B | <p>Cause(s)</p> <ul style="list-style-type: none"> Poor workmanship employed by Builder at the time of construction | |
| C | <p>Breach(es) Failure to comply with the following:</p> <ul style="list-style-type: none"> Home Building Act 1989 (NSW) under Section 18B Clauses 1 (a) Building contract - Defect liability period – Product warranty | |

| ITEM | COMMENTARY | PHOTOGRAPH(S) |
|---|--|--|
| D | <p>Proposed Rectification Scope of Works Allow to:</p> <ol style="list-style-type: none"> Provide site supervision. Supervisor to coordinate access and facilitate the works throughout the whole process. Gain access to required areas in accordance with Safework requirements. Cover and protect adjacent surfaces during the rectification work. Labour to apply construction adhesive waterproofing sealant Supply construction adhesive waterproofing sealant Make good any surfaces affected as part of the works, to their prior condition. Clean site and leave in a tidy condition upon completion of work | |

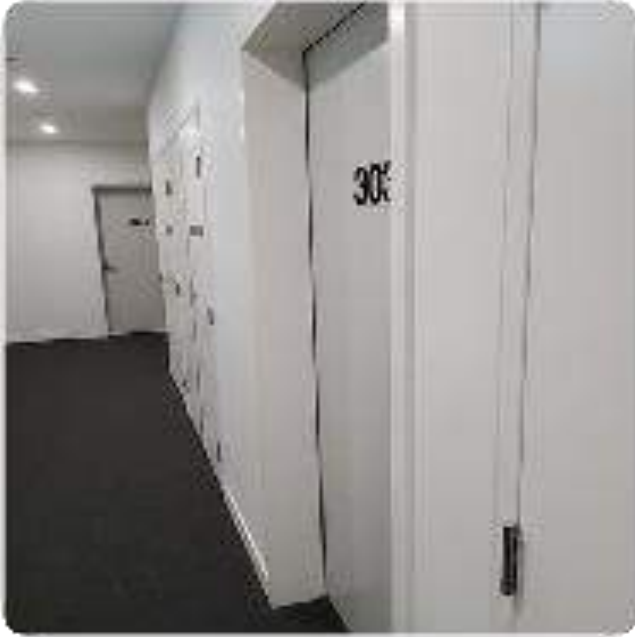
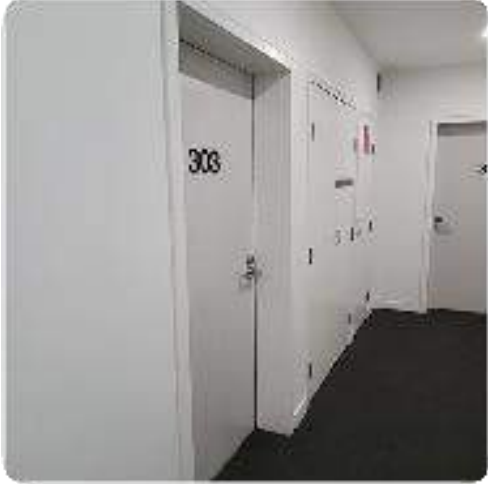
| | | | | | |
| B | <p>Cause(s)</p> <ul style="list-style-type: none"> Distortion of a building element affecting its use. | | | | | | | |
| C | <p>Breach(es) Failure to comply with the following:</p> <ul style="list-style-type: none"> Home Building Act 1989 (NSW) under Section 18B Clauses 1(f) & 18E(1)(b) NSW standards & tolerances 2017 – <p>9.5 Distortion of doors Door leaves are defective if, within three months of completion, they twist or bend greater than the limits listed in Table 9.05 below.</p> <p>TABLE 9.05 DISTORTION OF DOORS</p>

| D | <p>Proposed Rectification Scope of Works</p> <p>Allow to:</p> <ol style="list-style-type: none">1. Provide site supervision. Supervisor to coordinate access and facilitate the works throughout the whole process.2. Gain access to required areas in accordance with Safework requirements.3. Cover and protect adjacent surfaces during the rectification work.4. Supply new door to replace defective door5. Labour to remove defective door, install new door and existing door furniture6. Labour to paint new door in accordance with AS2311:2017 Guide to the painting of buildings7. Make good any surfaces affected as part of the works, to their prior condition.8. Clean site and leave in a tidy condition upon completion of work9. Dispose of building waste | A photograph showing a hallway with a white door on the left. The door has the number '303' on it. The hallway has a dark carpet and white walls. There are other doors further down the hallway. |
