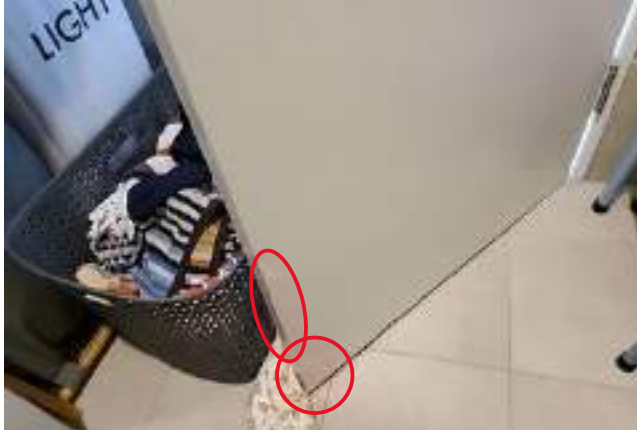
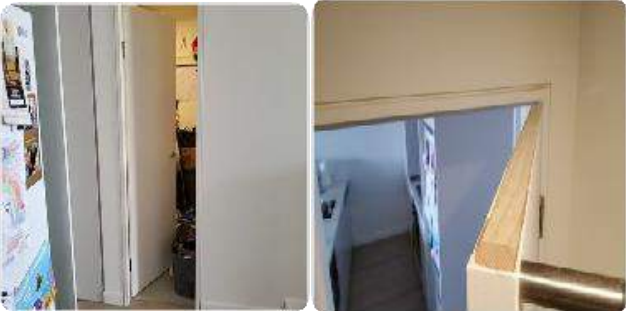
| ITEM | COMMENTARY | PHOTOGRAPH(S) |
|---|---|--|
| 2-303 | | |

| ITEM | COMMENTARY | PHOTOGRAPH(S) |
|---|---|--|
| A | <p>Location & Description Laundry door – Painting and moisture damage</p> <p>The Author has observed evidence of distortion to the back of the laundry door and the laundry door has not been fully sealed and the door leaf has moisture damage.</p> <p>The Author is of the view, that the defect originated due to poor workmanship employed by the Builder at the time of construction.</p> | |
| B | <p>Cause(s)</p> <ul style="list-style-type: none"> • Poor workmanship employed by Builder at the time of construction; • Failure of Builder to carry out the AS2311:2017 Guide to the painting of buildings | |
| C | <p>Breach(es) Failure to comply with the following:</p> <ul style="list-style-type: none"> ▪ Home Building Act 1989 (NSW) under Section 18B Clauses (a) & (c); ▪ Building contract – Defect liability period ▪ AS2311:2017 Guide to the painting of buildings | |

| ITEM | COMMENTARY | PHOTOGRAPH(S) |
|---|---|--|
| D | <p>Proposed Rectification Scope of Works Allow to:</p> <ol style="list-style-type: none"> 1. Provide site supervision. Supervisor to coordinate access and facilitate the works throughout the whole process. 2. Gain access to required areas in accordance with Safework requirements. 3. Cover and protect adjacent surfaces during the rectification work. 4. Supply new door to replace defective door 5. Labour to remove defective door, install new door and existing door furniture 6. Labour to paint new door in accordance with AS2311:2017 Guide to the painting of buildings 7. Make good any surfaces affected as part of the works, to their prior condition. 8. Clean site and leave in a tidy condition upon completion of work 9. Dispose of building waste | |

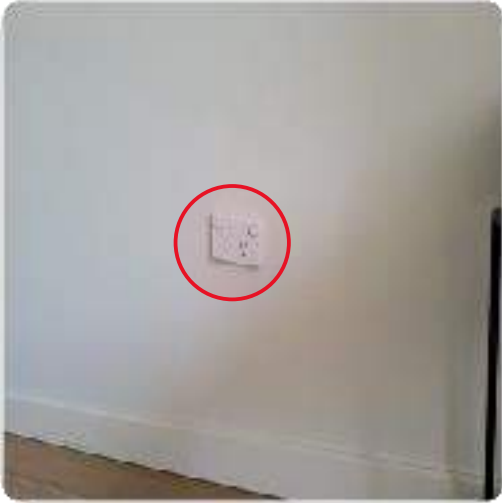
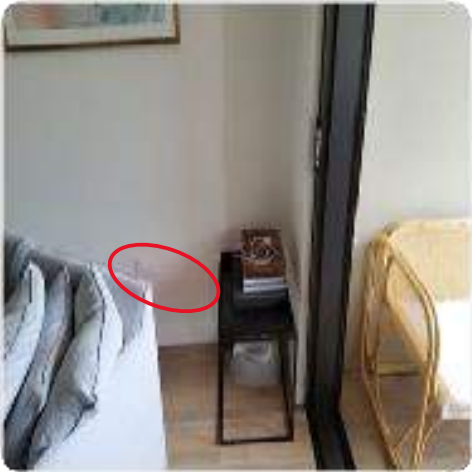
| ITEM | COMMENTARY | PHOTOGRAPH(S) |
|---|---|--|
| 3-303 | | |

| ITEM | COMMENTARY | PHOTOGRAPH(S) |
|---|---|--|
| A | <p>Location & Description Living area – Power point</p> <p>The Author has observed the power point to the northeast wall in the living area has been out of level</p> <p>The Author is of the view, that the defect originated due to poor workmanship employed by the Builder at the time of construction</p> | |
| B | <p>Cause(s)</p> <ul style="list-style-type: none"> Poor workmanship employed by Builder at the time of construction | |
| C | <p>Breach(es) <i>Failure to comply with the following:</i></p> <ul style="list-style-type: none"> <i>Home Building Act 1989 (NSW) under Section 18B Clauses 1 (a)</i> | |

| ITEM | COMMENTARY | PHOTOGRAPH(S) |
|---|---|--|
| D | <p>Proposed Rectification Scope of Works Allow to:</p> <ol style="list-style-type: none"> Provide site supervision. Supervisor to coordinate access and facilitate the works throughout the whole process. Gain access to required areas in accordance with Safework requirements. Cover and protect adjacent surfaces during the rectification work. Labour to adjust power point to make level Make good any surfaces affected as part of the works, to their prior condition. Clean site and leave in a tidy condition upon completion of work | |

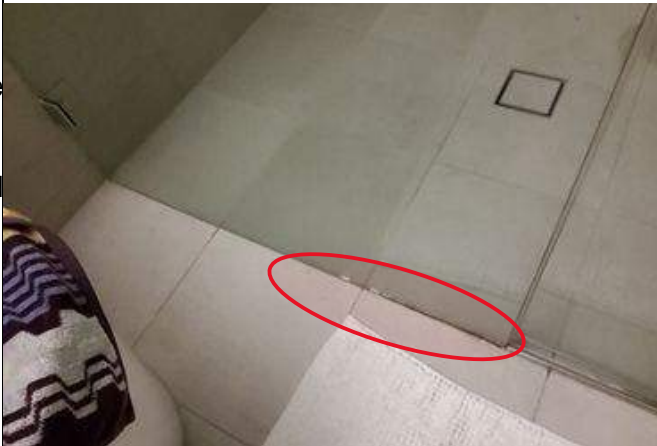
| ITEM | COMMENTARY | PHOTOGRAPH(S) |
|---|---|---|
| 5-303 | | |

| ITEM | COMMENTARY | PHOTOGRAPH(S) |
|---|---|---|
| A | <p>Location & Description Ensuite –Shower screen seal</p> <p>The Author has observed the ensuite fixed shower screen silicon fixing is loose, and water is ponding on the tile surface to the northeastern side of the floor waste.</p> <p>The Author conducted fall test using a digital level and found the fall was sufficient, however the ponding is caused due to the floor waste is sitting higher then the tile surface.</p> <p>The Author noted issue ponding issue was identified in TCA (Giaouris) report item U 304.7 Attachment F Defect schedule.</p> <p>The Author is of the view, that the defect originated due to poor workmanship employed by the Builder at the time of construction.</p> | |
| B | <p>Cause(s)</p> <ul style="list-style-type: none"> • Poor workmanship employed by Builder at the time of construction | |
| C | <p>Breach(es) <i>Failure to comply with the following:</i></p> <ul style="list-style-type: none"> ▪ Home Building Act 1989 (NSW) under Section 18B Clauses 1 (a)&(c) ▪ Building contract - Defect liability period – Product warranty | |

| ITEM | COMMENTARY | PHOTOGRAPH(S) |
|---|---|---|
| D | <p>Proposed Rectification Scope of Works Allow to:</p> <ol style="list-style-type: none"> 1. Provide site supervision. Supervisor to coordinate access and facilitate the works throughout the whole process. 2. Gain access to required areas in accordance with Safework requirements. 3. Cover and protect adjacent surfaces during the rectification work. 4. Labour to apply construction adhesive waterproofing sealant 5. Supply construction adhesive waterproofing sealant 6. Make good any surfaces affected as part of the works, to their prior condition. 7. Clean site and leave in a tidy condition upon completion of work | |

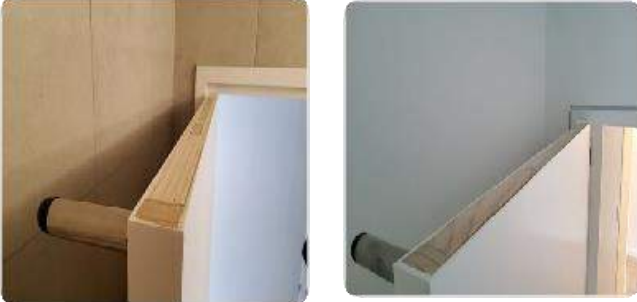
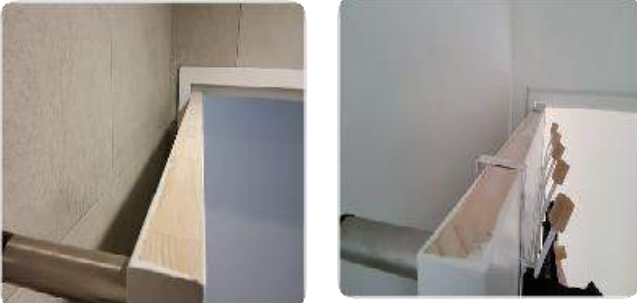
| ITEM | COMMENTARY | PHOTOGRAPH(S) |
|---|--|---|
| 1-304 | | |

| ITEM | COMMENTARY | PHOTOGRAPH(S) |
|---|--|---|
| A | <p>Location & Description Doors throughout interior – Painting</p> <p>The Author has observed doors throughout have not been fully sealed.</p> <p>The Author noted issue was identified in TCA (Giaouris) report item U 304.6 Attachment F Defect schedule.</p> <p>The Author is of the view, that the defect originated due to poor workmanship employed by the Builder at the time of construction.</p> | |
| B | <p>Cause(s)</p> <ul style="list-style-type: none"> Poor workmanship employed by Builder at the time of construction | |

| ITEM | COMMENTARY | PHOTOGRAPH(S) |
|---|--|---|
| D | <p>Proposed Rectification Scope of Works Allow to:</p> <ol style="list-style-type: none"> Provide site supervision. Supervisor to coordinate access and facilitate the works throughout the whole process. Gain access to required areas in accordance with Safework requirements. Cover and protect adjacent surfaces during the rectification work. Labour to remove and reinstall doors following repair Labour to apply paint system in accordance with AS2311:2009 'Guide to Painting of Buildings' Supply paint and ancillaries Make good any surfaces affected as part of the works, to their prior condition. Clean site and leave in a tidy condition upon completion of work | |

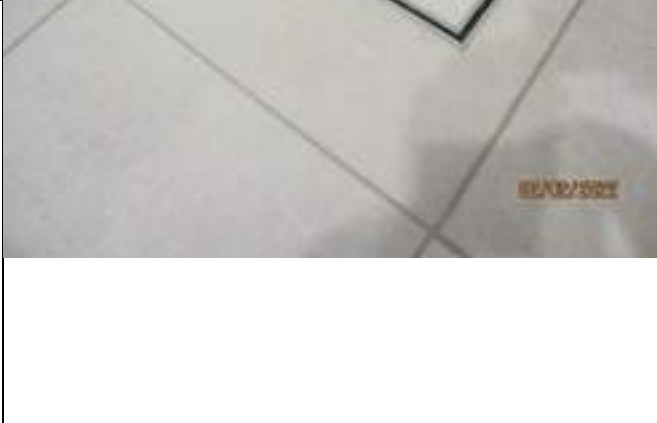
| ITEM | COMMENTARY | PHOTOGRAPH(S) |
|---|--|--|
| A | <p>Location & Description Ensuite – Water ponding in shower</p> <p>The Author has observed the ensuite fixed shower screen silicon fixing is loose, and water is ponding on the tile surface to the northeastern side of the floor waste.</p> <p>The Author conducted fall test using a digital level and found the fall was sufficient, however the ponding is caused due to the floor waste is sitting higher than the tile surface.</p> <p>The Author noted ponding issue was identified in TCA (Giaouris) report item U 304.7 Attachment F Defect schedule.</p> <p>The Author is of the view, that the defect originated due to poor workmanship employed by the Builder at the time of construction.</p> | |
| B | <p>Cause(s)</p> <ul style="list-style-type: none"> Poor workmanship employed by Builder at the time of construction | |
| C | <p>Breach(es) Failure to comply with the following:</p> <ul style="list-style-type: none"> Home Building Act 1989 (NSW) under Section 18B Clauses 1 (a)&(c) AS3958.1-2007 Ceramic tiles Part 1: Guide to the installation of ceramic tiles Building contract - Defect liability period – Product warranty | |

| ITEM | COMMENTARY | PHOTOGRAPH(S) |
|---|--|--|
| D | <p>Proposed Rectification Scope of Works Allow to:</p> <ol style="list-style-type: none"> Provide site supervision. Supervisor to coordinate access and facilitate the works throughout the whole process. Gain access to required areas in accordance with Safework requirements. Cover and protect adjacent surfaces during the rectification work. Labour to remove tiles siting lower than level of floor waste Repair tile screed and grade to provide sufficient falls to drainage inlet Reinstate tiling in accordance with AS3958.1 Supply tiles, adhesive and grout Make good any surfaces affected as part of the works, to their prior condition. Clean site and leave in a tidy condition upon completion of work | |

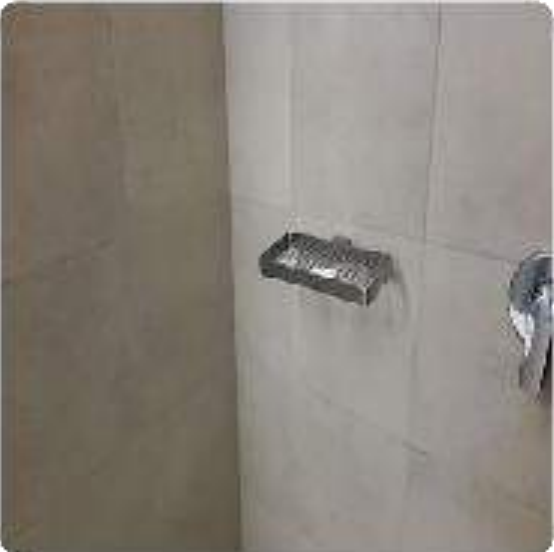
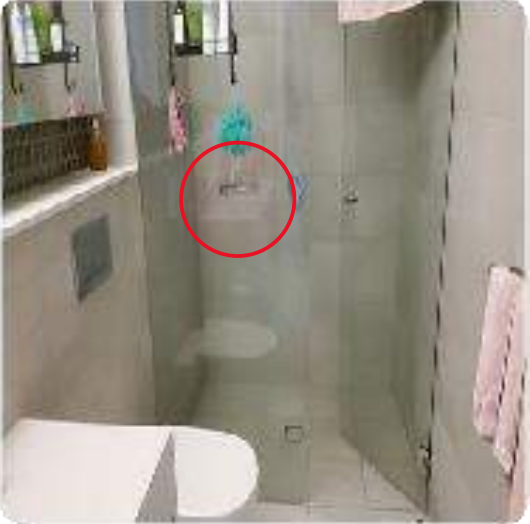
| ITEM | COMMENTARY | PHOTOGRAPH(S) |
|---|--|--|
| 3-304 | | |

| ITEM | COMMENTARY | PHOTOGRAPH(S) |
|---|--|--|
| A | <p>Location & Description Ensuite shower – Soap holder</p> <p>The Author has observed the soap holder in the shower is loose.</p> <p>The Author is of the view, that the defect is the responsibility of the Builder under the building contract maintenance period and under Section 18E(1)(b) of the Home Building Act 1989.</p> | |
| B | <p>Cause(s)</p> <ul style="list-style-type: none"> • Failure of Builder to that the Builder has failed to complete the works in accordance with building contract specifications. | |
| C | <p>Breach(es) Failure to comply with the following:</p> <ul style="list-style-type: none"> ▪ Home Building Act 1989 (NSW) under Section 18B Clauses 1(a) ▪ Building contract – Defect liability period | |

| ITEM | COMMENTARY | PHOTOGRAPH(S) |
|---|--|--|
| D | <p>Proposed Rectification Scope of Works Allow to:</p> <ol style="list-style-type: none"> 1. Provide site supervision. Supervisor to coordinate access and facilitate the works throughout the whole process. 2. Gain access to required areas in accordance with Safework requirements. 3. Cover and protect adjacent surfaces during the rectification work. 4. Labour to fix loose soap holder 5. Make good any surfaces affected as part of the works, to their prior condition. 6. Clean site and leave in a tidy condition upon completion of work | |

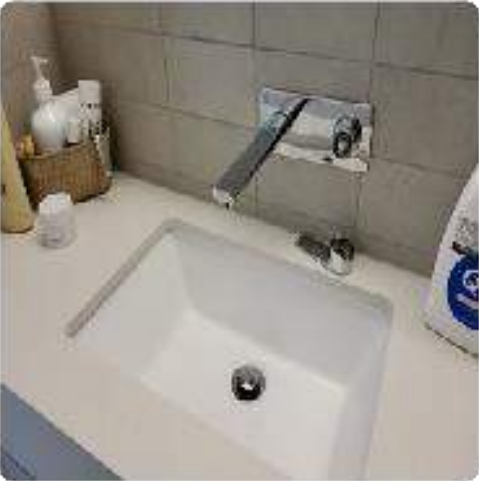
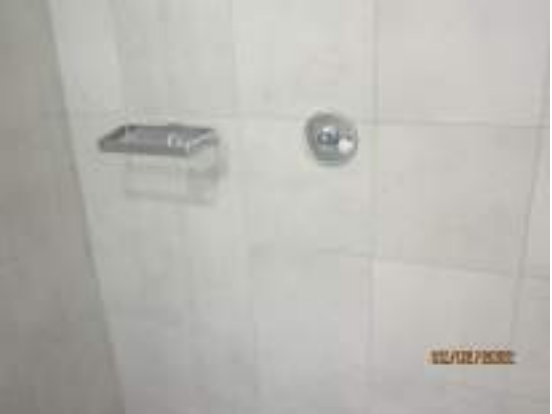
| ITEM | COMMENTARY | PHOTOGRAPH(S) |
|---|---|--|
| 4-304 | | |

| ITEM | COMMENTARY | PHOTOGRAPH(S) |
|---|---|--|
| A | <p>Location & Description Ensuite vanity and shower mixer tap handle</p> <p>The Author has observed the basin mixer tap to ensuite vanity and shower are loose.</p> <p>The Author is of the view, The Author is of the view, that the defect is the responsibility of the Builder under the building contract maintenance period and under Section 18E(1)(b) of the Home Building Act 1989.</p> | |
| B | <p>Cause(s)</p> <ul style="list-style-type: none"> Poor workmanship employed by Builder at the time of construction; | |
| C | <p>Breach(es) Failure to comply with the following:</p> <ul style="list-style-type: none"> Home Building Act 1989 (NSW) under Section 18B Clauses 1 (a) Building contract – Defect liability period | |

| ITEM | COMMENTARY | PHOTOGRAPH(S) |
|---|---|--|
| D | <p>Proposed Rectification Scope of Works Allow to:</p> <ol style="list-style-type: none"> Provide site supervision. Supervisor to coordinate access and facilitate the works throughout the whole process. Gain access to required areas in accordance with Safework requirements. Cover and protect adjacent surfaces during the rectification work. Labour to fix loose mixer tap handle Make good any surfaces affected as part of the works, to their prior condition. Clean site and leave in a tidy condition upon completion of work | |

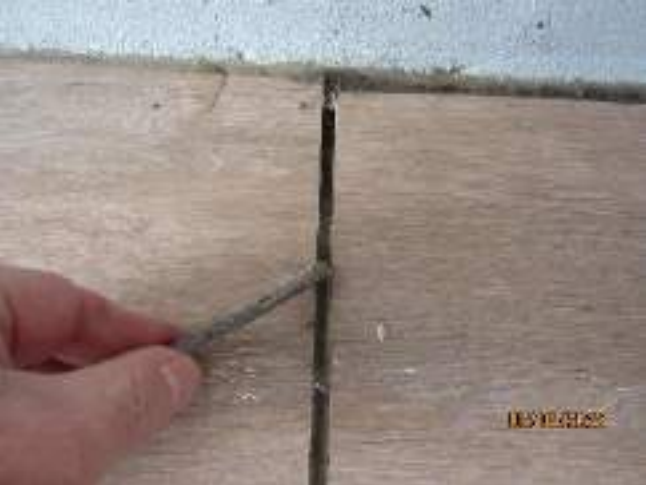
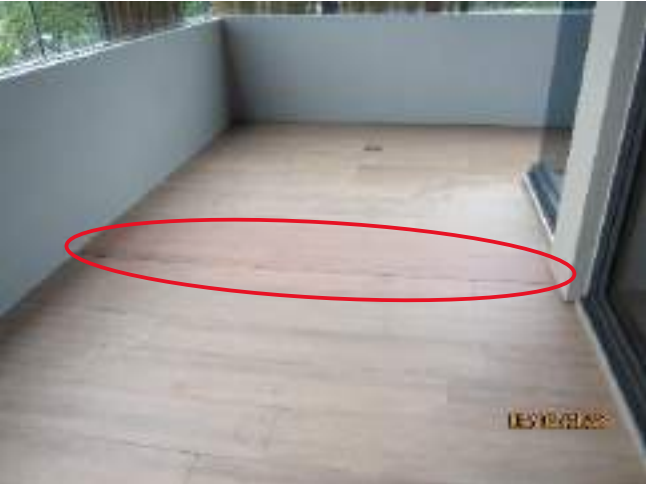
| ITEM | COMMENTARY | PHOTOGRAPH(S) |
|---|--|--|
| 6-304 | | |

| ITEM | COMMENTARY | PHOTOGRAPH(S) |
|---|--|--|
| A | <p>Location & Description Balcony – Drummy tiles and movement joints</p> <p>The Author has observed that tile movement joints has not been provide in accordance with AS3958.1:2007, and that tiles adjacent to the movement joint to the eastern side of balcony are drummy.</p> <p>The Author noted issue was identified in TCA (Giaouris) report item U 304.19 and U 304.23 Attachment F Defect schedule.</p> <p>The Author is of the view that the Builder has failed to carry out the works in accordance with AS3958.1 and that the defects originated from poor workmanship employed by the Builder at the time of construction.</p> | |
| B | <p>Cause(s)</p> <ul style="list-style-type: none"> Poor workmanship employed by Builder at the time of construction | <p>Defective movement joint on southern side of balcony</p> |
| C | <p>Breach(es) <i>Failure to comply with the following:</i></p> <ul style="list-style-type: none"> Home Building Act 1989 (NSW) under Section 18B Clauses 1(a)&(c) AS3958.1-2007 Ceramic tiles Part 1: Guide to the installation of ceramic tiles Building contract – Works to carried out in accordance with Australian Standards | |

| ITEM | COMMENTARY | PHOTOGRAPH(S) |
|---|--|--|
| D | <p>Proposed Rectification Scope of Works Allow to:</p> <ol style="list-style-type: none"> Provide site supervision. Supervisor to coordinate access and facilitate the works throughout the whole process. Gain access to required areas in accordance with Safework requirements. Cover and protect adjacent surfaces during the rectification work. Labour to remove all drummy tiles to each side of movement joint, Cut tile screed – depth of cut controlled to not affect waterproof membrane under screed, Install preformed tile movement joint, lay new tiles with minimum 90% glue coverage to rear of tiles, as stipulated by AS3958.1 Lay new tiles with sufficient falls and grout joints as to AS3958.1 Make good any surfaces affected as part of the works, to their prior condition. Clean site and leave in a tidy condition upon completion of work | <p>Location of defective movement joint and drummy tiles on southern side of balcony</p> |

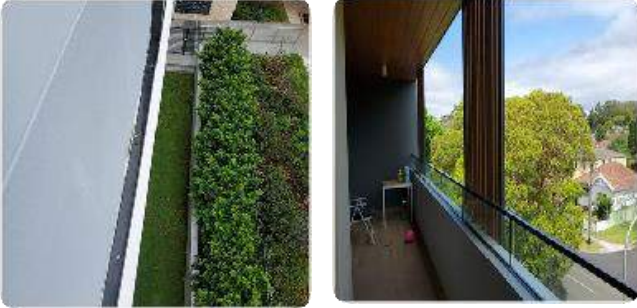
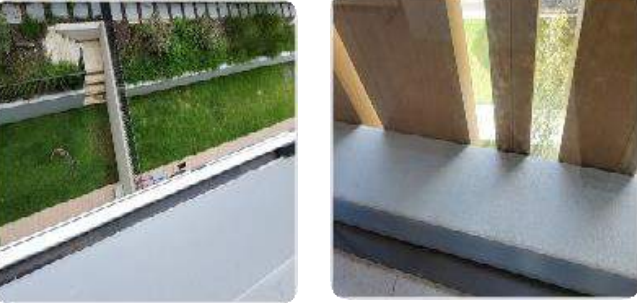
| ITEM | COMMENTARY | PHOTOGRAPH(S) |
|---|--|---|
| 1-305 | | |

| ITEM | COMMENTARY | PHOTOGRAPH(S) |
|---|--|---|
| A | <p>Location & Description Balcony – Metal screen installation</p> <p>The Author has observed fixing in bottom sliding screen track on external are rusty, and southwestern screen to balcony is binding with the balcony masonry wall.</p> <p>The Author is of the view, that the fixings are not suitable for exterior use and the binding of the before mentioned screen originated due to poor workmanship employed by the Builder at the time of construction.</p> | |
| B | <p>Cause(s)</p> <ul style="list-style-type: none"> Poor workmanship employed by Builder at the time of construction | |
| C | <p>Breach(es)</p> <p><i>Failure to comply with the following:</i></p> <ul style="list-style-type: none"> Home Building Act 1989 (NSW) under Section 18B Clauses 1(a)&(f) Does not operate as intended by the manufacturer NCC Volume 3 Part A2 – Suitability of materials and products | |

| ITEM | COMMENTARY | PHOTOGRAPH(S) |
|---|--|---|
| D | <p>Proposed Rectification Scope of Works</p> <p>Allow to:</p> <ol style="list-style-type: none"> Provide site supervision. Supervisor to coordinate access and facilitate the works throughout the whole process. Gain access to required areas in accordance with Safework requirements. Cover and protect adjacent surfaces during the rectification work. Supply and erect scaffold to provide a safe working platform Dismantle metal screen frame and adjust to provide clearances Reinstall metal screening Replace rust fixings Seal fixings in bottom screen track to prevent water penetration into concrete substrate Dismantle scaffolding Make good any surfaces affected as part of the works, to their prior condition. Clean site and leave in a tidy condition upon completion of work | |

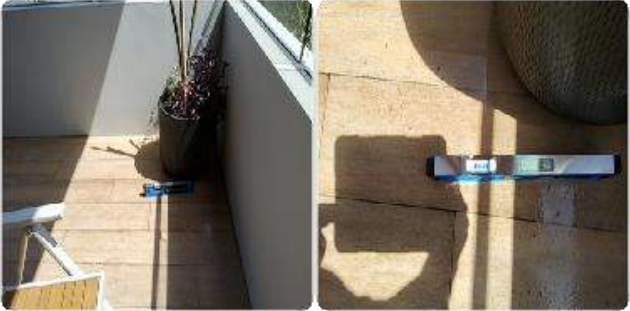
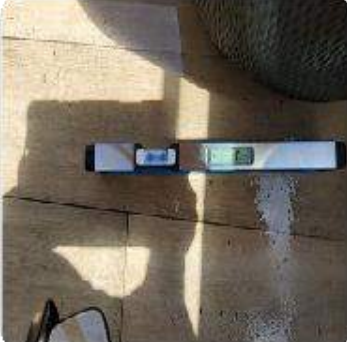
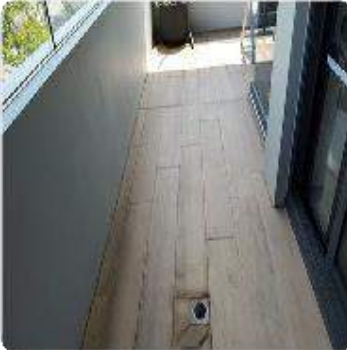
| ITEM | COMMENTARY | PHOTOGRAPH(S) |
|---|--|--|
| 2-305 | | |

| ITEM | COMMENTARY | PHOTOGRAPH(S) |
|---|--|--|
| A | <p>Location & Description Balcony – Tiling</p> <p>The Author has observed water ponding on tile floor surface to southwest corner of balcony. The Author conducted testing using a digital level and found zero fall to area tested.</p> <p>The Author is of the view, that there is insufficient fall to southwest corner of balcony and the defect originated due to poor workmanship employed by the Builder at the time of construction.</p> | |
| B | <p>Cause(s)</p> <ul style="list-style-type: none"> • Poor workmanship employed by Builder at the time of construction; • Failure of Builder to carry out the in accordance with AS4654.2 | |
| C | <p>Breach(es) <i>Failure to comply with the following:</i></p> <ul style="list-style-type: none"> ▪ Home Building Act 1989 (NSW) under Section 18B Clauses 1 (a)); ▪ AS4654.2 Waterproofing membranes for external above-ground use Part 2: Design and installation ▪ Building contract specification | |

| ITEM | COMMENTARY | PHOTOGRAPH(S) |
|---|--|--|
| D | <p>Proposed Rectification Scope of Works Allow to:</p> <ol style="list-style-type: none"> 1. Provide site supervision. Supervisor to coordinate access and facilitate the works throughout the whole process. 2. Gain access to required areas in accordance with Safework requirements. 3. Labour to demolish and remove tiling, tile bed (screed) to nearest junction 4. Labour to expose concrete slab substrate, remove demolition waste and place in waste bin for disposal 5. Labour to grind concrete surface and prepare surface for new waterproofing system 6. Labour to apply waterproofing system in accordance with AS4654.1&2 to affected area and as to building contract specifications 7. Labour to repair render 8. Supply Dulux render materials | |

| | <ol style="list-style-type: none">9. Labour to place sand and cement tile screed and provide positive falls to drainage inlets in accordance with AS3958.1 and in accordance with building contract specifications10. Labour to mix sand and cement for tile screed and assist trades11. Supply sand and cement for tile screed12. Supply 'Efflock' to prevent efflorescence13. Supply and apply waterproofing system on top of tile bed to prevent efflorescence as to building contract specifications14. Supply and install preformed tile movement joint in accordance with AS3958.1 and building contract specifications if required15. Supply and fix new selected tiles and grout in accordance with AS3958.1:2007 and building contract specifications16. Supply 'Efflock' for tile adhesive and grouts to prevent efflorescence17. Labour to repair paint work to affected finishes18. Supply paint and ancillaries19. Remove and dispose of all building waste20. Make good any surfaces affected as part of the works, to their prior condition.21. Clean site and leave in a tidy condition upon completion of work | |

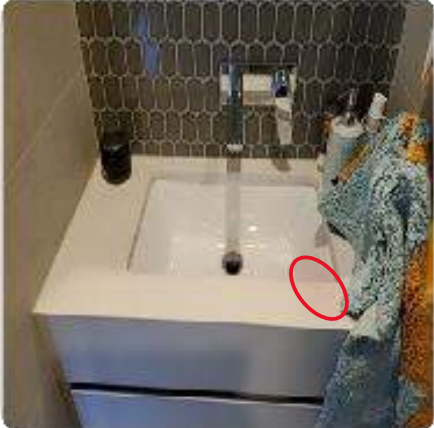
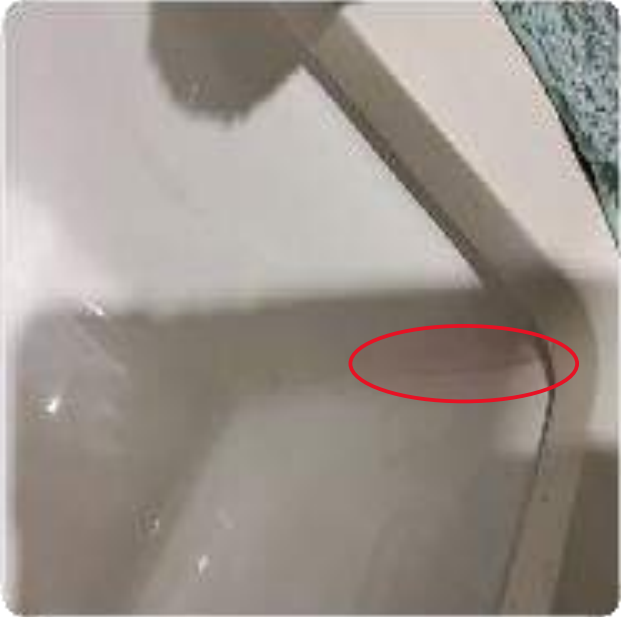
| ITEM | COMMENTARY | PHOTOGRAPH(S) |
|---|---|--|
| 4-305 | | |

| ITEM | COMMENTARY | PHOTOGRAPH(S) |
|---|---|--|
| A | <p>Location & Description Bathroom vanity basin</p> <p>The occupant reported to the Author at the time of inspection that the bathroom basin had a crack identified at handover. The Author has observed there is a crack to the basin to the southeast corner of the basin.</p> <p>The Author has assumed the occupants statement is true and correct.</p> <p>The Author is of the view, that the defect originated due to poor workmanship employed by the Builder at the time of construction.</p> | |
| B | <p>Cause(s)</p> <ul style="list-style-type: none"> Poor workmanship employed by Builder at the time of construction | |
| C | <p>Breach(es) Failure to comply with the following:</p> <ul style="list-style-type: none"> Home Building Act 1989 (NSW) under Section 18B Clauses 1(a); NSW Guide to Standards & Tolerances 2017 G – Responsibility to rectify – Builders are liable to repair damage caused to property in the course of completing their building work. | |

| ITEM | COMMENTARY | PHOTOGRAPH(S) |
|---|---|--|
| D | <p>Proposed Rectification Scope of Works Allow to:</p> <ol style="list-style-type: none"> Provide site supervision. Supervisor to coordinate access and facilitate the works throughout the whole process. Gain access to required areas in accordance with Safework requirements. Cover and protect adjacent surfaces during the rectification work. Labour to remove defective vanity basin and replace with new basin Supply new basin Make good any surfaces affected as part of the works, to their prior condition. Clean site and leave in a tidy condition upon completion of work | |

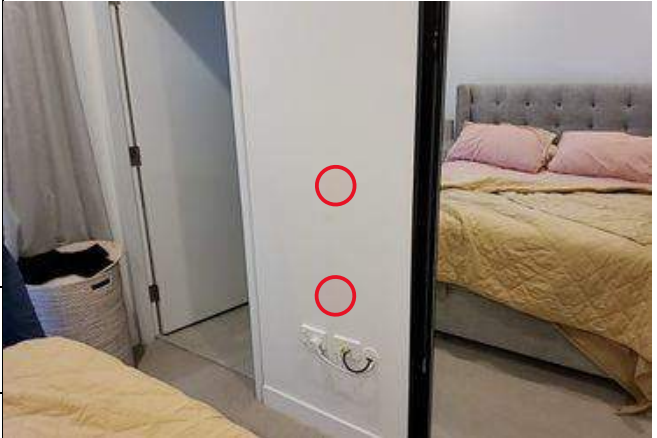
| ITEM | COMMENTARY | PHOTOGRAPH(S) |
|---|--|---|
| 6-305 | | |

| ITEM | COMMENTARY | PHOTOGRAPH(S) |
|---|--|---|
| A | <p>Location & Description Main bedroom western wall – Painting</p> <p>The Author has observed main bedroom on Western Wall under the location of the television there is a fixing which is protruding behind the plasterboard lining situated around about 1m and another fixing which is positioned above the power points</p> <p>The Author is of the view, that the defect originated due to poor workmanship employed by the Builder at the time of construction</p> | |
| B | <p>Cause(s)</p> <ul style="list-style-type: none"> Poor workmanship employed by Builder at the time of construction; | |
| C | <p>Breach(es) <i>Failure to comply with the following:</i></p> <ul style="list-style-type: none"> Home Building Act 1989 (NSW) under Section 18B Clauses (a) & (c); AS2311:2017 Guide to the painting of buildings NSW standards & tolerances 2017 – 13.2 Surface finish of paintwork <i>Paintwork is defective if the application has blemishes such as paint runs, paint sags, wrinkling, dust, bare or starved painted areas, colour variations, surface cracks, irregular and coarse brush marks, sanding marks, blistering, non-uniformity of gloss level and other irregularities in the surface that are visible from a normal viewing position. (Highlighting added)</i> | |

| ITEM | COMMENTARY | PHOTOGRAPH(S) |
|---|--|---|
| D | <p>Proposed Rectification Scope of Works Allow to:</p> <ol style="list-style-type: none"> Provide site supervision. Supervisor to coordinate access and facilitate the works throughout the whole process. Gain access to required areas in accordance with Safework requirements. Cover and protect adjacent surfaces during the rectification work. Labour to patch, repair and apply paint in accordance with AS2311:2017 Guide to the painting of buildings Supply paint and ancillaries Make good any surfaces affected as part of the works, to their prior condition. Clean site and leave in a tidy condition upon completion of work | |

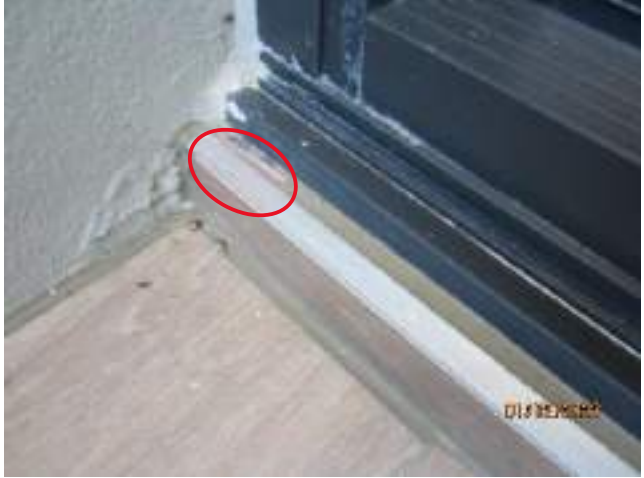
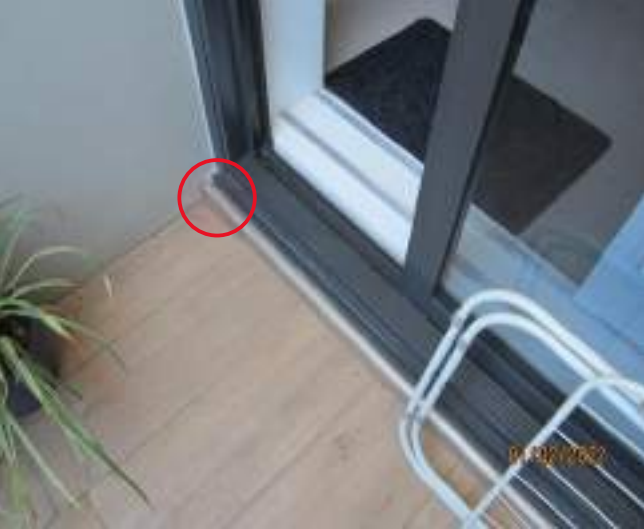
| ITEM | COMMENTARY | PHOTOGRAPH(S) |
|---|---|---|
| 2-306 | | |

| ITEM | COMMENTARY | PHOTOGRAPH(S) |
|---|---|---|
| A | <p>Location & Description Main bedroom - Balcony sliding door</p> <p>The Author has observed that there is a gap in the sealant to the top of threshold tile at the northern end of the sliding door.</p> <p>The Author noted that the issue was identified in TCA (Giaouris) report item U 306.13 Attachment F Defect schedule.</p> <p>The Author is of the view that the defect originated from poor workmanship employed by the Builder at the time of construction.</p> | |
| B | <p>Cause(s)</p> <ul style="list-style-type: none"> Poor workmanship employed by the Builder at the time of construction. | |
| C | <p>Breach(es) <i>Failure to comply with the following:</i></p> <ul style="list-style-type: none"> Home Building Act 1989 (NSW) under Section 18B Clauses (a) & (c); AS3958.1:2007 Incomplete contract works | |

| ITEM | COMMENTARY | PHOTOGRAPH(S) |
|---|---|---|
| D | <p>Proposed Rectification Scope of Works Allow to:</p> <ol style="list-style-type: none"> Provide site supervision. Supervisor to coordinate access and facilitate the works throughout the whole process. Gain access to required areas in accordance with Safework requirements Labour to apply sealant to repair gap to tiled threshold Clean site and leave in a tidy condition upon completion of work | <p style="text-align: center;">Location of gap to sealant</p> |

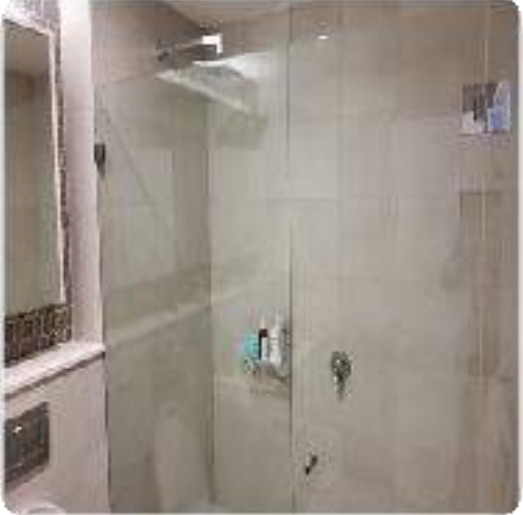
| ITEM | COMMENTARY | PHOTOGRAPH(S) |
|---|---|--|
| A | <p>Location & Description Main bathroom – Shower screen</p> <p>The Author has observed there is insufficient clearance between the shower screen door in the main bathroom and the fixed panel at the top of the door and needs adjustment to provide a more clearance.</p> <p>The Author is of the view, that the defect originated due to poor workmanship employed by the Builder at the time of construction.</p> | |
| B | <p>Cause(s)</p> <ul style="list-style-type: none"> Poor workmanship employed by Builder at the time of construction | |
| C | <p>Breach(es) <i>Failure to comply with the following:</i></p> <ul style="list-style-type: none"> <i>Home Building Act 1989 (NSW) under Section 18B Clauses 1(a)</i> | |

| ITEM | COMMENTARY | PHOTOGRAPH(S) |
|---|---|--|
| D | <p>Proposed Rectification Scope of Works Allow to:</p> <ol style="list-style-type: none"> Provide site supervision. Supervisor to coordinate access and facilitate the works throughout the whole process. Gain access to required areas in accordance with Safework requirements. Cover and protect adjacent surfaces during the rectification work. Labour to adjust door to provided sufficient clearances Make good any surfaces affected as part of the works, to their prior condition. Clean site and leave in a tidy condition upon completion of work | |

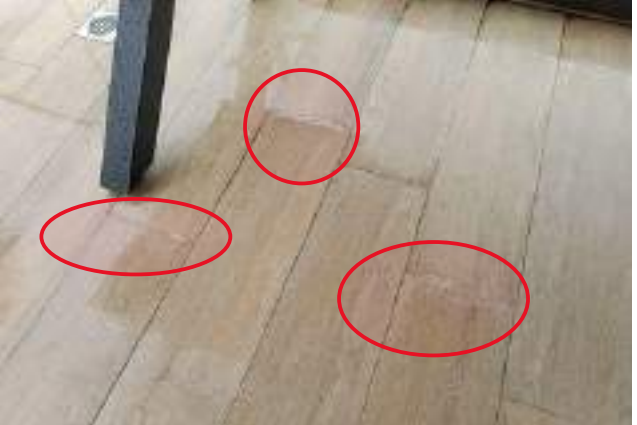
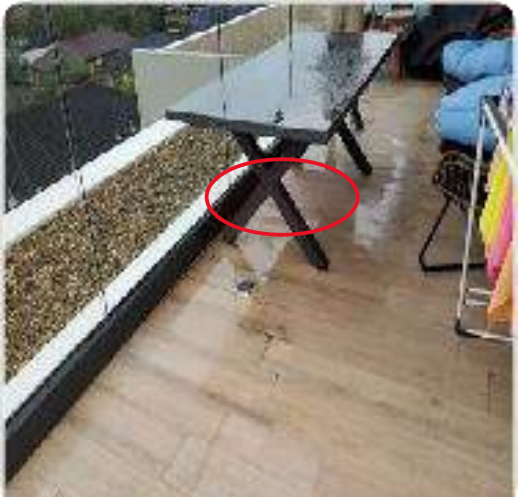
| ITEM | COMMENTARY | PHOTOGRAPH(S) |
|---|--|--|
| 2-403 | | |

| ITEM | COMMENTARY | PHOTOGRAPH(S) |
|---|--|--|
| A | <p>Location & Description Balcony terrace – Tiling</p> <p>The occupant reported to the Author at the time of inspection that the tiles to the northern side of the terrace area and reported, that on hot days with direct sunlight on the tiles there is evidence of a white substance that discharges from the tile joints on the northern side of the terrace.</p> <p>The Author is of the view, that the efflorescence is due to salt deposits in the tile screed or adhesive being carried to the surface by evaporation or hydrostatic pressure and that this could have been anticipated by the Builder based on the location and exposure of the tiling.</p> | |
| B | <p>Cause(s)</p> <ul style="list-style-type: none"> Poor workmanship employed by Builder at the time of construction; | |
| C | <p>Breach(es) Failure to comply with the following:</p> <ul style="list-style-type: none"> Home Building Act 1989 (NSW) under Section 18B Clauses 1 (a); NSW standards & tolerances 2017 - Efflorescence | |

| ITEM | COMMENTARY | PHOTOGRAPH(S) |
|---|--|--|
| D | <p>Proposed Rectification Scope of Works</p> <p>Please Note – Measures to prevent efflorescence included in item 1-403.</p> | |

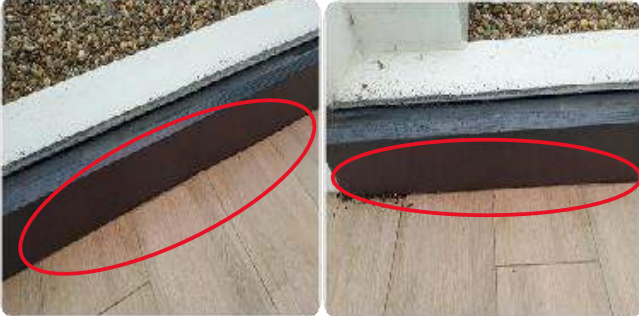
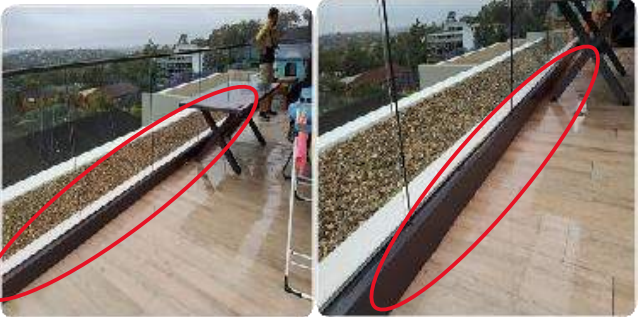
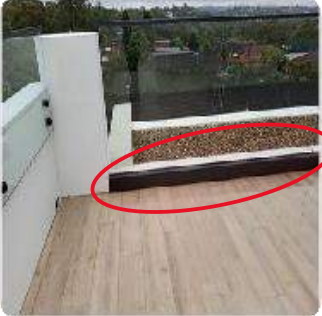
| ITEM | COMMENTARY | PHOTOGRAPH(S) |
|---|--|--|
| 3-403 | | |

| ITEM | COMMENTARY | PHOTOGRAPH(S) |
|---|--|--|
| A | <p>Location & Description Balcony terrace north – Tiling movement joint</p> <p>The Author has observed that there is no flexible joint which has been provided to the northern side of the terrace at junction of floor tiling and the balustrade hob.</p> <p>The Author is of the view, that the defect originated due to poor workmanship employed by the Builder at the time of construction.</p> | |
| B | <p>Cause(s)</p> <ul style="list-style-type: none"> • Poor workmanship employed by Builder at the time of construction; • Failure of Builder to carry out the works in accordance with AS3958.1:2007 | |
| C | <p>Breach(es) Failure to comply with the following:</p> <ul style="list-style-type: none"> ▪ Home Building Act 1989 (NSW) under Section 18B Clauses 1(a) & (c); ▪ AS3958.1:2007 Part 1: Guide to the installation of ceramic tiles | |

| ITEM | COMMENTARY | PHOTOGRAPH(S) |
|---|--|--|
| D | <p>Proposed Rectification Scope of Works</p> <p>Please Note – Joint sealing included in item 1-403.</p> | |

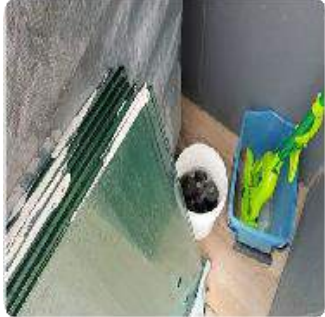
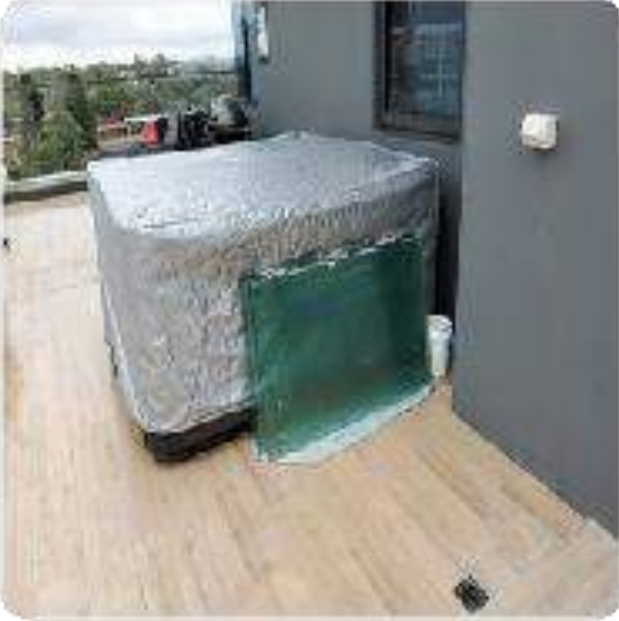
| ITEM | COMMENTARY | PHOTOGRAPH(S) |
|---|--|--|
| 4-403 | | |

| ITEM | COMMENTARY | PHOTOGRAPH(S) |
|---|--|--|
| A | <p>Location & Description Balcony terrace – Builders remediation works</p> <p>The Author has observed that sections of the glass balustrade have been removed from the western and southern side of the balcony terrace.</p> <p>The owner occupant reported to the Author at the time of inspection, that the Builder had carried out remedial work to repair defective rendering to the balustrade walls. The Author observed patching to render of the balustrade walls in the locations where the glass balustrade had been removed. The Author observed that the removed glass balustrade had been stacked against the spa on the western side of the balcony terrace and adjacent to the staked glass balustrade was a bucket with the balustrade fixtures.</p> <p>The Author has found on conducting a percussion test that area where the render has been repaired to the external wall of balcony terrace was drummy and observed the render finish had significant craze cracks.</p> <p>The Author is of the view, that the Builder has failed to satisfactory apply the render system to the walls in accordance with the manufacturers guidelines and complete the repair works.</p> <p>The Author is also of the view, that the glass balustrade having not been reinstated by the Builder has created a significant safety risk to the occupants.</p> | |
| B | <p>Cause(s)</p> <ul style="list-style-type: none"> • Poor workmanship employed by Builder at the time of construction; • Failure of Builder to carry out the in accordance with manufacturers guidelines • Failure of the Builder to complete the repair works | |
| C | <p>Breach(es)</p> <p><i>Failure to comply with the following:</i></p> <ul style="list-style-type: none"> ▪ Home Building Act 1989 (NSW) under Section 18B Clauses 1(a) & (f); ▪ Building contract – Defect liability period ▪ Incomplete contract works | |

| D | <p>Proposed Rectification Scope of Works</p> <p>Allow to:</p> <ol style="list-style-type: none">1. Provide site supervision. Supervisor to coordinate access and facilitate the works throughout the whole process.2. Gain access to required areas in accordance with Safework requirements.3. Cover and protect adjacent surfaces during the rectification work.4. Labour to remove defective render and dispose of demolition waste5. Labour to prepare substrate for rendering in accordance with the manufacturers guidelines6. Labour to apply proprietary render system to affected areas in accordance with manufacturers guidelines and building specifications7. Supply proprietary render system materials and ancillaries8. Labour to prepare rendered surfaces and apply paint system to match existing finishes9. Supply paint and ancillaries10. Labour to reinstate glass balustrade and metal handrails11. Labour to remove and dispose of building waste materials12. Make good any surfaces affected as part of the works, to their prior condition.13. Clean all affect surfaces14. Clean site and leave in a tidy condition upon completion of work | |

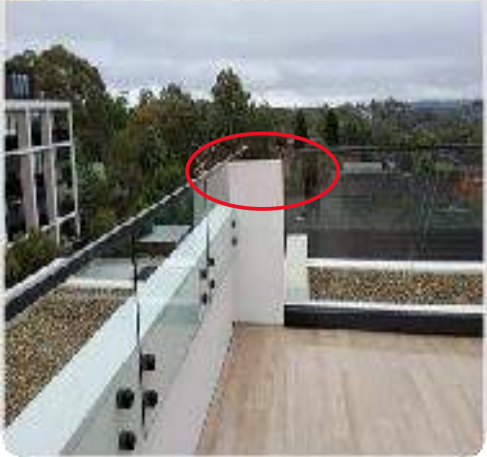
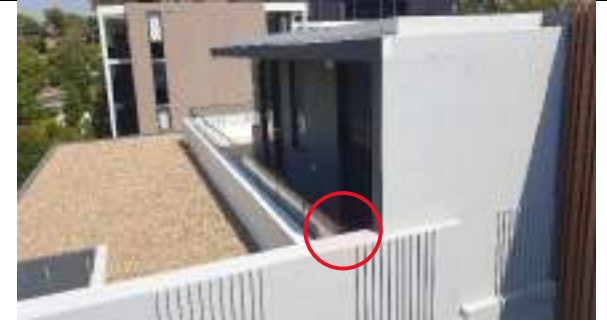
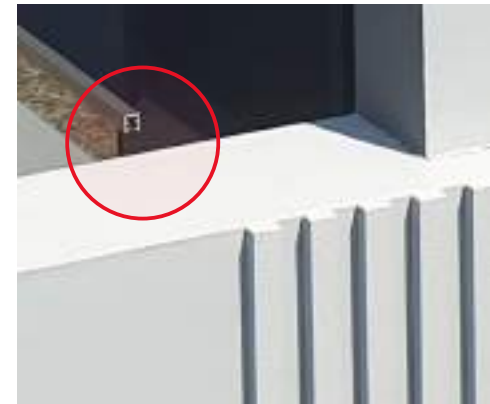
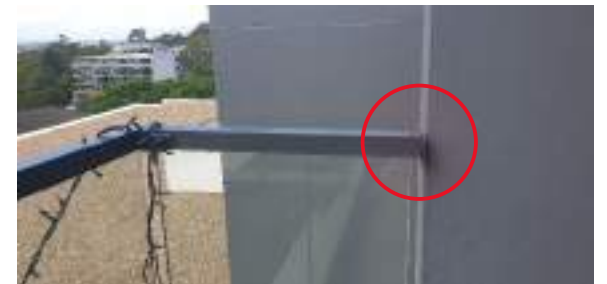
| ITEM | COMMENTARY | PHOTOGRAPH(S) |
|---|---|--|
| 5-403 | | |

| ITEM | COMMENTARY | PHOTOGRAPH(S) |
|---|---|--|
| A | <p>Location & Description</p> <p>Northwestern and Southeast balustrade connection</p> <p>The Author has observed that the balustrade rail to the northwest and southeast corners of the balcony terrace are not securely connected.</p> <p>The Author is of the view, that the balustrade rail installation does not comply with the NCC 2016 Vol2 3.9.2.2</p> <p>3.9.2.2 Barriers to prevent falls</p> <p>(a) A continuous barrier must be provided along the side of a trafficable surface, such as—</p> <p>(i) a stairway, ramp or the like; and</p> <p>(ii) a floor, corridor, hallway, balcony, deck, verandah, mezzanine, access bridge or the like; and</p> | |
| B | <p>Cause(s)</p> <ul style="list-style-type: none"> • Failure of the Builder to carry out the with in accordance with the NCC 2016 Vol2 3.9.2.2 • Failure of Builder to carry out the in accordance with building contract specifications | |
| C | <p>Breach(es)</p> <p>Failure to comply with the following:</p> <ul style="list-style-type: none"> ▪ Home Building Act 1989 (NSW) under Section 18B Clauses 1(a) & (c); ▪ NCC 2017 Vol2 3.9.2.2 | |

| ITEM | COMMENTARY | PHOTOGRAPH(S) |
|---|---|--|
| D | <p>Proposed Rectification Scope of Works</p> <p>Allow to: ADD FIXING OF HANDRAIL TO NORTHEASTERN END OF TERRACE</p> <ol style="list-style-type: none"> 1. Provide site supervision. Supervisor to coordinate access and facilitate the works throughout the whole process. 2. Gain access to required areas in accordance with Safework requirements. 3. Cover and protect adjacent surfaces during the rectification work. 4. Labour to lay extend height of rendered column to provide balustrade connection 5. Supply bricks, sand and cement 6. Labour to apply proprietary render system to affected areas in accordance with manufacturers guidelines and building specifications | |

7. Supply proprietary render system materials and ancillaries
8. Labour to prepare rendered surfaces and apply paint system to match existing finishes
9. Supply paint and ancillaries
10. Labour to extend metal balustrade rail and fix to make secure
11. Supply balustrade connections and ancillaries
12. Make good any surfaces affected as part of the works, to their prior condition.
13. Clean site and leave in a tidy condition upon completion of work

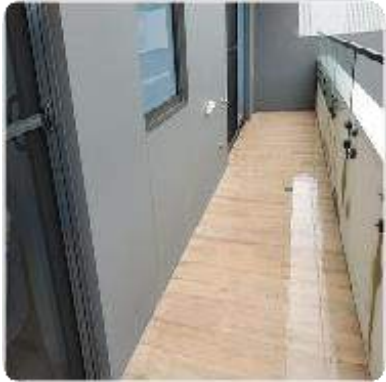
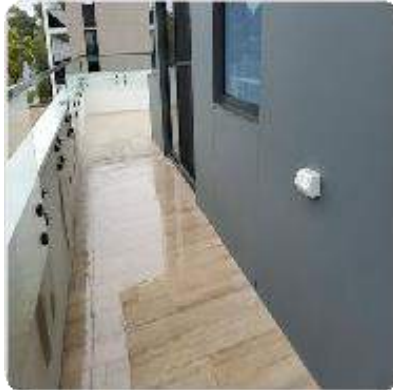
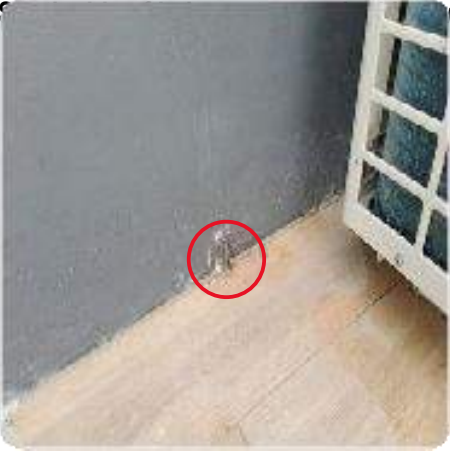
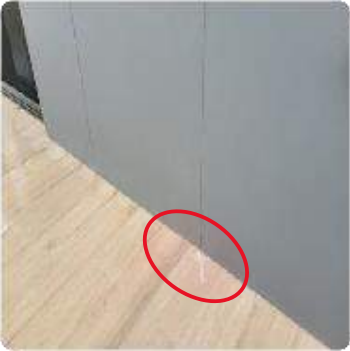
| ITEM | COMMENTARY | PHOTOGRAPH(S) |
|---|---|--|
| 6-403 | | |

| ITEM | COMMENTARY | PHOTOGRAPH(S) |
|---|---|--|
| A | <p>Location & Description Unit 403 - Exterior rendered and cladding PE/Drainage</p> <p>The Author has observed.</p> <ul style="list-style-type: none"> weep holes to the perimeter of the exterior have been sealed by paint and render materials, there is a white discharge coming from various weep holes there is drummy and delamination of render to the building façade to the southeast side of the terrace outside the bedroom door. Rainwater was penetrating and seeping from cavity at the bottom corner to the eastern side of the sliding door to bedroom 3 <p>The Author is of the view, the Builder has failed to carry out the works in accordance with HEBEL manufacturers guidelines, AS2904 Damp-proof courses and flashings.</p> <p>Furthermore, the Author as identified in Item C-2 of the schedule the Building has failed to adequately weatherproof the Building by not completing the waterproofing and providing flashing to the roof above in accordance with NCC Vol1 2016 FP1.4 Weatherproofing, AS5654.2 and building contract specifications.</p> <p>The Author is of the view, that the Builder has systematically failed to carry out the works with due care, skill, diligence and in accordance with the relevant Australian standards and legislative requirements.</p> | <p style="text-align: center;">Southeastend of balcony terrace Unit 403</p> |
| B | <p>Cause(s)</p> <ul style="list-style-type: none"> Systematic failure if the Building to carry out the works in accordance with requirements of the NCC, relevant Australian Standards and manufacturers guidelines. Poor workmanship employed by Builder at the time of construction | |
| C | <p>Breach(es) <i>Failure to comply with the following:</i></p> <ul style="list-style-type: none"> Home Building Act 1989 (NSW) under Section 18B Clauses 1(a) & (c); NCC Vol1 2016 FP1.4 Weatherproofing Manufacturers installation requirements – Weepa covers AS2904 Damp-proof courses and flashings AS4654.2 -2012 Waterproofing membranes for external above-ground use Part 2: Design and installation | |

| <p>D</p> | <p>Proposed Rectification Scope of Works Allow to:</p> <p>IN CONJUNCTION WITH REMEDIATION WORKS IN RELATION TO ITEMS R-1 AND C-2 OF THIS SCHEDULE.</p> <ol style="list-style-type: none">1. Provide site supervision. Supervisor to coordinate access and facilitate the works throughout the whole process.2. Gain access to required areas in accordance with Safework requirements.3. Cover and protect adjacent surfaces during the rectification work.4. Labour to recover weepholes5. Labour to remove defective render and dispose of demolition waste6. Labour to prepare substrate for rendering in accordance with the manufacturers guidelines7. Labour to apply proprietary render system to affected areas in accordance with manufacturers guidelines and building specifications8. Supply proprietary render system materials and ancillaries9. Labour to prepare rendered surfaces and apply paint system to match existing finishes10. Supply paint and ancillaries11. Make good any surfaces affected as part of the works, to their prior condition.12. Clean site and leave in a tidy condition upon completion of work | <p>rest</p> <p>Image of Weepa cavity drain painted over</p> <p>Moisture discharging from cavity to southern façade causing efflorescence staining to tile surface</p> |

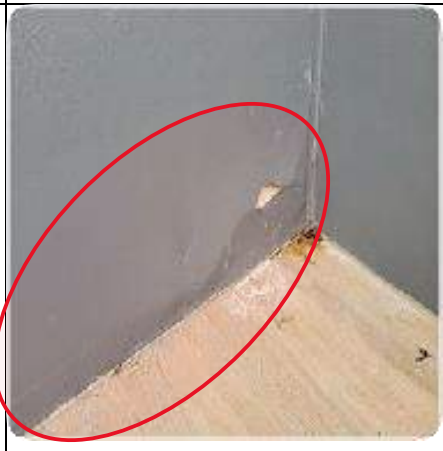
| Description Photograph(s) 6-403 | | |

| Description Photograph(s) 6-403 | | |
|---|---|---|
| <p>Location of delaminating and drummy render southeastern end of terrace balcony</p> | <p>Blocked Weepa drainage slots to western façade</p> | <p>Efflorescence staining to tile surface caused from discharge from moisture seeping cavity drainage to south side of balcony terrace</p> |
| <p>Location of efflorescence staining to tile surface on south side of balcony terrace</p> | <p>Delaminating and drummy render to southeast corner of balcony terrace to exterior wall of bedroom 3</p> | <p>Efflorescence staining to tile surface caused from discharge from moisture seeping cavity drainage to south side of balcony terrace</p> |

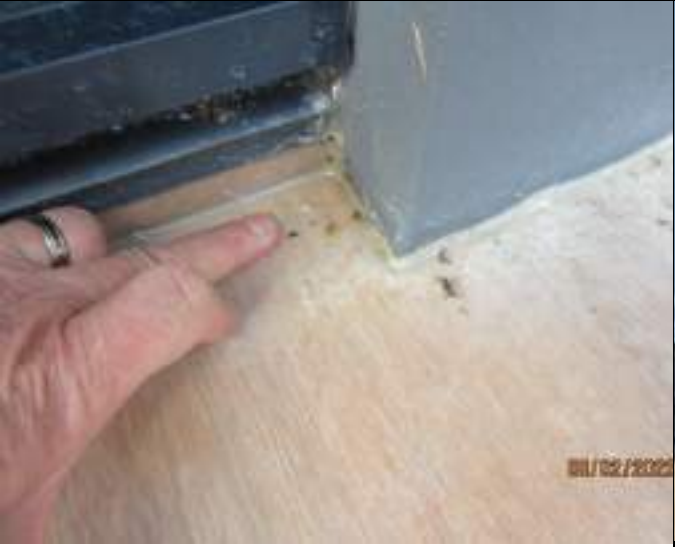
Water seeping at junction of wall and sliding door to southeast following rain

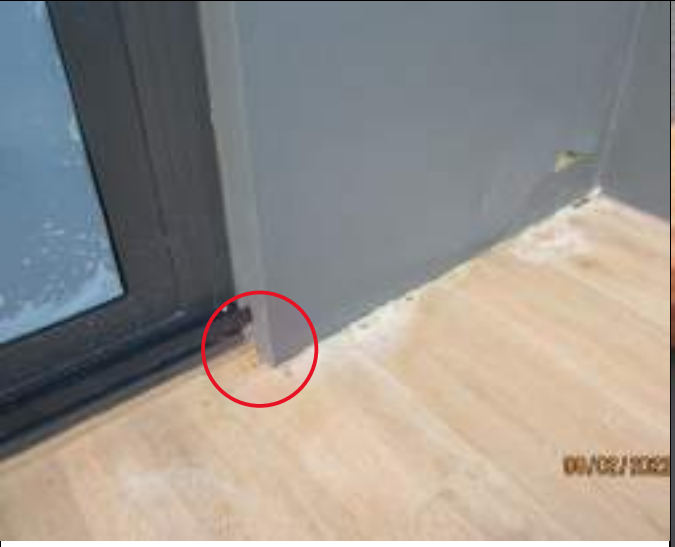
Location of water penetration

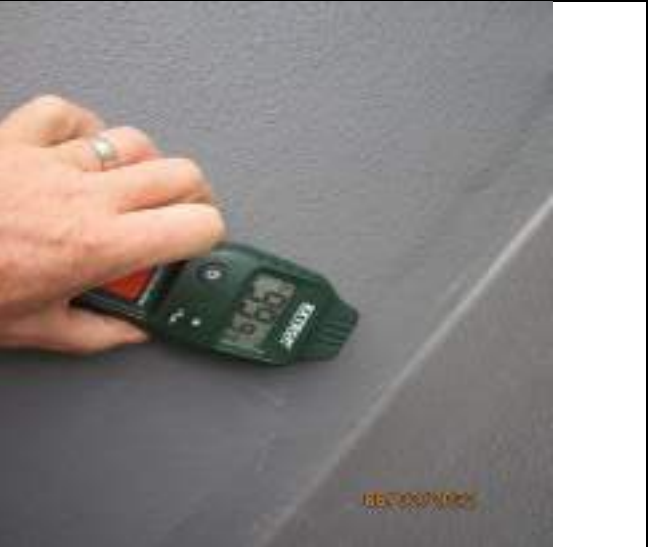
Highly elevated level of moisture indicated to surface of rendered Hebel wall at southeast corner

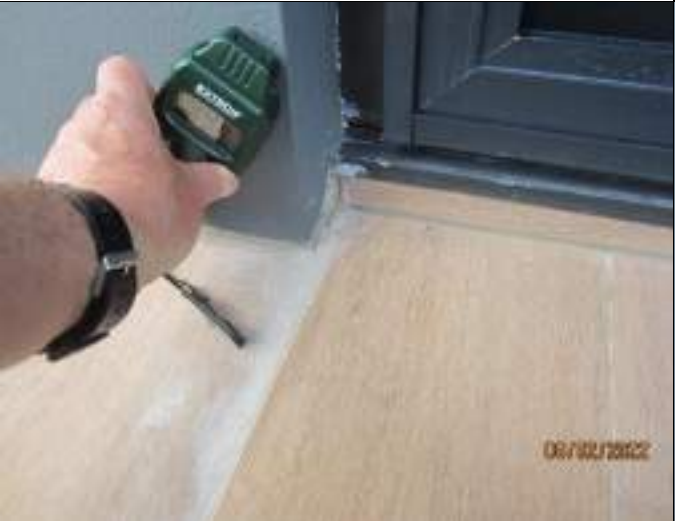
Evidence of moisture seeping and efflorescence staining at western side of southeast sliding door

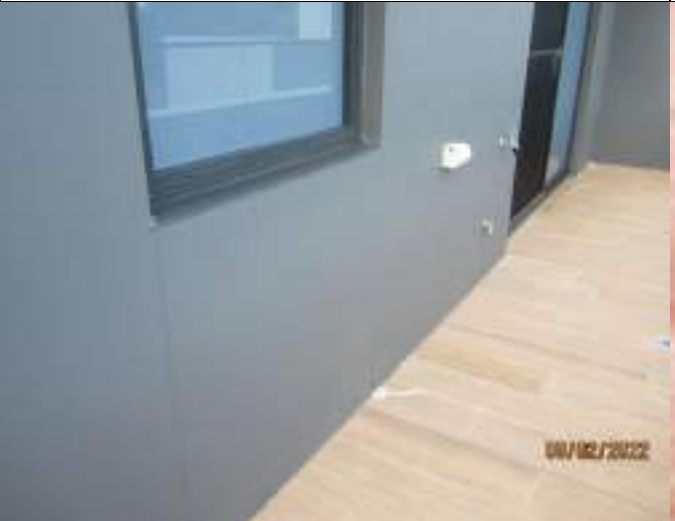
Location of moisture seepage and efflorescence staining to western side of southeast sliding door

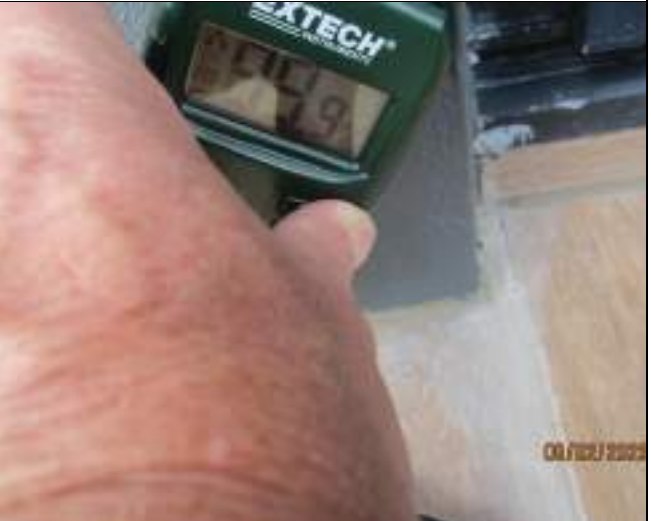
High level of moisture indicated to Hebel rendered wall above location of water seepage and efflorescence staining
