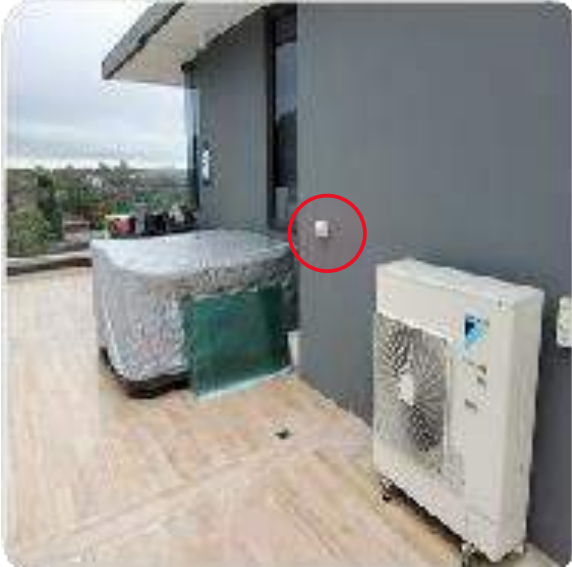
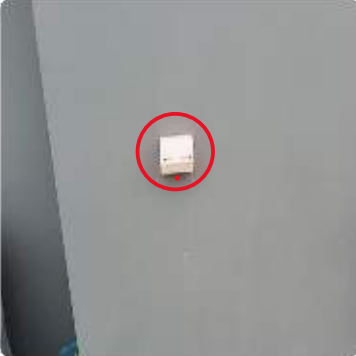
| ITEM | COMMENTARY | PHOTOGRAPH(S) |
|---|--|--|
| 7-403 | | |

| ITEM | COMMENTARY | PHOTOGRAPH(S) |
|---|--|--|
| A | <p>Location & Description Balcony terrace west – Power point</p> <p>The lot owner reported to the Author at the time of inspection, that there is no power to the external power point located on the western side of the balcony terrace.</p> <p>The Author has assumed that the lot owners statement is true and correct.</p> <p>The Author is of the view, that the Builder has failed to complete the works in accordance with building contract specifications.</p> | |
| B | <p>Cause(s)</p> <ul style="list-style-type: none"> • Poor workmanship employed by Builder at the time of construction; • Failure of Builder to complete the works in accordance with the building contract specifications | |
| C | <p>Breach(es) Failure to comply with the following:</p> <ul style="list-style-type: none"> ▪ Home Building Act 1989 (NSW) under Section 18B Clauses 1(a) ▪ Incomplete contract works | |

| ITEM | COMMENTARY | PHOTOGRAPH(S) |
|---|--|--|
| D | <p>Proposed Rectification Scope of Works Allow to:</p> <ol style="list-style-type: none"> 1. Provide site supervision. Supervisor to coordinate access and facilitate the works throughout the whole process. 2. Gain access to required areas in accordance with Safework requirements. 3. Cover and protect adjacent surfaces during the rectification work. 4. Labour to provide power to external power point 5. Make good any surfaces affected as part of the works, to their prior condition. 6. Clean site and leave in a tidy condition upon completion of work | |

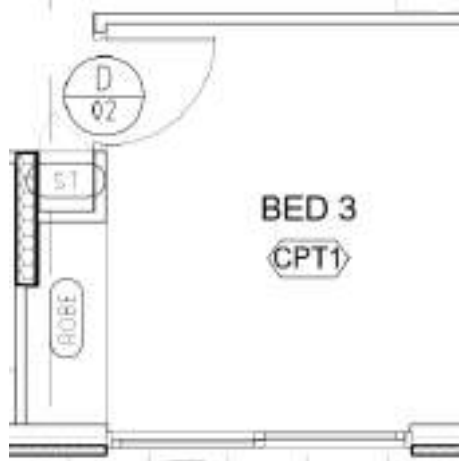
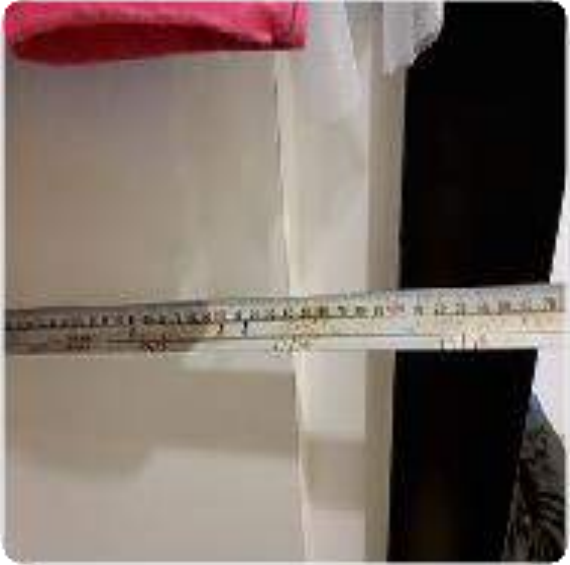
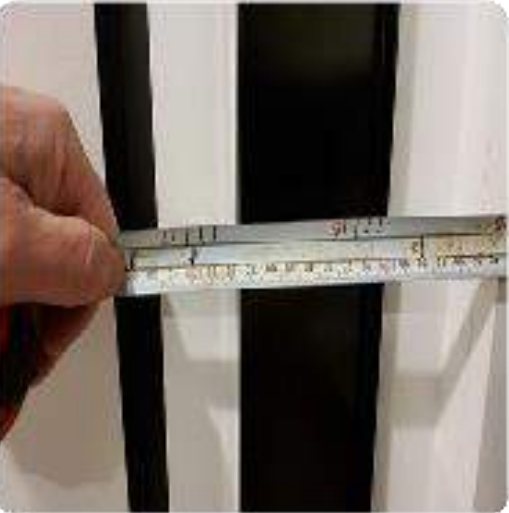
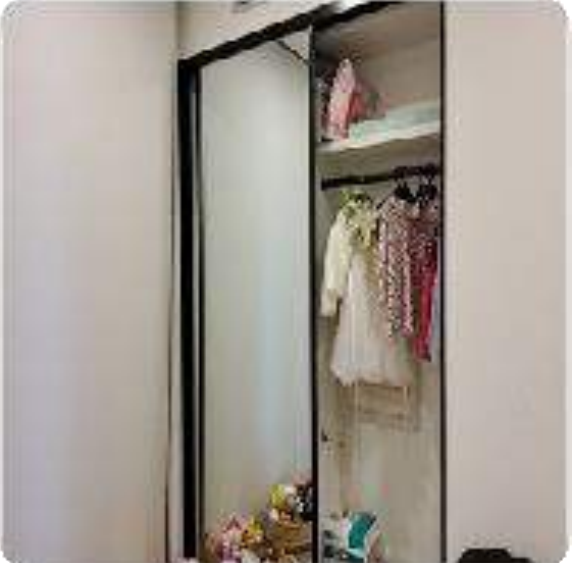
| ITEM | COMMENTARY | PHOTOGRAPH(S) |
|---|--|--|
| 9-403 | | |

| ITEM | COMMENTARY | PHOTOGRAPH(S) |
|---|--|--|
| A | <p>Location & Description Bedroom 3 built in robe</p> <p>The lot reported to the Author at the time of inspection, that there is insufficient depth on the northern side of built in robe to hang clothing. The Author has observed that the northern side of the built-in-robe measures 400 mm to the northern side provided for hanging clothing and measures 490 mm to the southern end that has draws and shelving. On review of the architectural plans there is a service void to the northern side of robe that caused the reduction in depth.</p> <p>The Author is of the view, that the Builder should have provided the shelving to the northern side and for the hanging space to be provided to the southern side</p> | |
| B | <p>Cause(s)</p> <ul style="list-style-type: none"> Failure of Builder to ensure that the work will be reasonably fit for the specified purpose of result. | |
| C | <p>Breach(es) Failure to comply with the following:</p> <ul style="list-style-type: none"> Home Building Act 1989 (NSW) under Section 18B Clauses 1(f) | |

| D | <p>Proposed Rectification Scope of Works</p> <p>Allow to:</p> <ol style="list-style-type: none">1. Provide site supervision. Supervisor to coordinate access and facilitate the works throughout the whole process.2. Gain access to required areas in accordance with Safework requirements.3. Cover and protect adjacent surfaces during the rectification work.4. Labour to remove existing joinery and install new joinery5. Supply new joinery6. Make good any surfaces affected as part of the works, to their prior condition.7. Clean site and leave in a tidy condition upon completion of work | |

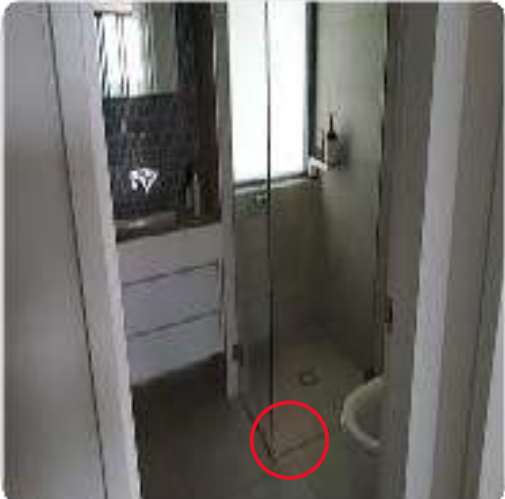
| ITEM | COMMENTARY | PHOTOGRAPH(S) |
|---|---|--|
| 10-403 | | |

| ITEM | COMMENTARY | PHOTOGRAPH(S) |
|---|---|--|
| A | <p>Location & Description Main bathroom shower screen – Damage</p> <p>The lot owner reported to the Author at the time of inspection, that the shower screen had been removed to by the Builder to conduct some remedial work, the Author observed that there is evidence that the fixed panel to the northern side of the shower has been damaged to the northeast corner with evidence the glass has been chipped.</p> <p>The Author is of the view, that the damaged due to poor workmanship employed by the Builder to carry out the maintenance.</p> | |
| B | <p>Cause(s)</p> <ul style="list-style-type: none"> Poor workmanship employed by Builder in carry out the repair work. | |
| C | <p>Breach(es) <i>Failure to comply with the following:</i></p> <ul style="list-style-type: none"> Home Building Act 1989 (NSW) under Section 18B Clauses 1 (a) & (c); NSW Guide to Standards & Tolerances 2017 G – Responsibility to rectify – Builders are liable to repair damage caused to property in the course of completing their building work. | |

| ITEM | COMMENTARY | PHOTOGRAPH(S) |
|---|---|--|
| D | <p>Proposed Rectification Scope of Works Allow to:</p> <ol style="list-style-type: none"> Provide site supervision. Supervisor to coordinate access and facilitate the works throughout the whole process. Gain access to required areas in accordance with Safework requirements. Cover and protect adjacent surfaces during the rectification work. Labour to remove damaged shower screen, install new shower screen and seal all junctions to make watertight Supply new shower screen and sealant Make good any surfaces affected as part of the works, to their prior condition. Clean site and leave in a tidy condition upon completion of work | |

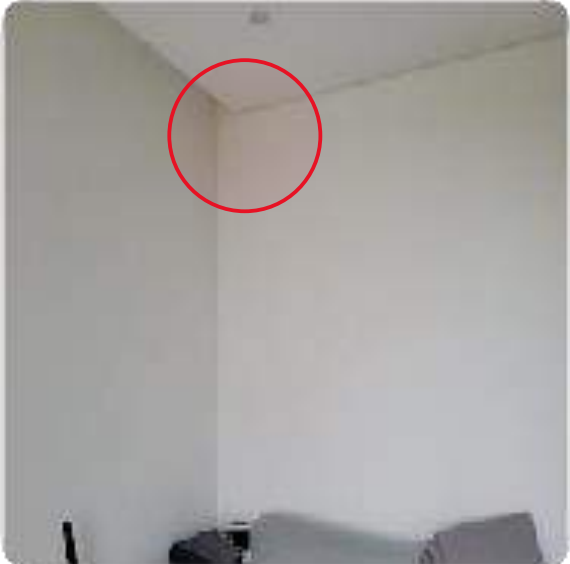
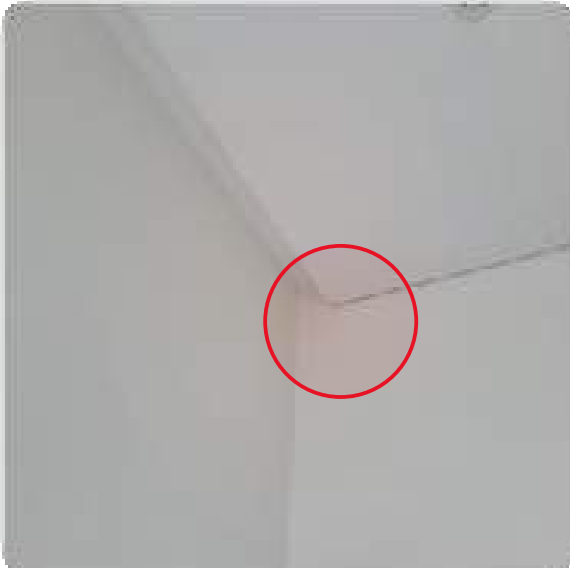
| ITEM | COMMENTARY | PHOTOGRAPH(S) |
|---|--|--|
| 12-403 | | |

| ITEM | COMMENTARY | PHOTOGRAPH(S) |
|---|--|--|
| A | <p>Location & Description Bedroom 2 ceiling – Painting</p> <p>The Author has observed paint repair in bedroom two to the northwest side of the room towards the upper ceiling and step up from the ceiling bulkhead patching has not been completed.</p> <p>The Author is of the view, that the Builder has failed to complete the repair works.</p> | |
| B | <p>Cause(s)</p> <ul style="list-style-type: none"> • Failure of Builder to complete the rectifications works | |
| C | <p>Breach(es) Failure to comply with the following:</p> <ul style="list-style-type: none"> ▪ Home Building Act 1989 (NSW) under Section 18B Clauses 1(a) ▪ Building contract – Defect liability period | |

| ITEM | COMMENTARY | PHOTOGRAPH(S) |
|---|--|--|
| D | <p>Proposed Rectification Scope of Works Allow to:</p> <ol style="list-style-type: none"> 1. Provide site supervision. Supervisor to coordinate access and facilitate the works throughout the whole process. 2. Gain access to required areas in accordance with Safework requirements. 3. Labour to complete paint repair to affected area 4. Supply paint ancillaries 5. Cover and protect adjacent surfaces during the rectification work. 6. Make good any surfaces affected as part of the works, to their prior condition. 7. Clean site and leave in a tidy condition upon completion of work | |

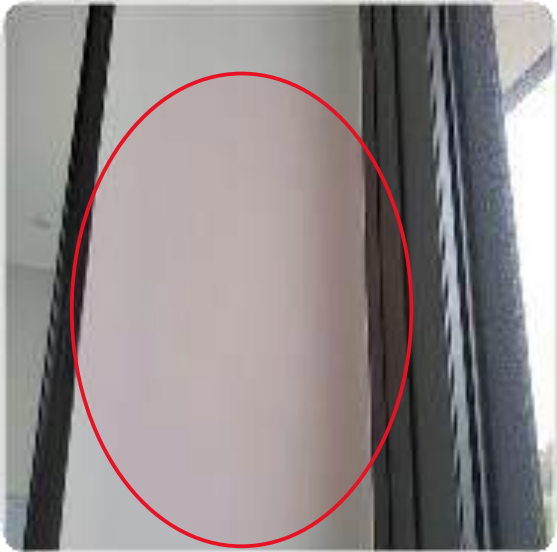
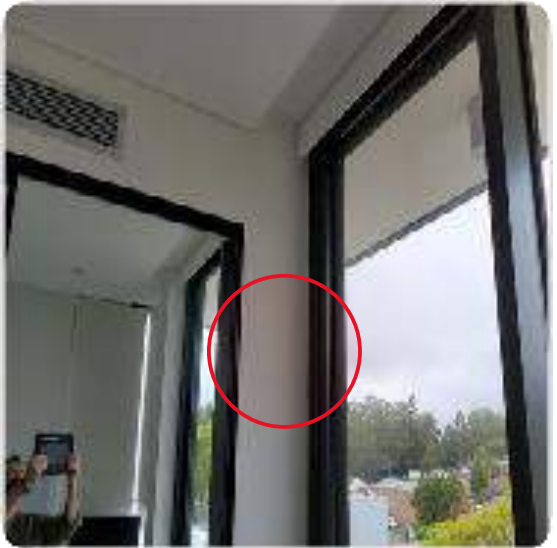
| ITEM | COMMENTARY | PHOTOGRAPH(S) |
|---|--|--|
| 13-403 | | |

| ITEM | COMMENTARY | PHOTOGRAPH(S) |
|---|--|--|
| A | <p>Location & Description Bedroom 2 southeastern corner – Painting</p> <p>The Author has observed poor paint finish to the southeast corner of bedroom 2 adjacent to the sliding door.</p> <p>The Author is of the view, that the defect originated due to poor workmanship employed by the Builder at the time of construction</p> | |
| B | <p>Cause(s)</p> <ul style="list-style-type: none"> Poor workmanship employed by Builder at the time of construction | |
| C | <p>Breach(es) <i>Failure to comply with the following:</i></p> <ul style="list-style-type: none"> Home Building Act 1989 (NSW) under Section 18B Clauses (a) & (c); AS2311:2017 Guide to the painting of buildings NSW standards & tolerances 2017 – 13.2 Surface finish of paintwork <i>Paintwork is defective if the application has blemishes such as paint runs, paint sags, wrinkling, dust, bare or starved painted areas, colour variations, surface cracks, irregular and coarse brush marks, sanding marks, blistering, non-uniformity of gloss level and other irregularities in the surface that are visible from a normal viewing position. (Highlighting added)</i> | |

| ITEM | COMMENTARY | PHOTOGRAPH(S) |
|---|--|--|
| D | <p>Proposed Rectification Scope of Works Allow to:</p> <ol style="list-style-type: none"> Provide site supervision. Supervisor to coordinate access and facilitate the works throughout the whole process. Gain access to required areas in accordance with Safework requirements. Cover and protect adjacent surfaces during the rectification work. Labour to patch, repair and apply paint in accordance with AS2311:2017 Guide to the painting of buildings Supply paint and ancillaries Make good any surfaces affected as part of the works, to their prior condition. Clean site and leave in a tidy condition upon completion of work | |

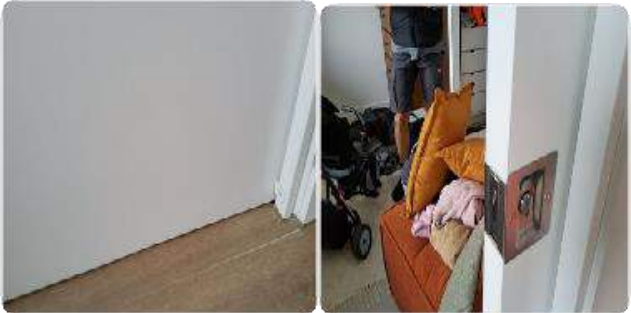
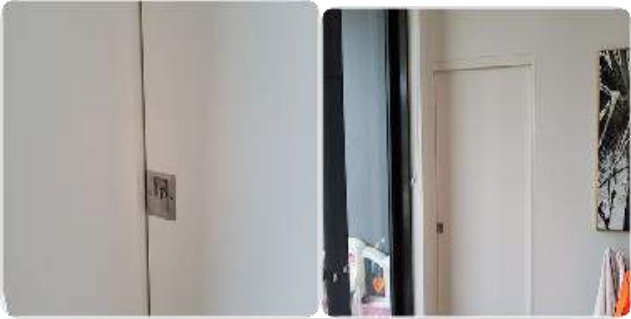
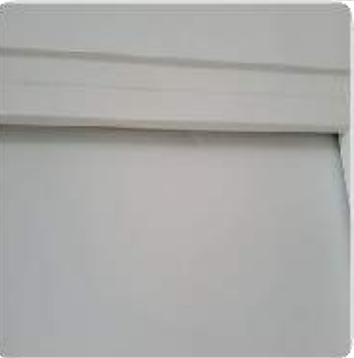
| ITEM | COMMENTARY | PHOTOGRAPH(S) |
|---|--|--|
| 14-403 | | |

| ITEM | COMMENTARY | PHOTOGRAPH(S) |
|---|--|--|
| A | <p>Location & Description Main bedroom door –Painting and Door furniture installation</p> <p>The Author has observed that the cavity sliding door to main bedroom –</p> <ul style="list-style-type: none"> the guide installed at the bottom of the door is causing damage due to operation and contact with the door paint finish The door furniture set is not catching keeper, needs adjustment. <p>The Author is of the view, that the defect originated due to poor workmanship employed by the Builder at the time of construction</p> | |
| B | <p>Cause(s)</p> <ul style="list-style-type: none"> Poor workmanship employed by Builder at the time of construction; Door does not operate as intended | |
| C | <p>Breach(es) Failure to comply with the following:</p> <ul style="list-style-type: none"> Home Building Act 1989 (NSW) under Section 18B Clauses 1(a) Building contract – Defect liability period AS2311:2017 Guide to the painting of buildings NSW standards & tolerances 2017 – 13.2 Surface finish of paintwork <p>Paintwork is defective if the application has blemishes such as paint runs, paint sags, wrinkling, dust, bare or starved painted areas, colour variations, surface cracks, irregular and coarse brush marks, sanding marks, blistering, non-uniformity of gloss level and other irregularities in the surface that are visible from a normal viewing position. (Highlighting added)</p> | |

| ITEM | COMMENTARY | PHOTOGRAPH(S) |
|---|--|--|
| D | <p>Proposed Rectification Scope of Works Allow to:</p> <ol style="list-style-type: none"> Provide site supervision. Supervisor to coordinate access and facilitate the works throughout the whole process. Gain access to required areas in accordance with Safework requirements. Cover and protect adjacent surfaces during the rectification work. Labour to repair affected paintwork in accordance with AS2311:2017 Guide to the painting of buildings Labour to adjust door furniture and guides to operate as intended Supply paint and ancillaries Make good any surfaces affected as part of the works, to their prior condition. Clean site and leave in a tidy condition upon completion of work | |

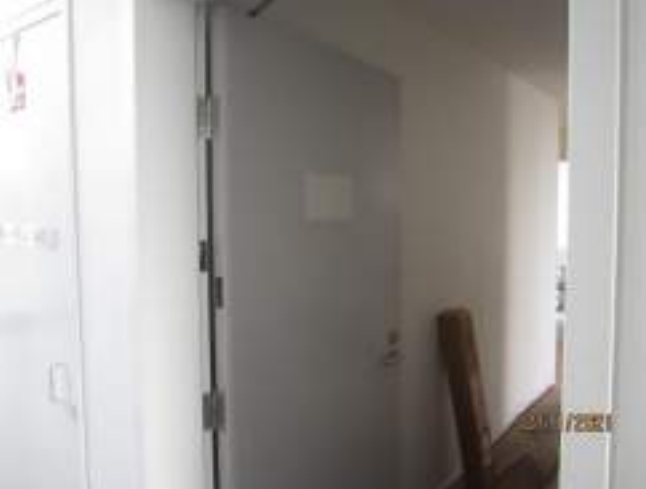
| ITEM | COMMENTARY | PHOTOGRAPH(S) |
|---|--|---|
| 16-403 | | |

| ITEM | COMMENTARY | PHOTOGRAPH(S) |
|---|--|---|
| A | <p>Location & Description Entry door signage</p> <p>The occupant reported to the Author at the time of inspection, that the Builder had removed the unit number sign from the entry to repair defective pain works to the door and that the defective item remains outstanding.</p> <p>The Author has assumed that the owners statements are true and correct.</p> <p>The Author is of the view, that the Builder has failure to carry out the repair works.</p> | |
| B | <p>Cause(s)</p> <ul style="list-style-type: none"> • Poor workmanship employed by Builder at the time of construction • Incomplete maintenance works | |
| C | <p>Breach(es) Failure to comply with the following:</p> <ul style="list-style-type: none"> ▪ Home Building Act 1989 (NSW) under Section 18B Clauses 1(a); ▪ Building contract – Defect liability period ▪ Incomplete contract works | |

Unit number is missing to entry unit door.

| ITEM | COMMENTARY | PHOTOGRAPH(S) |
|---|--|---|
| D | <p>Proposed Rectification Scope of Works Allow to:</p> <ol style="list-style-type: none"> 1. Provide site supervision. Supervisor to coordinate access and facilitate the works throughout the whole process. 2. Gain access to required areas in accordance with Safework requirements. 3. Cover and protect adjacent surfaces during the rectification work. 4. Labour to repair defective paintworks in accordance with AS2311:2017 Guide to the painting of buildings 5. Labour to fix unit number signage to entry door 6. Supply paint and ancillaries 7. Supply signage 8. Make good any surfaces affected as part of the works, to their prior condition. 9. Clean site and leave in a tidy condition upon completion of work | |

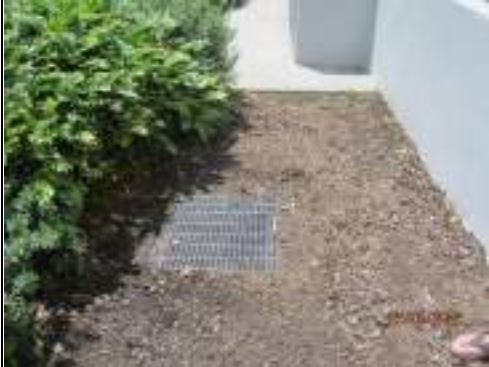
| DEFECT NO. | LOCATION | AREA | BREACH | PHOTOGRAPH | DEFECT DESCRIPTION |
|---|---|---|---|---|--|
| C 1 | Landscape (north of site) | Storm water pit | Not fit for purpose | | <p>Bark is washing down storm water pit</p> <p>HARPER OBSERVATIONS AND COMMENTS – RESOLVED – SCREEN MESH INSTALLED.</p> |

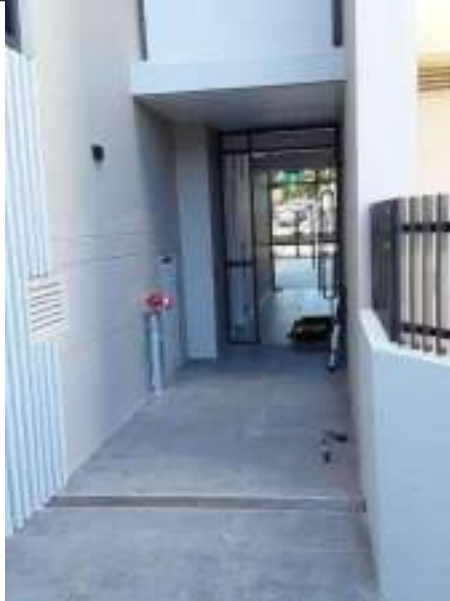
| DEFECT NO. | LOCATION | AREA | BREACH | PHOTOGRAPH | DEFECT DESCRIPTION |
|---|---|---|---|---|--|
| C 2 | Ground floor north entry | Entry door threshold | See section 8.7 of this report. | | Hebel external wall installed higher than internal habitable spaces. HARPER OBSERVATIONS AND COMMENTS – LOCATION OF ALLEGE DEFECT NOT INDICTED. |

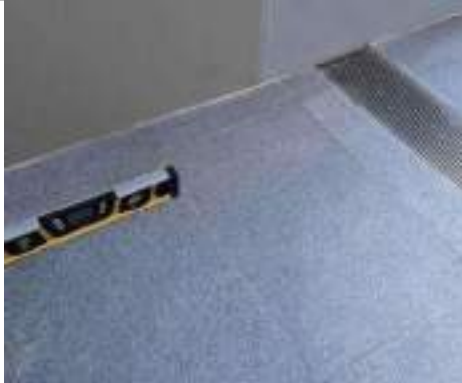
| DEFECT NO. | LOCATION | AREA | BREACH | PHOTOGRAPH | DEFECT DESCRIPTION |
|---|---|---|---|---|--|
| C 3 | Ground floor north entry | Floor tiles | See section 8.4 of this report. | | Insufficient falls of 2mm per metre. HARPER OBSERVATIONS AND COMMENTS – OUTSTANDING REFER ITEM C-10 SECTION 10 HARPER DEFECT SCHEDULE. |

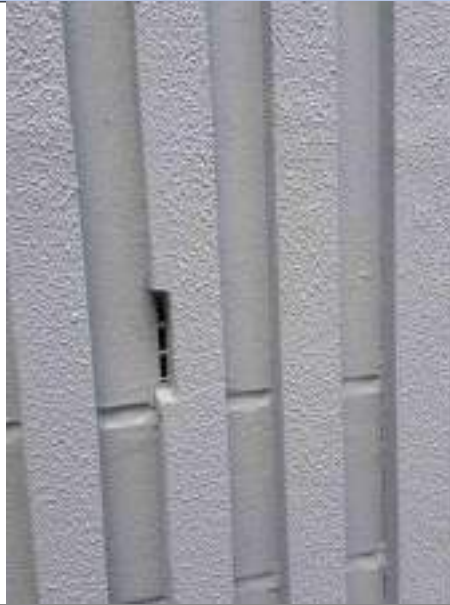
| DEFECT NO. | LOCATION | AREA | BREACH | PHOTOGRAPH | DEFECT DESCRIPTION |
|---|---|---|---|---|--|
| C 5 | Ground floor south entry | Hebel cladding (weepholes) | Note | | Some weepholes have been installed to the Hebel facade. <div style="border: 1px dashed black; padding: 5px; width: fit-content; margin: 10px auto;"> HARPER OBSERVATIONS AND COMMENTS – CONCUR, NOTED </div> |

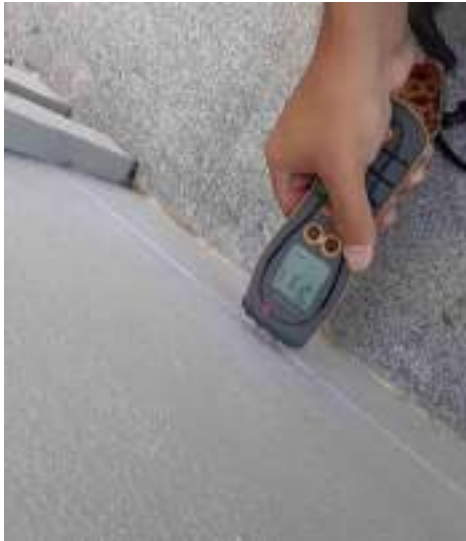
| DEFECT NO. | LOCATION | AREA | BREACH | PHOTOGRAPH | DEFECT DESCRIPTION |
|---|---|---|---|---|--|
| C 6 | Ground floor south entry | Hebel cladding | See section 8.7 of this report. | | Elevated moisture to wall outside of G05. No drainage to facade. Concrete hob not installed as per plans. <div style="border: 1px dashed black; padding: 5px; width: fit-content; margin: 10px auto;"> HARPER OBSERVATIONS AND COMMENTS – LOW LEVEL OF MOISTURE INDICATED. </div> <div style="text-align: right; margin-top: 10px;"> </div> |

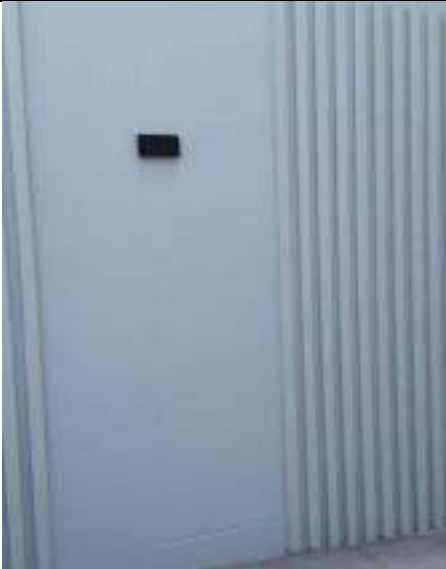
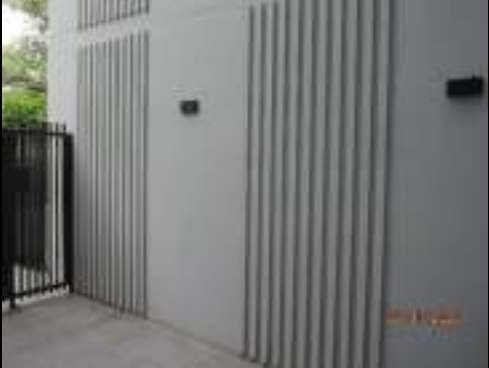
| DEFECT NO. | LOCATION | AREA | BREACH | PHOTOGRAPH | DEFECT DESCRIPTION |
|---|---|---|---|---|--|
| C 7 | Ground floor south entry | Hebel cladding | See section 8.26 of this report. | | <p>No pressure equalisation slots have been installed.</p> <p>HARPER OBSERVATIONS AND COMMENTS – CONCUR, OUTSTANDING, REFER ITEM C-7 SECTION 10 HARPER REPORT..</p> |

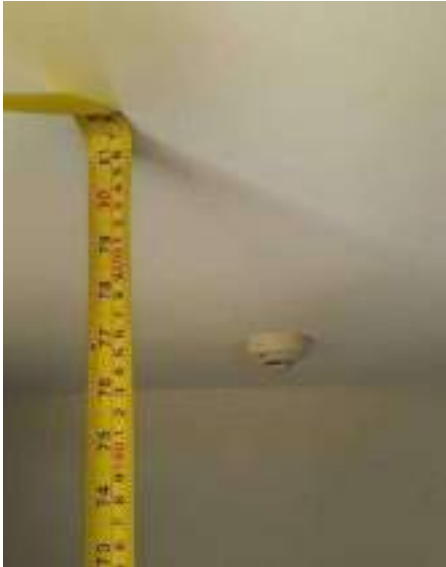
| DEFECT NO. | LOCATION | AREA | BREACH | PHOTOGRAPH | DEFECT DESCRIPTION |
|---|---|---|---|---|--|
| C 8 | Common area | Toilet ceiling | See section 8.14 of this report. | | <p>Ceiling height is 2080mm</p> <p>HARPER OBSERVATIONS AND COMMENTS – CEILING HEIGHT IS DUE TO NO ALLOWANCE FOR FLOOR AND CEILING FINISHES.</p> <p>HOWEVER, IT IS HARPER'S VIEW THAT THE ROOM IS 'FIT FOR PURPOSE' AS THE ROOM HEIGHT IS ONLY 20 MM BELOW THE MINIMUM HEIGHT UNDER THE REFERENCED SECTION OF THE NCC WITH NO APPARENT IMPACT ON USE OF ROOM.</p> |

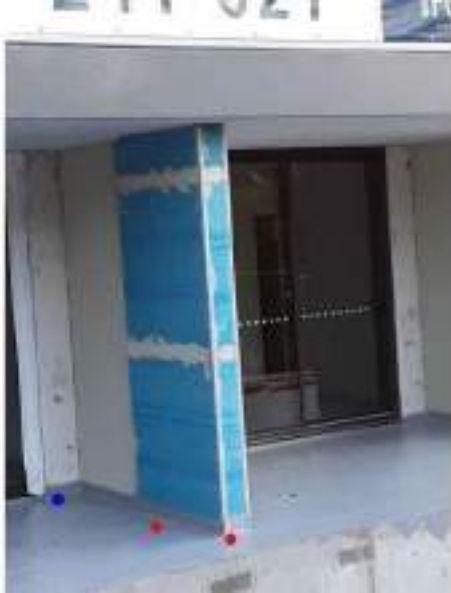
| DEFECT NO. | LOCATION | AREA | BREACH | PHOTOGRAPH | DEFECT DESCRIPTION |
|---|---|---|--|---|---|
| C 10 | East facade | Cladding | See sections 8.5 and 8.6 of this report. | | <p>Red - waterproofing turned up base of FC sheets. Blue - Hebel with no cavity drains.</p> <p>HARPER OBSERVATIONS AND COMMENTS – NO EVIDENCE OF RECTIFICATION AS WORKS COMPLETE AT THE TIME OF INSPECTION.</p> |

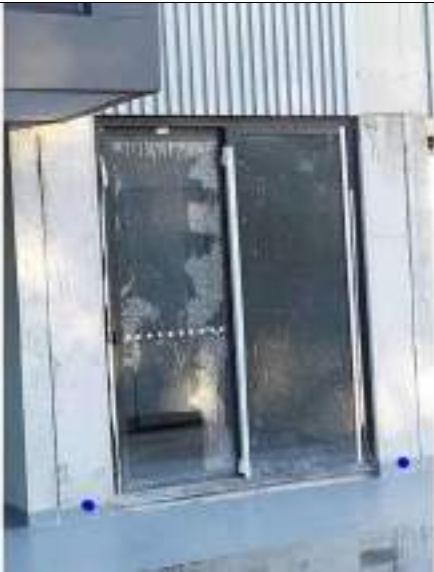
| DEFECT NO. | LOCATION | AREA | BREACH | PHOTOGRAPH | DEFECT DESCRIPTION |
|---|---|---|--|---|---|
| C 11 | East facade | Hebel cladding | See sections 8.5 and 8.6 of this report. | | <p>No drainage to Hebel. Waterproofing has been turned up base of Hebd.</p> <p>HARPER OBSERVATIONS AND COMMENTS – WATERPROOFING – NO EVIDENCE OF RECTIFICATION AS WORKS COMPLETE AT THE TIME OF INSPECTION.</p> <p>HEBEL DRAINAGE – OUTSTANDING, REFER ITEM 8-GO2 SECTION 10 HARPER DEFECT SCHEDULE.</p> |

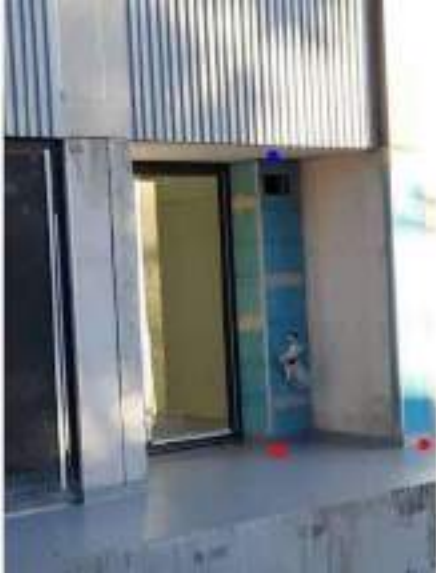
| DEFECT NO. | LOCATION | AREA | BREACH | PHOTOGRAPH | DEFECT DESCRIPTION |
|---|---|---|--|---|--|
| C 12 | East facade | Cladding | See sections 8.5 and 8.6 of this report. | | <p>Red - waterproofing turned up base of FC sheets. Blue - No drip groove to soffit.</p> <p>HARPER OBSERVATIONS AND COMMENTS – WATERPROOFING – NO EVIDENCE OF RECTIFICATION AS WORKS HAD BEEN COMPLETED AT THE TIME OF INSPECTION.</p> |

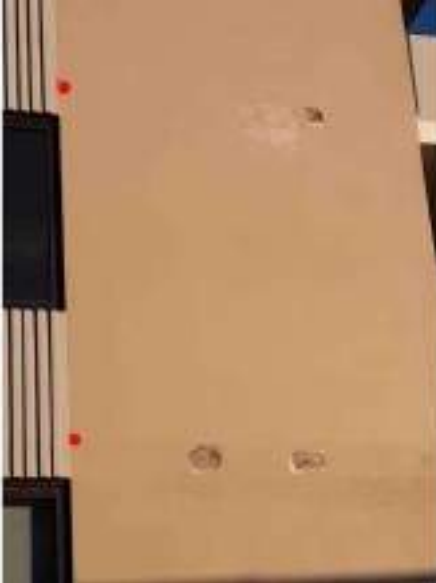
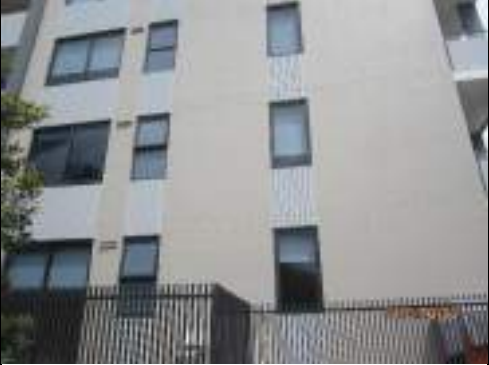
| DEFECT NO. | LOCATION | AREA | BREACH | PHOTOGRAPH | DEFECT DESCRIPTION |
|---|---|---|--|---|--|
| C 13 | East facade | Hebel cladding | See section 8.26 of this report. | | <p>No pressure equalisation slots to wall. One weephole only visible.</p> <p>HARPER OBSERVATIONS AND COMMENTS – PE SLOTS ARE LOCATED IN ACCORDANCE WITH MANUFACTURERS GUIDELINES.</p> |

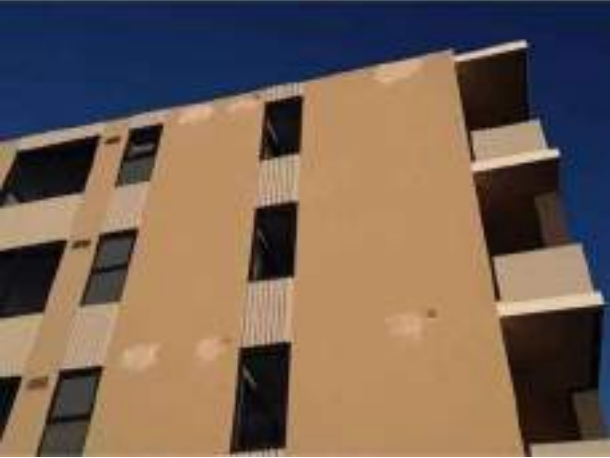
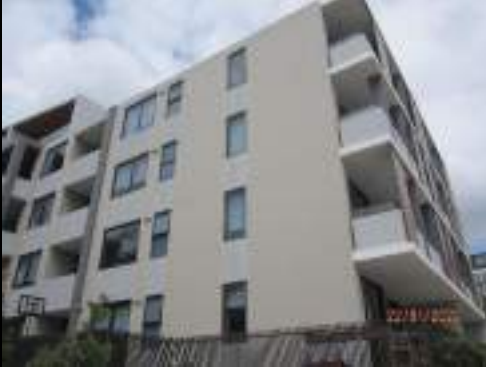
| DEFECT NO. | LOCATION | AREA | BREACH | PHOTOGRAPH | DEFECT DESCRIPTION |
|---|---|---|--|---|---|
| C 14 | East facade | Cladding | See sections 8.5 and 8.6 of this report. | | <p>No visible pressure equalisation slots as required by Hebel manufacturer.</p> <p>HARPER OBSERVATIONS AND COMMENTS – PE SLOTS ARE LOCATED IN ACCORDANCE WITH MANUFACTURERS GUIDELINES.</p> |

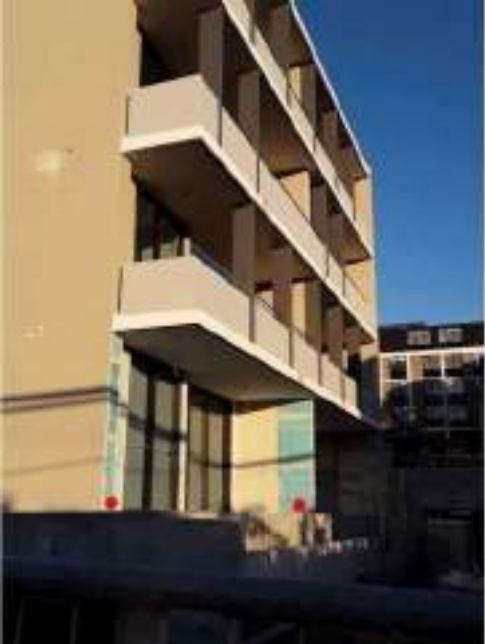
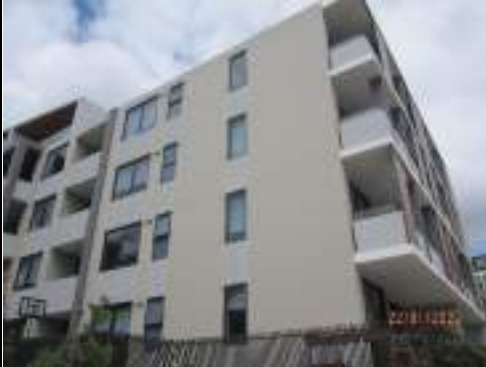
| DEFECT NO. | LOCATION | AREA | BREACH | PHOTOGRAPH | DEFECT DESCRIPTION |
|---|---|---|--|---|---|
| C 15 | East facade | FC cladding | See section 8.5 and 8.6 of this report. | | <p>Base of FC sheets have been waterproofed up.</p> <p>HARPER OBSERVATIONS AND COMMENTS – WATERPROOFING – NO EVIDENCE OF RECTIFICATION AS WORKS HAD BEEN COMPLETED AT THE TIME OF INSPECTION.</p> |

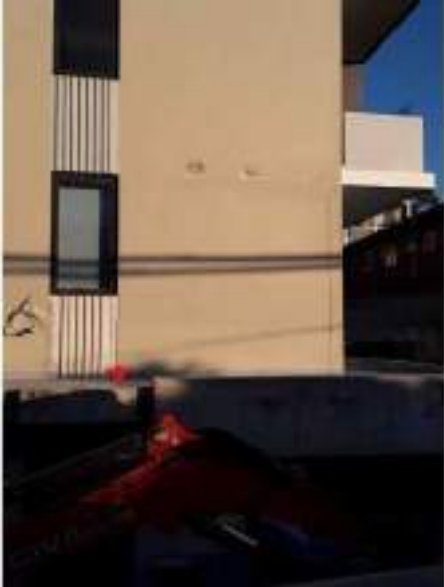
| DEFECT NO. | LOCATION | AREA | BREACH | PHOTOGRAPH | DEFECT DESCRIPTION |
|---|---|---|--|---|--|
| C 16 | East facade | Cladding | See sections 8.5 and 8.6 of this report. | | Weephole has been waterproofed over, no drainage for Hebel. HARPER OBSERVATIONS AND COMMENTS – PE SLOTS ARE LOCATED IN ACCORDANCE WITH MANUFACTURERS GUIDELINES. |

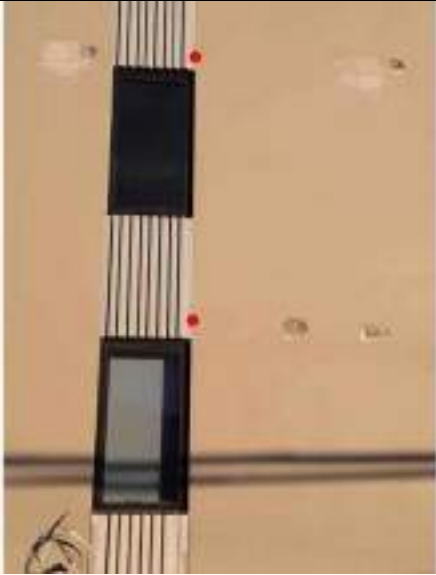
| DEFECT NO. | LOCATION | AREA | BREACH | PHOTOGRAPH | DEFECT DESCRIPTION |
|---|---|---|--|---|--|
| C 17 | East facade | Hebel cladding | See section 8.26 of this report. | | Insufficient Hebel drainage HARPER OBSERVATIONS AND COMMENTS – PE SLOTS ARE LOCATED IN ACCORDANCE WITH MANUFACTURERS GUIDELINES. |

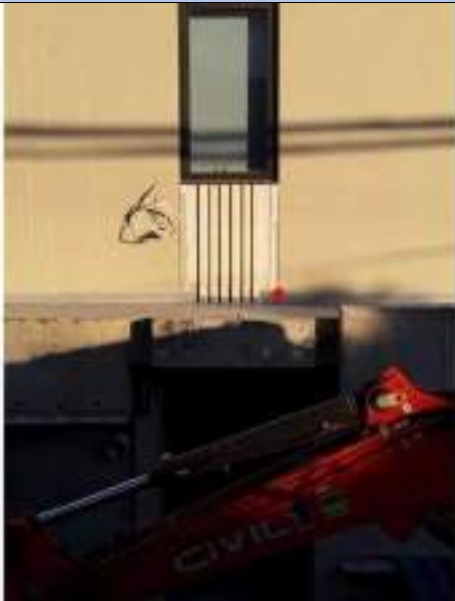
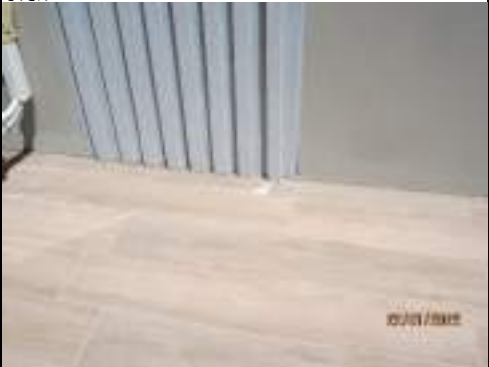
| DEFECT NO. | LOCATION | AREA | BREACH | PHOTOGRAPH | DEFECT DESCRIPTION |
|---|---|---|--|---|---|
| C 18 | East facade | Cladding | See sections 8.5 and 8.6 of this report. | | <p>The single drainage provision has been waterproofed over.</p> <p>HARPER OBSERVATIONS AND COMMENTS – TEMPORARY WEEPA PROTECTION NOT REMOVED, REFER ITEM 8-GO2 SECTION 10 HARPER DEFECT SCHEDULE.</p> |

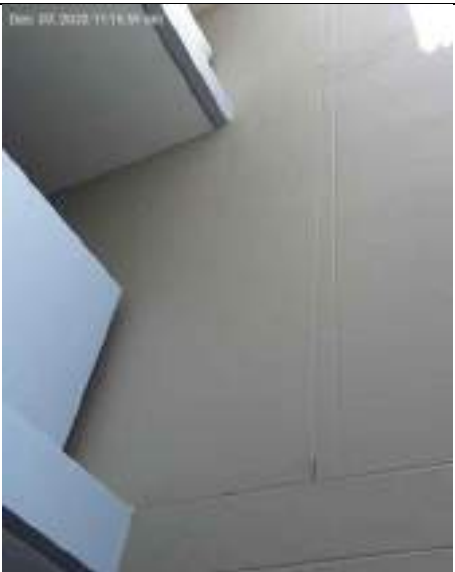
| DEFECT NO. | LOCATION | AREA | BREACH | PHOTOGRAPH | DEFECT DESCRIPTION |
|---|---|---|--|---|---|
| C 19 | East facade | Hebel cladding | Note | | <p>Some drainage provisions were identified at the Property.</p> <p>HARPER OBSERVATIONS AND COMMENTS –CONCUR</p> |

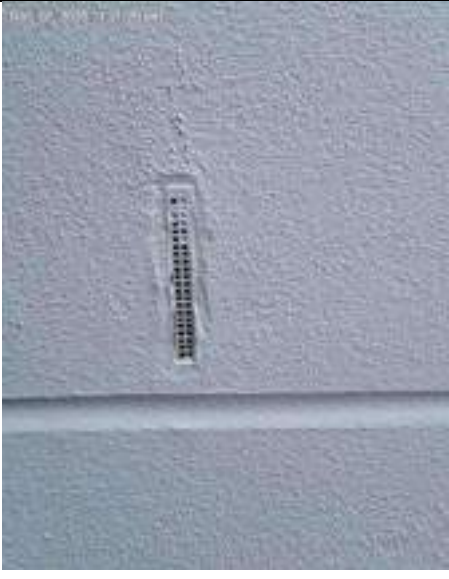
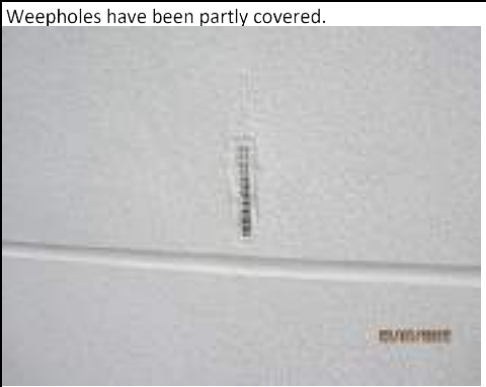
| DEFECT NO. | LOCATION | AREA | BREACH | PHOTOGRAPH | DEFECT DESCRIPTION |
|---|---|---|--|---|--|
| C 21 | East facade | Hebel cladding | Works have not been completed with due care and skill. | | <p>Weepholes have been partly covered.</p> <p>HARPER OBSERVATIONS AND COMMENTS – RESOLVED</p> |

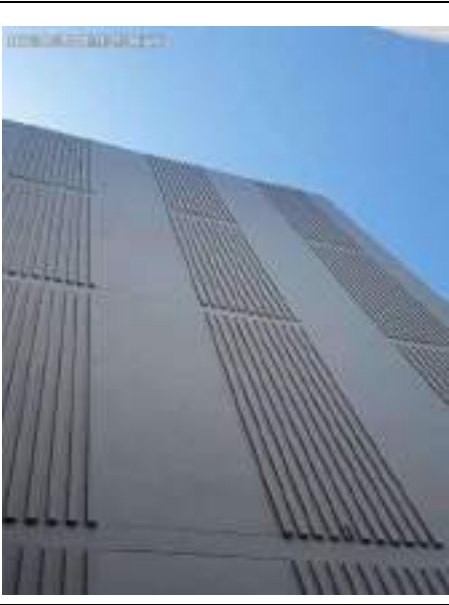
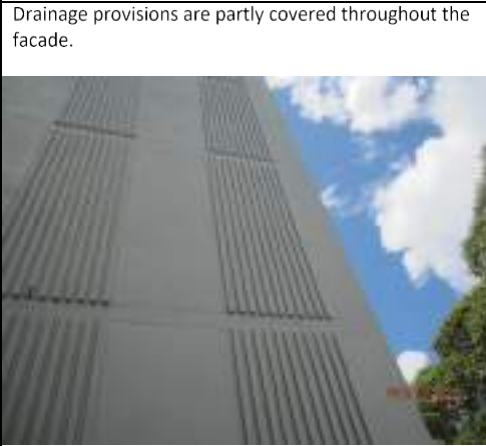
| DEFECT NO. | LOCATION | AREA | BREACH | PHOTOGRAPH | DEFECT DESCRIPTION |
|---|---|---|--|---|--|
| C 22 | East facade | Hebel cladding | See section 8.26 of this report. | | <p>Drainage provisions are partly covered throughout the facade.</p> <p>HARPER OBSERVATIONS AND COMMENTS – PE SLOTS ARE LOCATED IN ACCORDANCE WITH MANUFACTURERS GUIDELINES.</p> |

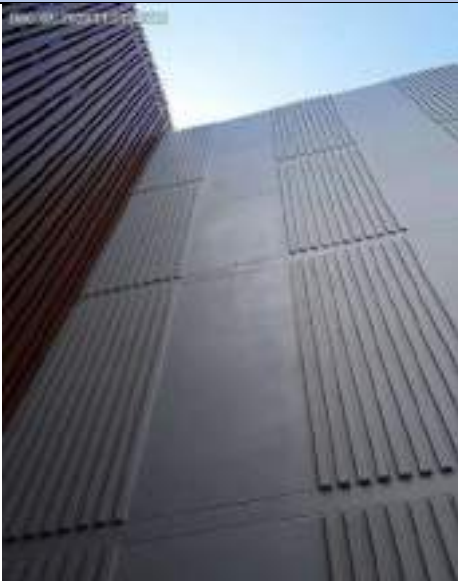
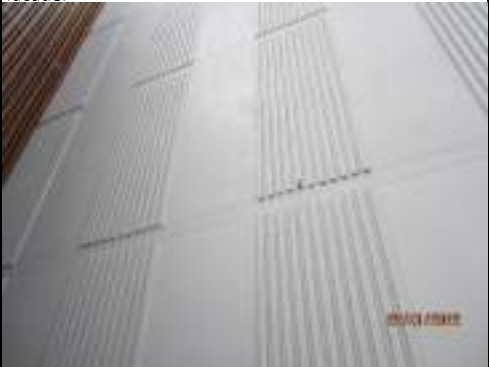
| DEFECT NO. | LOCATION | AREA | BREACH | PHOTOGRAPH | DEFECT DESCRIPTION |
|---|---|---|---|---|---|
| C 23 | East facade | Hebel cladding | See section 8.26 of this report. | | <p>Drainage provisions are partly covered throughout the facade.</p> <p>HARPER OBSERVATIONS AND COMMENTS – RESOLVED</p> |

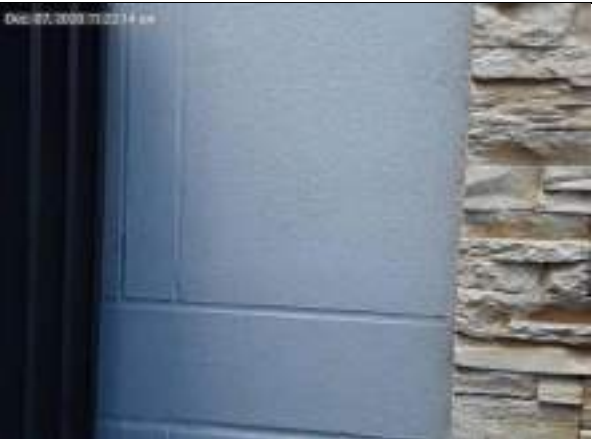
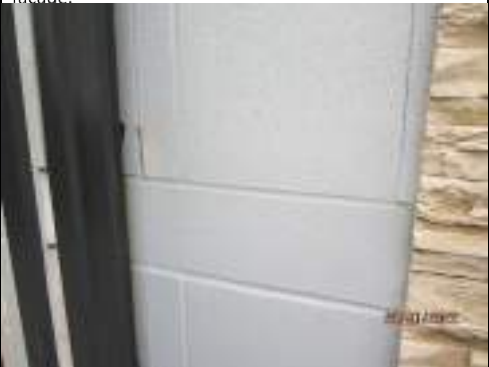
| DEFECT NO. | LOCATION | AREA | BREACH | PHOTOGRAPH | DEFECT DESCRIPTION |
|---|---|---|---|---|---|
| C 24 | East facade | Hebel cladding | See section 8.26 of this report. | | <p>Drainage provisions are partly covered throughout the facade.</p> <p>HARPER OBSERVATIONS AND COMMENTS – RESOLVED</p> |

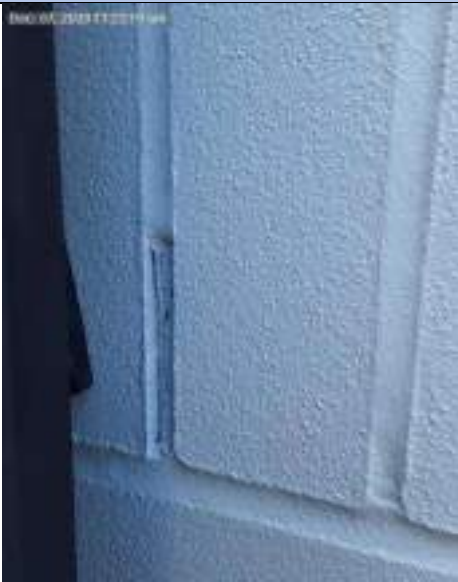
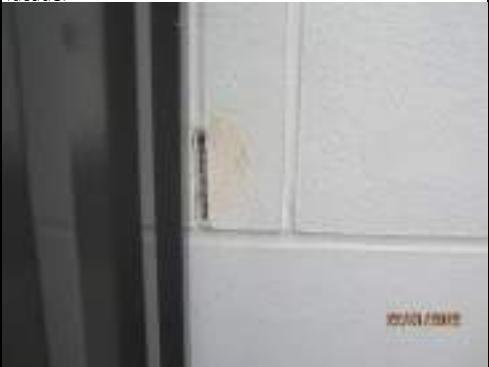
| DEFECT NO. | LOCATION | AREA | BREACH | PHOTOGRAPH | DEFECT DESCRIPTION |
|---|---|---|--|---|--|
| C 25 | East facade | Hebel cladding | See section 8.26 of this report. | | <p>Drainage provisions are partly covered throughout the facade.</p> <p>HARPER OBSERVATIONS AND COMMENTS – RESOLVED</p> |

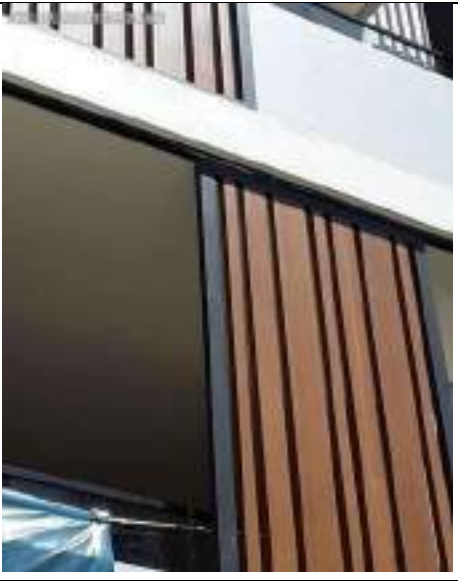
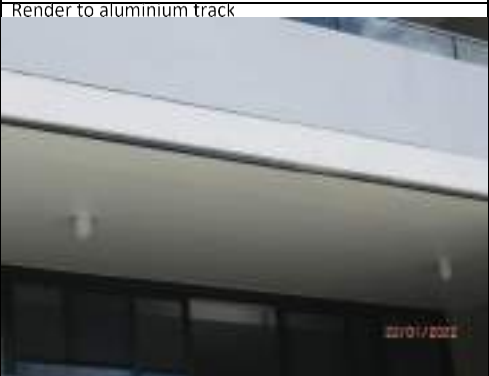
| DEFECT NO. | LOCATION | AREA | BREACH | PHOTOGRAPH | DEFECT DESCRIPTION |
|---|---|---|--|---|--|
| C 26 | East facade | Privacy screen | Works have not been completed with due care and skill. | | <p>Render to aluminium track</p> <p>HARPER OBSERVATIONS AND COMMENTS – CONCUR, OUTSTANDING REFER ITEM C-2 SECTION 10 HARPER DEFECT SCHEDULE.</p> |

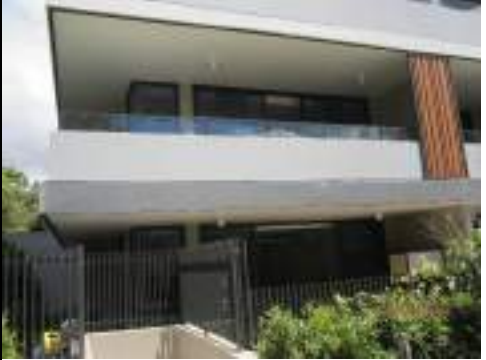
| DEFECT NO. | LOCATION | AREA | BREACH | PHOTOGRAPH | DEFECT DESCRIPTION |
|---|---|---|---|---|---|
| C 27 | East facade | Balcony slab edge | See section 8.9 of this report. | | Efflorescence. HARPER OBSERVATIONS AND COMMENTS – CONCUR – ON GOING, CONCUR, OUTSTANDING REFER ITEM C-2 SECTION 10 HARPER DEFECT SCHEDULE. |

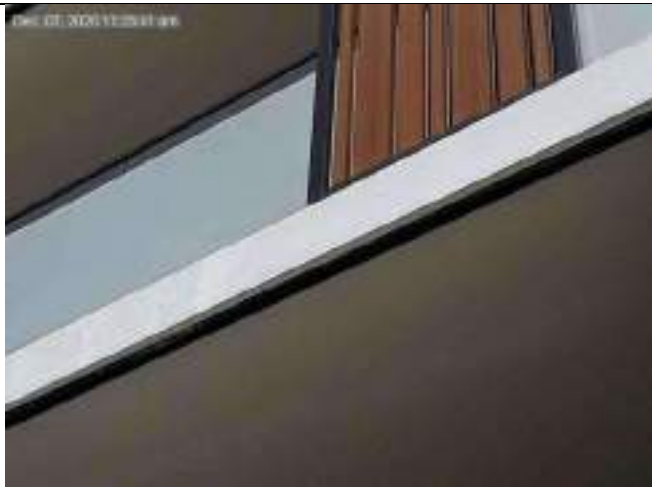
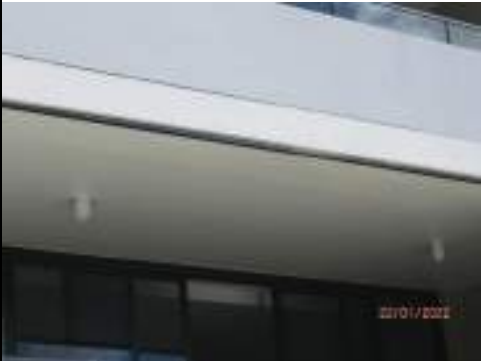
| DEFECT NO. | LOCATION | AREA | BREACH | PHOTOGRAPH | DEFECT DESCRIPTION |
|---|---|---|---|---|---|
| C 28 | East facade | Balcony slab edge | See section 8.9 of this report | | Efflorescence. HARPER OBSERVATIONS AND COMMENTS – CONCUR – ON GOING, REFER ITEM C-2 SECTION 10 HARPER DEFECT SCHEDULE. |

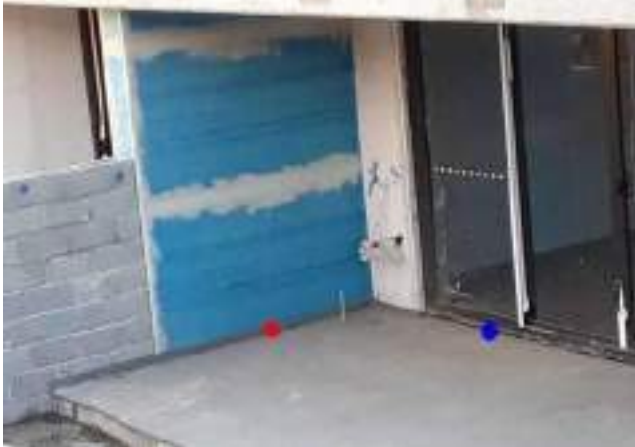
| DEFECT NO. | LOCATION | AREA | BREACH | PHOTOGRAPH | DEFECT DESCRIPTION |
|---|---|---|---|---|--|
| C 31 | East facade | Hebel cladding | See section 8.26 of this report. | | <p>Red - FC installed below water level. Blue - set down height once tiled will not be compliant with AS4654.2.</p> <p>HARPER OBSERVATIONS AND COMMENTS – WATERPROOFING – NO EVIDENCE OF RECTIFICATION AS WORKS COMPLETE AT THE TIME OF INSPECTION.</p> |

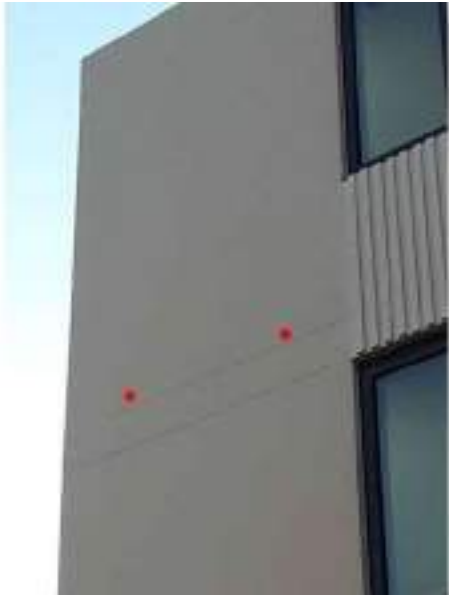
| DEFECT NO. | LOCATION | AREA | BREACH | PHOTOGRAPH | DEFECT DESCRIPTION |
|---|---|---|---|---|--|
| C 32 | West facade | Hebel cladding | See section 8.26 of this report. | | <p>Missing drainage provisions to Hebel</p> <p>HARPER OBSERVATIONS AND COMMENTS – CONCUR – OUTSTANDING, REFER ITEM C-7 SECTION 10 HARPER DEFECT SCHEDULE.</p> |

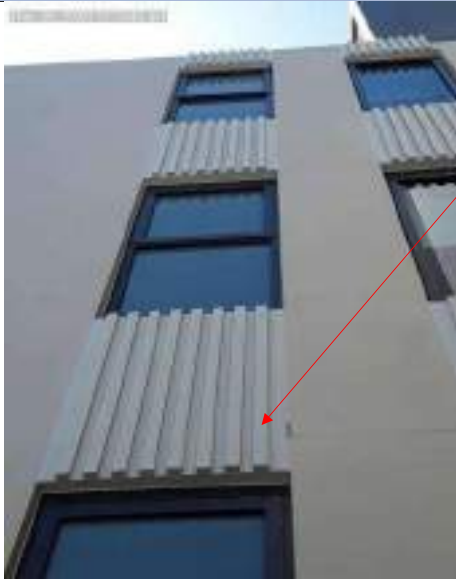
| DEFECT NO. | LOCATION | AREA | BREACH | PHOTOGRAPH | DEFECT DESCRIPTION |
|---|---|---|---|---|---|
| C 35 | West facade | Hebel cladding | Note. | | Hebel drainage provision. |

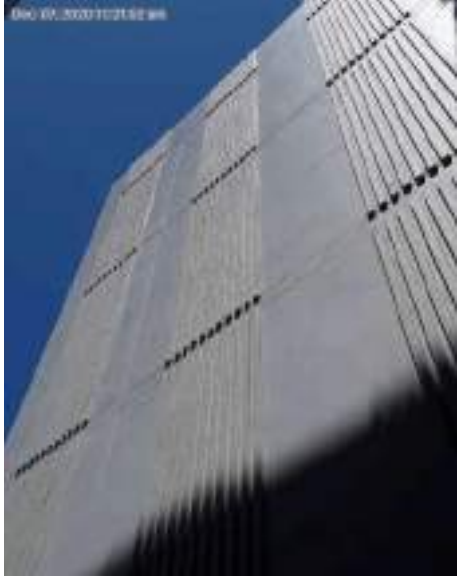
| DEFECT NO. | LOCATION | AREA | BREACH | PHOTOGRAPH | DEFECT DESCRIPTION |
|---|---|---|---|---|--|
| C 37 | West facade | Hebel cladding | See section 8.26 of this report. | | Missing drainage provisions to Hebel. <div style="border: 1px dashed black; padding: 5px;"> HARPER OBSERVATIONS AND COMMENTS – CONCUR, OUTSTANDING, OUTSTANDING, REFER ITEM C-7 SECTION 10 HARPER DEFECT SCHEDULE. </div> |

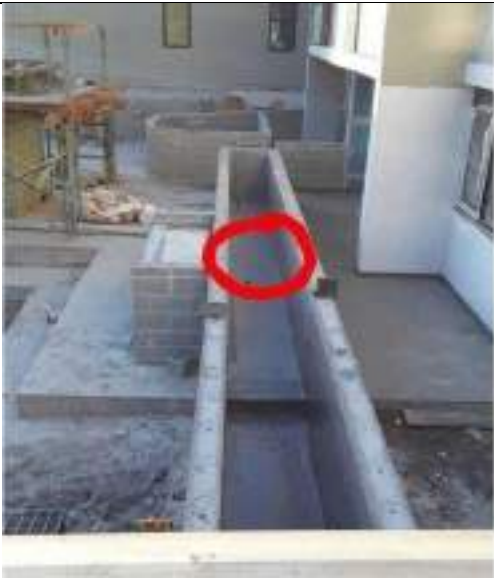
| DEFECT NO. | LOCATION | AREA | BREACH | PHOTOGRAPH | DEFECT DESCRIPTION |
|---|---|---|---|---|--|
| C 38 | North Facade | Planter box | See section 8.4 of this report. Breach of 2.13 and 2.5.2 of AS4654.2 requiring falls to the base of the planter. | | Water is ponding in base of planter. Breach of AS4654.2. <div style="border: 1px dashed black; padding: 5px;"> HARPER OBSERVATIONS AND COMMENTS - WORKS COMPLETED AT TIME OF INSPECTION. </div> |

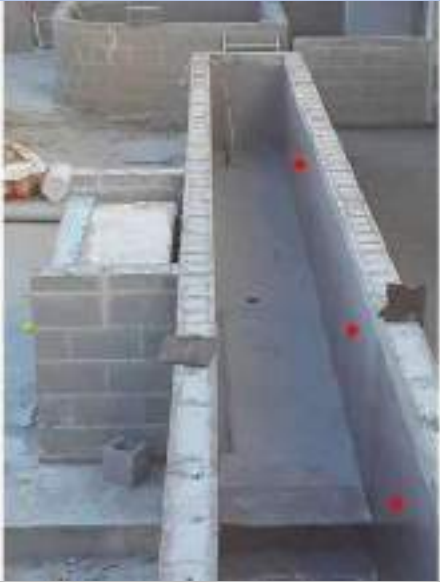
| DEFECT NO. | LOCATION | AREA | BREACH | PHOTOGRAPH | DEFECT DESCRIPTION |
|---|---|---|---|---|---|
| C 39 | North Facade | Planter box | Breach of 2.5.3.1 of AS4654.2 requiring a smooth substrate. | | Blockwork has not been bagged prior to waterproofing. Smooth substrate required for waterproof application. <div style="border: 1px dashed black; padding: 5px; width: fit-content;"> HARPER OBSERVATIONS AND COMMENTS - WORKS COMPLETED AT TIME OF INSPECTION. </div> |

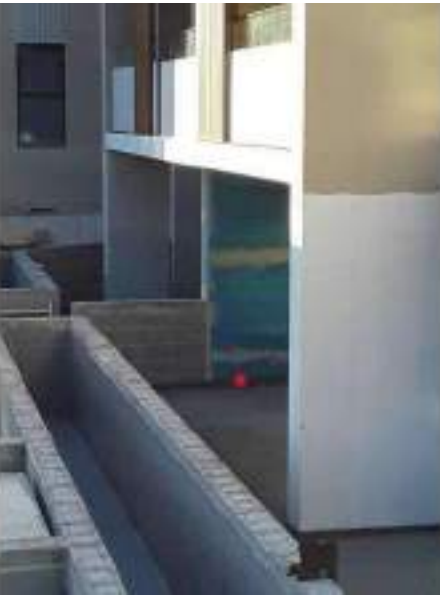
| DEFECT NO. | LOCATION | AREA | BREACH | PHOTOGRAPH | DEFECT DESCRIPTION |
|---|---|---|---|---|---|
| C 40 | North Facade | Units balcony | See section 8.5 of this report. | | FC sheet has been installed below water level. <div style="border: 1px dashed black; padding: 5px; width: fit-content;"> HARPER OBSERVATIONS AND COMMENTS - WORKS COMPLETED AT TIME OF INSPECTION. </div> |

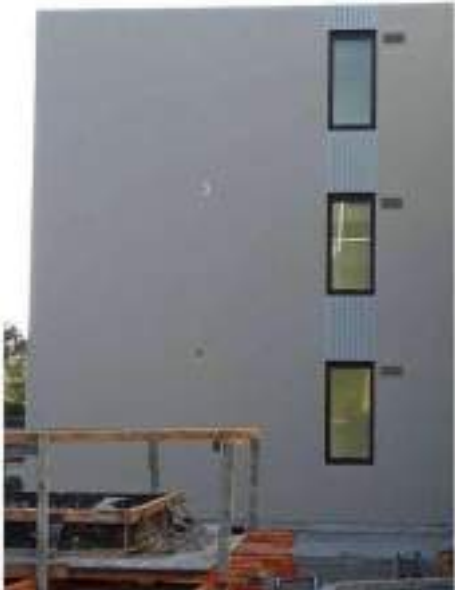
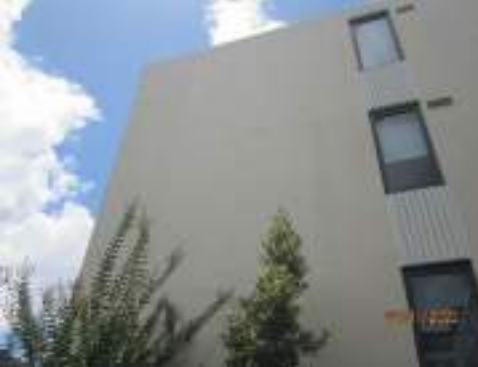
| DEFECT NO. | LOCATION | AREA | BREACH | PHOTOGRAPH | DEFECT DESCRIPTION |
|---|---|---|---|---|--|
| C 41 | North Facade | Hebel cladding | See section 8.26 of this report. | | <p>Missing pressure equalisation slots to Hebel.</p> <p>HARPER OBSERVATIONS AND COMMENTS – CONCUR, OUTSTANDING. OUTSTANDING, REFER ITEM C-7 SECTION 10 HARPER DEFECT SCHEDULE.</p> |

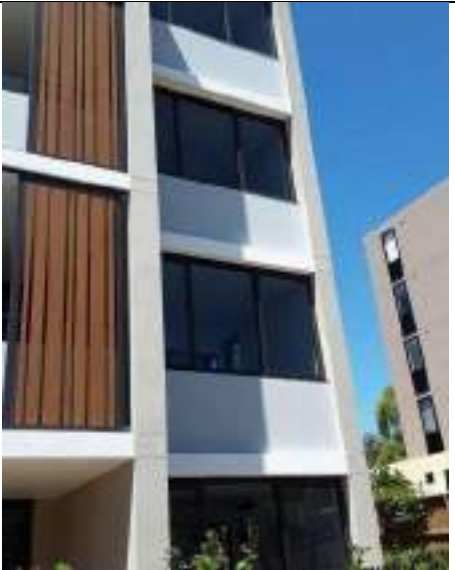
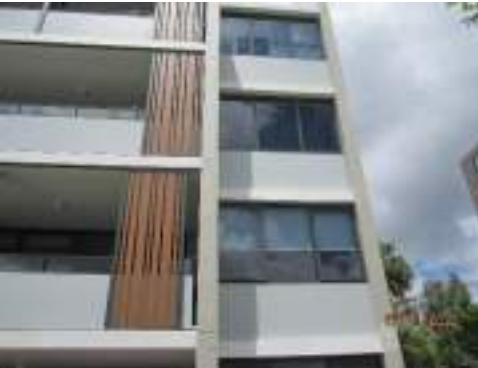
| DEFECT NO. | LOCATION | AREA | BREACH | PHOTOGRAPH | DEFECT DESCRIPTION |
|---|---|---|---|---|--|
| C 42 | North Facade | Privacy screen | See sections 8.5 and 8.26 of this report. | | <p>Missing drainage provisions to walls under windows</p> <p>HARPER OBSERVATIONS AND COMMENTS – CONCUR – OUTSTANDING, OUTSTANDING, REFER ITEM C-7 SECTION 10 HARPER DEFECT SCHEDULE.</p> |
