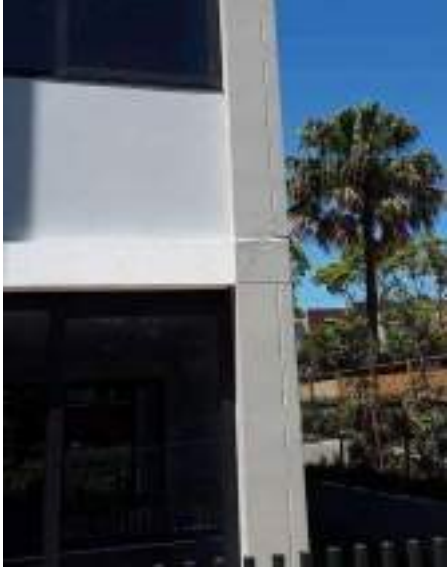
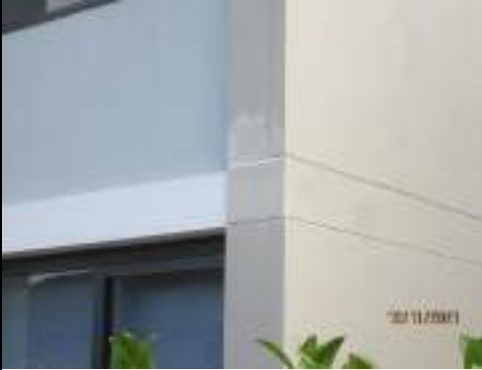
| DEFECT NO. | LOCATION | AREA | BREACH | PHOTOGRAPH | DEFECT DESCRIPTION |
|---|---|---|--|---|--|
| C 43 | North Facade | Hebel cladding | Works have not been completed with due care and skill. | | <p>Poor rendering work.</p> <p>HARPER OBSERVATIONS AND COMMENTS – OUTSTANDING, OUTSTANDING, REFER ITEM C-4 SECTION 10 HARPER DEFECT SCHEDULE.</p> |

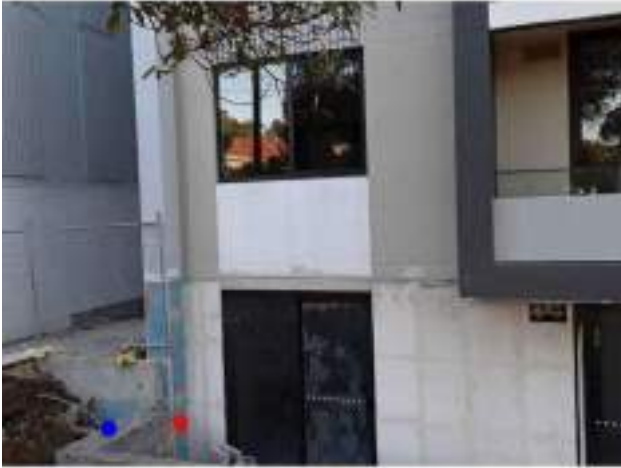
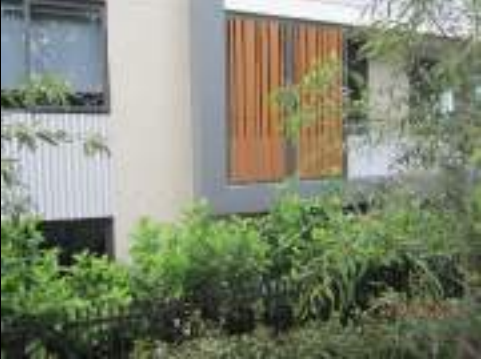
| DEFECT NO. | LOCATION | AREA | BREACH | PHOTOGRAPH | DEFECT DESCRIPTION |
|---|---|---|--|---|--|
| C 44 | South Facade (Mitchell Avenue) | Hebel cladding | See sections 8.5 and 8.26 of this report. | | <p>No Hebel drainage. Blue - FC installed below ground level. Red - base of FC has been waterproofed up</p> <p>HARPER OBSERVATIONS AND COMMENTS – HEBEL DRAINAGE – PE SLOTS ARE LOCATED IN ACCORDANCE WITH MANUFACTURERS GUIDELINES.</p> |

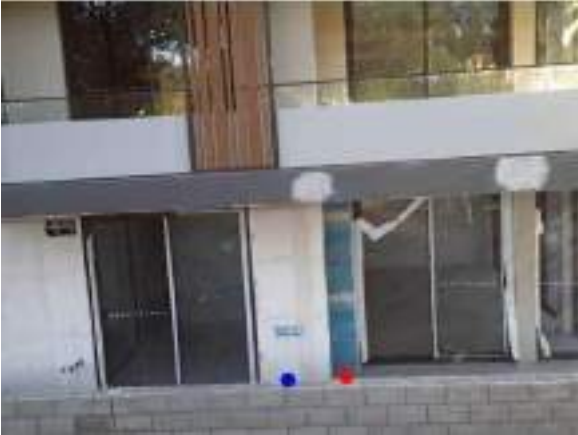
| DEFECT NO. | LOCATION | AREA | BREACH | PHOTOGRAPH | DEFECT DESCRIPTION |
|---|---|---|---|---|---|
| C 45 | South Facade (Mitchell Avenue) | Cladding | See sections 8.5 and 8.26 of this report. | | <p>Red - base of FC waterproofed up. Blue - Hebel with no drainage.</p> <p>HARPER OBSERVATIONS AND COMMENTS – WATERPROOFING – NO EVIDENCE OF RECTIFICATION AS WORKS COMPLETE AT THE TIME OF INSPECTION.</p> |

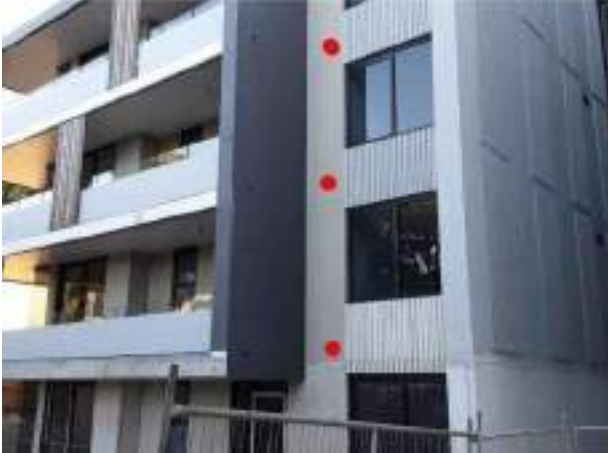
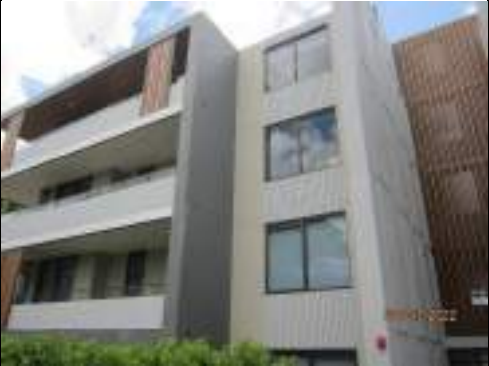
| DEFECT NO. | LOCATION | AREA | BREACH | PHOTOGRAPH | DEFECT DESCRIPTION |
|---|---|---|---|---|---|
| C 46 | South Facade (Mitchell Avenue) | Hebel cladding | See section 8.26 of this report. | | <p>No facade drainage</p> <p>HARPER OBSERVATIONS AND COMMENTS – PE SLOTS ARE LOCATED TO THE EAST BELOW WINDOWS ARE IN ACCORDANCE WITH MANUFACTURERS GUIDELINES.</p> <p>HOWEVER, THE PE/DRAINAGE SLOT TO UNIT 105 HAS BEEN PAINTED OVER. REFER ITEM 4-G05 SECTION 10 HARPER DEFECT SCHEDULE</p> |

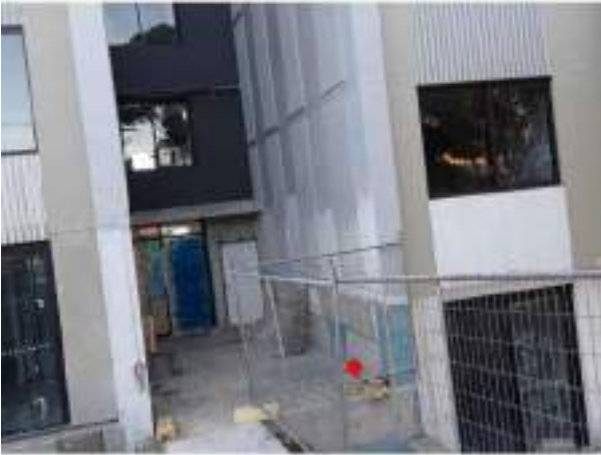
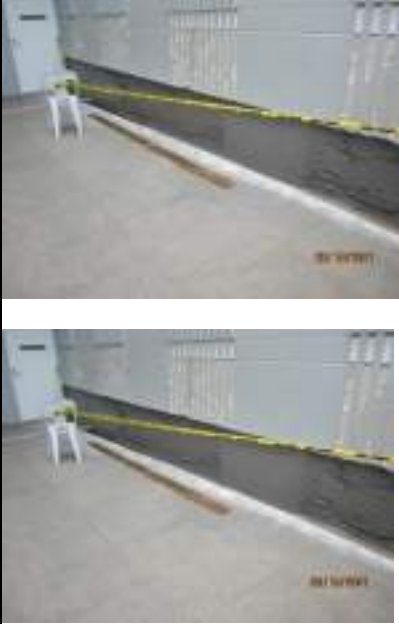
| DEFECT NO. | LOCATION | AREA | BREACH | PHOTOGRAPH | DEFECT DESCRIPTION |
|---|---|---|--|--|---|
| C 47 | South Facade (Mitchell Avenue) | Hebel cladding | See section 8.5 of this report. Works have not been completed with due care and skill or as per manufacturer s details. | | <p>FC installed below water level.</p> <p>HARPER OBSERVATIONS AND COMMENTS - WORKS NOT CARRIED OUT IN ACCORDANCE WITH ENGINEERS DESIGN. REFER ITEM C-8 SECTION 10 HARPER DEFECT SCHEDULE</p> |

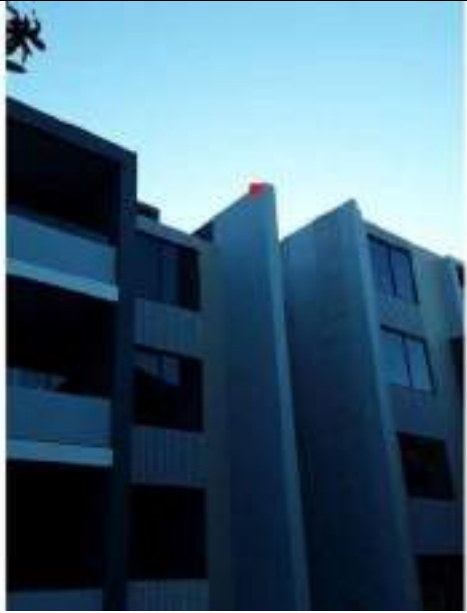
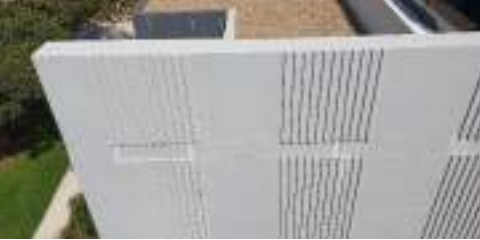
| <p>11 Mitchell Ave, Jannali</p> <p>C 48</p> | <p>South Facade (Mitchell Avenue)</p> | <p>Hebel cladding</p> | | | | <p style="text-align: right;"><small>Defect Schedule(Common area)</small></p> <p>Parapet wall caps required if Hebel, FC or Dintel.</p> <p>HARPER OBSERVATIONS AND COMMENTS – OUTSTANDING, REFER ITEM C-2 SECTION 10 HARPER DEFECT SCHEDULE</p> |

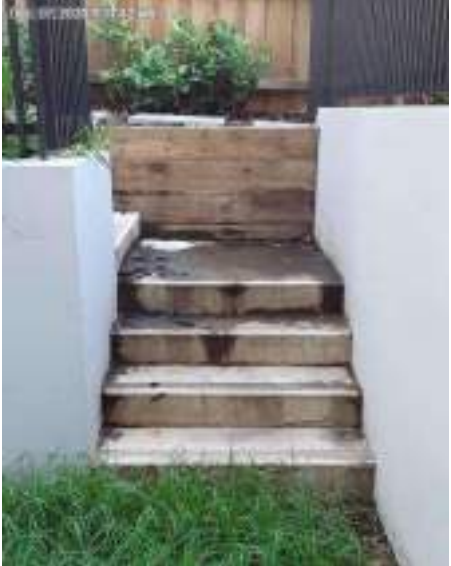
| DEFECT NO. | LOCATION | AREA | BREACH | PHOTOGRAPH | DEFECT DESCRIPTION |
|---|---|---|--|---|---|
| C 49 | South Facade (Mitchell Avenue) | Stair | Risk of trips and falls. | | <p>Water is ponding on steps presenting a trip hazard.</p> <p>Timber sleeper retaining walls typically have a maximum height of 600mm. Engineer to confirm structural adequacy.</p> <p>HARPER OBSERVATIONS AND COMMENTS – RETAINING WALL - RESOLVED</p> |

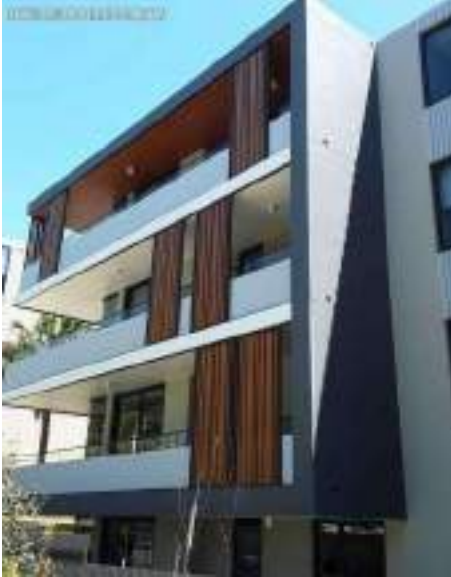
| DEFECT NO. | LOCATION | AREA | BREACH | PHOTOGRAPH | DEFECT DESCRIPTION |
|---|---|---|--|---|---|
| C 50 | South Facade (Mitchell Avenue) | Cladding | See section 8.9 and 8.24 of this report. | | <p>Eaves to be tested for combustibility</p> <p>Efflorescence</p> <p>HARPER OBSERVATIONS AND COMMENTS –</p> <p>EAVE LINING – NOT A DEFECT – WOODFORD ALUMINIUM IS NON-COMBUSTIBLE</p> <p>EFFLORESCENCE – ONGOING REFER ITEM C-2 SECTION 10 HARPER DEFECT SCHEDULE.</p> |

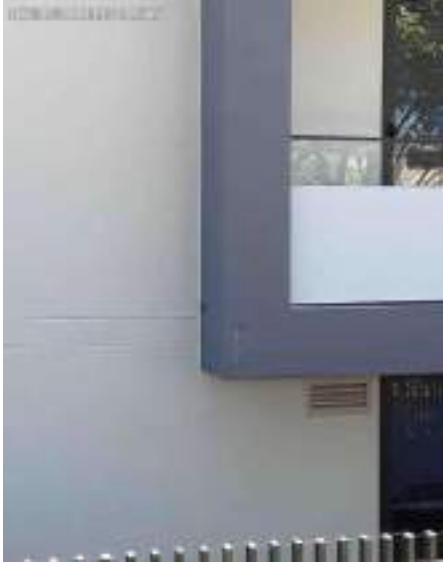
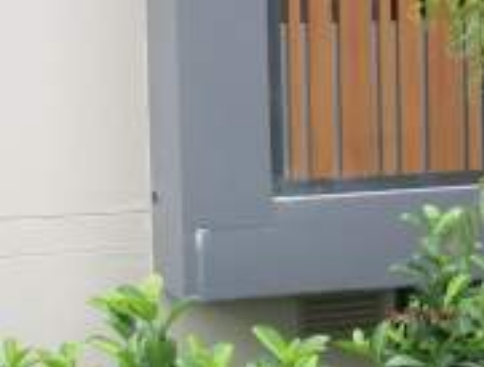
| DEFECT NO. | LOCATION | AREA | BREACH | PHOTOGRAPH | DEFECT DESCRIPTION |
|---|---|---|---|---|--|
| C 51 | South Facade (Mitchell Avenue) | Balcony slab edge | See section 8.9 of this report. | | <p>Efflorescence in this location is the result of failed waterproof membrane upturn.</p> <p>HARPER OBSERVATIONS AND COMMENTS – EFFLORESCENCE – ONGOING, REFER ITEM C-2 SECTION 10 HARPER DEFECT SCHEDULE</p> |

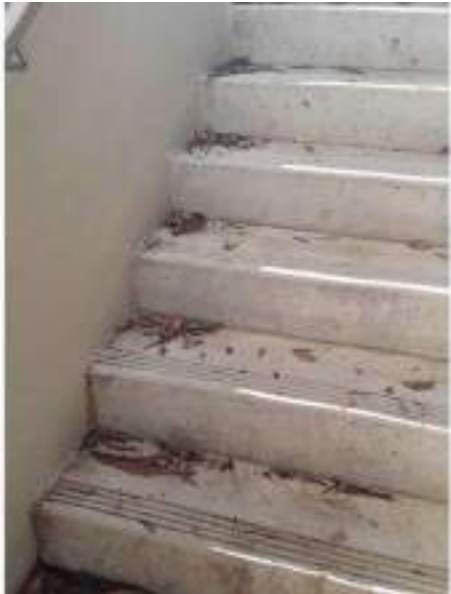
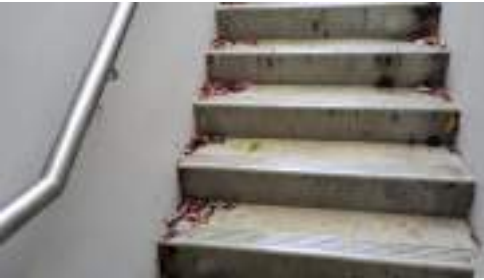
| DEFECT NO. | LOCATION | AREA | BREACH | PHOTOGRAPH | DEFECT DESCRIPTION |
|---|---|---|---|---|--|
| C 52 | Basement 1 | South east fire stair to ground level | See section 8.15 of this report. | | <p>Missing nosing or compliant non-slip finish to steps</p> <p>HARPER OBSERVATIONS AND COMMENTS – OUTSTANDING REFER ITEM FS-1 SECTION 10 HARPER DEFECT SCHEDULE</p> |

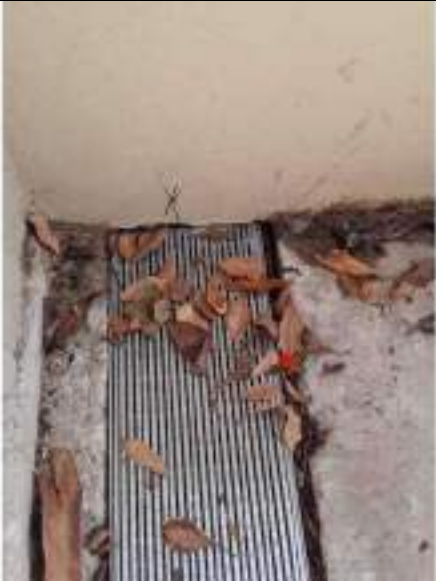
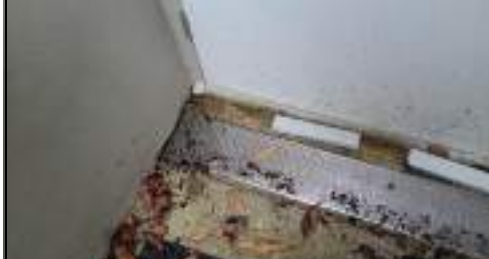
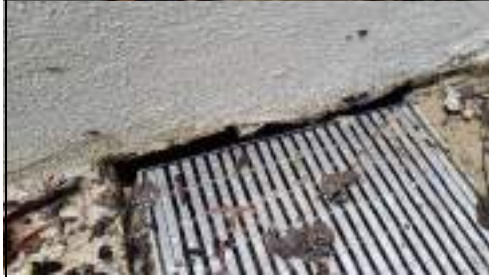
| DEFECT NO. | LOCATION | AREA | BREACH | PHOTOGRAPH | DEFECT DESCRIPTION |
|---|---|---|--|---|---|
| C 53 | Basement 1 | South east fire stair to ground level | See section 8.23 of this report. Incomplete work. | | <p>Gap to side of grated drain.</p> <p>HARPER OBSERVATIONS AND COMMENTS –OUTSTANDING</p> |

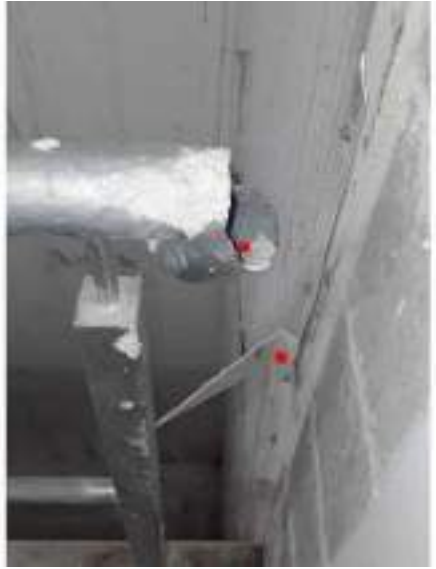
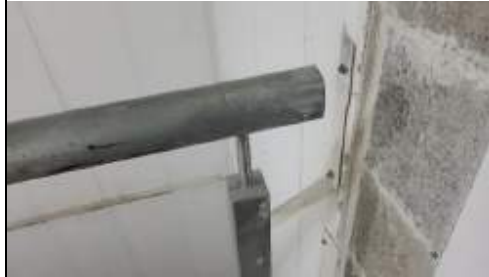
| DEFECT NO. | LOCATION | AREA | BREACH | PHOTOGRAPH | DEFECT DESCRIPTION |
|---|---|---|--|---|---|
| C 54 | Basement 1 | South east fire stair to ground level | Incomplete works Works have not been completed with due care and skill. | | <p>A. Handrail cut off.</p> <p>B. Dintel off cut</p> <p>HARPER OBSERVATIONS AND COMMENTS – HANDRAIL CUT IS SHARP AND COULD CAUSE INJURY</p> <p>DINCEL OFF CUT – OUTSTANDING</p> <p>REFER ITEM FS-2 SECTION 10 HARPER DEFECT SCHEDULE</p> |

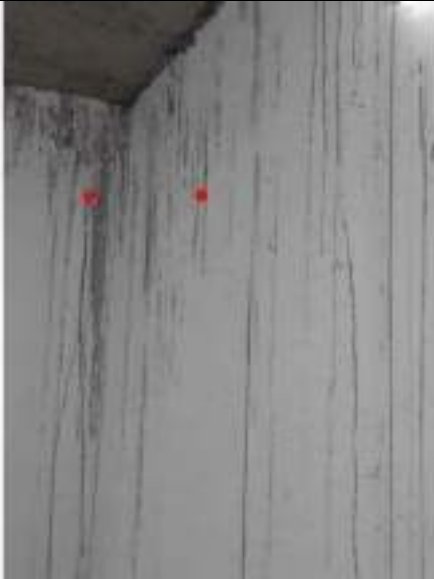
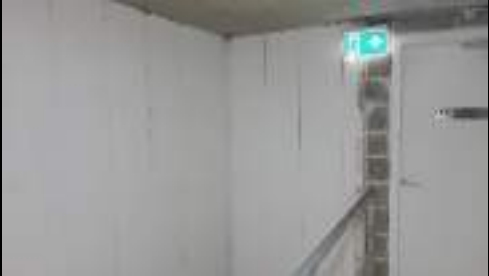
| DEFECT NO. | LOCATION | AREA | BREACH | PHOTOGRAPH | DEFECT DESCRIPTION |
|---|---|---|--|---|---|
| C 55 | Basement 1 | South east fire stair to ground level | Works have not been completed with due care and skill. | | Incomplete cleaning of concrete slurry. HARPER OBSERVATIONS AND COMMENTS –RESOLVED |

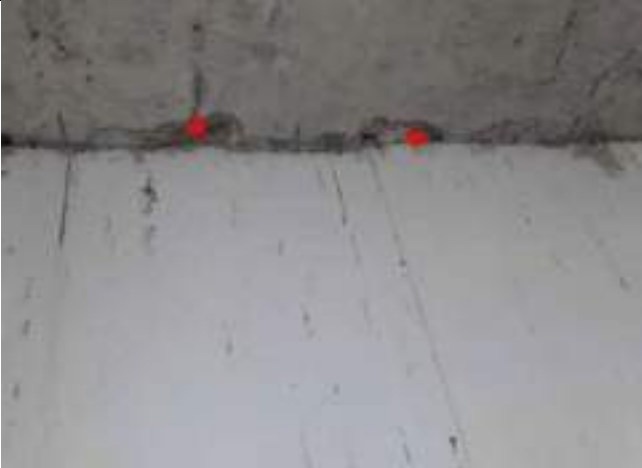
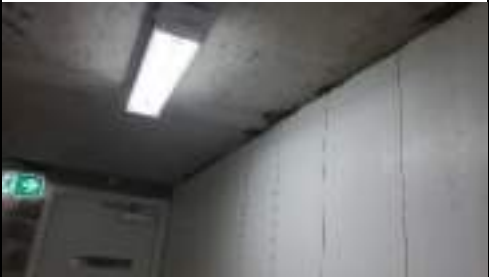
| DEFECT NO. | LOCATION | AREA | BREACH | PHOTOGRAPH | DEFECT DESCRIPTION |
|---|---|---|--|---|---|
| C 56 | Basement 1 | South east fire stair to ground level | Works have not been completed with due care and skill. | | Sawdust and debris in concrete SH Rectified HARPER OBSERVATIONS AND COMMENTS –RESOLVED |

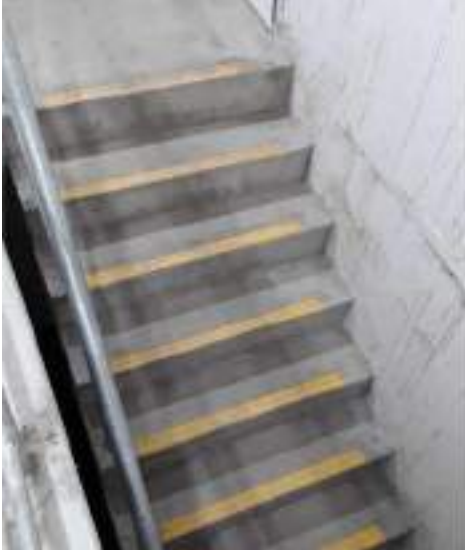
| DEFECT NO. | LOCATION | AREA | BREACH | PHOTOGRAPH | DEFECT DESCRIPTION |
|---|---|---|--|---|---|
| C 57 | Basement 1 | South east fire stair to ground level | See section 8.15 of this report. | | <p>No nosing or non-slip finish.</p> <p>Details of paint to be provided to identify if non-compliant and tested to AS4586.</p> <p>HARPER OBSERVATIONS AND COMMENTS – NO DETAILS OF PAINT PROVIDED. REFER ITEM FS-1 SECTION 10 HARPER DEFECT SCHEDULE</p> |

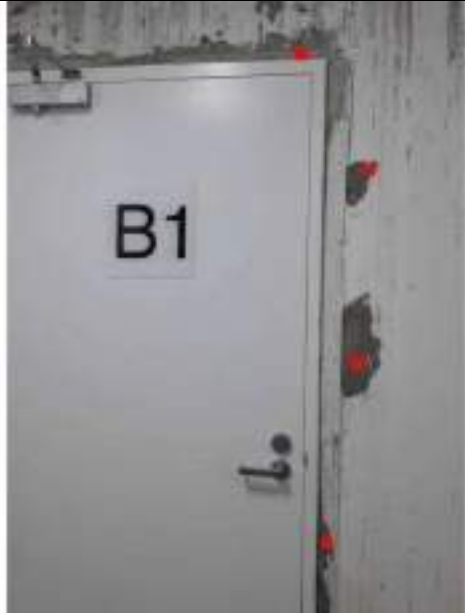
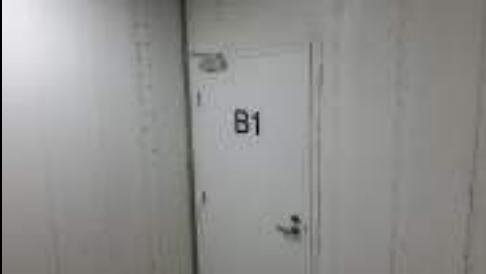
| DEFECT NO. | LOCATION | AREA | BREACH | PHOTOGRAPH | DEFECT DESCRIPTION |
|---|---|---|--|---|---|
| C 58 | Basement 1 | South east fire stair to ground level | Works have not been completed with due care and skill. | | <p>Visible patching and slurry over pour from construction.</p> <p>HARPER OBSERVATIONS AND COMMENTS –RESOLVED</p> |

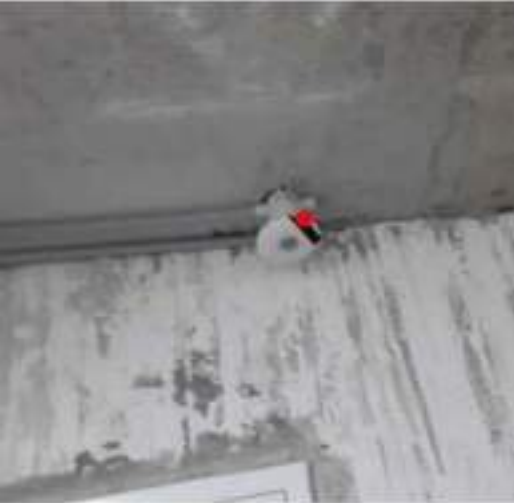
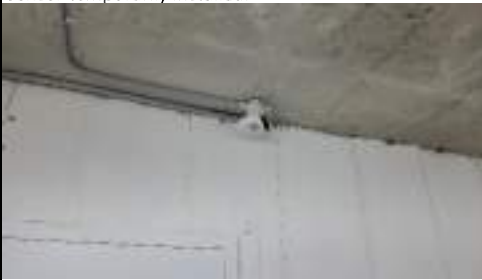
| DEFECT NO. | LOCATION | AREA | BREACH | PHOTOGRAPH | DEFECT DESCRIPTION |
|---|---|---|--|--|--|
| C 59 | Basement 1 | South east fire stair to ground level | Works have not been completed with due care and skill. | | <p>Sensor temporarily installed.</p> <p>HARPER OBSERVATIONS AND COMMENTS –LIGHT SENSOR IS WORKING</p> |

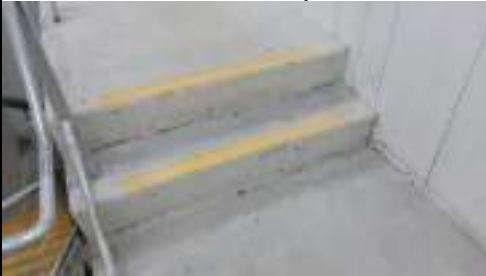
| DEFECT NO. | LOCATION | AREA | BREACH | PHOTOGRAPH | DEFECT DESCRIPTION |
|---|---|---|--|---|--|
| C 61 | Basement 1 | South east fire stair to ground lev | Breach of D2.13 of the BCA. See section 8.17 of this report. | | <p>First riser is 179mm, adjacent riser is 185mm. Greater than 5mm difference in adjacent riser</p> <p>HARPER OBSERVATIONS AND COMMENTS – DEVIATION IN RISERS HEIGHTS COMPLY WITH NCC 2019 3.9.1.2</p> |

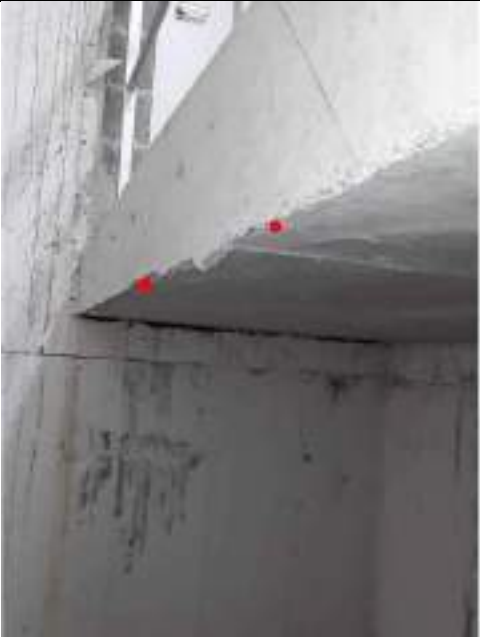
| DEFECT NO. | LOCATION | AREA | BREACH | PHOTOGRAPH | DEFECT DESCRIPTION |
|---|---|---|--|--|---|
| C 62 | Basement 1 | South east fire stair to ground level | Works have not been completed with due care and skill. | | Rough concrete edge. HARPER OBSERVATIONS AND COMMENTS –RESOLVED |

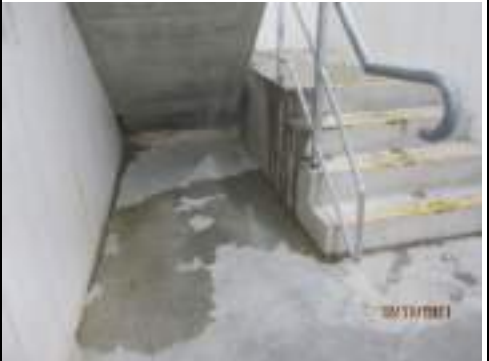
| DEFECT NO. | LOCATION | AREA | BREACH | PHOTOGRAPH | DEFECT DESCRIPTION |
|---|---|---|---|---|--|
| C 63 | Basement 2 | South east fire stair to ground level | Safety issue. | | <p>Water from base of stair entering adjacent storage area.</p> <p>Water ponding on the floor of the emergency exit is a potential slip hazard.</p> <p>HARPER OBSERVATIONS AND COMMENTS –OUTSTANDING REFER ITEM B-1 SECTION 10 HARPER DEFECT SCHEDULE</p> |

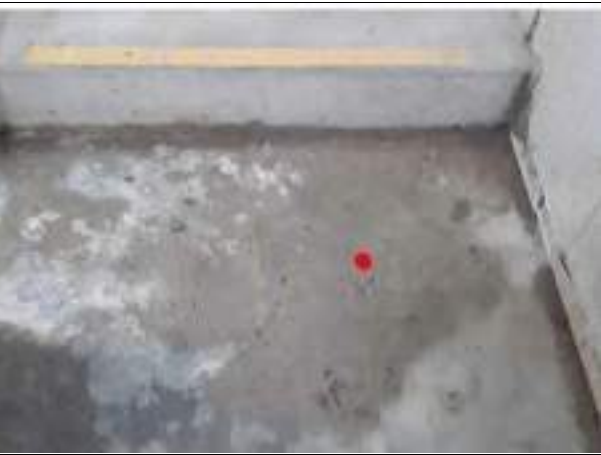
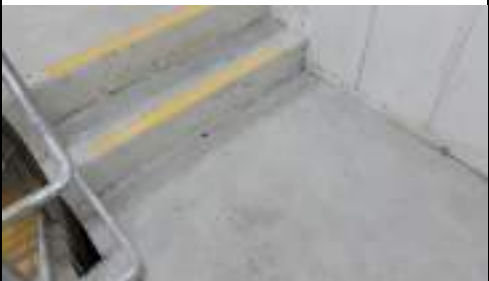
| DEFECT NO. | LOCATION | AREA | BREACH | PHOTOGRAPH | DEFECT DESCRIPTION |
|---|---|---|---|---|--|
| C 64 | Basement 2 | South east fire stair to ground level | Not fit for purpose | | <p>The surface to the base of the stair is not only wet, but very rough in finish as such is not fit for purpose as it could cause slips and falls.</p> <p>HARPER OBSERVATIONS AND COMMENTS –RESOLVED</p> |

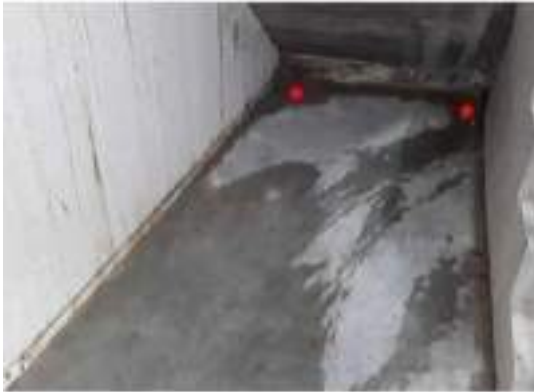
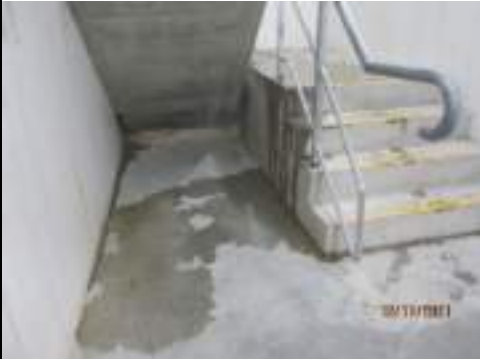
| DEFECT NO. | LOCATION | AREA | BREACH | PHOTOGRAPH | DEFECT DESCRIPTION |
|---|---|---|--|---|---|
| C 65 | Basement 2 | South east fire stair to ground level | Safety issue. | | <p>Ground water entering the fire stair area and adjacent storage.</p> <p>Water entering the adjacent storage areas restricts it from being used for its intended purpose.</p> <p>Water sitting on the surface of the emergency access stair is a safety hazard.</p> <p>HARPER OBSERVATIONS AND COMMENTS –OUTSTANDING REFER ITEM B-1 SECTION 10 HARPER DEFECT SCHEDULE</p> |

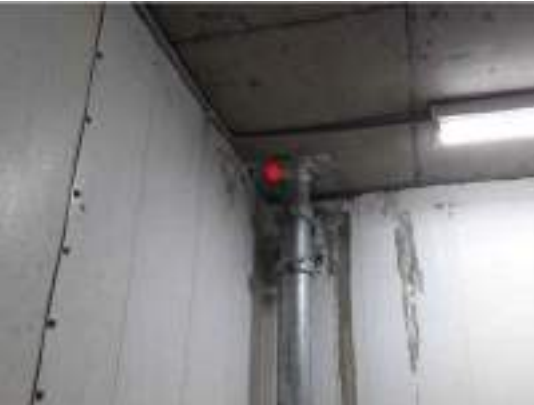
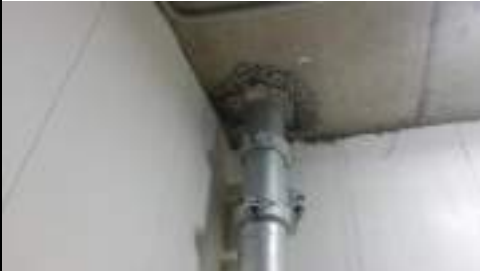
| DEFECT NO. | LOCATION | AREA | BREACH | PHOTOGRAPH | DEFECT DESCRIPTION |
|---|---|---|--|---|---|
| C 66 | Basement 2 | South east fire stair to ground level | Works have not been completed with due care and skill. | | <p>Sarking tape used around penetration</p> <p>HARPER OBSERVATIONS AND COMMENTS –RESOLVED</p> |

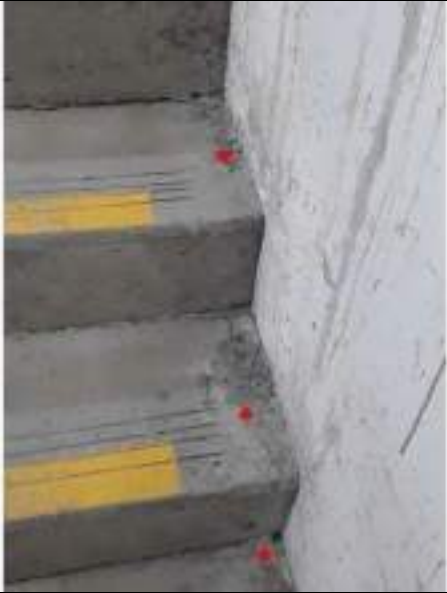
| DEFECT NO. | LOCATION | AREA | BREACH | PHOTOGRAPH | DEFECT DESCRIPTION |
|---|---|---|--|---|---|
| C 67 | Basement 2 | South east fire stair to ground level | Works have not been completed with due care and skill. | | Concrete slurry on treads. HARPER OBSERVATIONS AND COMMENTS –RESOLVED |

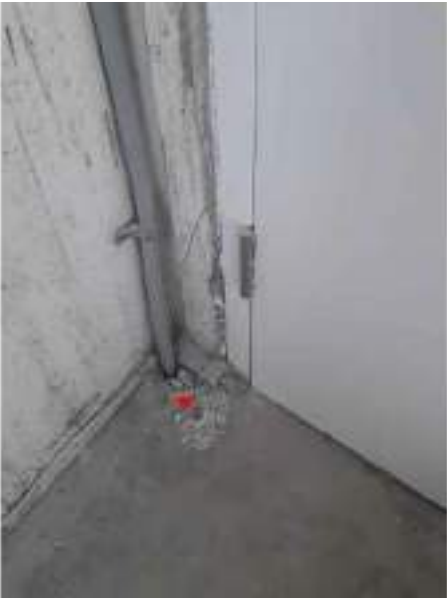
| DEFECT NO. | LOCATION | AREA | BREACH | PHOTOGRAPH | DEFECT DESCRIPTION |
|---|---|---|--|---|---|
| C 68 | Basement 2 | South east fire stair to ground level | Works have not been completed with due care and skill. | | Concrete hump poor workmanship HARPER OBSERVATIONS AND COMMENTS –RESOLVED |

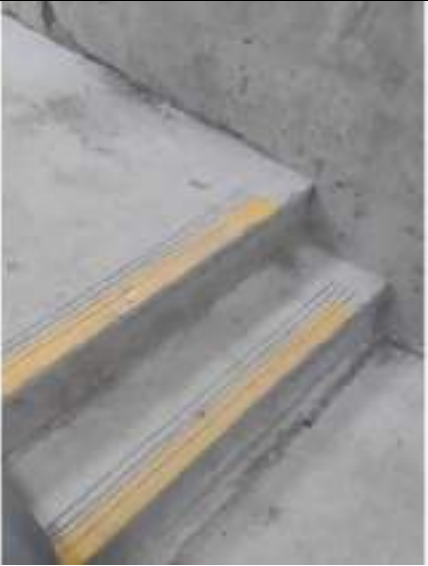
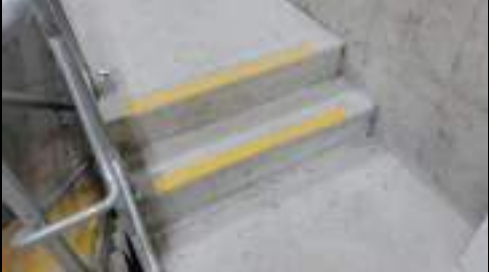
| DEFECT NO. | LOCATION | AREA | BREACH | PHOTOGRAPH | DEFECT DESCRIPTION |
|---|---|---|---|---|---|
| C 69 | Basement 1 | North east fire stair to ground level | See section 8.15 of this report. | | <p>No nosing or non-slip finish.</p> <p>Details of paint to be provided to identify if non-compliant and tested to AS4586.</p> <p>HARPER OBSERVATIONS AND COMMENTS –RESOLVED</p> |

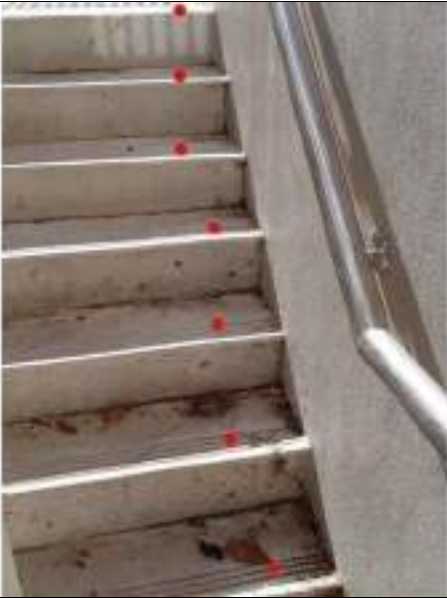
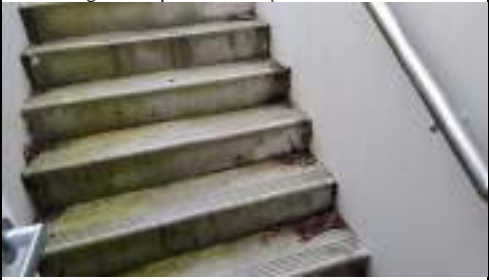
| DEFECT NO. | LOCATION | AREA | BREACH | PHOTOGRAPH | DEFECT DESCRIPTION |
|---|---|---|---|---|---|
| C 70 | Basement 1 | North east fire stair to ground level | See section 8.15 of this report. | | <p>No nosing or compliant non-slip finish</p> <p>HARPER OBSERVATIONS AND COMMENTS –OUTSTANDING REFER ITEM FS-1 SECTION 10 HARPER DEFECT SCHEDULE</p> |

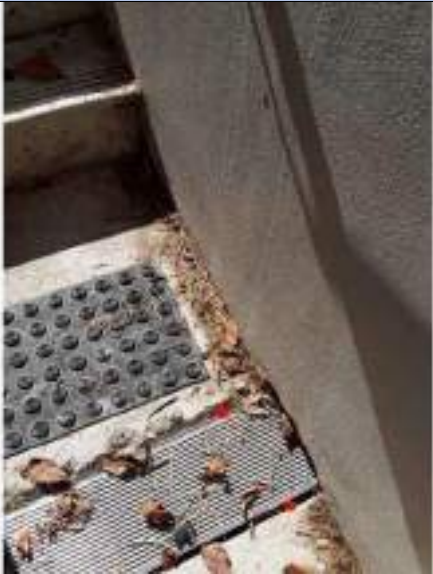
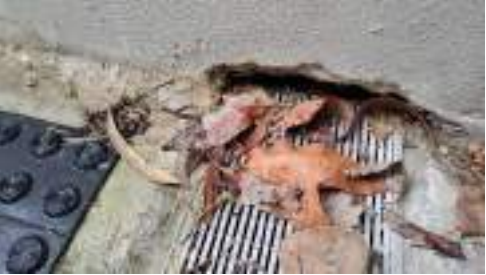
| DEFECT NO. | LOCATION | AREA | BREACH | PHOTOGRAPH | DEFECT DESCRIPTION |
|---|---|---|--|---|---|
| C 71 | Basement 1 | North east fire stair to ground level | See section 8.23 of this report. Incomplete work. | | <p>Gap adjacent to grate. Water can enter under grated drain</p> <p>HARPER OBSERVATIONS AND COMMENTS –OUTSTANDING REFER ITEM B-1 SECTION 10 HARPER DEFECT SCHEDULE</p> |

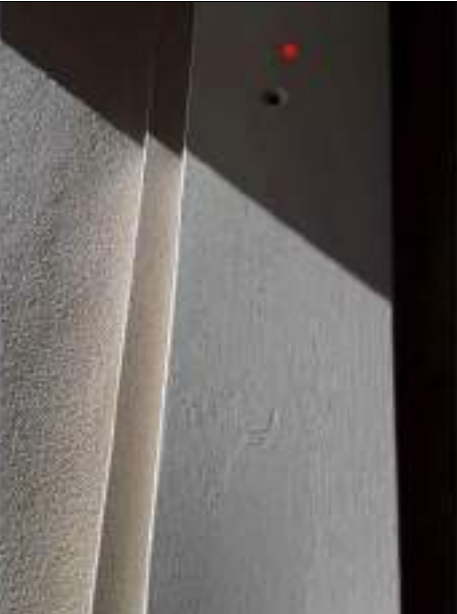
| DEFECT NO. | LOCATION | AREA | BREACH | PHOTOGRAPH | DEFECT DESCRIPTION |
|---|---|---|--|---|---|
| C 72 | Basement 1 | North east fire stair to ground level | Fire engineer to assess | | <p>Hollow fire rated frame Scott refer certification sh refer certification</p> <p>HARPER OBSERVATIONS AND COMMENTS –FIRE SAFETY CERTIFICATE PROVIDED.</p> |

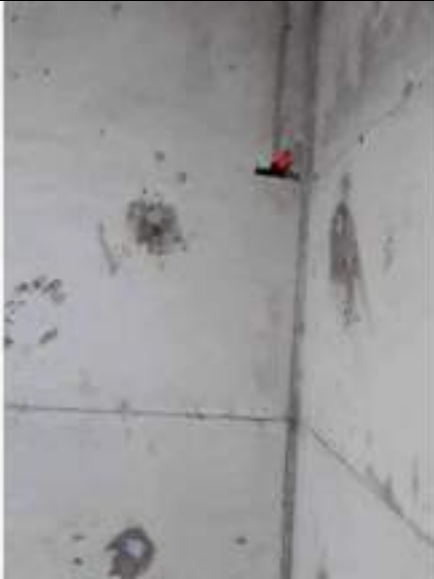
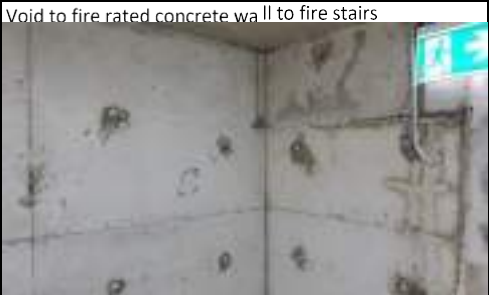
| DEFECT NO. | LOCATION | AREA | BREACH | PHOTOGRAPH | DEFECT DESCRIPTION |
|---|---|---|---|---|--|
| C 73 | Basement 1 | North east fire stair to ground level | Incomplete work. | | <p>Void to fire rated concrete wall to fire stairs</p> <p>HARPER OBSERVATIONS AND COMMENTS –RESOLVED</p> |

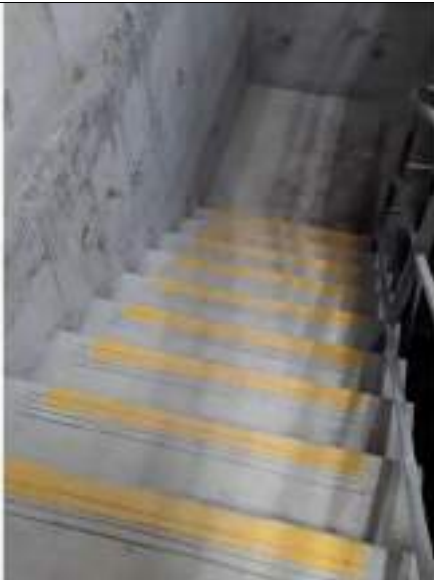
| DEFECT NO. | LOCATION | AREA | BREACH | PHOTOGRAPH | DEFECT DESCRIPTION |
|---|---|---|---|---|--|
| C 74 | Basement 1 | North east fire stair to ground level | See section 8.15 of this report. | | <p>No nosing or compliant non-slip finish</p> <p>Details of paint to be provided to identify if non compliant and tested to AS4586.</p> <p>HARPER OBSERVATIONS AND COMMENTS – NO DETAILS OF PAINT PROVIDED.</p> |

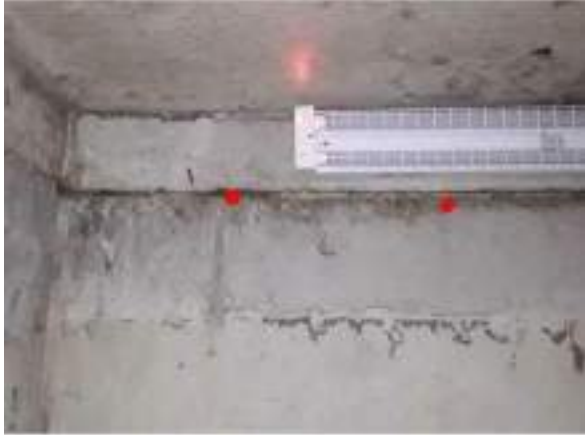
| DEFECT NO. | LOCATION | AREA | BREACH | PHOTOGRAPH | DEFECT DESCRIPTION |
|---|---|---|---|---|---|
| C 75 | Basement 1 | North east fire stair to ground level | Works have not been completed with due care and skill. Fire engineer to assess | | Void to concrete. Moisture ingress Possible fire defect HARPER OBSERVATIONS AND COMMENTS –FIRE SAFETY CERTIFICATE PROVIDED. |

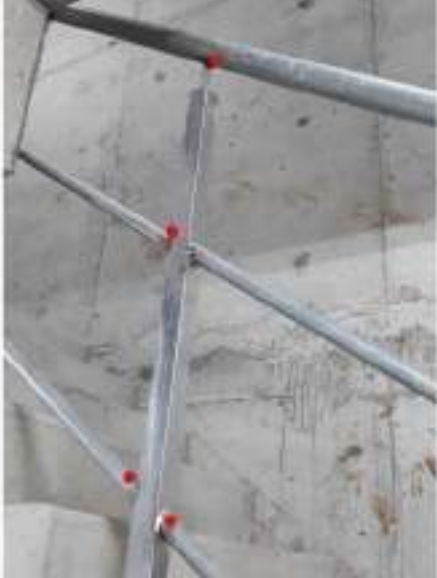
| DEFECT NO. | LOCATION | AREA | BREACH | PHOTOGRAPH | DEFECT DESCRIPTION |
|---|---|---|---|---|---|
| C 76 | Basement 1 | North east fire stair to ground level | See section 8.19 of this report. | | Corrosion HARPER OBSERVATIONS AND COMMENTS –RESOLVED |

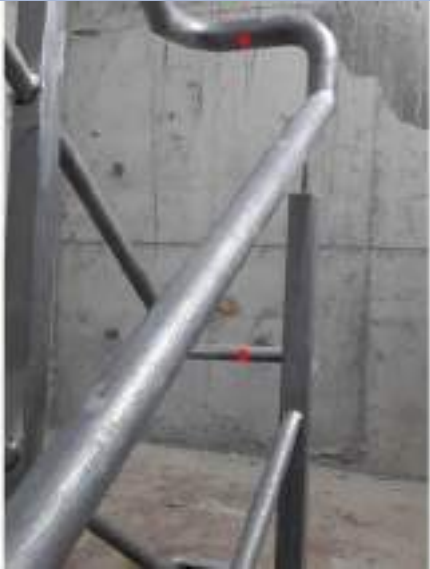
| DEFECT NO. | LOCATION | AREA | BREACH | PHOTOGRAPH | DEFECT DESCRIPTION |
|---|---|---|---|---|--|
| C 79 | Basement 1 | North east fire stair to ground level | See section 8.18 of this report. | | Non continuous handrail. <div style="border: 1px dashed black; padding: 5px;"> HARPER OBSERVATIONS AND COMMENTS - RESOLVED </div> |

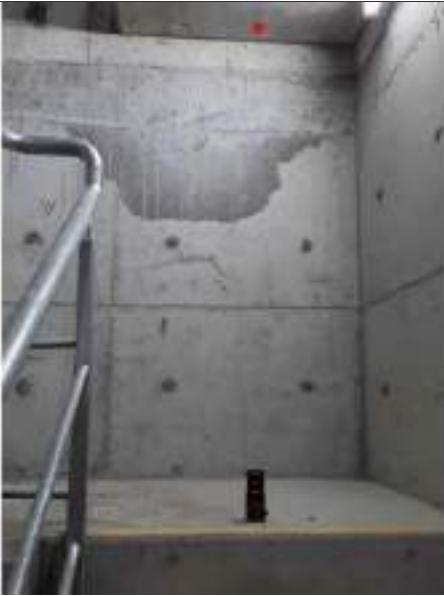
| DEFECT NO. | LOCATION | AREA | BREACH | PHOTOGRAPH | DEFECT DESCRIPTION |
|---|---|---|---|---|--|
| C 80 | Basement 2 | North east fire stair to ground level | See section 8.14 of this report. | | Ceiling height 1.95 metres. HARPER OBSERVATIONS AND COMMENTS – OUTSTANDING <div style="border: 1px dashed black; padding: 5px;"> HARPER OBSERVATIONS AND COMMENTS – CONCUR, OUTSTANDING REFER ITEM B2-2 SECTION 10 HARPER DEFECT SCHEDULE </div> |

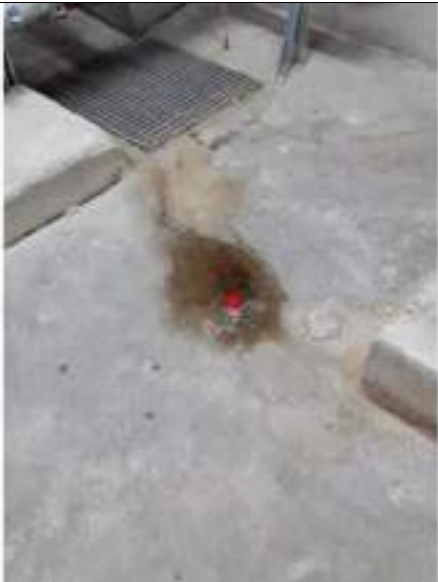
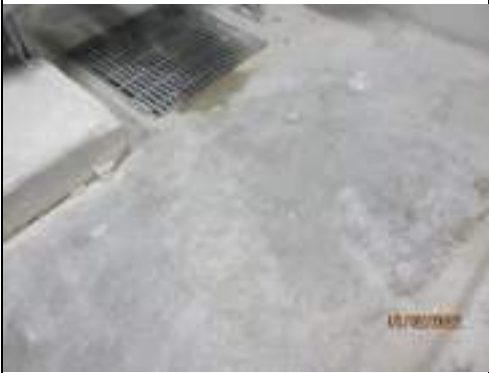
| DEFECT NO. | LOCATION | AREA | BREACH | PHOTOGRAPH | DEFECT DESCRIPTION |
|---|---|---|---|---|---|
| C 81 | Basement 2 | hydrant room | See section 8.4 of this report. | | <p>Water ponding</p> <p>HARPER OBSERVATIONS AND COMMENTS – RESOLVED</p> |

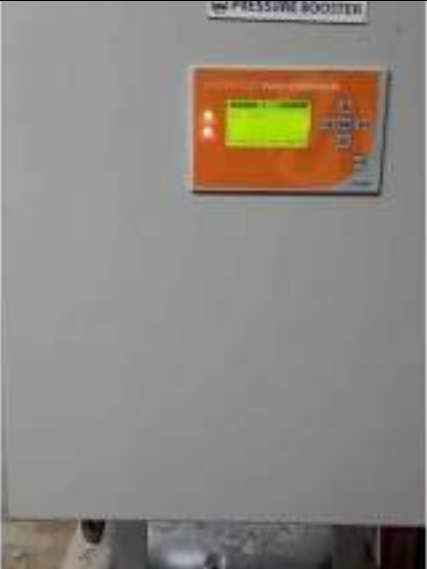
| DEFECT NO. | LOCATION | AREA | BREACH | PHOTOGRAPH | DEFECT DESCRIPTION |
|---|---|---|---|---|---|
| C 82 | Basement 2 | North east – hydrant room | Not fit for purpose. | | <p>Pump not operational in fault mode. Pumps have not been commissioned.</p> <p>HARPER OBSERVATIONS AND COMMENTS – RESOLVED</p> |

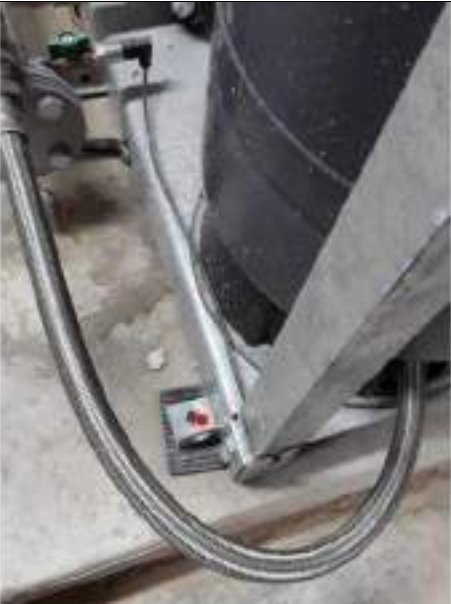
| DEFECT NO. | LOCATION | AREA | BREACH | PHOTOGRAPH | DEFECT DESCRIPTION |
|---|---|---|---|---|---|
| C 83 | Basement 2 | North east – hydrant room | Incomplete work | | <p>Missing fixings throughout</p> <p>HARPER OBSERVATIONS AND COMMENTS – RESOLVED</p> |

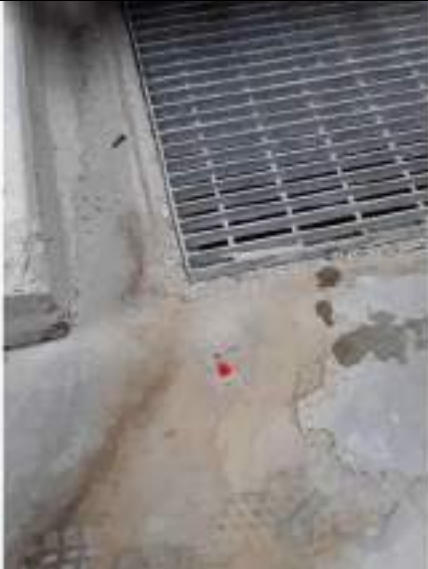
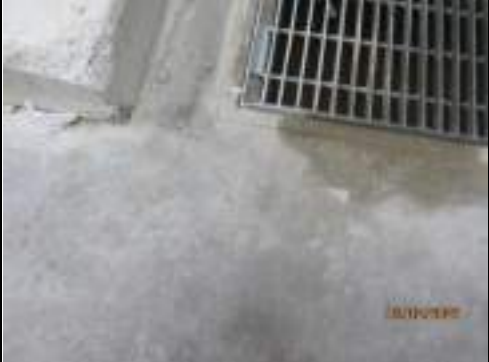
| DEFECT NO. | LOCATION | AREA | BREACH | PHOTOGRAPH | DEFECT DESCRIPTION |
|---|---|---|---|---|--|
| C 84 | Basement 2 | North east – hydrant room | Incomplete work. | | Nail in floor. Trip and safety hazard HARPER OBSERVATIONS AND COMMENTS – RESOLVED |

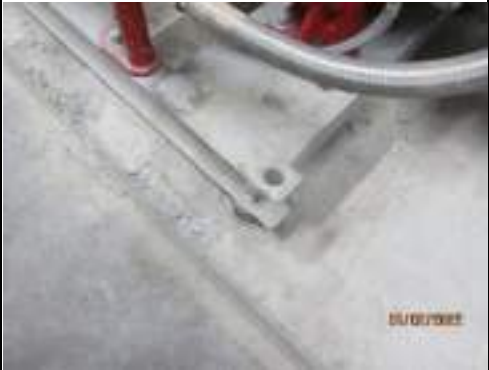
| DEFECT NO. | LOCATION | AREA | BREACH | PHOTOGRAPH | DEFECT DESCRIPTION |
|---|---|---|---|---|--|
| C 85 | Basement 2 | North east – hydrant room | Incomplete work | | Missing fixings HARPER OBSERVATIONS AND COMMENTS – RESOLVED |

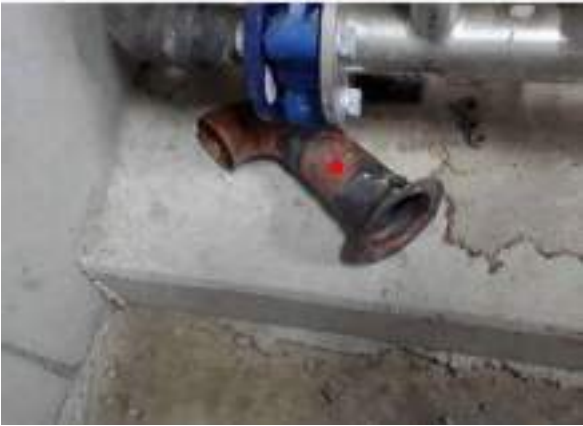
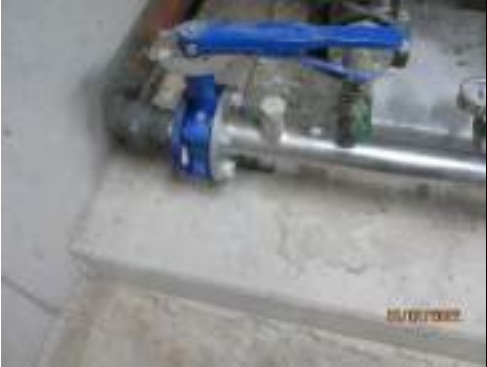
| DEFECT NO. | LOCATION | AREA | BREACH | PHOTOGRAPH | DEFECT DESCRIPTION |
|---|---|--|---|---|--|
| C 88 | Basement 2 | North east – hydrant room North east hydrant room | Not fit for purpose. | | <p>Incomplete work.</p> <p>HARPER OBSERVATIONS AND COMMENTS – RESOLVED</p> |

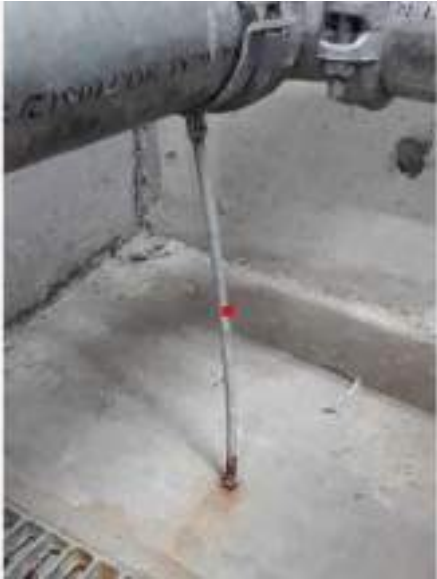
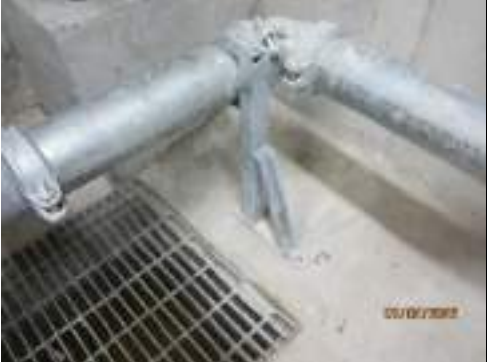
| DEFECT NO. | LOCATION | AREA | BREACH | PHOTOGRAPH | DEFECT DESCRIPTION |
|---|---|--|---|---|--|
| C 89 | Basement 2 | – | Not fit for purpose See section 8.19 of this report. | | <p>Hanging rod bending and corroded and installed instead of unistrut.</p> <p>Threaded rods are used for hanging not supporting</p> <p>HARPER OBSERVATIONS AND COMMENTS – RESOLVED</p> |

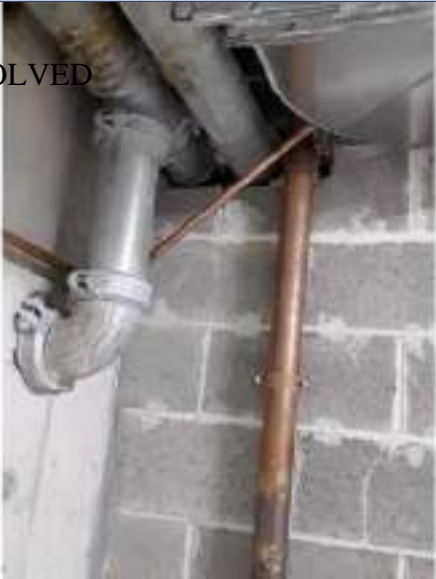
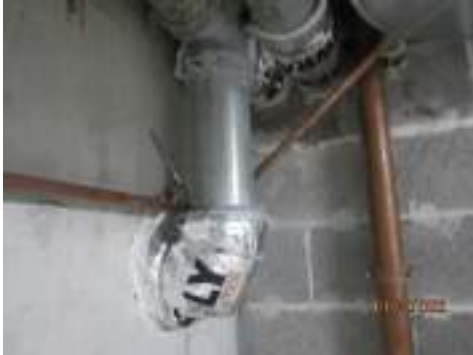
| DEFECT NO. | LOCATION | AREA | BREACH | PHOTOGRAPH | DEFECT DESCRIPTION |
|---|---|---|--|---|--|
| C 90 | Basement 2 | North east – hydrant room | Fire engineer to inspect. HARPER OBSERVATIONS AND COMMENTS – RESOLVED | | Open void to fire rated wall. |

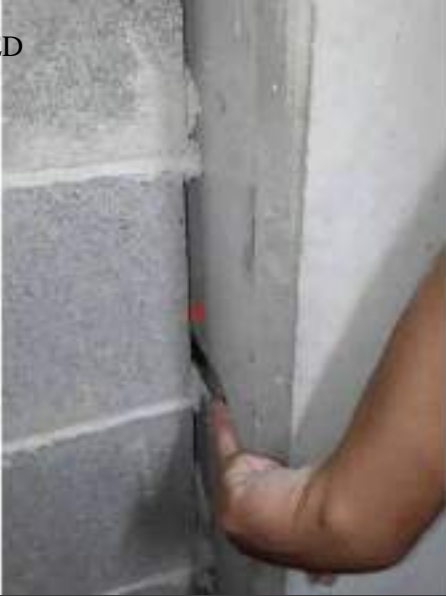
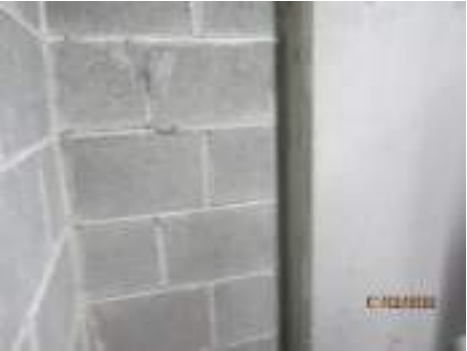
| DEFECT NO. | LOCATION | AREA | BREACH | PHOTOGRAPH | DEFECT DESCRIPTION |
|---|---|---|--|---|--|
| C 91 | Basement 2 | North east – hydrant room | Fire engineer to inspect. HARPER OBSERVATIONS AND COMMENTS – RESOLVED | | Void to fire rated wall. |

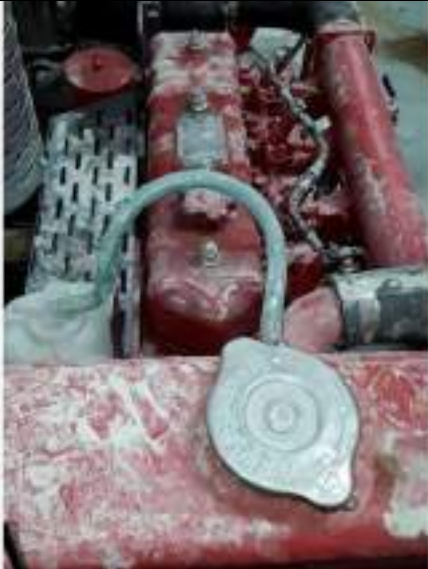
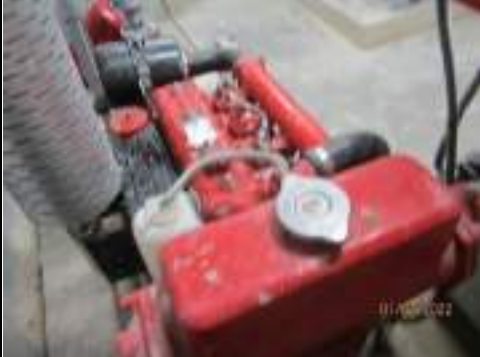
| DEFECT NO. | LOCATION | AREA | BREACH | PHOTOGRAPH | DEFECT DESCRIPTION |
|---|---|---|--|---|--|
| C 92 | Basement 2 | North east – hydrant room | Works have not been completed with due care and skill. | | Slurry over diesel pump set may void manufacturer's warranty HARPER OBSERVATIONS AND COMMENTS – RESOLVED |

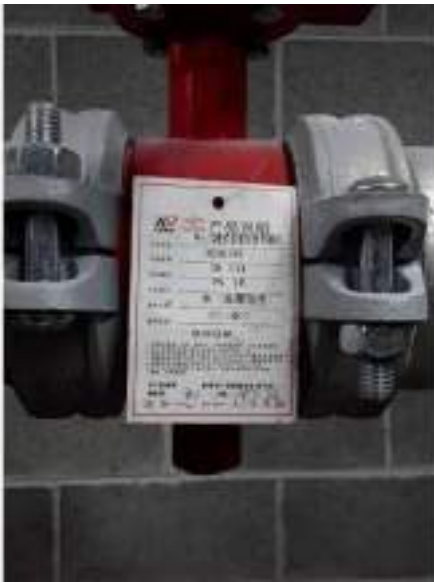
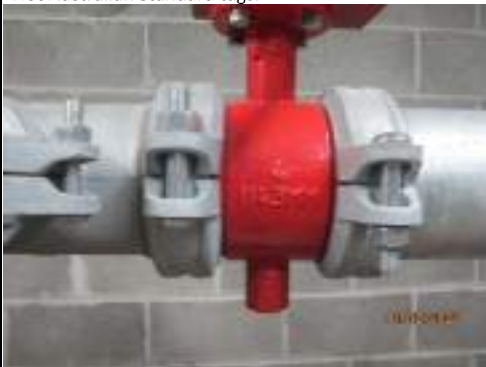
| DEFECT NO. | LOCATION | AREA | BREACH | PHOTOGRAPH | DEFECT DESCRIPTION |
|---|---|---|--|---|--|
| C 93 | Basement 2 | North east – hydrant room | Works have not been completed with due care and skill. | | Not Australian Standard tags. HARPER OBSERVATIONS AND COMMENTS – SIGNAGE REMOVED |

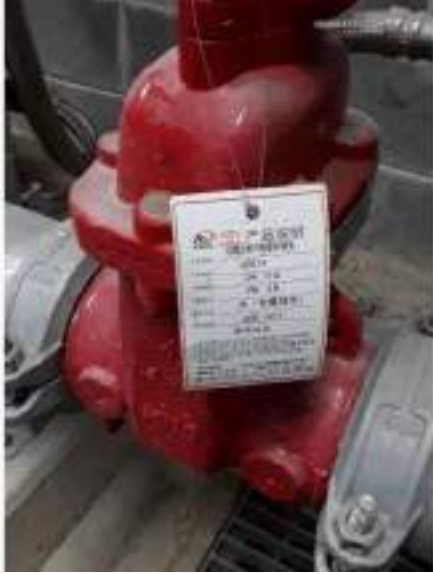
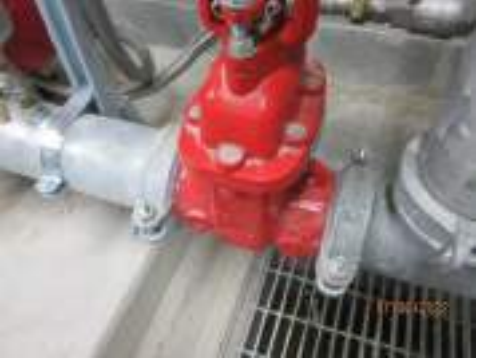
| DEFECT NO. | LOCATION | AREA | BREACH | PHOTOGRAPH | DEFECT DESCRIPTION |
|---|---|---|---|---|---|
| | | | | | <p>HARPER OBSERVATIONS AND COMMENTS – SIGNAGE REMOVED</p> |

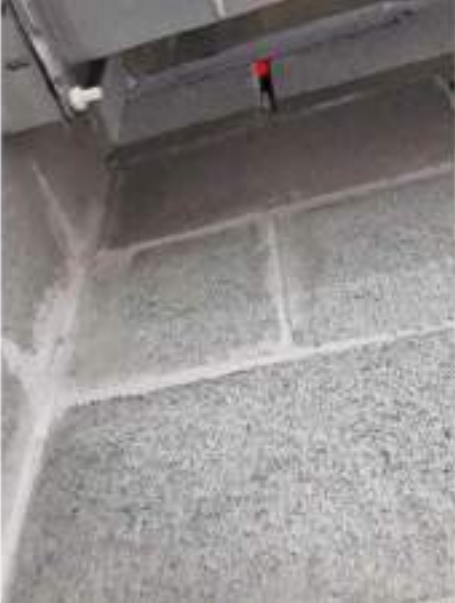
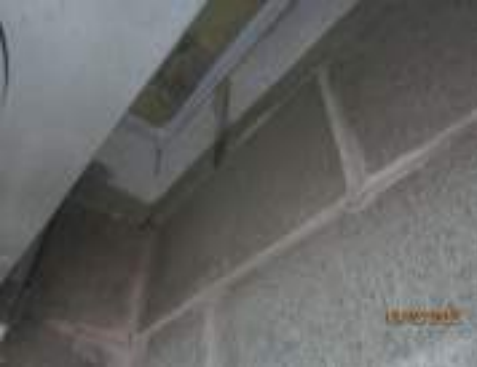
| DEFECT NO. | LOCATION | AREA | BREACH | PHOTOGRAPH | DEFECT DESCRIPTION |
|---|---|---|---|---|---|
| C 94 | Basement 2 | North east – hydrant room | Fire engineer to inspect. | | <p>Void in fire rated wall.</p> <p>HARPER OBSERVATIONS AND COMMENTS – RESOLVED</p> |

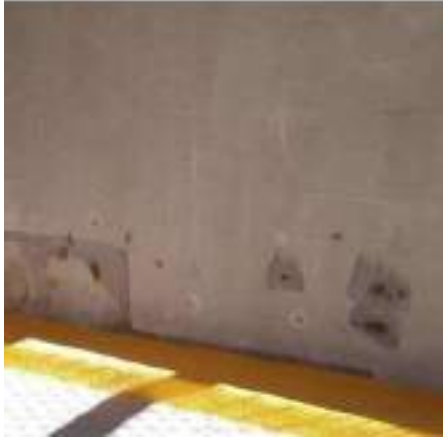
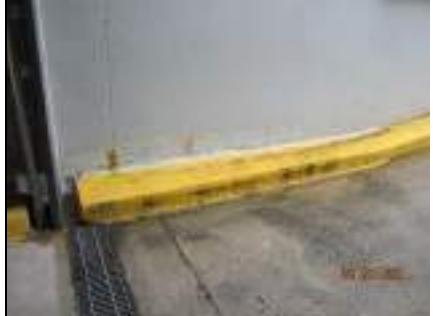
| DEFECT NO. | LOCATION | AREA | BREACH | PHOTOGRAPH | DEFECT DESCRIPTION |
|---|---|---|--|---|--|
| C 95 | Basement 1 | Main entry | See section 8.19 of this report. | | Localised waterproofing repairs. Corrosion.. HARPER OBSERVATIONS AND COMMENTS – REPAIRS FAILING, ISSUE OUTSTANDING REFER ITEM B1-2 SECTION 10 HARPER DEFECT SCHEDULE |

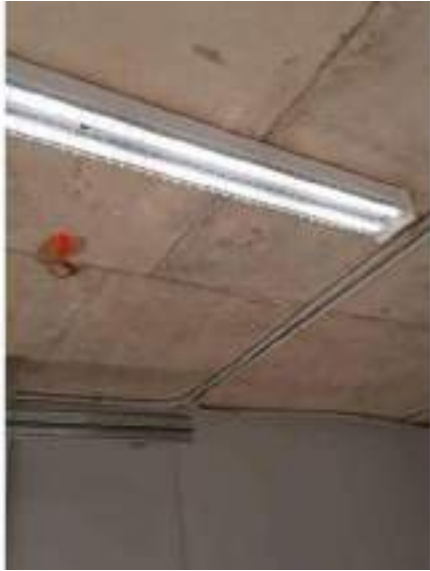
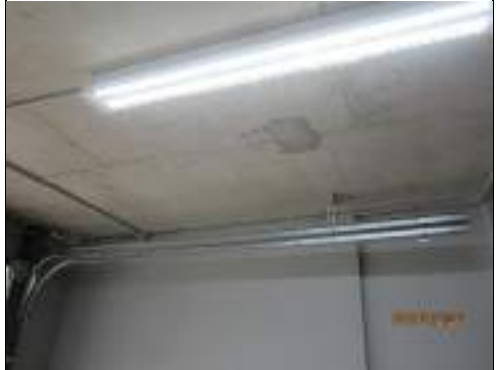
| DEFECT NO. | LOCATION | AREA | BREACH | PHOTOGRAPH | DEFECT DESCRIPTION |
|---|---|---|--|---|--|
| C 96 | Basement 1 | Main entry | Works have not been completed with due care and skill. | | Paper retained in soffit HARPER OBSERVATIONS AND COMMENTS –RESOLVED. |
