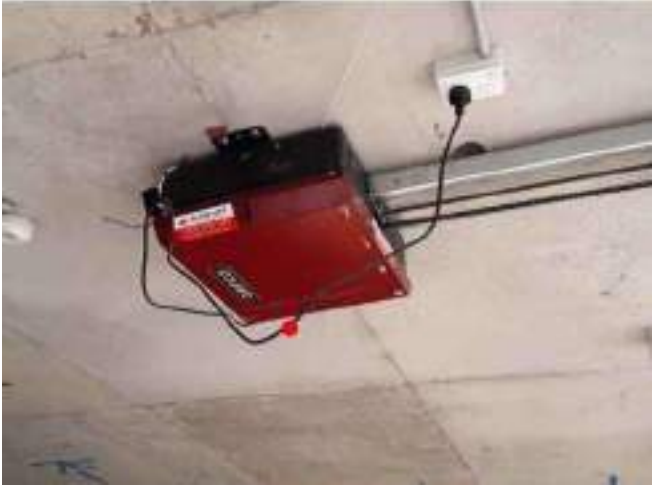
| DEFECT NO. | LOCATION | AREA | BREACH | PHOTOGRAPH | DEFECT DESCRIPTION |
|---|---|---|--|---|---|
| C 97 | Basement 1 | Main entry | Works have not been completed with due care and skill. | | Power cable to be shortened and clipped to concrete. HARPER OBSERVATIONS AND COMMENTS RESOLVED - CABLE RAISED TO PROVIDE SAFE CLEARANCE. NOTE IF CABLE SHORTED MAY VOID MANUFACTURERS WARRANTY. |

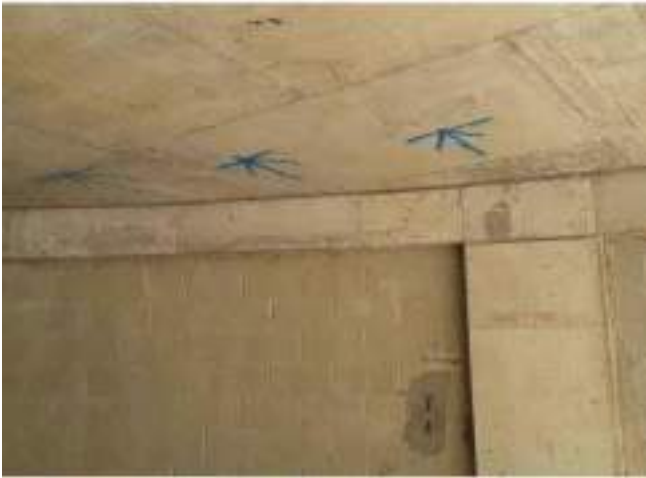
| DEFECT NO. | LOCATION | AREA | BREACH | PHOTOGRAPH | DEFECT DESCRIPTION |
|---|---|---|--|---|---|
| C 98 | Basement 1 | West wall | Incomplete work | | Builders set out has not been cleaned off. HARPER OBSERVATIONS AND COMMENTS -RESOLVED |

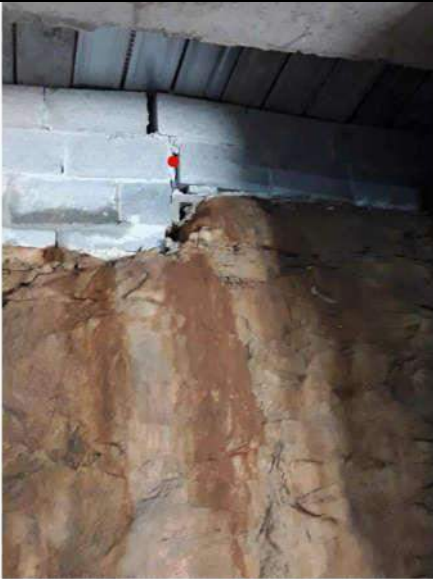
| DEFECT NO. | LOCATION | AREA | BREACH | PHOTOGRAPH | DEFECT DESCRIPTION |
|---|---|---|---|---|--|
| C 99 | Basement 1 | South wall | Structural engineer to assess. Not fit for purpose | | Block work wall, supporting Bondek has cracked. HARPER OBSERVATIONS AND COMMENTS –RESOLVED |

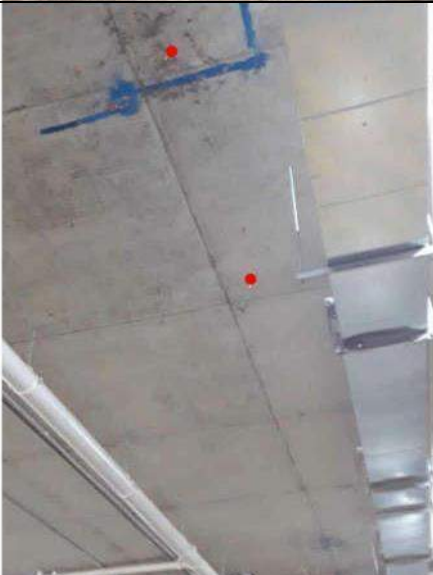
| DEFECT NO. | LOCATION | AREA | BREACH | PHOTOGRAPH | DEFECT DESCRIPTION |
|---|---|---|---|---|--|
| C 100 | Basement 1 | South wall | Works have not been completed with due care and skill. Incomplete work | | Nails retained throughout the soffit HARPER OBSERVATIONS AND COMMENTS –RESOLVED |

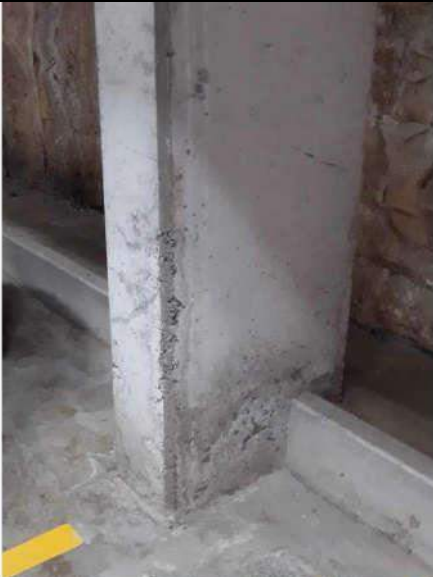
| DEFECT NO. | LOCATION | AREA | BREACH | PHOTOGRAPH | DEFECT DESCRIPTION |
|---|---|--|--|---|--|
| C 101 | Basement 1 Visitor parking bay | South (Column) | See section 8.20 of this report. | | Insufficiently vibrated concrete. HARPER OBSERVATIONS AND COMMENTS –RESOLVED |

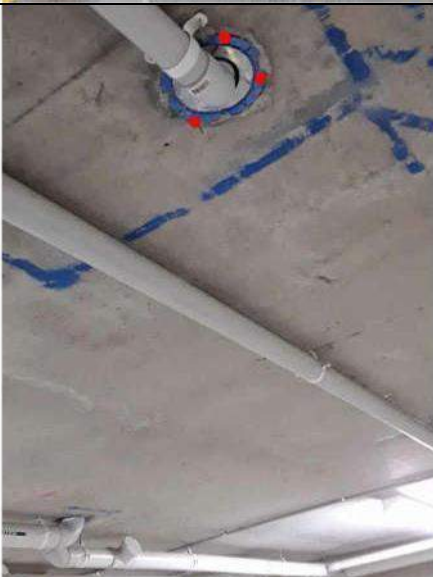
| DEFECT NO. | LOCATION | AREA | BREACH | PHOTOGRAPH | DEFECT DESCRIPTION |
|---|---|--|--|---|--|
| C 102 | Basement 1 | South –over parking bay 18 (floor waste) | Works have not been completed with due care and skill. | | Nails to soffit parking bay 18 Builders set out retained HARPER OBSERVATIONS AND COMMENTS –RESOLVED |

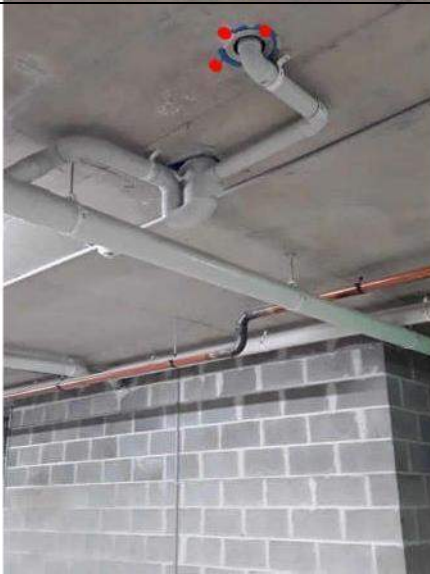
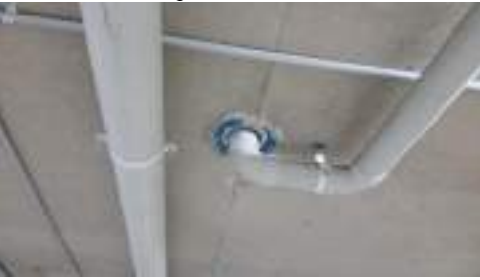
| DEFECT NO. | LOCATION | AREA | BREACH | PHOTOGRAPH | DEFECT DESCRIPTION |
|---|---|---|--|---|---|
| C 104 | Basement 1 | South | Works have not been completed with due care and skill. | | <p data-bbox="1615 815 1883 831">Nails retained throughout soffit</p> <p data-bbox="1615 1147 1928 1195">HARPER OBSERVATIONS AND COMMENTS –RESOLVED</p> |

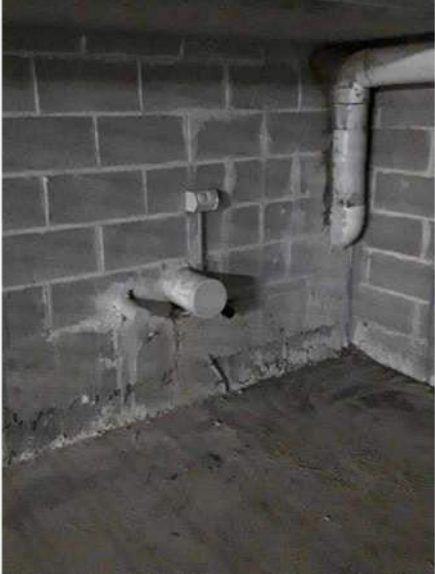
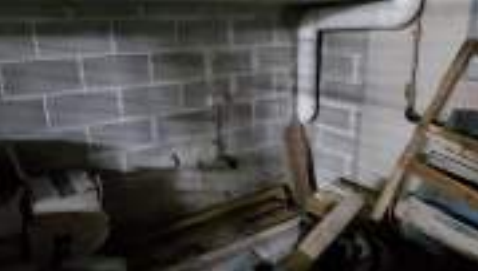
| DEFECT NO. | LOCATION | AREA | BREACH | PHOTOGRAPH | DEFECT DESCRIPTION |
|---|---|---|---|---|--|
| C 105 | Basement 1 | South east corner | Incomplete work. | | <p>Incomplete hydraulic work to southeast corner and incomplete concreting.</p> <p>HARPER OBSERVATIONS AND COMMENTS –RESOLVED</p> |

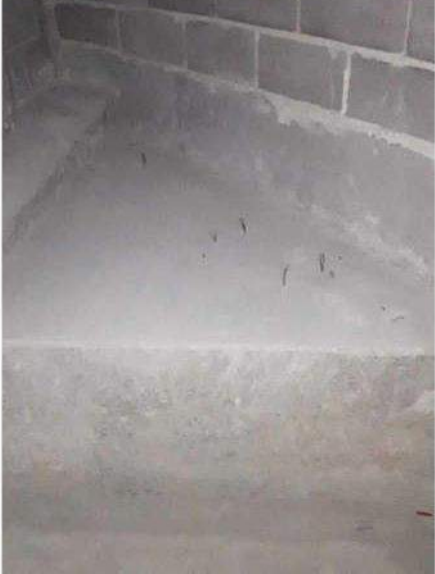
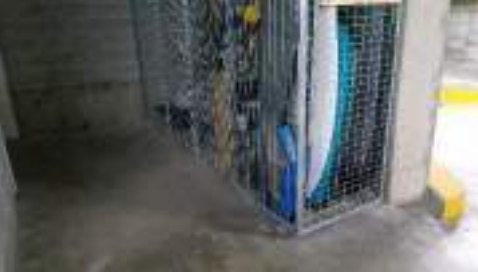
| DEFECT NO. | LOCATION | AREA | BREACH | PHOTOGRAPH | DEFECT DESCRIPTION |
|---|---|---|---|---|--|
| C 106 | B1 and B2 ramp | Adjacent store | Incomplete work | | <p>Nails retained in store adjacent to B1 to B2 ramp</p> <p>HARPER OBSERVATIONS AND COMMENTS –LOCATION NOT ACCESSIBLE.</p> |

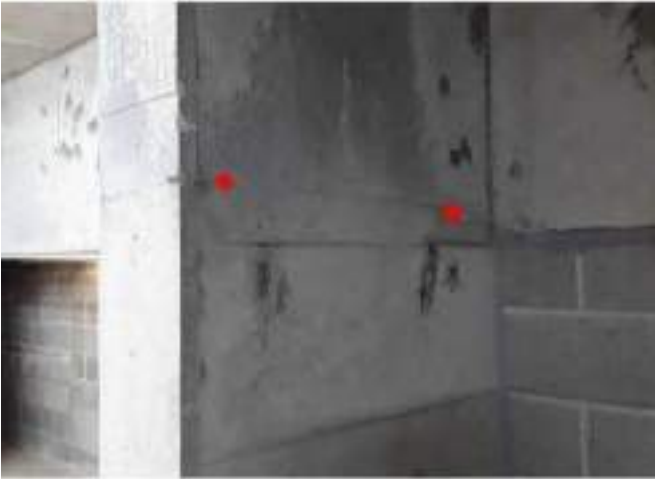
| DEFECT NO. | LOCATION | AREA | BREACH | PHOTOGRAPH | DEFECT DESCRIPTION |
|---|---|---|--|---|--|
| C 107 | Basement 1 | East column | Structural engineer to inspect. | | Cold joint in structural column adjacent to ramp. HARPER OBSERVATIONS AND COMMENTS – NO SPECIFIC STRUCTURAL ENGINEERS INSPECTION CERTIFICATION PROVIDED. |

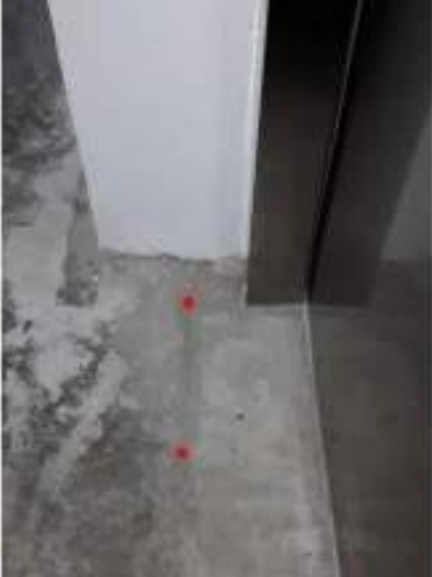
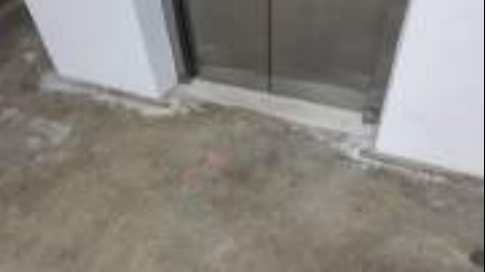
| DEFECT NO. | LOCATION | AREA | BREACH | PHOTOGRAPH | DEFECT DESCRIPTION |
|---|---|---|--|---|--|
| C 108 | Basement 1 | Exit | Works have not been completed with due care and skill. | | Hump at lift exit. HARPER OBSERVATIONS AND COMMENTS –RESOLVED. |

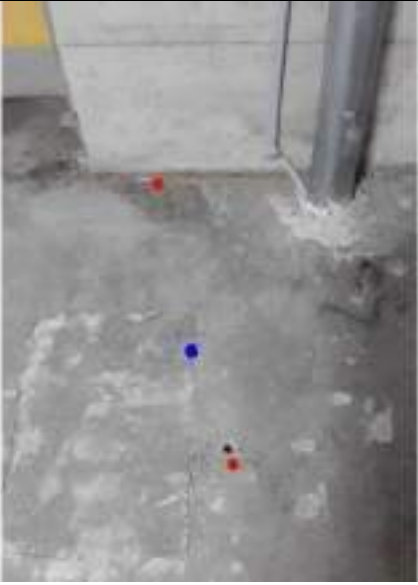
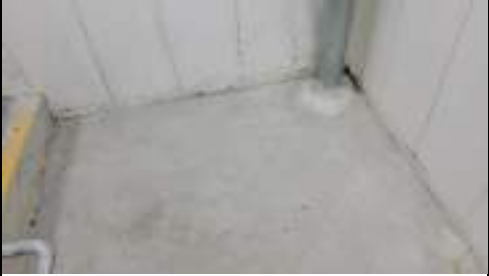
| DEFECT NO. | LOCATION | AREA | BREACH | PHOTOGRAPH | DEFECT DESCRIPTION |
|---|---|---|--|---|--|
| C 109 | Basement 1 | Exit | Works have not been completed with due care and skill. | | A. Open conduit HARPER OBSERVATIONS AND COMMENTS –RESOLVED. |

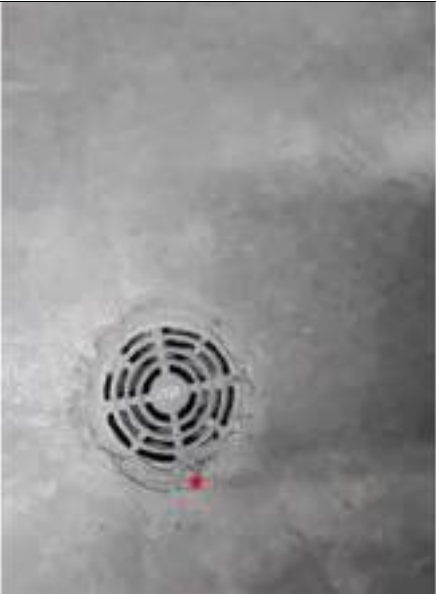
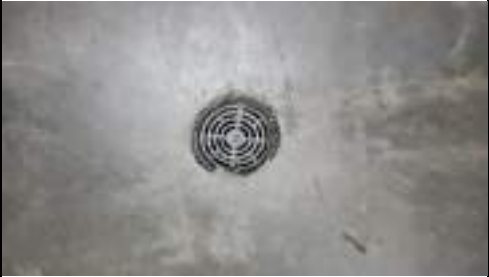
| DEFECT NO. | LOCATION | AREA | BREACH | PHOTOGRAPH | DEFECT DESCRIPTION |
|---|---|---|--|---|--|
| C 110 | Basement 1 | North east floor waste | Works have not been completed with due care and skill. | | A. Duct tape to concrete B. Concrete around drain has not been completed with due care and skill HARPER OBSERVATIONS AND COMMENTS –RESOLVED |

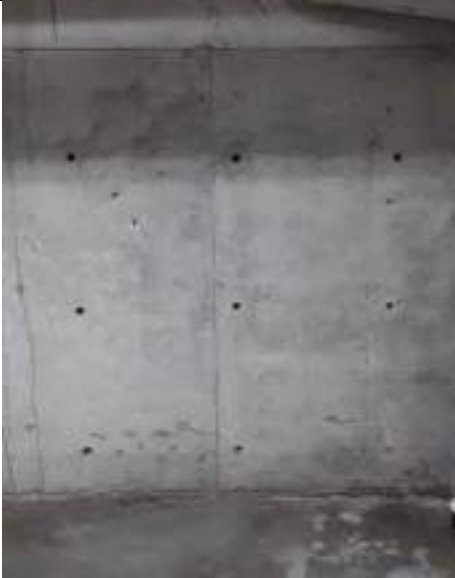
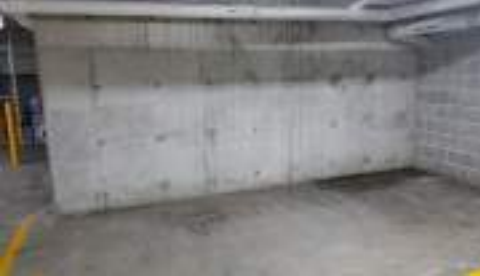
| DEFECT NO. | LOCATION | AREA | BREACH | PHOTOGRAPH | | DEFECT DESCRIPTION |
|---|---|---|---|---|--|---|
| C 111 | Basement 1 | North east fire stair | Incomplete work. | | | <p>Missing coil tie plugs.</p> <p>HARPER OBSERVATIONS AND COMMENTS –RESOLVED.</p> |

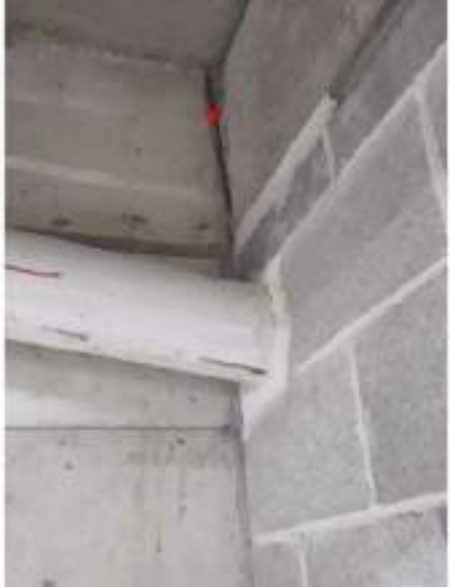
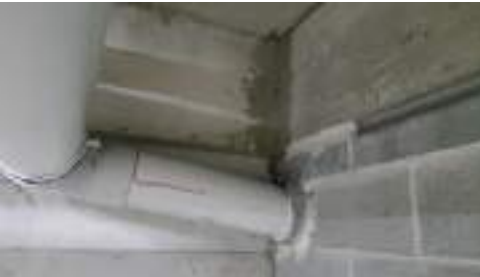
| DEFECT NO. | LOCATION | AREA | BREACH | PHOTOGRAPH | | DEFECT DESCRIPTION |
|---|---|---|---|---|--|---|
| C 112 | Basement 1 | Parking bay 2 | Incomplete work . | | | <p>Form work retained to parking bay 2 .</p> <p>HARPER OBSERVATIONS AND COMMENTS –RESOLVED.</p> |

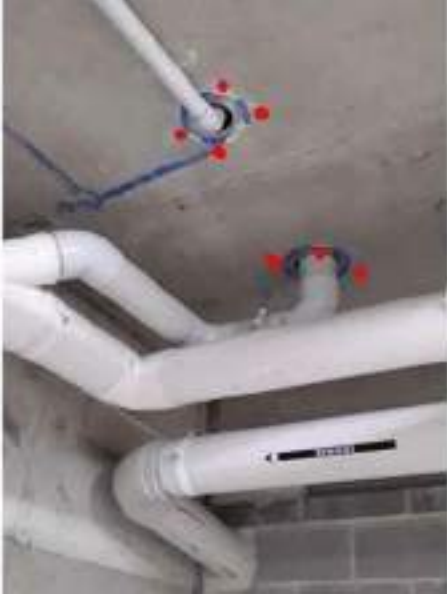
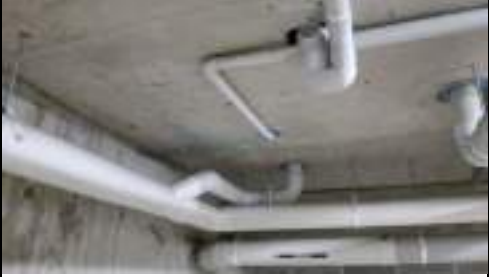
| DEFECT NO. | LOCATION | AREA | BREACH | PHOTOGRAPH | DEFECT DESCRIPTION |
|---|---|---|---|---|---|
| C 113 | Basement 1 | Parking bay 2 | Incomplete work. | | <p>A. Nails retained in soffit.</p> <p>Nails protruding from soffit are a safety hazard for maintenance plumbing work.</p> <p>B. Builders setout retained on soffit</p> <p>HARPER OBSERVATIONS AND COMMENTS –RESOLVED.</p> |

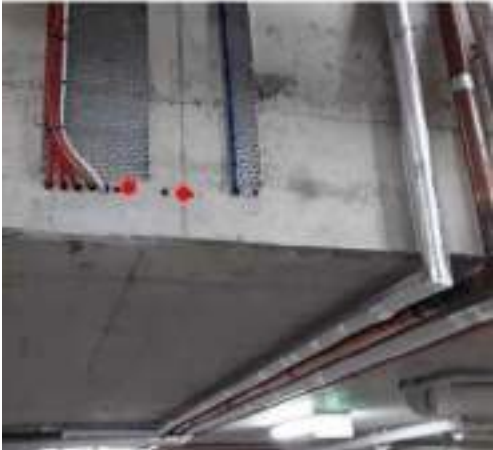
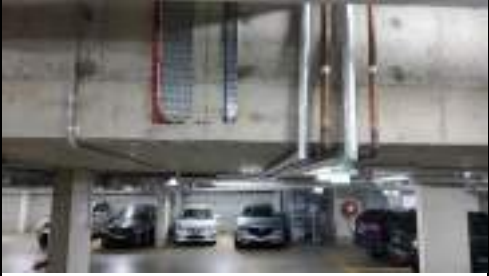
| DEFECT NO. | LOCATION | AREA | BREACH | PHOTOGRAPH | DEFECT DESCRIPTION |
|---|---|---|---|---|---|
| C 114 | Basement 1 | B1 and B2 ramp | Incomplete work | | <p>6 open conduits to concrete.</p> <p>HARPER OBSERVATIONS AND COMMENTS –NOT A DEFECT</p> |

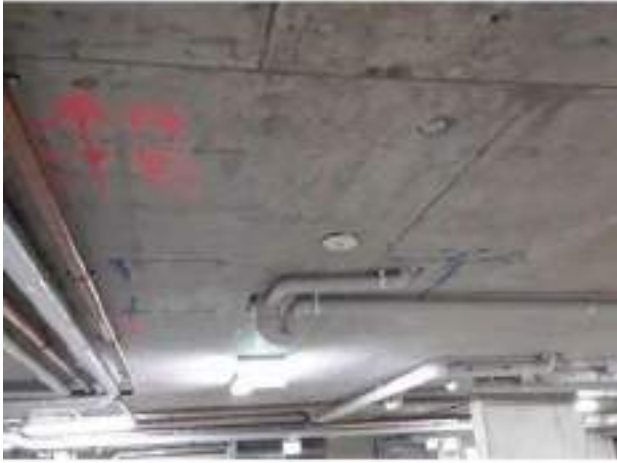
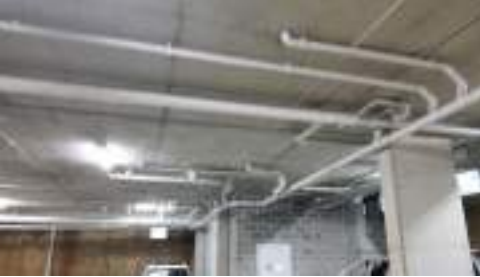
| DEFECT NO. | LOCATION | AREA | BREACH | PHOTOGRAPH | DEFECT DESCRIPTION |
|---|---|---|--|---|---|
| C 115 | Basement 1 | Ceiling area | Incomplete work. | | <p>Builders set out marks retained throughout.</p> <p>HARPER OBSERVATIONS AND COMMENTS –RESOLVED</p> |

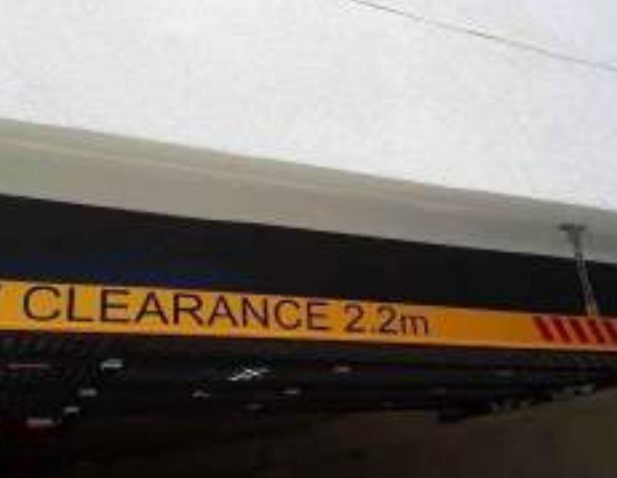
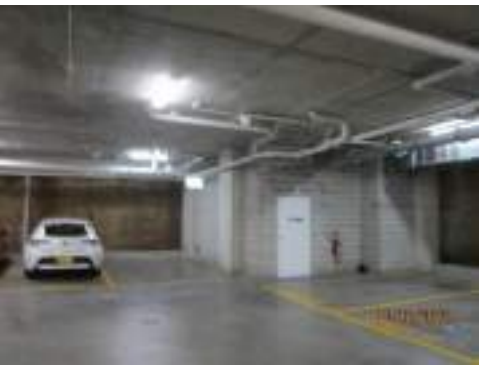
| DEFECT NO. | LOCATION | AREA | BREACH | PHOTOGRAPH | DEFECT DESCRIPTION |
|---|---|---|--|---|---|
| C 116 | Basement 1 | Ceiling clearance height | Works have not been completed with due care and skill. | | <p>Note clearance of 2.2m required to basement</p> <p>Exit sign inside basement is under 2100mm high.</p> <p>HARPER OBSERVATIONS AND COMMENTS –RESOLVED</p> |

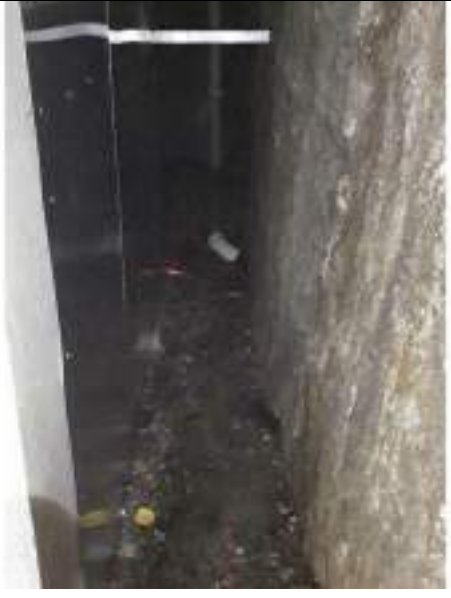
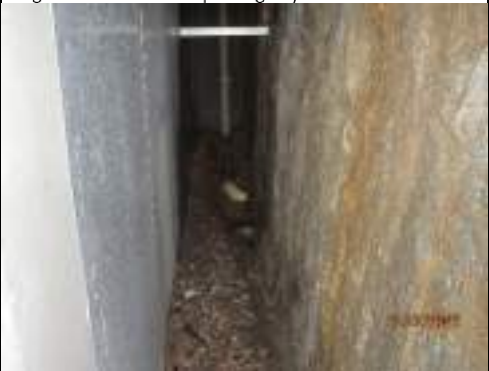
| DEFECT NO. | LOCATION | AREA | BREACH | PHOTOGRAPH | DEFECT DESCRIPTION |
|---|---|---|--|---|---|
| C 117 | Basement 2 | North wall | See section 8.4 of this report. | | <p>Stagnant water behind parking bay 30.</p> <p>HARPER OBSERVATIONS AND COMMENTS – RESOLVED</p> |

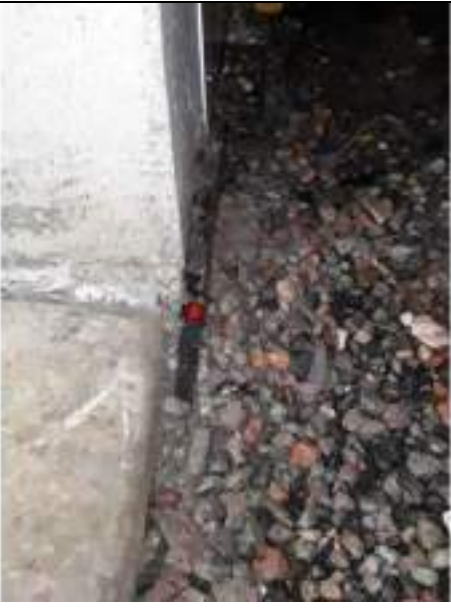
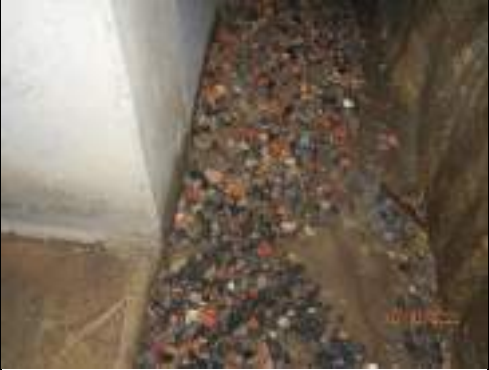
| DEFECT NO. | LOCATION | AREA | BREACH | PHOTOGRAPH | DEFECT DESCRIPTION |
|---|---|---|--|---|---|
| C 118 | Basement 2 | North wall | <p>See section 8.4 of this report.</p> <p>Dish drain not draining as such not fit for purpose.</p> | | <p>A. Saturated formwork to parking bay 30. B. Water ponding in dish drain.</p> <p>HARPER OBSERVATIONS AND COMMENTS – RESOLVED</p> |

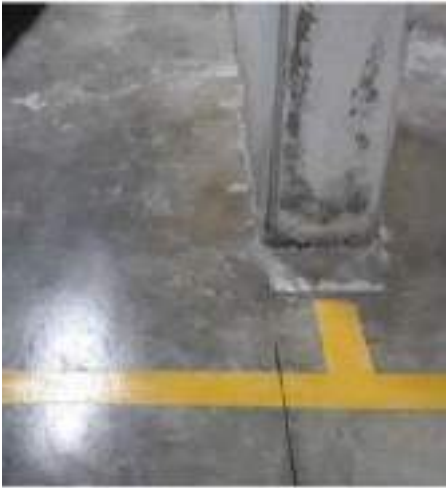
| DEFECT NO. | LOCATION | AREA | BREACH | PHOTOGRAPH | DEFECT DESCRIPTION |
|---|---|---|---|---|--|
| C119 | Basement 2 | Parking bay 29 | See section 8.20 of this report. | | Insufficient vibration of concrete. HARPER OBSERVATIONS AND COMMENTS –RESOLVED |

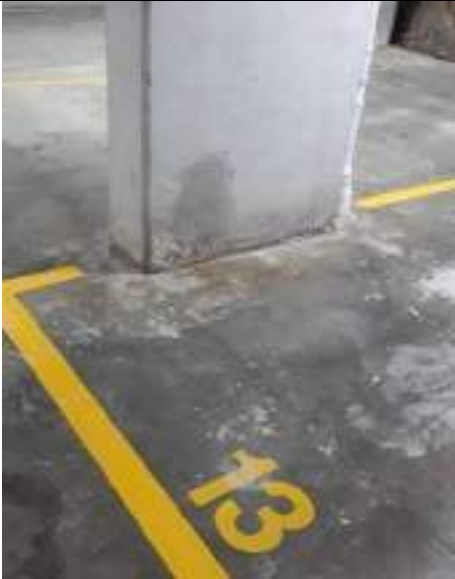
| DEFECT NO. | LOCATION | AREA | BREACH | PHOTOGRAPH | DEFECT DESCRIPTION |
|---|---|---|---|---|--|
| C120 | Basement 2 | Parking bay 13 | See section 8.20 of this report. | | Insufficient vibration of concrete. HARPER OBSERVATIONS AND COMMENTS –RESOLVED |

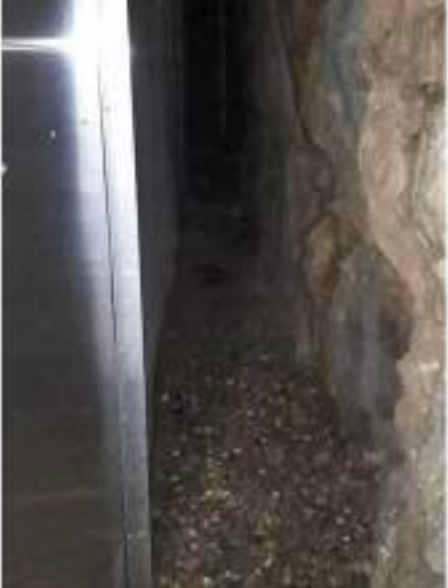
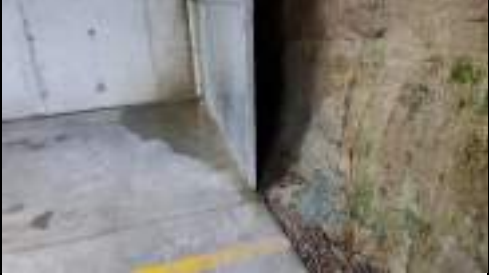
| DEFECT NO. | LOCATION | AREA | BREACH | PHOTOGRAPH | DEFECT DESCRIPTION |
|---|---|---|---|---|---|
| C122 | Basement 2 | Behind parking bay 25 | Not fit for purpose | | <p>Dish drain incomplete behind parking bay 25 Restricted with rock in way of water flow.</p> <p>HARPER OBSERVATIONS AND COMMENTS –DRAINAGE RESOLVED.</p> <p>WATER LEAKING FROM STORMWATER PIPE POOLING CONCRETE. REFER ITEM B2-3 SECTION 10 HARPER DEFECT SCHEDULE</p> |

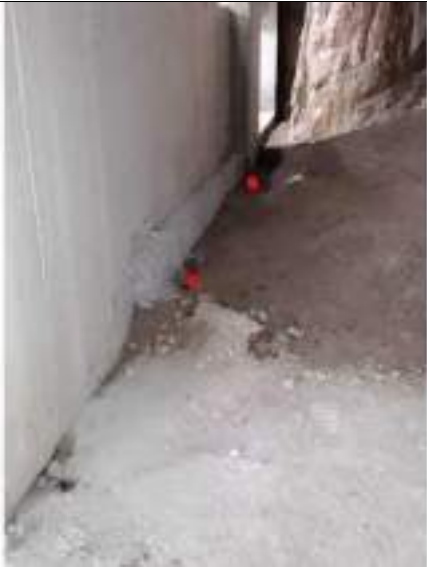
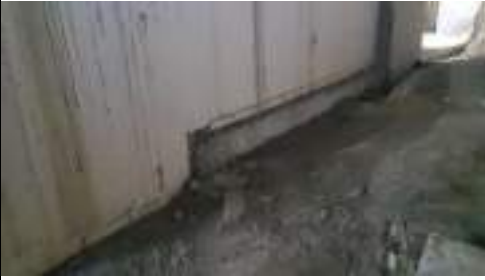
| DEFECT NO. | LOCATION | AREA | BREACH | PHOTOGRAPH | | DEFECT DESCRIPTION |
|---|---|---|--|---|--|---|
| C 123 | Basement 2 | North of building - adjacent to ramp | Works have not been completed with due care and skill. | | | <p>HARPER OBSERVATIONS AND COMMENTS –RESOLVED</p> |

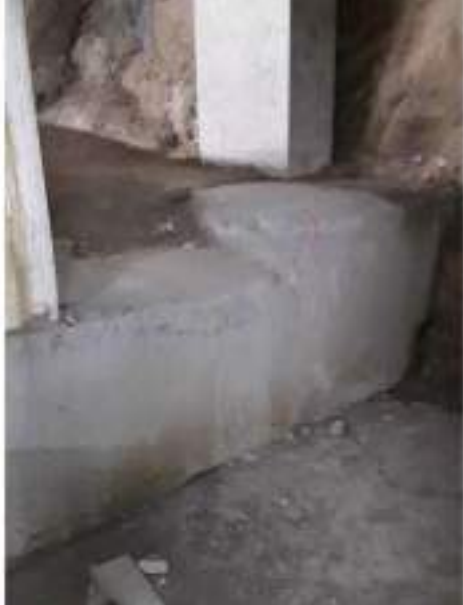
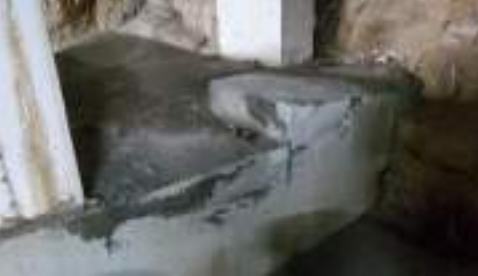
| DEFECT NO. | LOCATION | AREA | BREACH | PHOTOGRAPH | DEFECT DESCRIPTION |
|---|---|---|--|---|---|
| C 124 | Basement 2 | North of building - adjacent to ramp | Works have not been completed with due care and skill. | | <p>Poor concreting works adjacent to ramp.</p> <p>HARPER OBSERVATIONS AND COMMENTS –RESOLVED</p> |

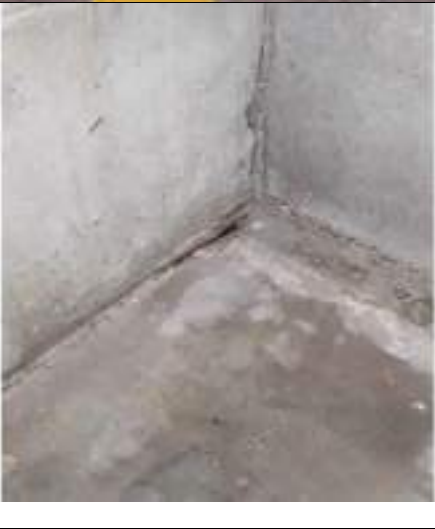
| DEFECT NO. | LOCATION | AREA | BREACH | PHOTOGRAPH | | DEFECT DESCRIPTION |
|---|---|---|---|---|--|---|
| C 127 | Basement 2 | Parking bay 24 | See section 8.19 of this report. Structural engineer to inspect. | | | Exposed and corroding reinforcement HARPER OBSERVATIONS AND COMMENTS –RESOLVED |

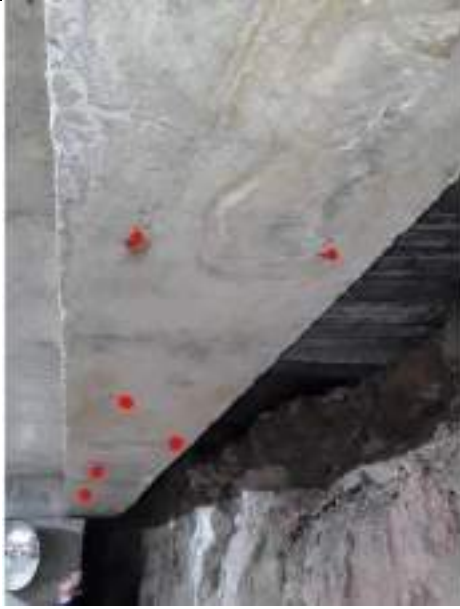
| DEFECT NO. | LOCATION | AREA | BREACH | PHOTOGRAPH | DEFECT DESCRIPTION |
|---|---|---|---|---|--|
| C128 | Basement 2 | North of building - adjacent to ramp | See section 8.19 of this report. Structural engineer to inspect. | | Corroding reinforcement. HARPER OBSERVATIONS AND COMMENTS –RESOLVED. NO SPECIFIC STRUCTURAL ENGINEERS INSPECTION DETAILS PROVIDED. |

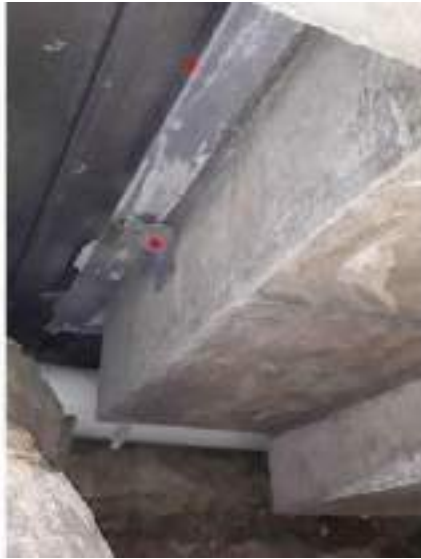
| DEFECT NO. | LOCATION | AREA | BREACH | PHOTOGRAPH | DEFECT DESCRIPTION |
|---|---|---|---|---|--|
| C129 | Basement 2 | North of building - adjacent to ramp | Structural engineer to inspect. | | Shelf angle installed without fixings and not grout packed to support Bondek. HARPER OBSERVATIONS AND COMMENTS – NO SPECIFIC STRUCTURAL ENGINEERS INSPECTION DETAILS PROVIDED. |

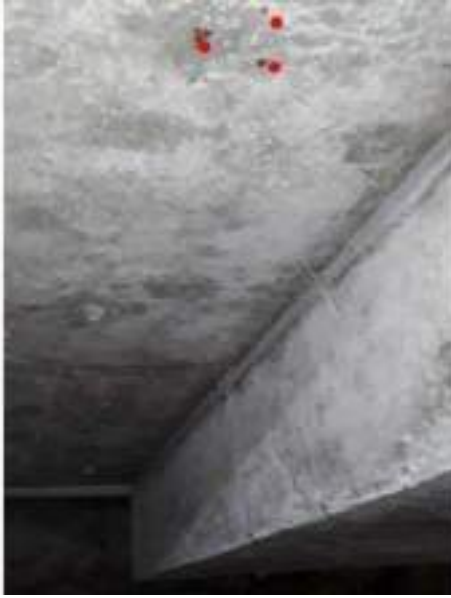
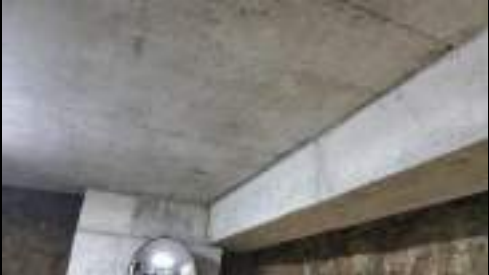
| DEFECT NO. | LOCATION | AREA | BREACH | PHOTOGRAPH | DEFECT DESCRIPTION |
|---|---|---|---|---|---|
| C 130 | Basement 2 | North of building - adjacent to ramp | See section 8.19 of this report. Structural engineer to inspect. | | Corroded reinforcements to base of ramp. HARPER OBSERVATIONS AND COMMENTS –RESOLVED. NO SPECIFIC STRUCTURAL ENGINEERS INSPECTION DETAILS PROVIDED. |

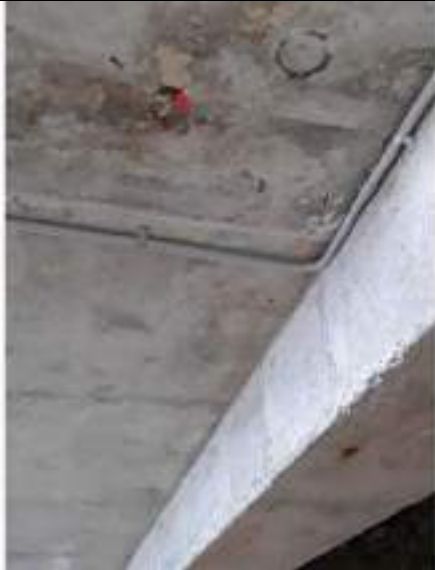
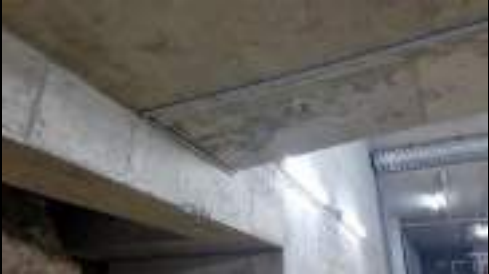
| DEFECT NO. | LOCATION | AREA | BREACH | PHOTOGRAPH | DEFECT DESCRIPTION |
|---|---|---|---|---|---|
| C 131 | Basement 2 | North of building - adjacent to ramp | See section 8.19 of this report. Structural engineer to inspect. | | Exposed reinforcement to base of ramp. HARPER OBSERVATIONS AND COMMENTS –RESOLVED. NO SPECIFIC STRUCTURAL ENGINEERS INSPECTION DETAILS PROVIDED. |

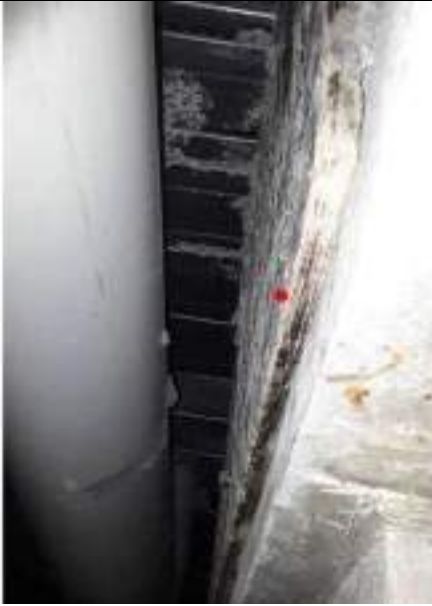
| DEFECT NO. | LOCATION | AREA | BREACH | PHOTOGRAPH | DEFECT DESCRIPTION |
|---|---|---|--|---|--|
| C 132 | Basement 2 | North of building - adjacent to ramp | Not fit for purpose. Incomplete work | | Retained formwork in moist environment. Will attract termites. HARPER OBSERVATIONS AND COMMENTS –RESOLVED |

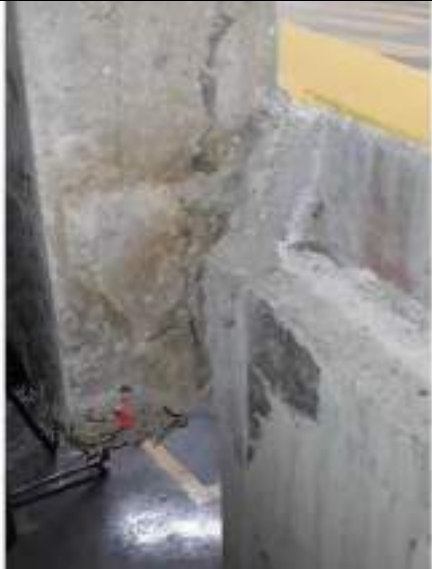
| DEFECT NO. | LOCATION | AREA | BREACH | PHOTOGRAPH | DEFECT DESCRIPTION |
|---|---|---|--|---|--|
| C 133 | Basement 2 | North of building - adjacent to ramp | Works have not been completed with due care and skill. | | Concrete beam filled with the debris HARPER OBSERVATIONS AND COMMENTS –RESOLVED |

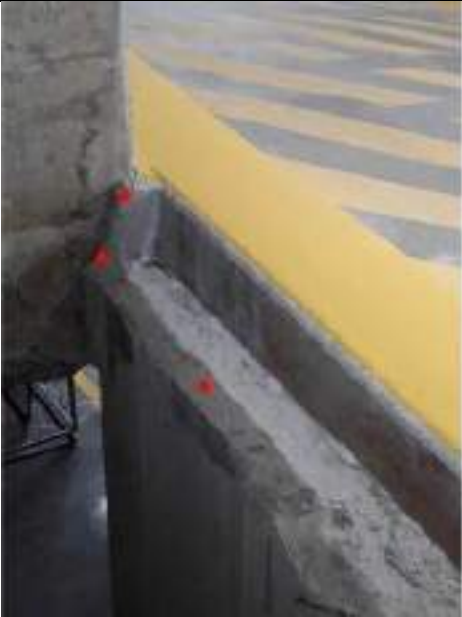
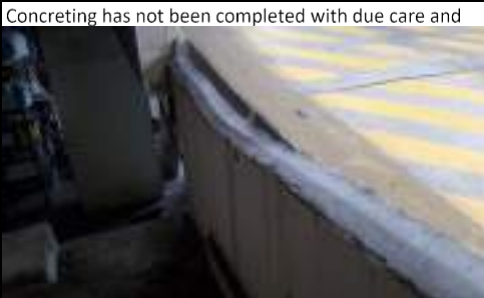
| DEFECT NO. | LOCATION | AREA | BREACH | PHOTOGRAPH | DEFECT DESCRIPTION |
|---|---|---|---|---|---|
| C 134 | Basement 2 | North of building - adjacent to ramp | Works have not been completed with due care and skill. | | <p>Concreting has not been completed with due care and</p> <p>HARPER OBSERVATIONS AND COMMENTS –RESOLVED</p> |

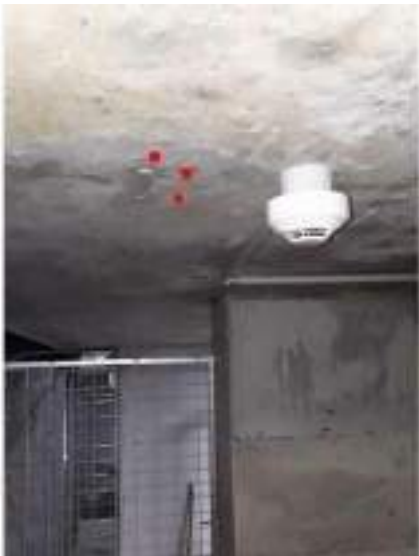
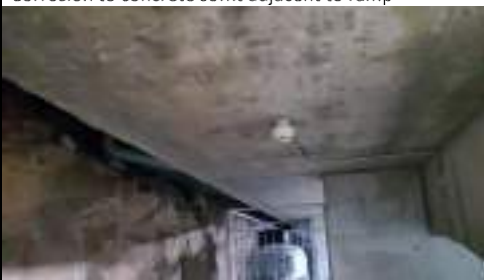
| DEFECT NO. | LOCATION | AREA | BREACH | PHOTOGRAPH | DEFECT DESCRIPTION |
|---|---|---|---|---|---|
| C 135 | Basement 2 | North of building - adjacent to ramp | See section 8.19 of this report. Structural engineer to inspect. | | <p>Corrosion to concrete soffit adjacent to ramp</p> <p>HARPER OBSERVATIONS AND COMMENTS –RESOLVED.</p> <p>NO SPECIFIC STRUCTURAL ENGINEERS INSPECTION DETAILS PROVIDED.</p> |

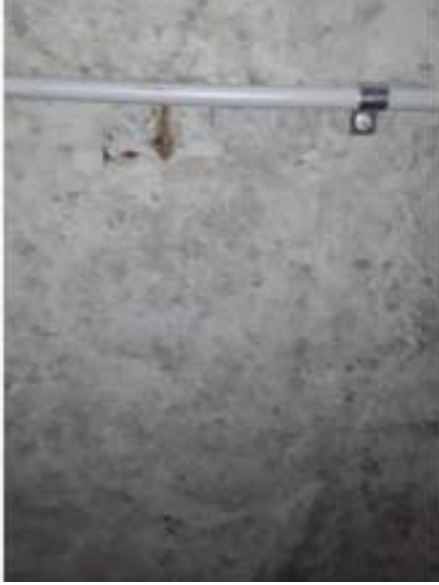
| DEFECT NO. | LOCATION | AREA | BREACH | PHOTOGRAPH | DEFECT DESCRIPTION |
|---|---|---|---|---|---|
| C 136 | Basement 2 | North of building - adjacent to ramp | See section 8.19 of this report. Structural engineer to inspect. | | Exposed reinforcement to soffit of concrete ramp. HARPER OBSERVATIONS AND COMMENTS –RESOLVED. NO SPECIFIC STRUCTURAL ENGINEERS INSPECTION DETAILS PROVIDED. |

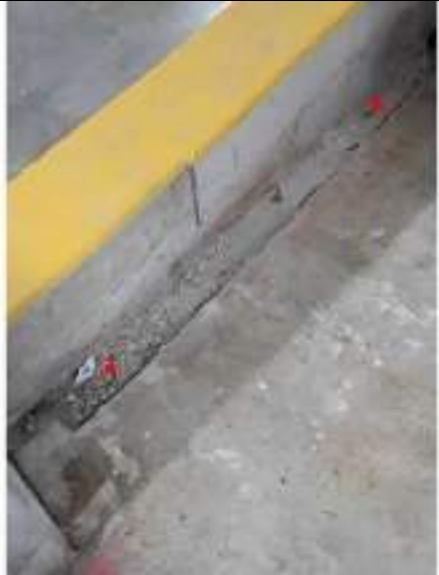
| DEFECT NO. | LOCATION | AREA | BREACH | PHOTOGRAPH | DEFECT DESCRIPTION |
|---|---|---|---|---|---|
| C 137 | Basement 2 | North of building - adjacent to ramp | Works have not been completed with due care and skill. | | Incomplete concreting. HARPER OBSERVATIONS AND COMMENTS –RESOLVED. |

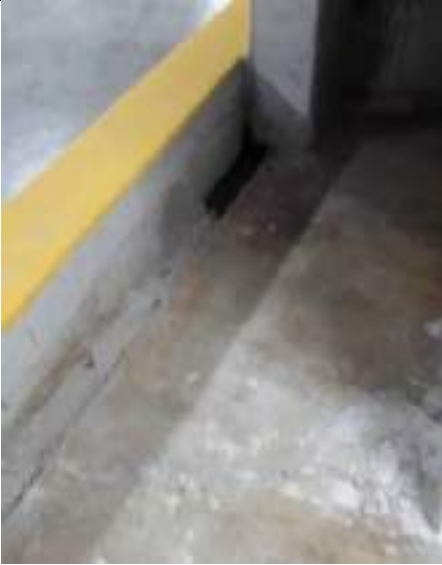
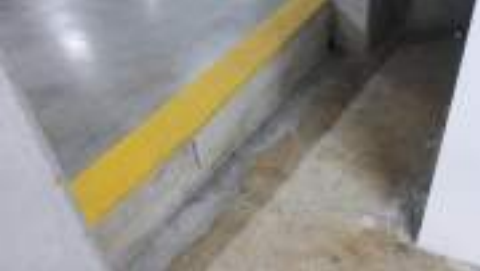
| DEFECT NO. | LOCATION | AREA | BREACH | PHOTOGRAPH | | DEFECT DESCRIPTION |
|---|---|---|--|---|--|--|
| C138 | Basement 2 | North of building - adjacent to ramp | Works have not been completed with due care and skill. | | | Missing concrete. HARPER OBSERVATIONS AND COMMENTS –RESOLVED. |

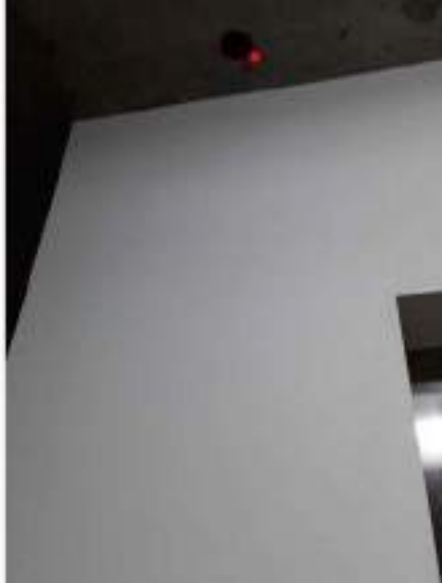
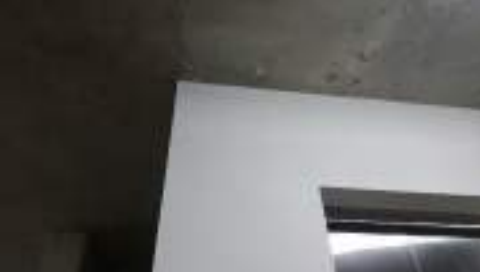
| DEFECT NO. | LOCATION | AREA | BREACH | PHOTOGRAPH | | DEFECT DESCRIPTION |
|---|---|---|--|---|--|--|
| C139 | Basement 2 | Lift area | Incomplete work | | | Open conduits. HARPER OBSERVATIONS AND COMMENTS –RESOLVED. |

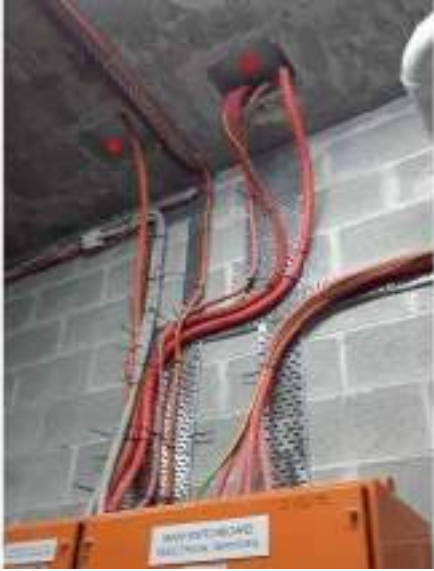
| DEFECT NO. | LOCATION | AREA | BREACH | PHOTOGRAPH | DEFECT DESCRIPTION |
|---|---|---|---|---|--|
| C 140 | Main switch room | Slab penetration | Fire engineer to inspect. | | Open fire rated riser. HARPER OBSERVATIONS AND COMMENTS –RESOLVED. |

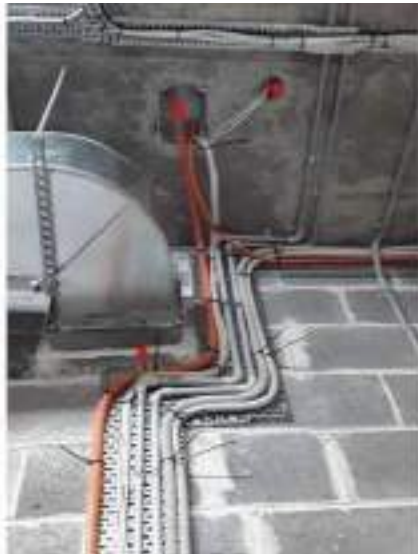
| DEFECT NO. | LOCATION | AREA | BREACH | PHOTOGRAPH | DEFECT DESCRIPTION |
|---|---|---|---|---|--|
| C 141 | Main switch room | Slab penetration | Fire engineer to inspect | | Fire safety consultant to inspect fire rating HARPER OBSERVATIONS AND COMMENTS –PENETRATIONS RESOLVED. |

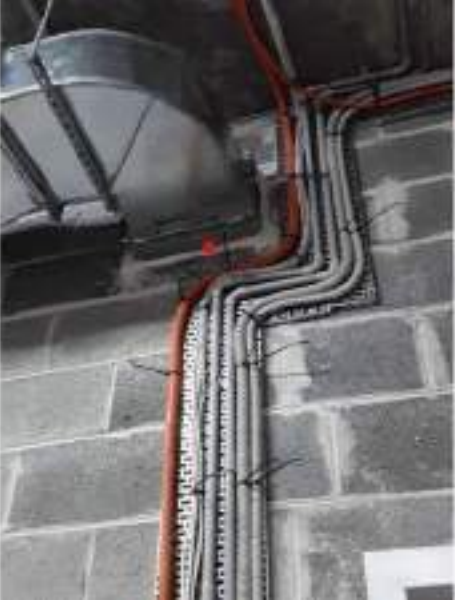
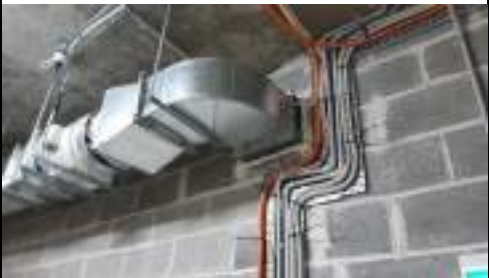
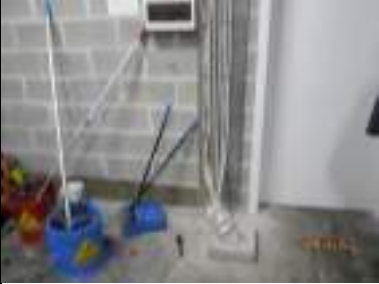
| DEFECT NO. | LOCATION | AREA | BREACH | PHOTOGRAPH | DEFECT DESCRIPTION |
|---|---|---|---|--|--|
| C 142 | Main switch room | Slab penetration | Fire engineer to inspect. | | <p data-bbox="1615 528 1868 600">HARPER OBSERVATIONS AND COMMENTS –RESOLVED. FIRE CERTIFICATE OF COMPLIANCE PROVIDED</p> <p data-bbox="1615 884 2024 956">NO TRUNK ING TO ELECTRICAL WIRING EXPOSED REFER ITEM B1-8 SECTION 10 HARPER DEFECT SCHEDULE.</p> |

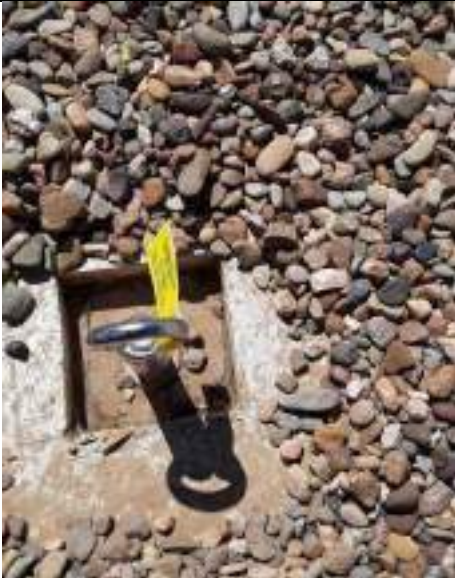
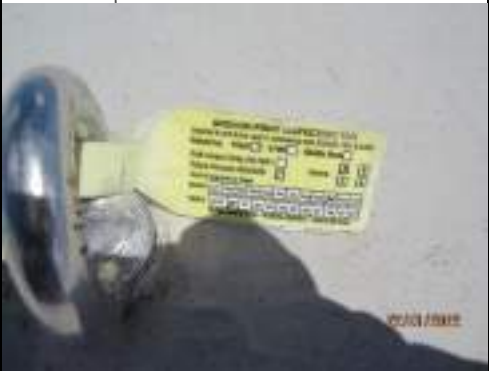
| DEFECT NO. | LOCATION | AREA | BREACH | PHOTOGRAPH | DEFECT DESCRIPTION |
|---|---|---|--|---|---|
| C 144 | Building L - Roof | Anchor bolt | Note. | | <p>Roof anchor points.</p> <p>HARPER OBSERVATIONS AND COMMENTS – NOTED INSPECTION DATED OCTOBER 2020</p> |

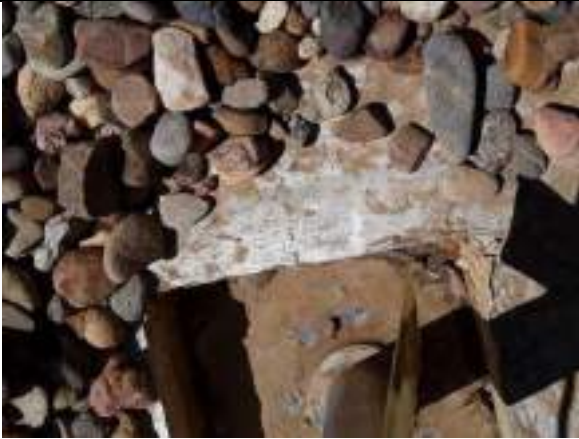
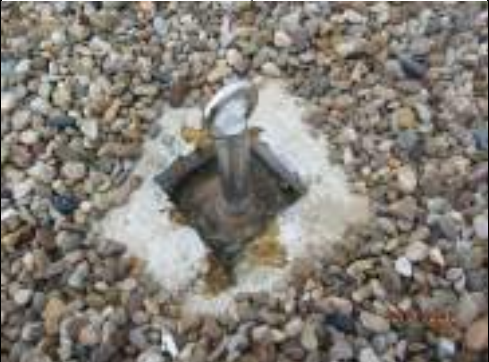
| DEFECT NO. | LOCATION | AREA | BREACH | PHOTOGRAPH | DEFECT DESCRIPTION |
|---|---|---|--|---|---|
| C 145 | Building L - Roof | Anchor bolt | <p>See section 8.11 of this report.</p> <p>Not fit for purpose</p> | | <p>Waterproofing is failing Adhesion failure between layers</p> <p>HARPER OBSERVATIONS AND COMMENTS – REFER ITEMS R-2 & R-3 SECTION 10 HARPER DEFECT SCHEDULE.</p> |

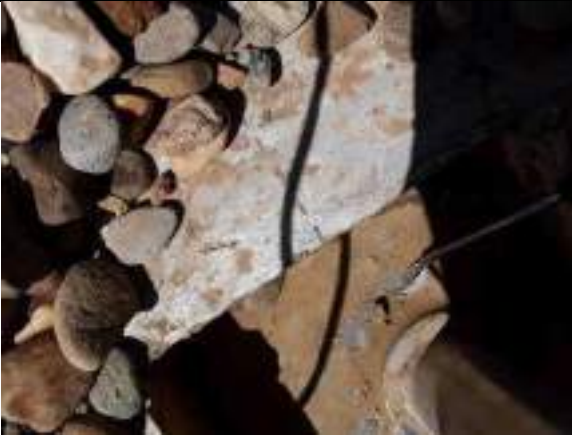
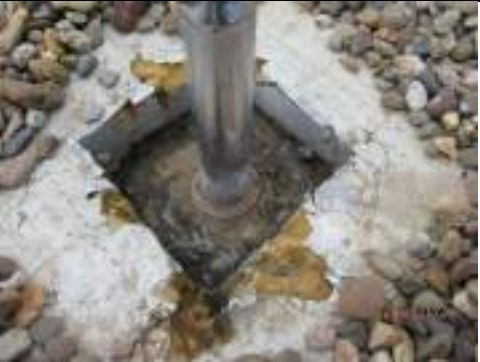
| DEFECT NO. | LOCATION | AREA | BREACH | PHOTOGRAPH | DEFECT DESCRIPTION |
|---|---|---|--|---|---|
| | | | | | <p>HARPER OBSERVATIONS AND COMMENTS –</p> <p>GRAVEL PLACED DIRECTLY OVER INSULATION.</p> <p>EVIDENCE OF DETERIORATION OF INSULATION.</p> <p>INSULATION NOT INSTALLED IN ACCORDANCE WITH MANUFACTURERS GUIDELINES.</p> <p>REFER ITEMS R-2 7 R-3 SECTION 10 HARPER DEFECT SCHEDULE</p> |

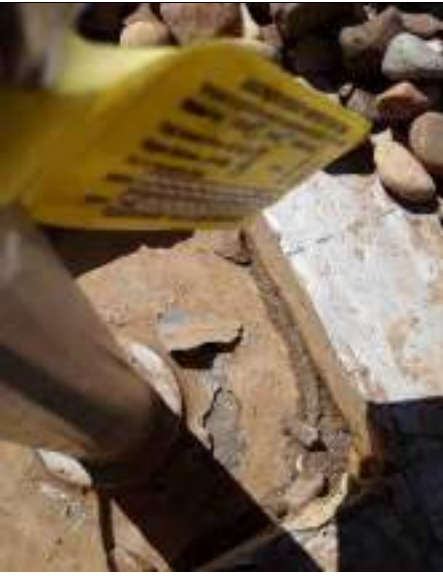
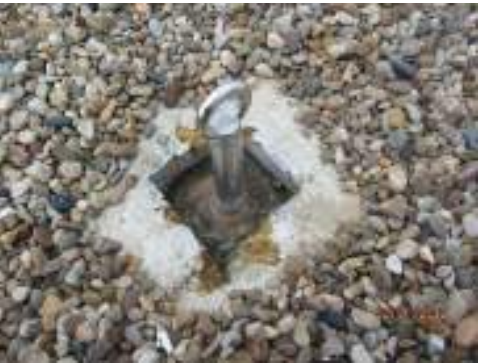
| DEFECT NO. | LOCATION | AREA | BREACH | PHOTOGRAPH | DEFECT DESCRIPTION |
|---|---|---|--|---|---|
| C 146 | Building L - Roof | Anchor bolt | See section 8.11 of this report. Not fit for purpose. | | <p>Waterproofing is failing</p> <p>Adhesion failure between layers</p> <p>HARPER OBSERVATIONS AND COMMENTS – REFER ITEMS R-2 7 R-3 SECTION 10 HARPER DEFECT SCHEDULE</p> |

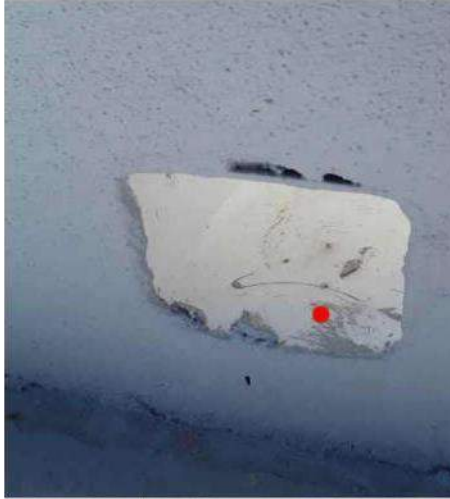
| DEFECT NO. | LOCATION | AREA | BREACH | PHOTOGRAPH | DEFECT DESCRIPTION |
|---|---|---|---|---|--|
| C 147 | Building L - Roof | Cladding | See section 8.8 of this report. | | Waterproofing does not extend into overflow. HARPER OBSERVATIONS AND COMMENTS – RESOLVED |

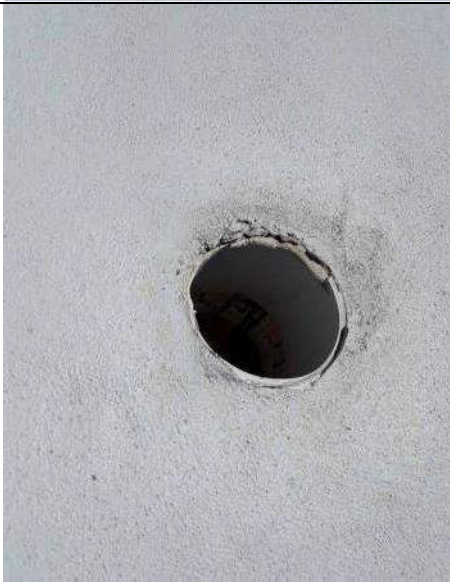
| DEFECT NO. | LOCATION | AREA | BREACH | PHOTOGRAPH | DEFECT DESCRIPTION |
|---|---|---|---|---|--|
| C 148 | Building L - Roof | Floor waste | See section 8.11 of this report. | | A. Waterproofing not turned down into floor waste. B. Puddle flange has not been provided. C. Drain cover not installed as required by AS4654.2. HARPER OBSERVATIONS AND COMMENTS – CONCUR B & C, OUTSTANDING. REFER ITEMS R-1 SECTION 10 HARPER DEFECT SCHEDULE |

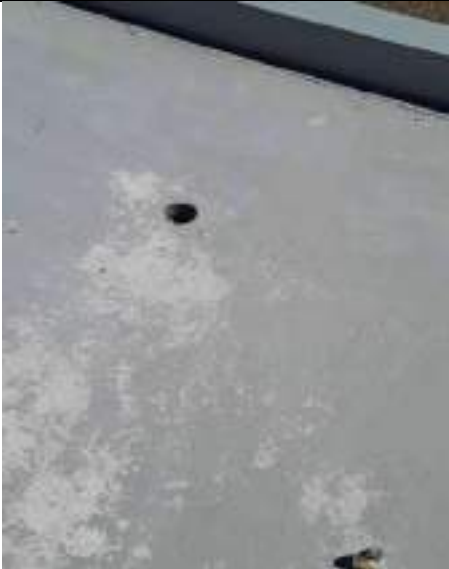
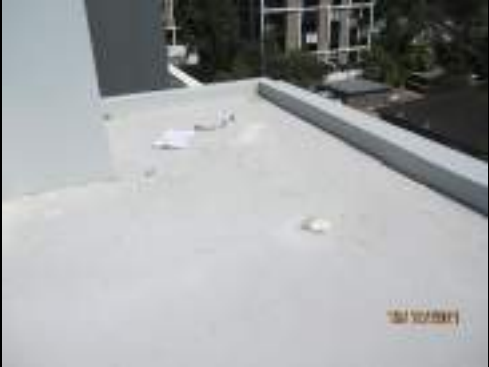
| DEFECT NO. | LOCATION | AREA | BREACH | PHOTOGRAPH | DEFECT DESCRIPTION |
|---|---|---|---|---|--|
| C 149 | Building L - Roof | Floor waste | See section 8.11 of this report. | | <p>A. Waterproofing not turned down into floor waste. B. Puddle flange has not been provided. C. Drain cover not installed as required by AS4654.2.</p> <p>HARPER OBSERVATIONS AND COMMENTS – CONCUR B & C. OUTSTANDING REFER ITEMS R-1 SECTION 10 HARPER DEFECT SCHEDULE</p> |

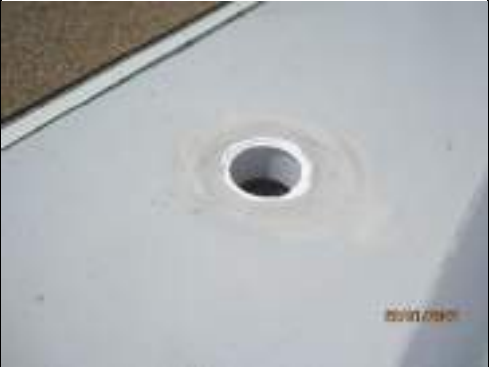
| DEFECT NO. | LOCATION | AREA | BREACH | PHOTOGRAPH | DEFECT DESCRIPTION |
|---|---|---|---|---|--|
| C 150 | Building L - Roof | Floor waste | See section 8.11 of this report. | | <p>B. Waterproofing not turned down into floor waste. Puddle flange has not been provided. Drain cover not installed as required by AS4654.2.</p> <p>HARPER OBSERVATIONS AND COMMENTS – CONCUR B & C. OUTSTANDING REFER ITEMS R-1 SECTION 10 HARPER DEFECT SCHEDULE</p> |

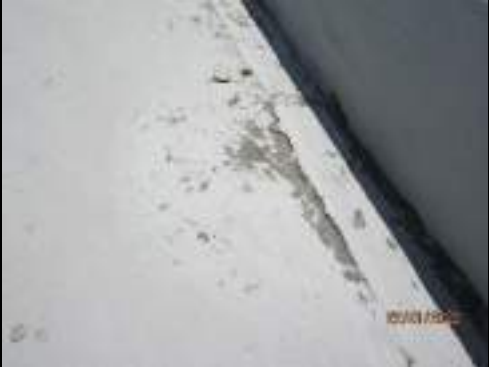
| DEFECT NO. | LOCATION | AREA | BREACH | PHOTOGRAPH | DEFECT DESCRIPTION |
|---|---|---|--|---|---|
| C 151 | Building L - Roof | Concrete hob | Works have not been completed with due care and skill. | | Rough substrate not compliant with AS4654.2 and manufacturers requirements. HARPER OBSERVATIONS AND COMMENTS – CONCUR, OUTSTANDING REFER ITEMS R-1 SECTION 10 HARPER DEFECT SCHEDULE |

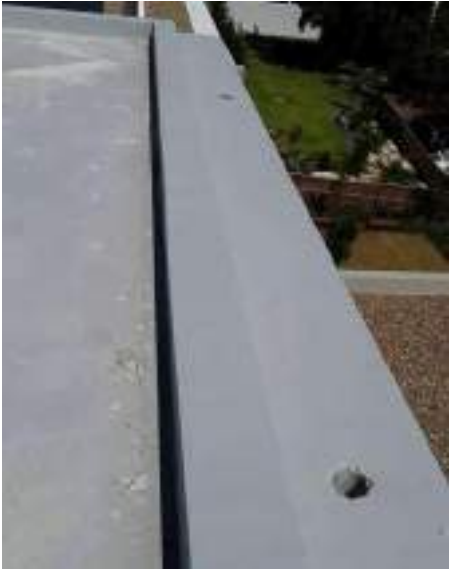
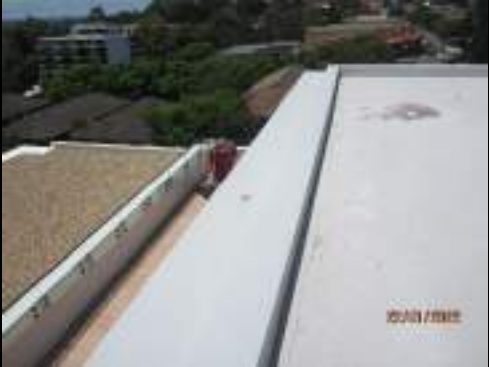
| DEFECT NO. | LOCATION | AREA | BREACH | PHOTOGRAPH | DEFECT DESCRIPTION |
|---|---|---|--|---|---|
| C152 | Building L - Roof | Concrete hob | See section 8.11 of this report. | | A. Waterproofing not turned down into floor waste. B. Puddle flange has not been provided. C. Drain cover not installed as required by AS4654.2. HARPER OBSERVATIONS AND COMMENTS – CONCUR B & C OUTSTANDING REFER ITEMS R-1 SECTION 10 HARPER DEFECT SCHEDULE |
