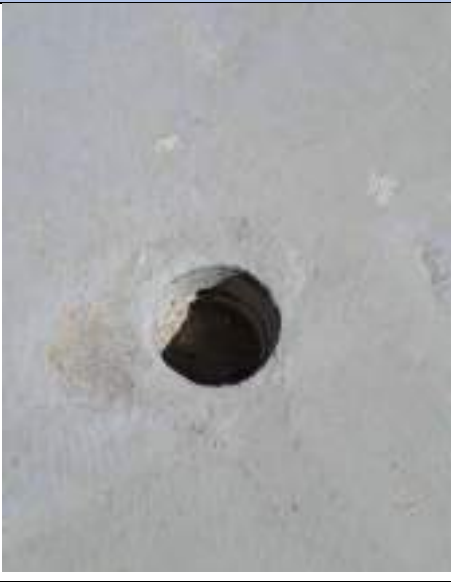
| DEFECT NO. | LOCATION | AREA | BREACH | PHOTOGRAPH | DEFECT DESCRIPTION |
|---|---|---|---|---|---|
| C 153 | Building L - Roof | Floor waste | See section 8.11 of this report. | | <p>A. Waterproofing not turned down into floor waste. B. Puddle flange has not been provided. C. Drain cover not installed as required by AS4654.2.</p> <p>HARPER OBSERVATIONS AND COMMENTS – CONCUR B & C OUTSTANDING REFER ITEMS R-1 SECTION 10 HARPER DEFECT SCHEDULE</p> |

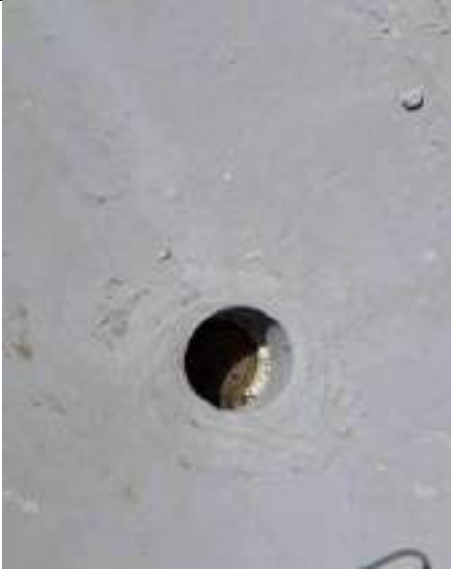
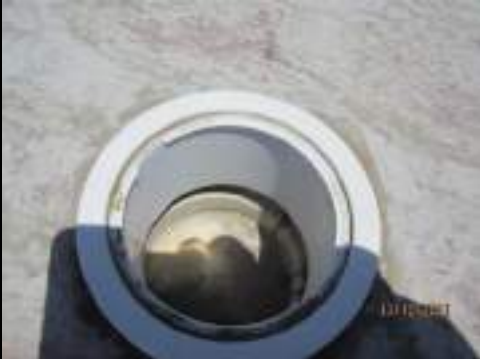
| DEFECT NO. | LOCATION | AREA | BREACH | PHOTOGRAPH | DEFECT DESCRIPTION |
|---|---|---|---|---|--|
| C155 | Building L - Roof | Floor waste | See section 8.11 of this report. | | <p>A. Puddle flange has not been provided. B. Drain cover not installed as required by AS4654.2.</p> <p>HARPER OBSERVATIONS AND COMMENTS – CONCUR B & C. OUTSTANDING REFER ITEMS R-1 SECTION 10 HARPER DEFECT SCHEDULE</p> |

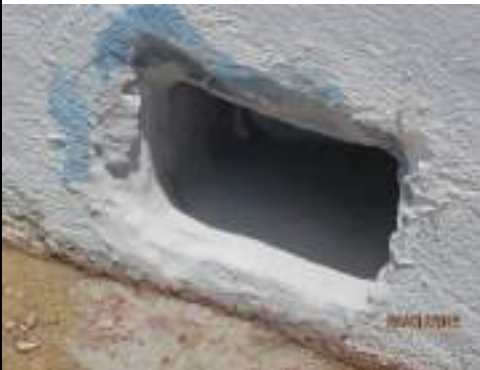
| DEFECT NO. | LOCATION | AREA | BREACH | PHOTOGRAPH | DEFECT DESCRIPTION |
|---|---|---|---|---|--|
| C156 | Building L - Roof | Overflow | See section 8.8 of this report. | | <p>Waterproofing does not turn into overflow</p> <p>HARPER OBSERVATIONS AND COMMENTS – RESOLVED</p> |

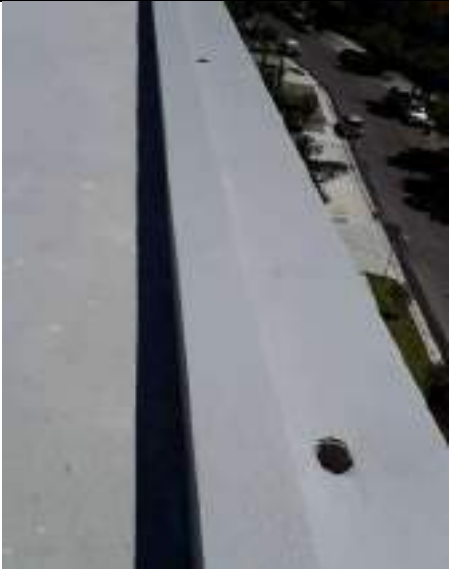
| DEFECT NO. | LOCATION | AREA | BREACH | PHOTOGRAPH | DEFECT DESCRIPTION |
|---|---|---|---|---|--|
| C157 | Building L - Roof | Overflow | See section 8.11 of this report. | | <ul style="list-style-type: none"> A. Waterproofing not turned down into floor waste. B. Puddle flange has not been provided. C. Drain cover not installed as required by AS4654.2. <p>HARPER OBSERVATIONS AND COMMENTS – CONCUR B & C OUTSTANDING REFER ITEMS R-1 SECTION 10 HARPER DEFECT SCHEDULE</p> |

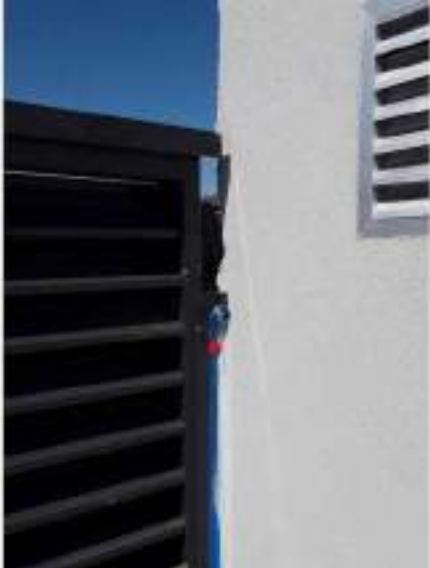
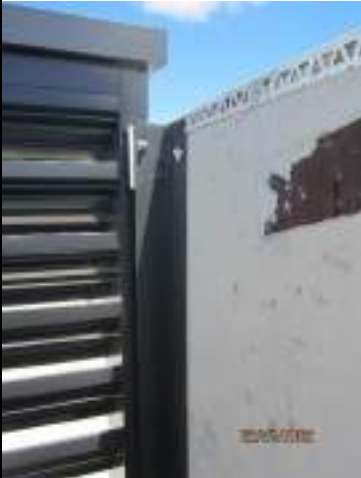
| DEFECT NO. | LOCATION | AREA | BREACH | PHOTOGRAPH | DEFECT DESCRIPTION |
|---|---|---|--|---|--|
| C 159 | Building U - Roof | Adjacent to louvres | Works have not been completed with due care and skill. | | Render protection tape left in position. Incomplete work. HARPER OBSERVATIONS AND COMMENTS – RESOLVED |

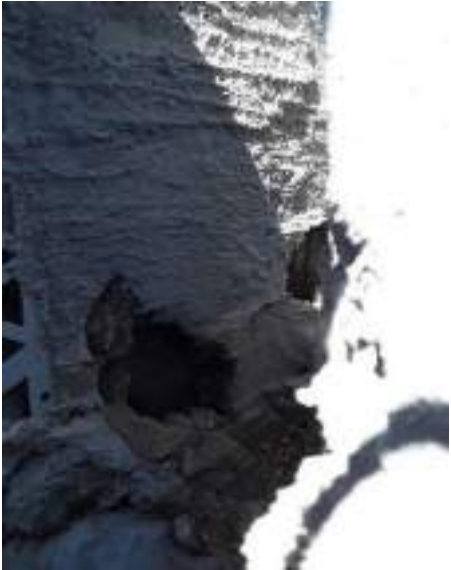
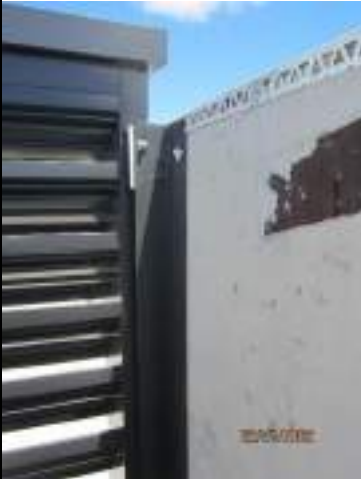
| DEFECT NO. | LOCATION | AREA | BREACH | PHOTOGRAPH | DEFECT DESCRIPTION |
|---|---|---|--|---|--|
| C 160 | Building U - Roof | Base of wall | Works have not been completed with due care and skill. | | Voids in render finish HARPER OBSERVATIONS AND COMMENTS – RESOLVED |

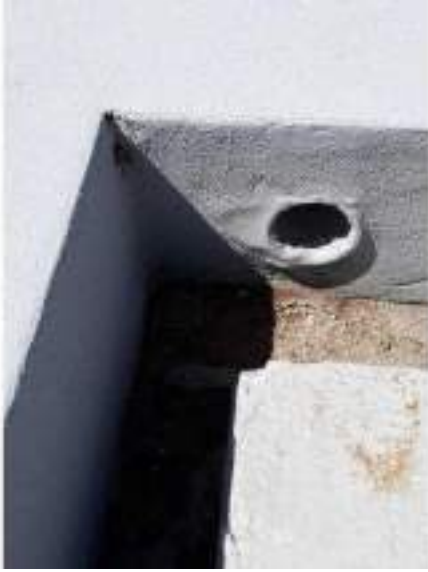
| DEFECT NO. | LOCATION | AREA | BREACH | PHOTOGRAPH | DEFECT DESCRIPTION |
|---|---|---|--|---|---|
| C161 | Building U - Roof | Overflow | See section 8.8 of this report. | | Waterproofing has not been turned into overflow. HARPER OBSERVATIONS AND COMMENTS – RESOLVED |

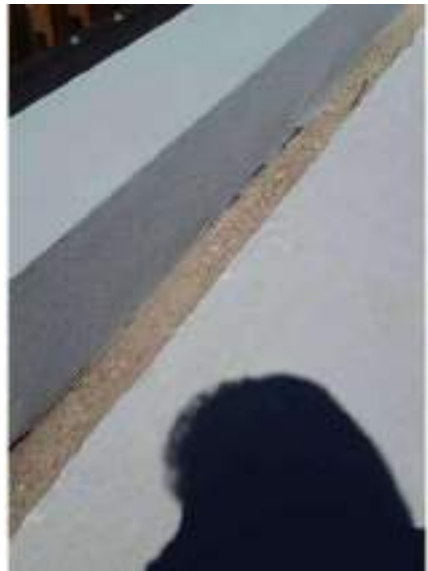
| DEFECT NO. | LOCATION | AREA | BREACH | PHOTOGRAPH | DEFECT DESCRIPTION |
|---|---|---|--|---|---|
| C162 | Building U - Roof | Concrete hob | Works have not been completed with due care and skill. | | Concrete hob formwork timber has created set down to perimeter of roof which will allow water to pond in recess. HARPER OBSERVATIONS AND COMMENTS – OUTSTANDING REFER ITEMS R-1 SECTION 10 HARPER DEFECT SCHEDULE |

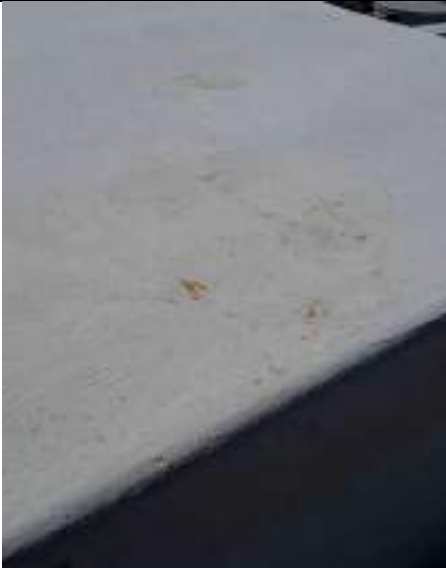
| DEFECT NO. | LOCATION | AREA | BREACH | PHOTOGRAPH | DEFECT DESCRIPTION |
|---|---|---|--|---|---|
| C 165 | Building U - Roof | Concrete slab waterproofing | Structural engineer to inspect. See section 8.19 of this report. | | Corrosion. HARPER OBSERVATIONS AND COMMENTS – CONCUR OUTSTANDING REFER ITEMS R-1 SECTION 10 HARPER DEFECT SCHEDULE |

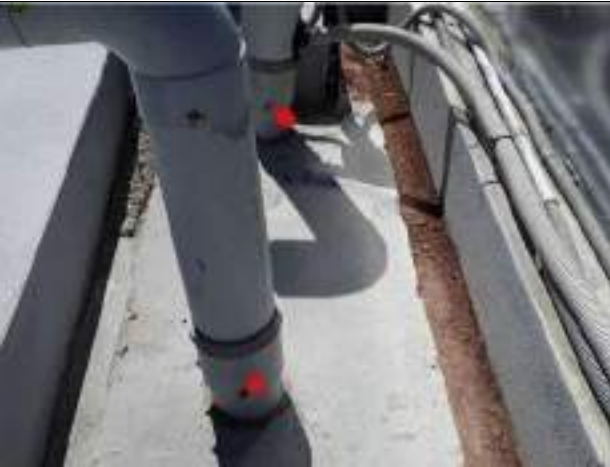
| DEFECT NO. | LOCATION | AREA | BREACH | PHOTOGRAPH | DEFECT DESCRIPTION |
|---|---|---|--|---|---|
| C 166 | Building U - Roof | Pipe penetration | See section 8.11 of this report. | | Waterproofing has not been turned up services pipe as required by AS4654.2. HARPER OBSERVATIONS AND COMMENTS – CONCUR OUTSTANDING REFER ITEMS R-1 SECTION 10 HARPER DEFECT SCHEDULE |

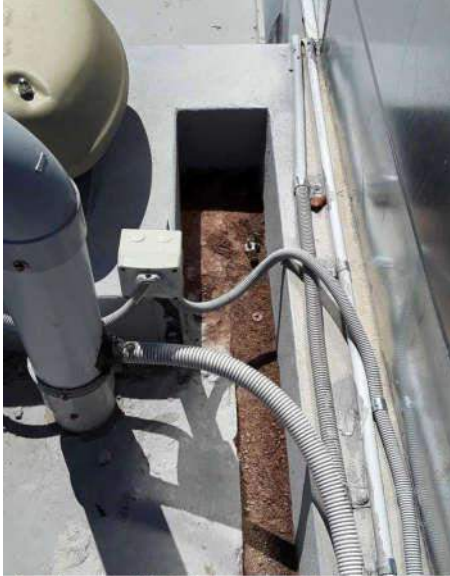
| DEFECT NO. | LOCATION | AREA | BREACH | PHOTOGRAPH | DEFECT DESCRIPTION |
|---|---|---|--|---|--|
| C 167 | Building U - Roof | Side open drain | Works have not been completed with due care and skill. | | Concrete hob formwork timber has created set down to perimeter of roof which will allow water to pond in recess. HARPER OBSERVATIONS AND COMMENTS – CONCUR OUTSTANDING REFER ITEMS R-1 SECTION 10 HARPER DEFECT SCHEDULE |

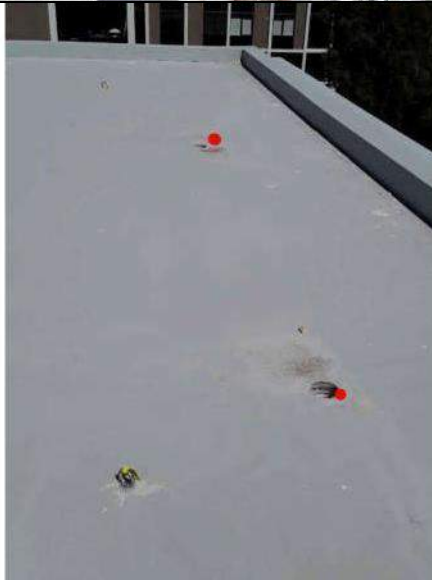
| DEFECT NO. | LOCATION | AREA | BREACH | PHOTOGRAPH | DEFECT DESCRIPTION |
|---|---|---|--|---|--|
| C 168 | Building U - Roof | Open drain | See section 8.11 of this report. | | Open drains throughout rooftop. Waterproofing not turned down into floor waste HARPER OBSERVATIONS AND COMMENTS – CONCUR OUTSTANDING REFER ITEMS R-1 SECTION 10 HARPER DEFECT SCHEDULE |

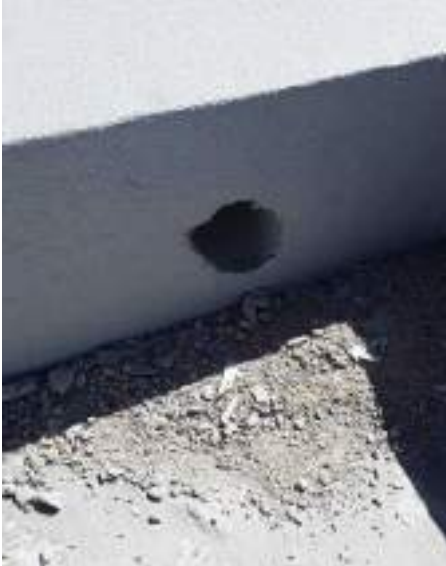
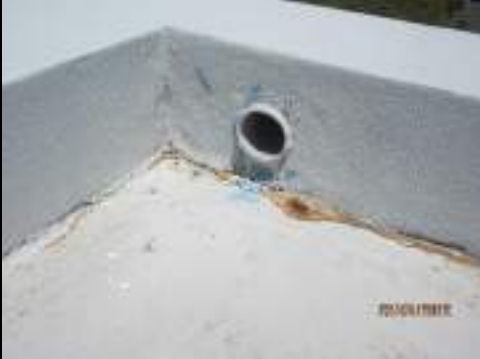
| DEFECT NO. | LOCATION | AREA | BREACH | PHOTOGRAPH | DEFECT DESCRIPTION |
|---|---|---|--|---|---|
| C 169 | Building U - Roof | Overflow | Works have not been completed with due care and skill. | | Overflows were filled with render debris. HARPER OBSERVATIONS AND COMMENTS – RESOLVED |

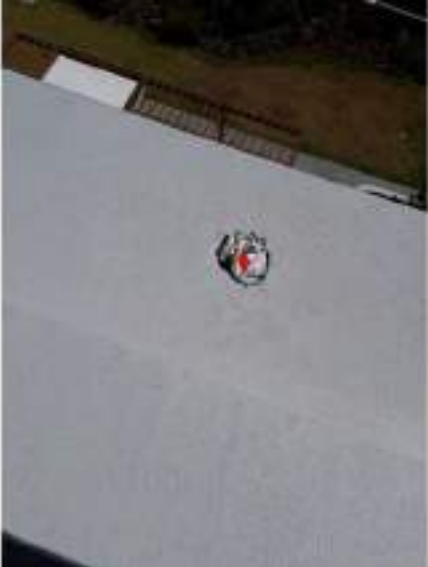
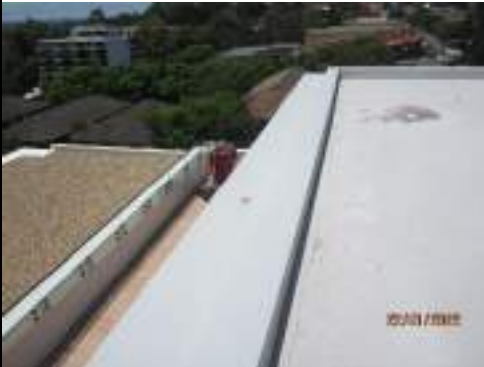
| DEFECT NO. | LOCATION | AREA | BREACH | PHOTOGRAPH | DEFECT DESCRIPTION |
|---|---|---|--|---|---|
| C 170 | Building U - Roof | Open drain | Works have not been completed with due care and skill. | | Paper bags stuffed into drain outlets throughout eave area. HARPER OBSERVATIONS AND COMMENTS – RESOLVED |

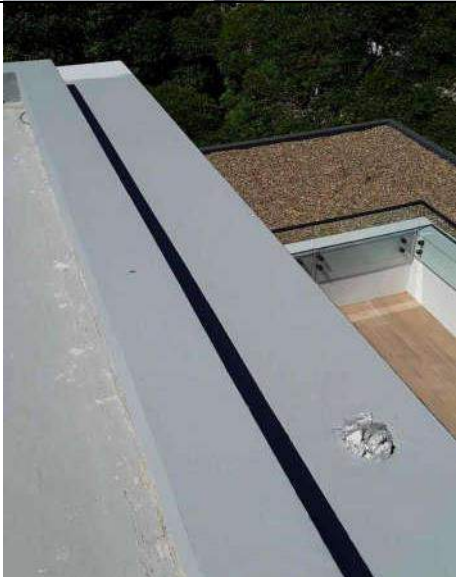
| DEFECT NO. | LOCATION | AREA | BREACH | PHOTOGRAPH | DEFECT DESCRIPTION |
|---|---|---|--|---|--|
| C 171 | Building U - Roof | Open drain | Works have not been completed with due care and skill. | | <p>Paper bags stuffed into drain outlets throughout eave area.</p> <p>HARPER OBSERVATIONS AND COMMENTS – RESOLVED</p> |

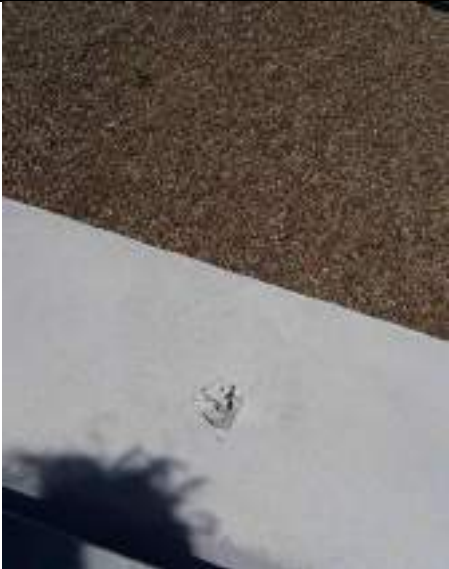
| DEFECT NO. | LOCATION | AREA | BREACH | PHOTOGRAPH | DEFECT DESCRIPTION |
|---|---|---|--|---|---|
| C172 | Building U - Roof | Open drain | Works have not been completed with due care and skill. | | <p>Paper bags stuffed into drain outlets throughout eave area.</p> <p>HARPER OBSERVATIONS AND COMMENTS – RESOLVED</p> |

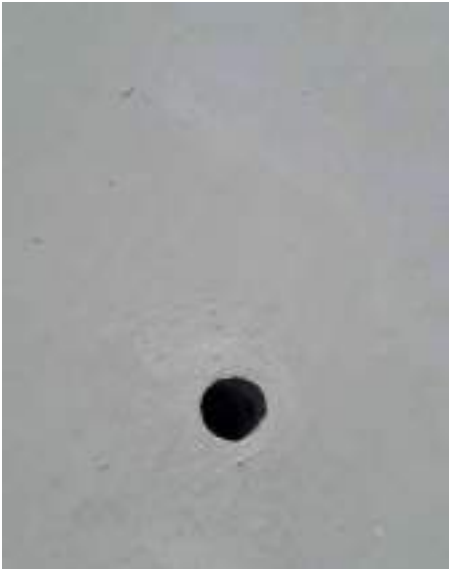
| DEFECT NO. | LOCATION | AREA | BREACH | PHOTOGRAPH | DEFECT DESCRIPTION |
|---|---|---|--|---|---|
| C173 | Building U - Roof | Floor waste (spot 1) | See section 8.11 of this report. | | <p>A. Waterproofing not turned down into floor waste. B. Puddle flange has not been provided. C. Drain cover not installed as required by AS4654.2.</p> <p>HARPER OBSERVATIONS AND COMMENTS – CONCUR B & C OUTSTANDING REFER ITEMS R-1 SECTION 10 HARPER DEFECT SCHEDULE</p> |

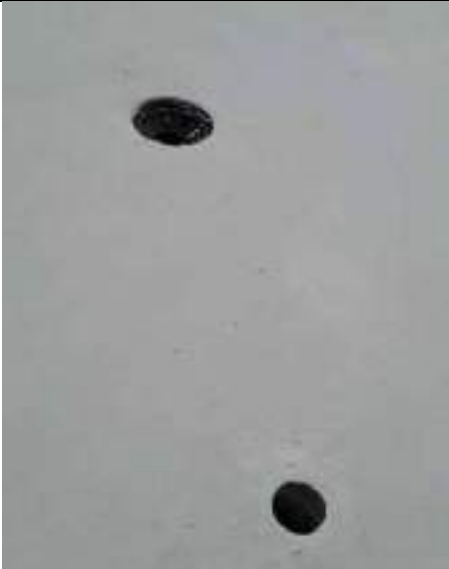
| DEFECT NO. | LOCATION | AREA | BREACH | PHOTOGRAPH | DEFECT DESCRIPTION |
|---|---|---|---|---|---|
| C 174 | Building U - Roof | Floor waste (spot 2) | See section 8.11 of this report. | | A. Waterproofing not turned down into floor waste. B. Puddle flange has not been provided. C. Drain cover not installed as required by AS4654.2. HARPER OBSERVATIONS AND COMMENTS – CONCUR B & C CONCUR OUTSTANDING REFER ITEMS R-1 SECTION 10 HARPER DEFECT SCHEDULE |

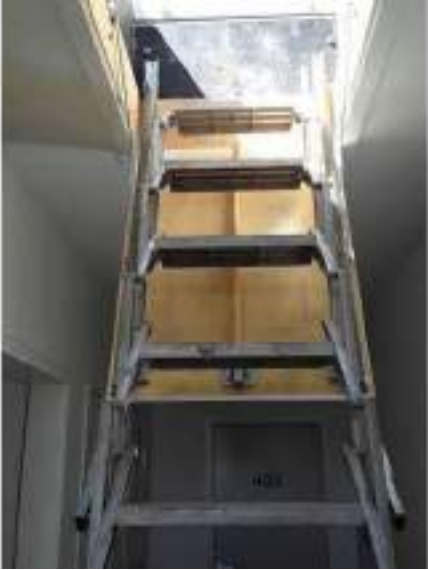
| DEFECT NO. | LOCATION | AREA | BREACH | PHOTOGRAPH | DEFECT DESCRIPTION |
|---|---|---|---|---|---|
| C 175 | Building L - Roof | Entry access ladder | Not fit for purpose . | | Domestic access ladder not to AS1657 . HARPER OBSERVATION AND COMMENTS – RESOLVED CERTIFICATE OF COMPLIANCE PROVIDED. |

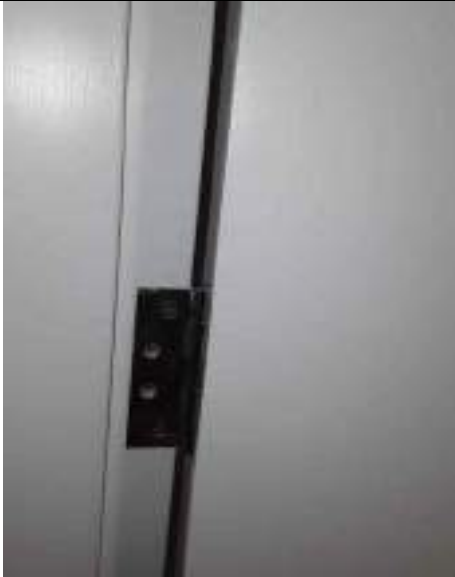
| DEFECT NO. | LOCATION | AREA | BREACH | PHOTOGRAPH | DEFECT DESCRIPTION |
|---|---|---|--|---|--|
| C 179 | Level G lobby | Service riser | Works have not been completed with due care and skill. | | <p>Missing screws to door hinge</p> <p>HARPER OBSERVATION AND COMMENTS – CONCUR OUTSTANDING REFER ITEM 2-GRD SECTION 10 HARPER DEFECT SCHEDULE</p> |

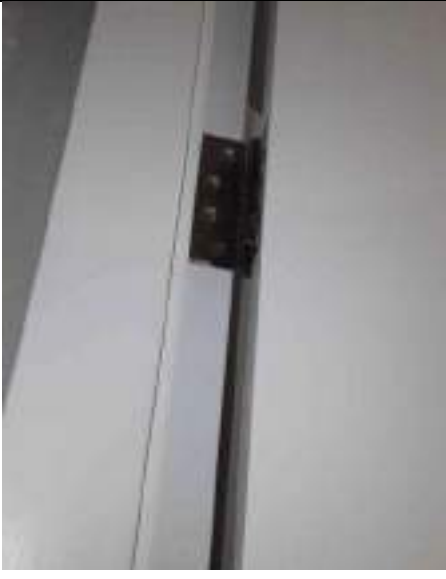
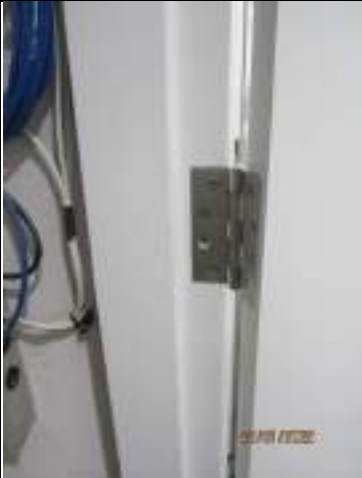
| DEFECT NO. | LOCATION | AREA | BREACH | PHOTOGRAPH | DEFECT DESCRIPTION |
|---|---|---|---|---|--|
| | | | | | <p data-bbox="1610 715 2069 786">HARPER OBSERVATION AND COMMENTS – OUTSTANDING REFER ITEM 2-GRD SECTION 10 HARPER DEFECT SCHEDULE</p> |

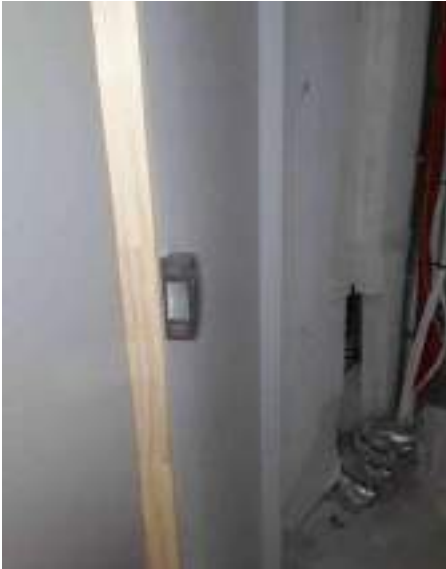
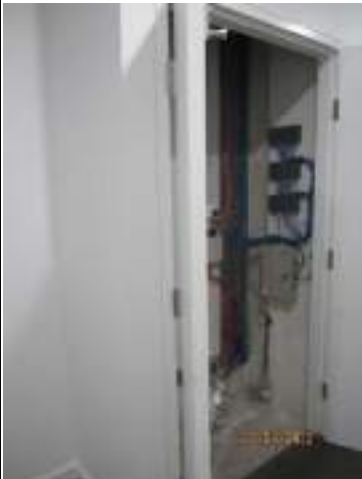
| DEFECT NO. | LOCATION | AREA | BREACH | PHOTOGRAPH | DEFECT DESCRIPTION |
|---|---|---|---|---|--|
| C 180 | Level G lobby | Service riser | Incomplete work . | | <p data-bbox="1610 804 1839 826">Incomplete plasterboard .</p> <p data-bbox="1610 1337 2069 1385">HARPER OBSERVATION AND COMMENTS – RESOLVED</p> |

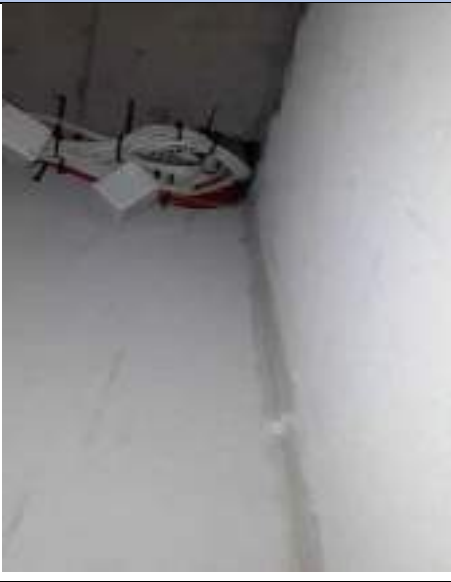
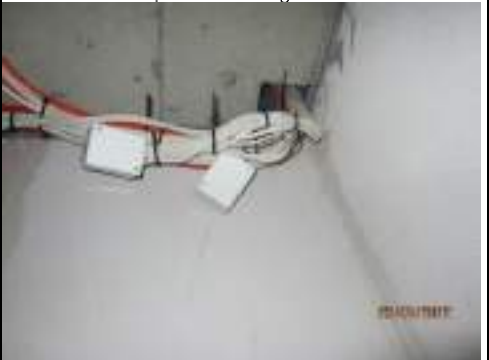
| DEFECT NO. | LOCATION | AREA | BREACH | PHOTOGRAPH | DEFECT DESCRIPTION |
|---|---|---|---|---|--|
| C181 | Level G lobby | Service riser | Fire engineer to inspect. | | <p>Possible non-compliant fire rating.</p> <p>HARPER OBSERVATION AND COMMENTS – RESOLVED</p> <p>FIRE SAFETY COMPLIANCE CERTIFICATE PROVIDED.</p> |

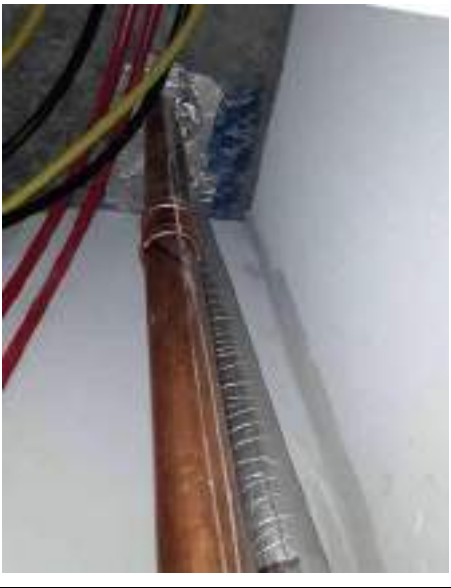
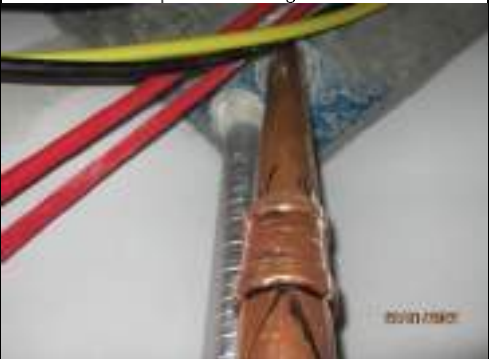
| DEFECT NO. | LOCATION | AREA | BREACH | PHOTOGRAPH | DEFECT DESCRIPTION |
|---|---|---|---|---|--|
| C182 | Level G lobby | Service riser | Fire engineer to inspect | | <p>Possible non-compliant fire rating</p> <p>HARPER OBSERVATION AND COMMENTS – RESOLVED</p> <p>FIRE SAFETY COMPLIANCE CERTIFICATE PROVIDED.</p> |

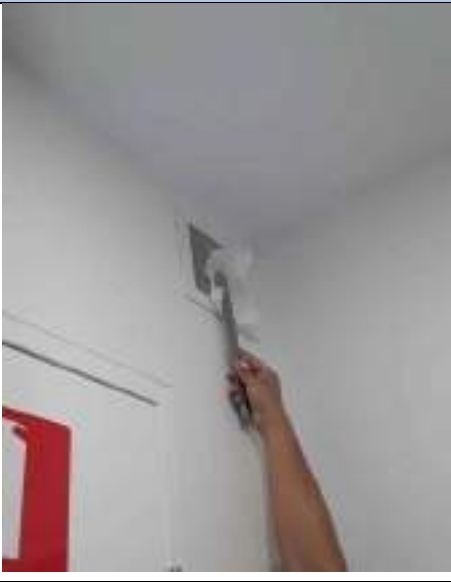
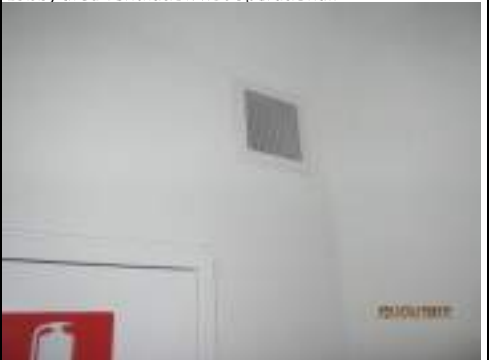
| DEFECT NO. | LOCATION | AREA | BREACH | PHOTOGRAPH | | DEFECT DESCRIPTION |
|---|---|---|---|---|--|---|
| C183 | Level G lobby | Service riser | Fire engineer to inspect. | | | Lobby area ventilation not operational. HARPER OBSERVATION AND COMMENTS – RESOLVED |

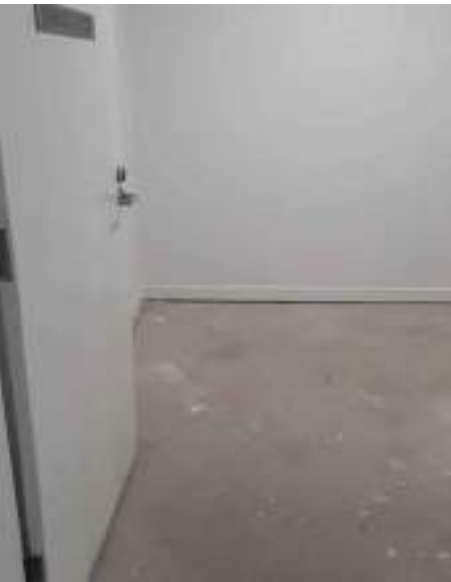
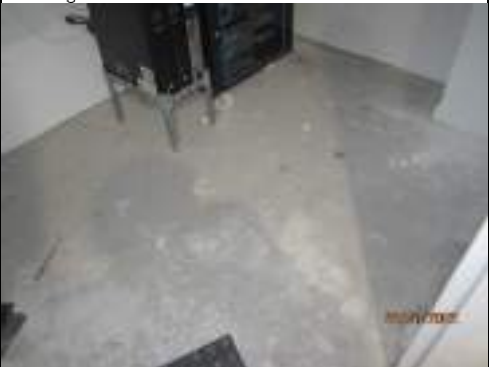
| DEFECT NO. | LOCATION | AREA | BREACH | PHOTOGRAPH | | DEFECT DESCRIPTION |
|---|---|---|---|---|--|---|
| C184 | Level G lobby | Service room | Incomplete work | | | Missing floor finish. HARPER OBSERVATION AND COMMENTS – NOT SPECIFIED ON CONTRACT |

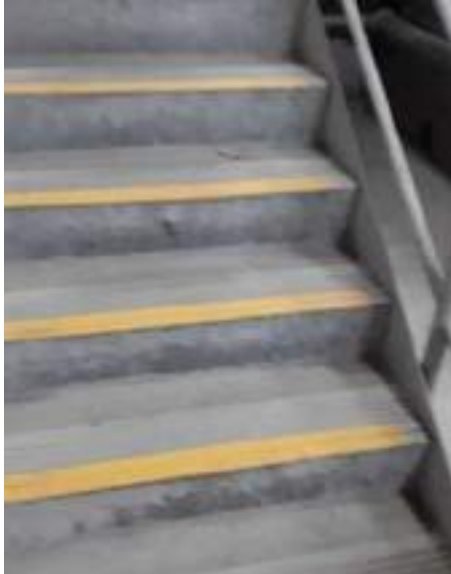
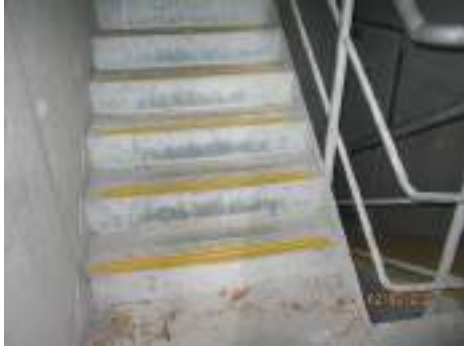
| DEFECT NO. | LOCATION | AREA | BREACH | PHOTOGRAPH | DEFECT DESCRIPTION |
|---|---|---|---|---|---|
| C 185 | Fire stair south of lift | Stair case nosing | See section 8.15 of this report. | | <p>No nosing or compliant non-slip finish.</p> <p>Details of paint to be provided to identify if non-compliant and tested to AS4586.</p> <p>HARPER OBSERVATION AND COMMENTS – REFER TO ITEM FS-1 SECTION 10 HARPER DEFECT SCHEDULE</p> |

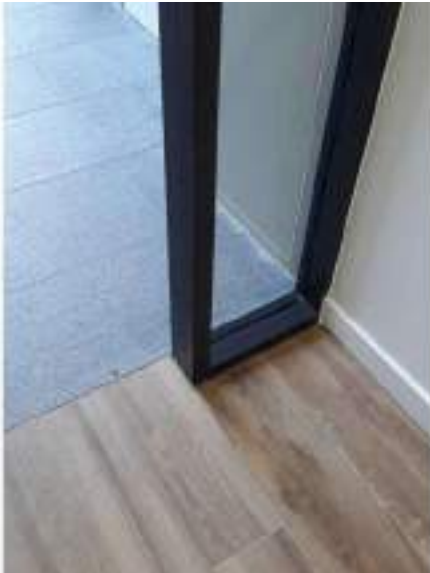
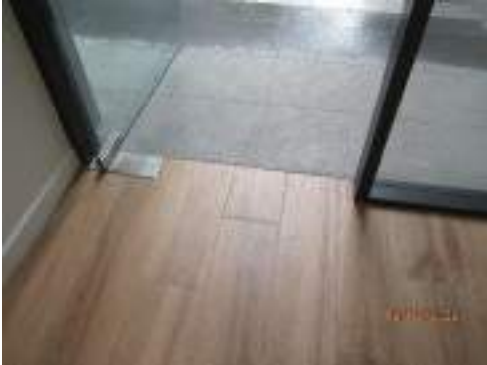
| DEFECT NO. | LOCATION | AREA | BREACH | PHOTOGRAPH | DEFECT DESCRIPTION |
|---|---|---|---|---|---|
| C 186 | Upper ground level | Entry door threshold | See section 8.3 of this report. | | <p>No compliant threshold detail.</p> <p>HARPER OBSERVATION AND COMMENTS – REFER TO ITEM C-1 SECTION 10 HARPER DEFECT SCHEDULE</p> |

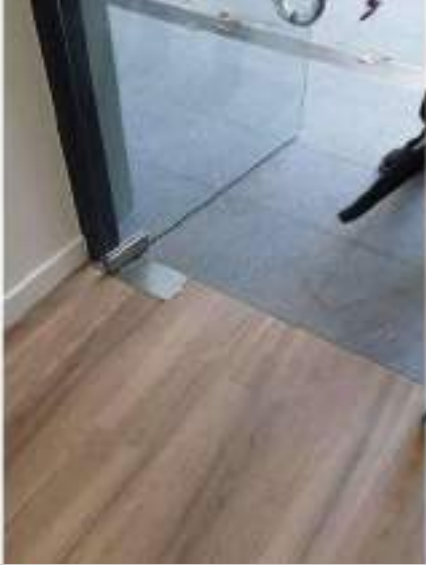
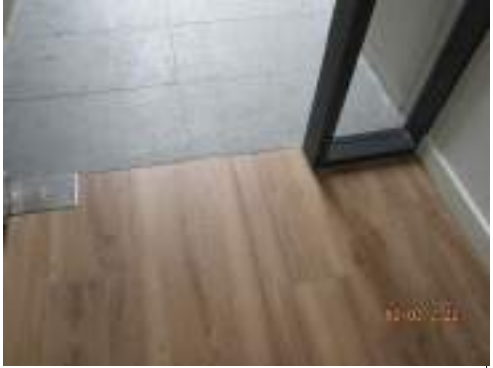
| DEFECT NO. | LOCATION | AREA | BREACH | PHOTOGRAPH | DEFECT DESCRIPTION |
|---|---|---|---|---|---|
| C 187 | Upper ground level | Entry door threshold | See section 8.3 of this report. | | No compliant threshold detail. |
| | | | | | <p style="color: red; text-align: center;">HARPER OBSERVATION AND COMMENTS – REFER TO ITEM C-1 SECTION 10 HARPER DEFECT SCHEDULE</p> |

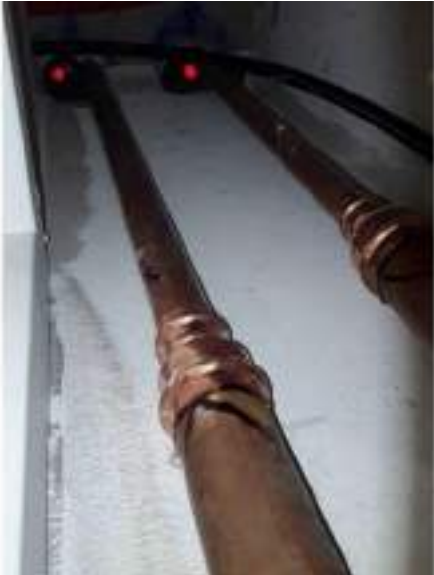
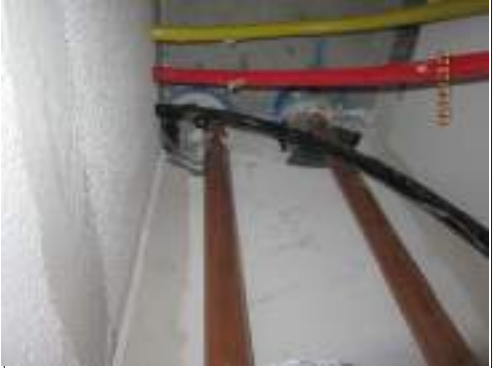
| DEFECT NO. | LOCATION | AREA | BREACH | PHOTOGRAPH | DEFECT DESCRIPTION |
|---|---|---|---|---|---|
| C 188 | Upper ground level | Service riser | Fire engineer to inspect. | | Missing fire rating to hydraulic pipe work. |
| | | | | | <p style="text-align: center;">HARPER OBSERVATION AND COMMENTS –RESOLVED</p> |

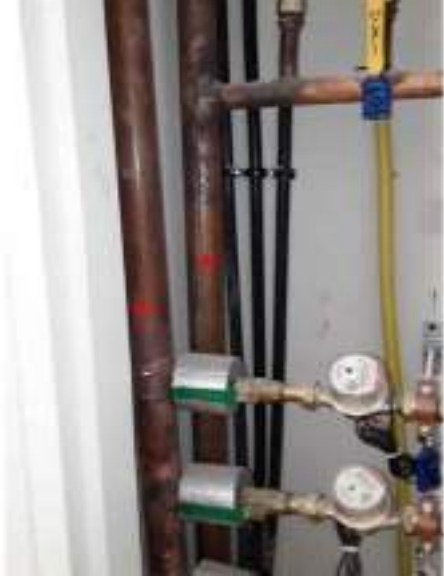
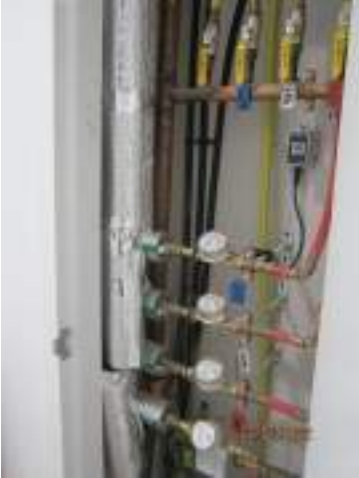
| DEFECT NO. | LOCATION | AREA | BREACH | PHOTOGRAPH | DEFECT DESCRIPTION |
|---|---|---|---|---|---|
| C 189 | Upper ground level | Service riser | Hydraulic engineer to inspect. | | <p>No insulation to hot pipes.</p> <p>HARPER OBSERVATION AND COMMENTS – RESOLVED</p> |

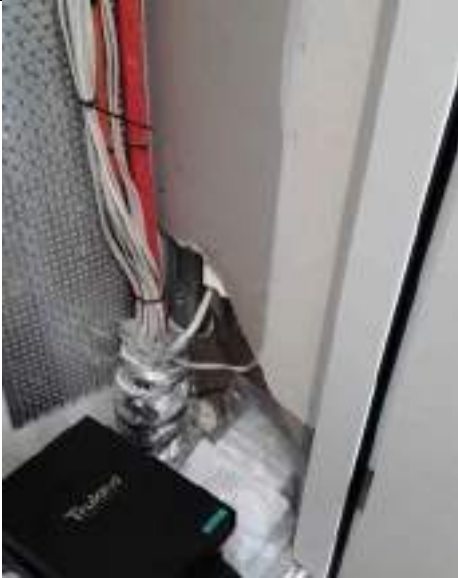
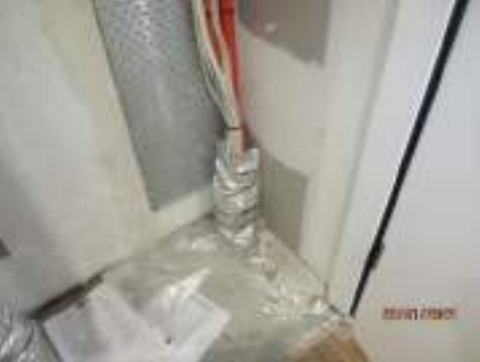
| DEFECT NO. | LOCATION | AREA | BREACH | PHOTOGRAPH | DEFECT DESCRIPTION |
|---|---|---|---|---|---|
| C 190 | Upper ground level | Service riser | Fire engineer to inspect | | <p>Incomplete plasterboard.</p> <p>HARPER OBSERVATION AND COMMENTS – RESOLVED</p> |

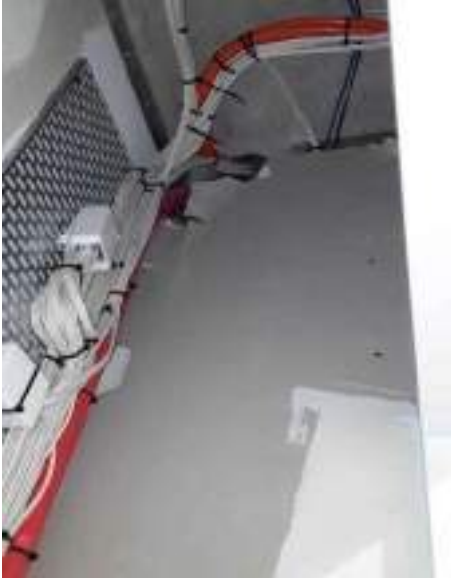
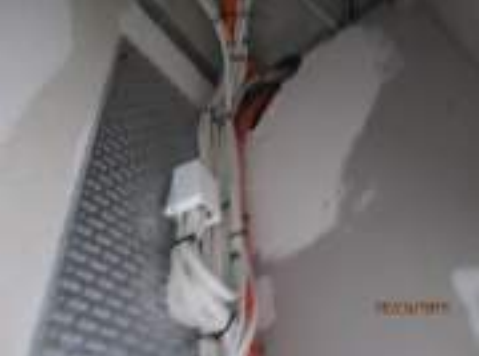
| DEFECT NO. | LOCATION | AREA | BREACH | PHOTOGRAPH | | DEFECT DESCRIPTION |
|---|---|---|---|---|--|---|
| C 191 | Upper ground level | Service riser | Hydraulic engineer to inspect. | | | Services penetrations in service riser. HARPER OBSERVATION AND COMMENTS – RESOLVED |

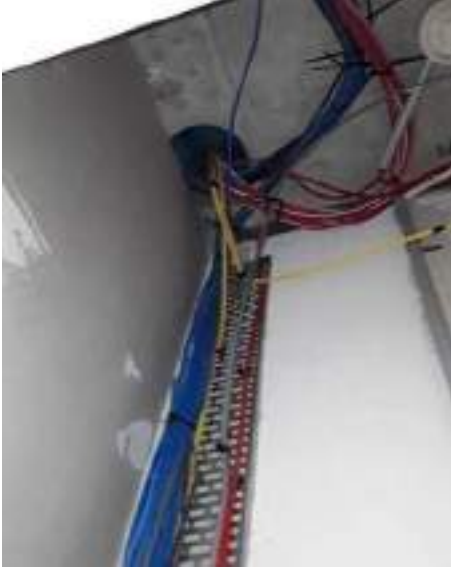
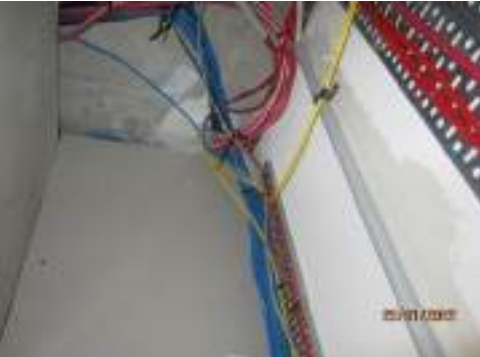
| DEFECT NO. | LOCATION | AREA | BREACH | PHOTOGRAPH | | DEFECT DESCRIPTION |
|---|---|---|---|---|--|---|
| C 192 | Upper ground level | Service riser | Fire engineer to inspect | | | Services penetrations in service riser , HARPER OBSERVATION AND COMMENTS – RESOLVED |
