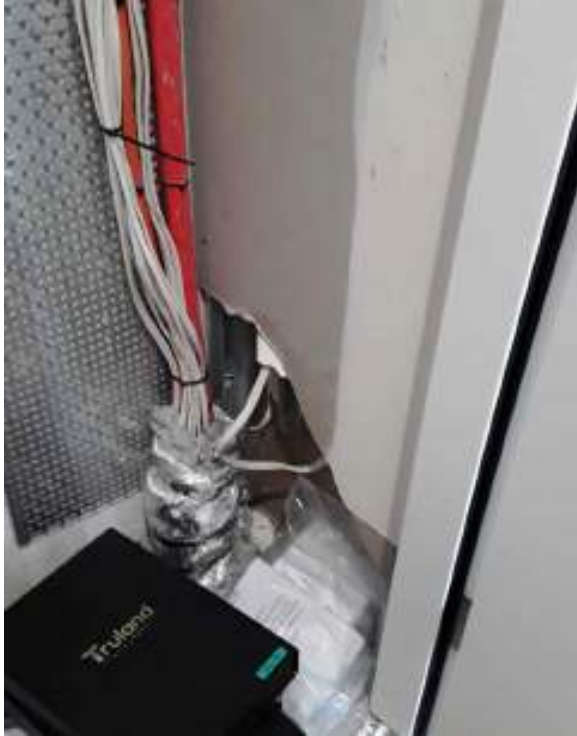
C 190 – Upper ground level, service riser

Incomplete plasterboard.

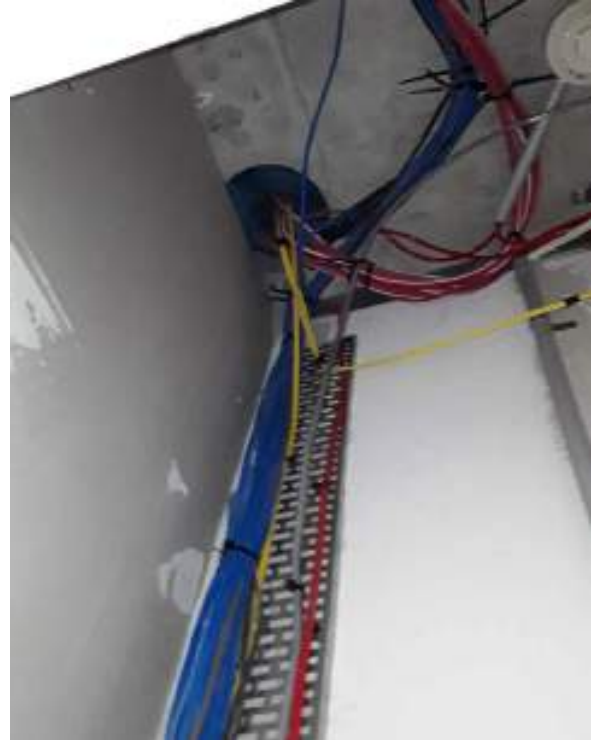
C 192 – Upper ground level, service riser

Services penetrations in service riser.

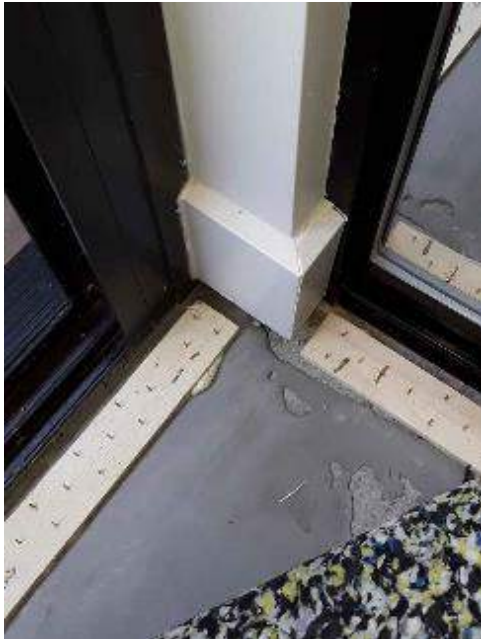
U 304.11 – Unit 304, bedroom 2 door threshold

No waterstop.

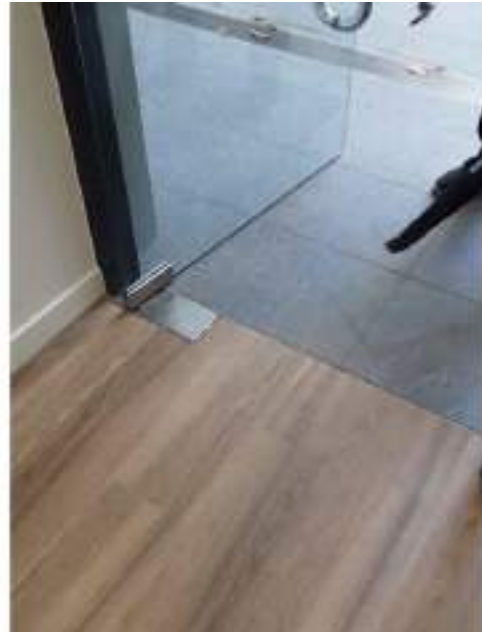
C 187 – Upper ground level, entry door threshold

No compliant threshold detail.

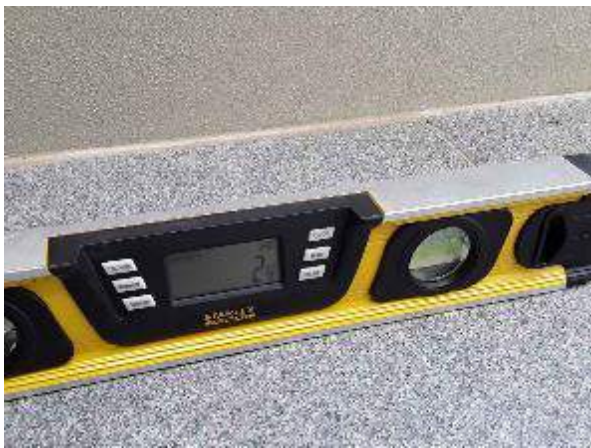
C 3 – G.floor north entry, floor tiles

Insufficient falls of 2mm per metre.

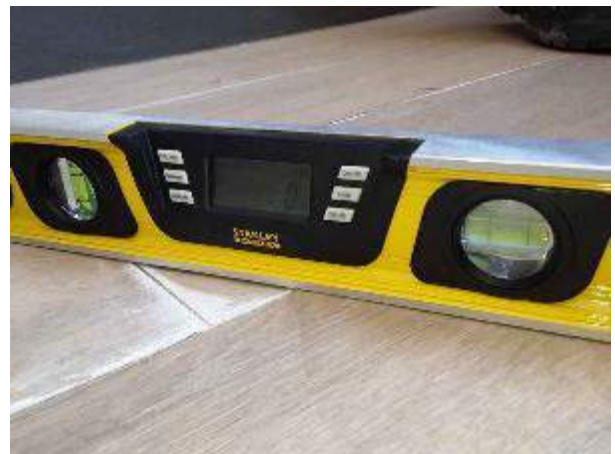
U 306.16 – Main bedroom balcony, floor tiles

No falls provided to the external tiled balcony.

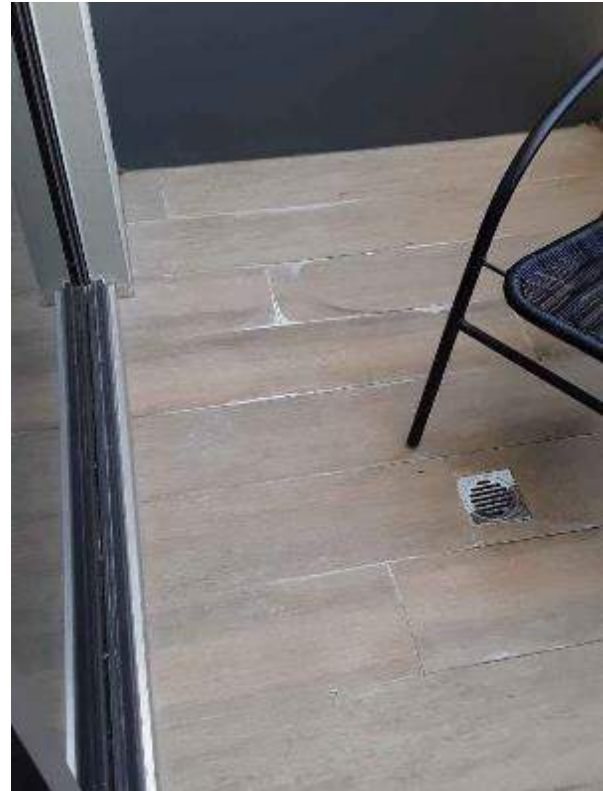
U 306.12 – Unit 306 Main bed balcony, floor tiles

Efflorescence a result of water ponding.

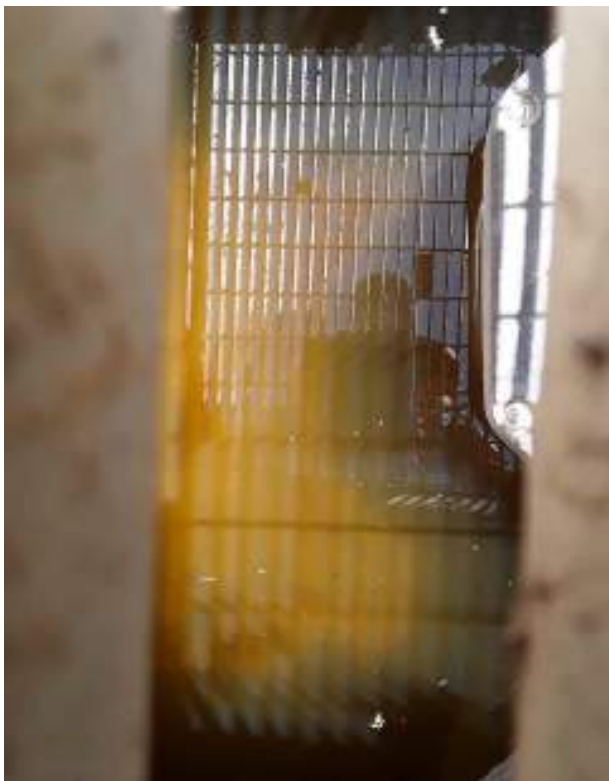
C 218 – driveway, stormwater pit

Water ponding in the base of driveway pit.

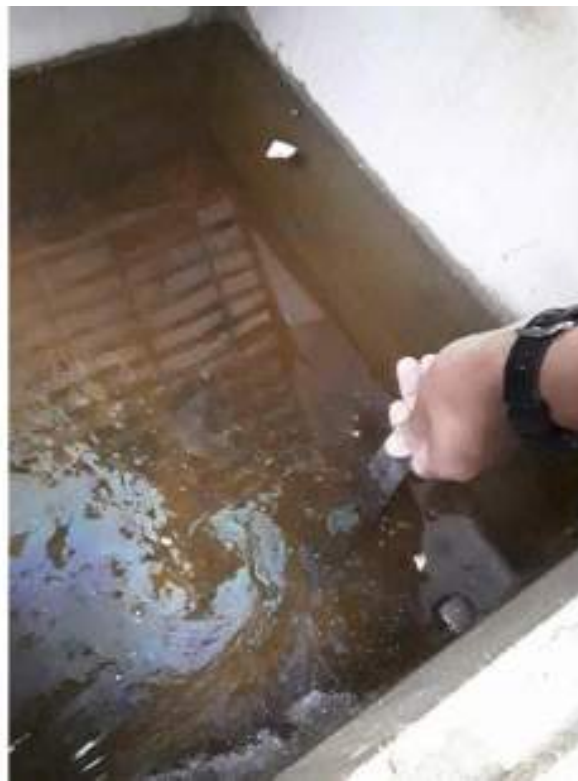
C 87– basement, hydrant room

280mm water ponding in the pit.

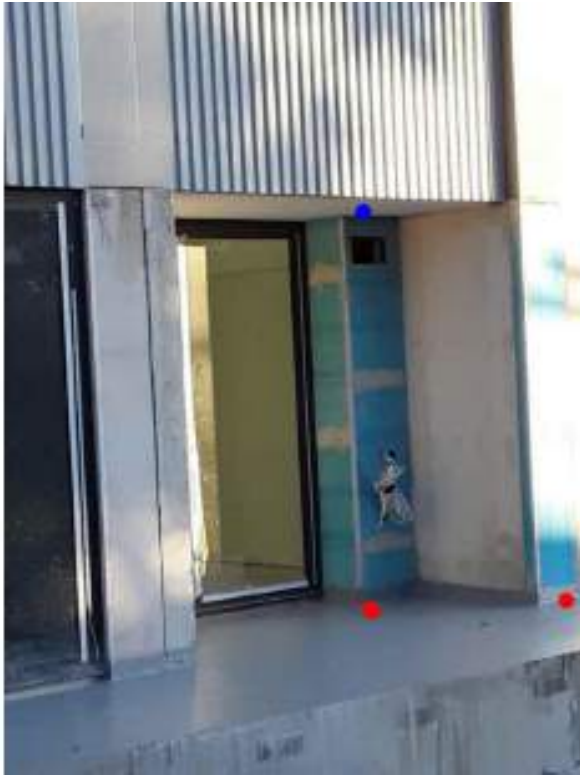
C 13 – East facade, unit balcony

Waterproofing turned up base of FC sheets.

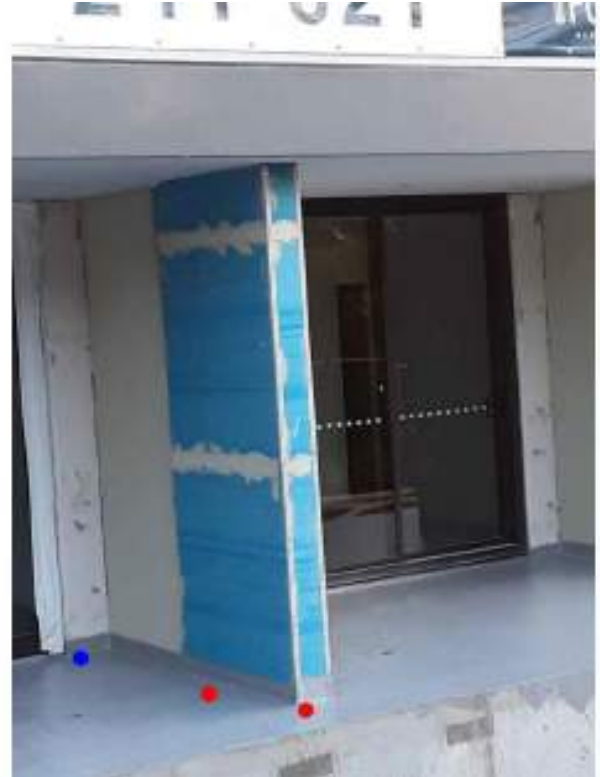
C 10 – East facade, unit balcony

Waterproofing turned up base of FC sheets.

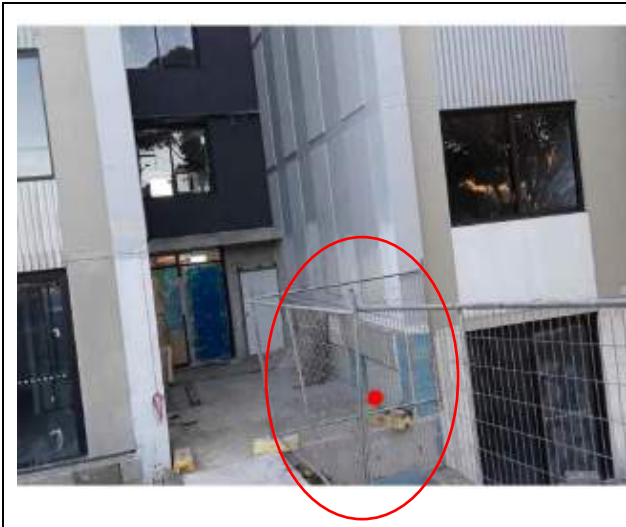
C 47 – South facade (Mitchell Avenue), Hebel cladding

FC installed below water level.

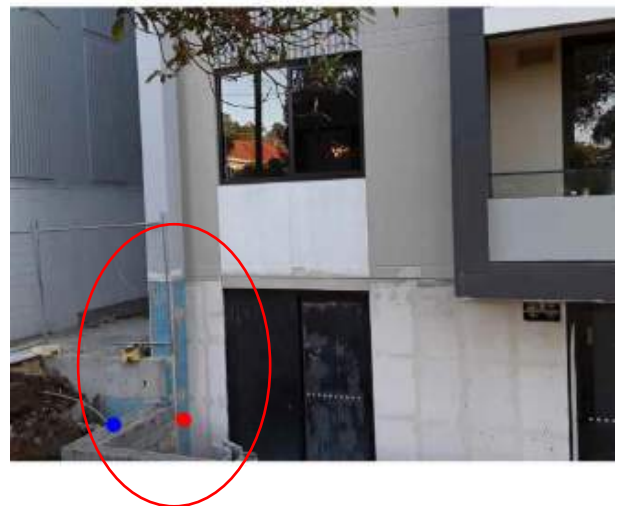
C 44 – South facade (Mitchell Avenue), Hebel cladding

FC installed below ground level.

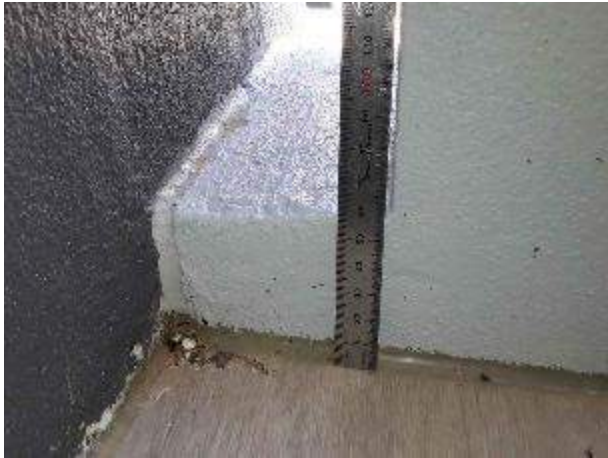
U 306.20 – Unit 306 main bed balcony, overflow

Overflow is higher than the balcony setdown.

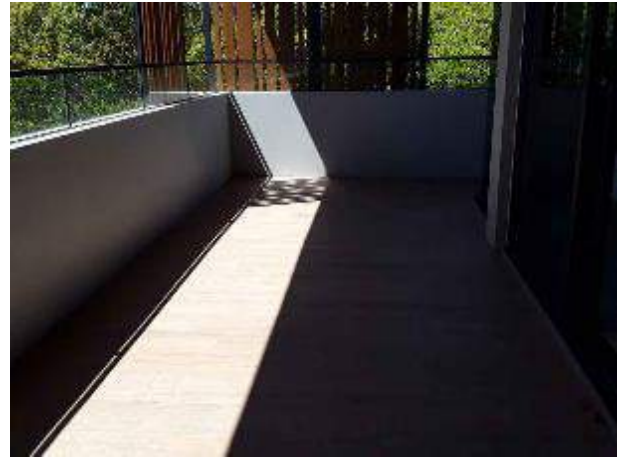
U 304.16 – Unit 30 main balcony, overflow

No overflow provision.

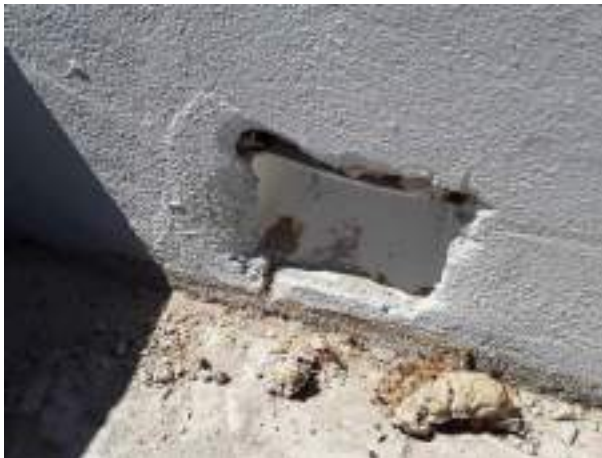
C 156 – Building L, roof overflow

Waterproofing has not been turned into overflow.

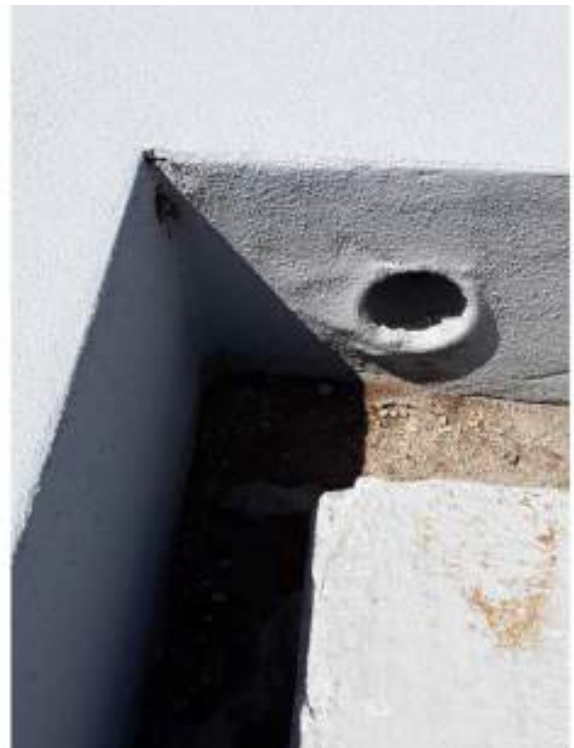
C 161 – Building U, roof overflow

Waterproofing has not been turned into overflow.

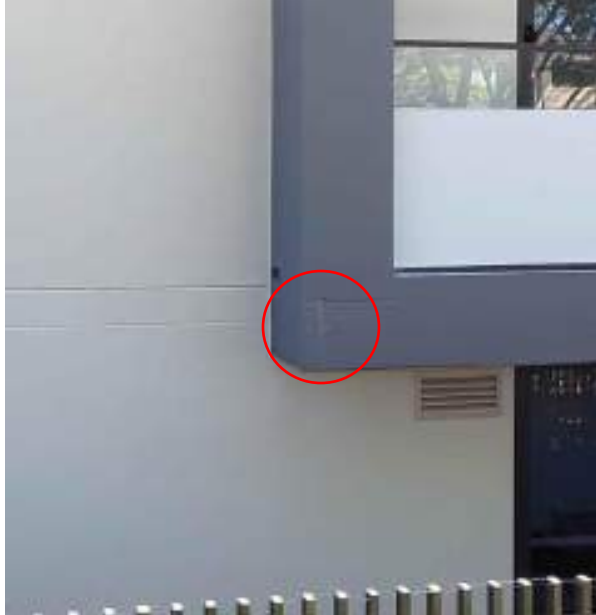
C 50 – South facade (Mitchell Avenue),
balcony edge slab

Efflorescence.

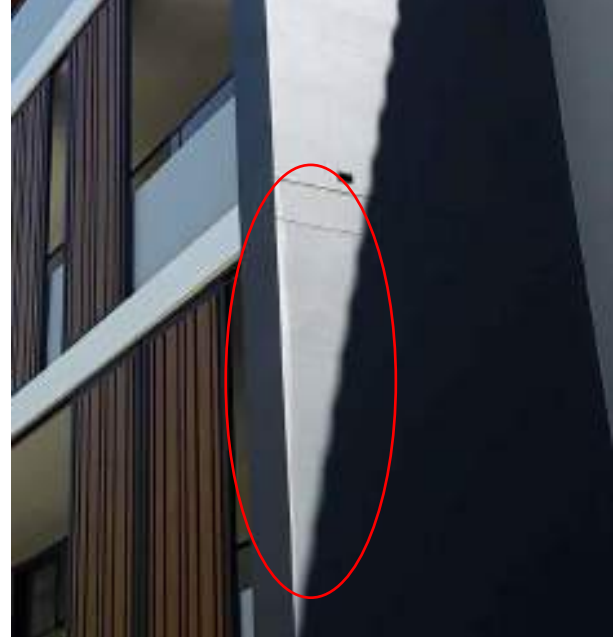
C 50 – South facade (Mitchell Avenue),
cladding

Efflorescence.

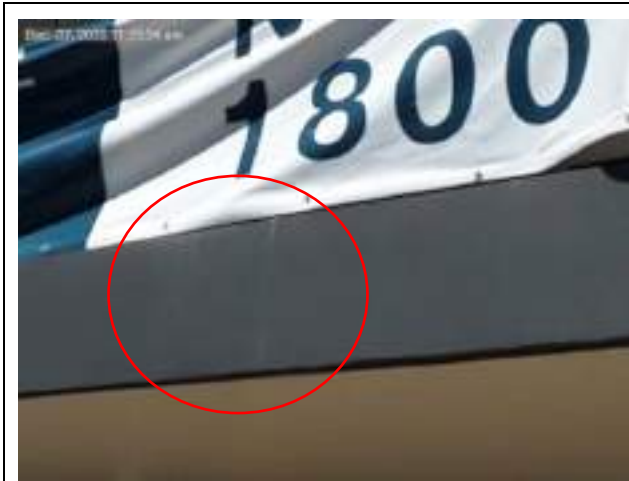
C 27 – East facade, balcony slab edge

Efflorescence.

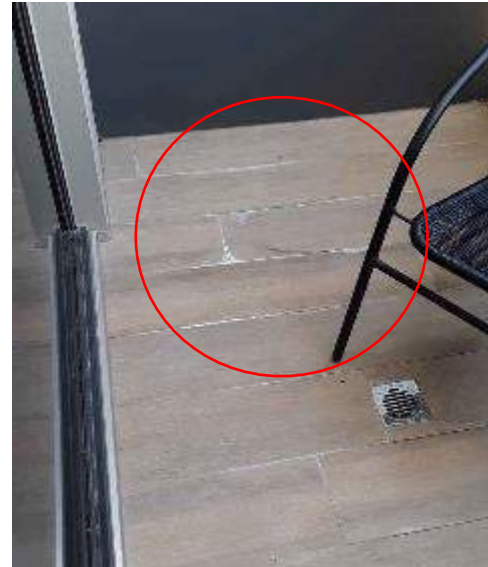
C 306.12 – Unit 306 main bedroom balcony, floor tiles

Efflorescence.

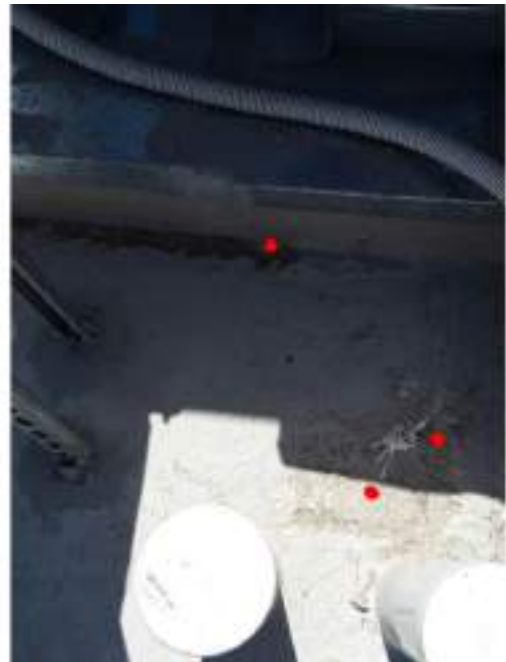
C 164 - Building U roof, concrete hob

Waterproofing not turned down into floor waste	Rough substrate not suitable for waterproofing.
  <p><u>C 166 - Building U roof, pipe penetration</u></p> <p>Waterproofing has not been turned up services pipe as required by AS4654.2.</p>	  <p><u>C 152 – Building L roof, concrete hob</u></p> <p>Rough substrate not suitable for waterproofing.</p>

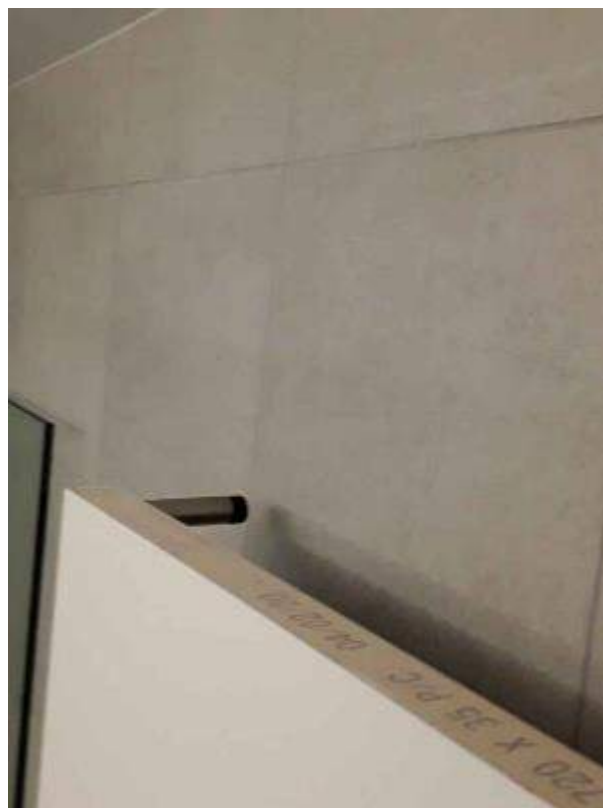
U 304.6 – Unit 304, bathroom top of the door

Top of the door has not been sealed.	Top of the door has not been sealed.
--------------------------------------	--------------------------------------

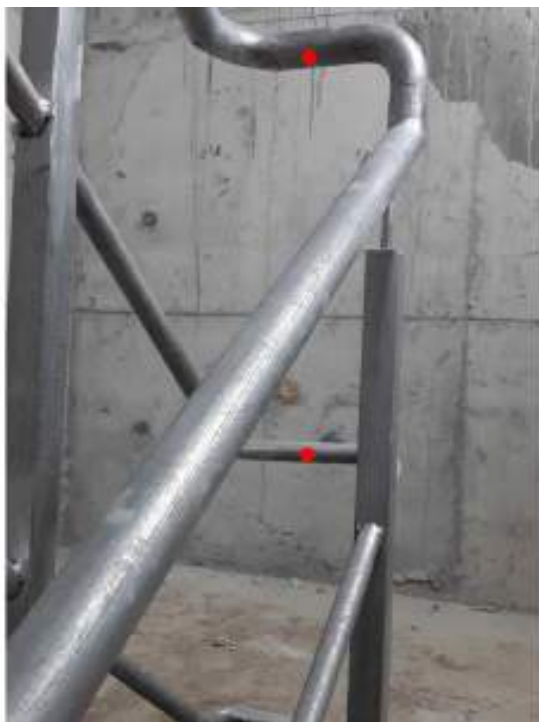
C 79 – Basement 1, north-east fire stair

Handrail not continuous.

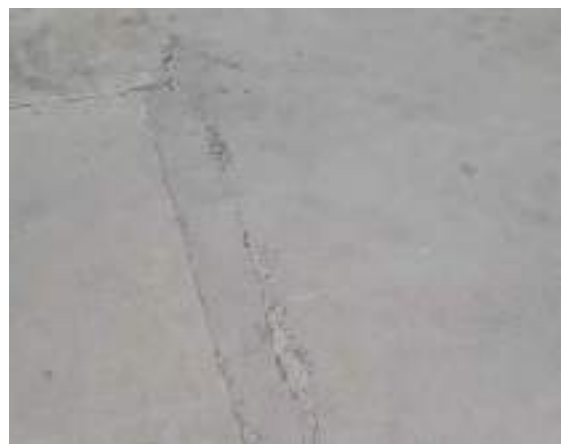
C 238 - Driveway, concrete slab

Cold joint or crack to the concrete driveway.

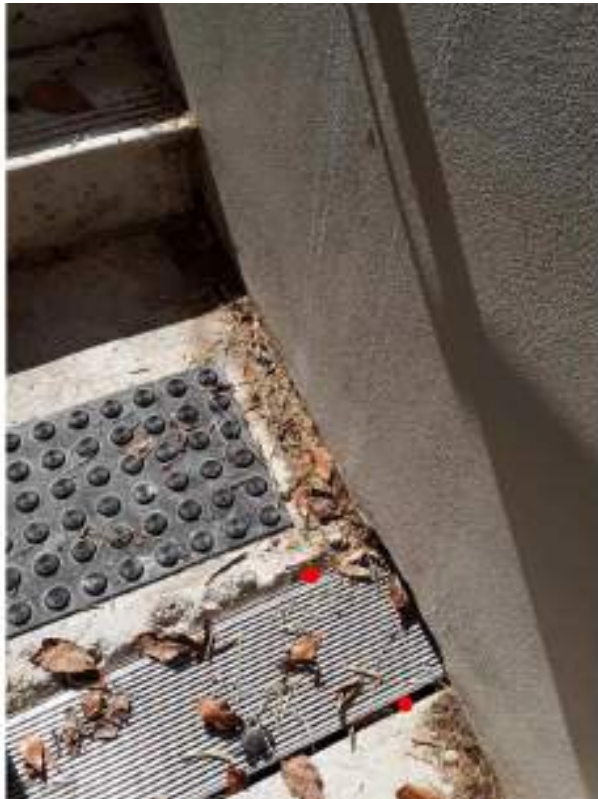
C 71 – Basement 1, north-east fire stairs to ground level

Gap to the side of the grated drain.

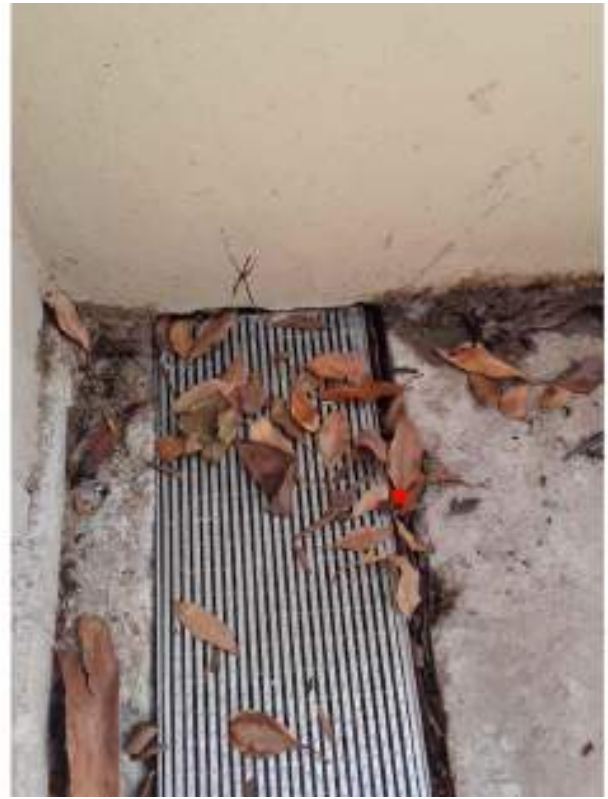
C 53 – Basement 1, south-east fire stairs to ground level

Gap to the side of the grated drain.
