Mitchell Ave Developments P/L vs Fore Sydney Constructions P/L  
Report issued: 25 February 2022  
Both Tramex and Protometre moisture meters are used to attain comparative Moisture readings

## **10.6 Attachment F - Defects Schedule**

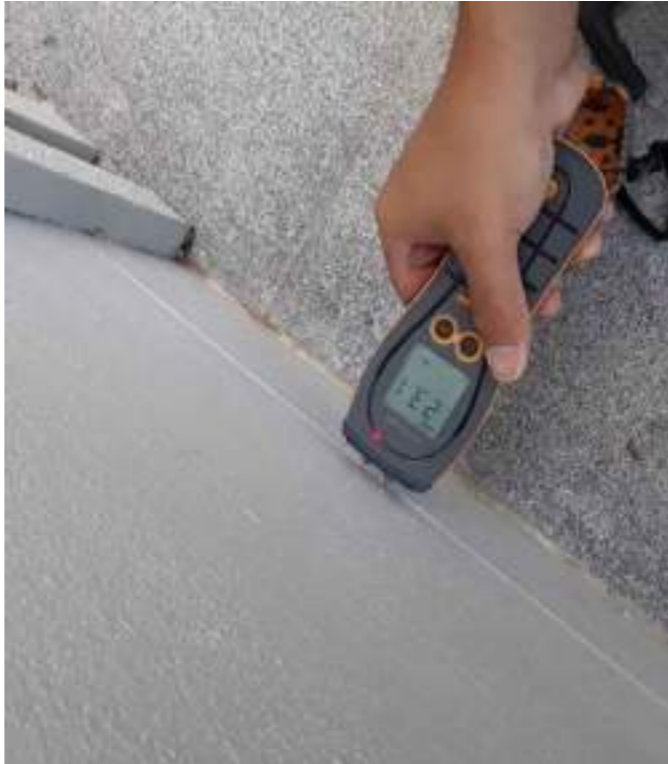
Some weepholes have been installed to the Hebel facade.
C 6	Ground floor south entry	Hebel cladding	See section 8.7 of this report.

Elevated moisture to wall outside of G05.  No drainage to facade.  Concrete hob not installed as per plans.

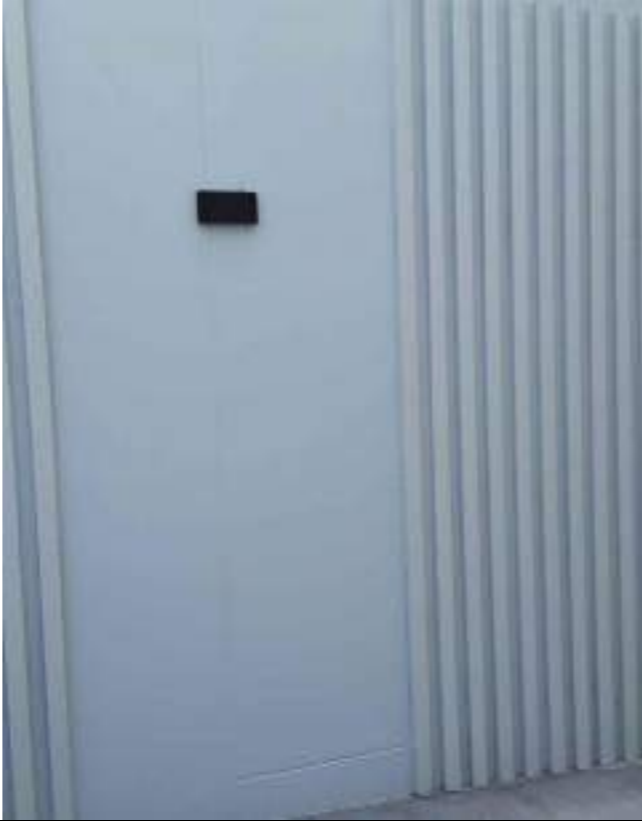
DEFECT NO.	LOCATION	AREA	BREACH	PHOTOGRAPH	DEFECT DESCRIPTION
C 7	Ground floor south entry	Hebel cladding	See section 8.26 of this report.

No pressure equalisation slots have been installed.
<b>Common area (toilet)</b>					
C 8	Common area	Toilet ceiling	See section 8.14 of this report.

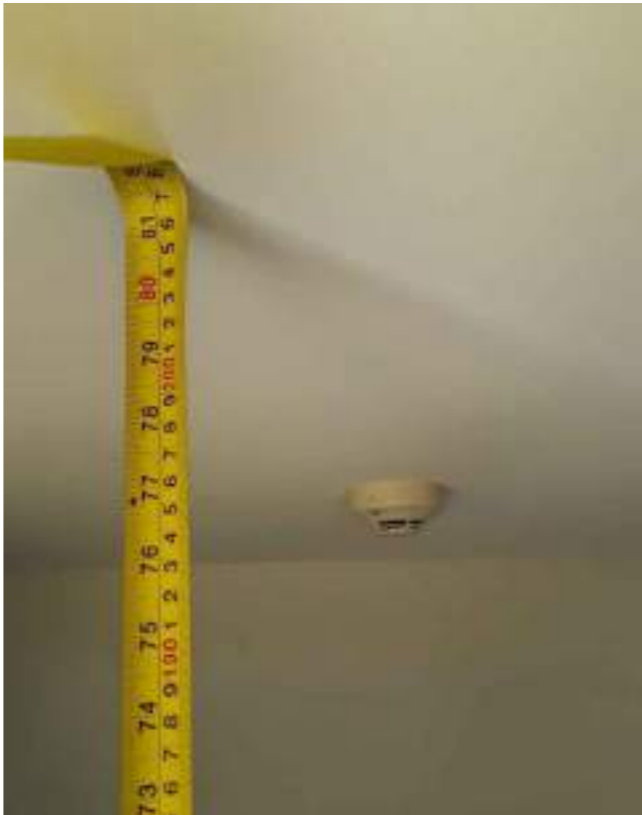
Ceiling height is 2080mm.

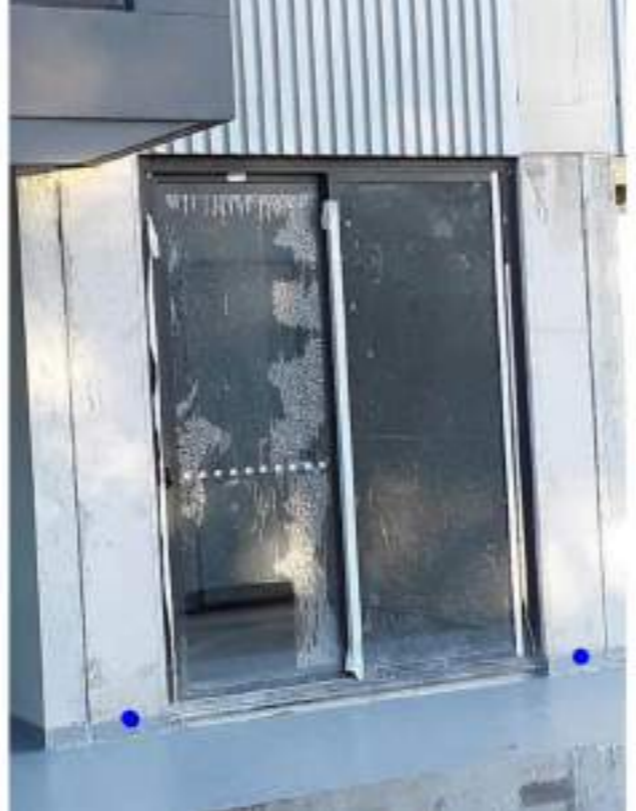
Red - waterproofing turned up base of FC sheets. Blue - Hebel with no cavity drains.
C 11	East facade	Hebel cladding	See sections 8.5 and 8.6 of this report.

No drainage to Hebel. Waterproofing has been turned up base of Hebel.

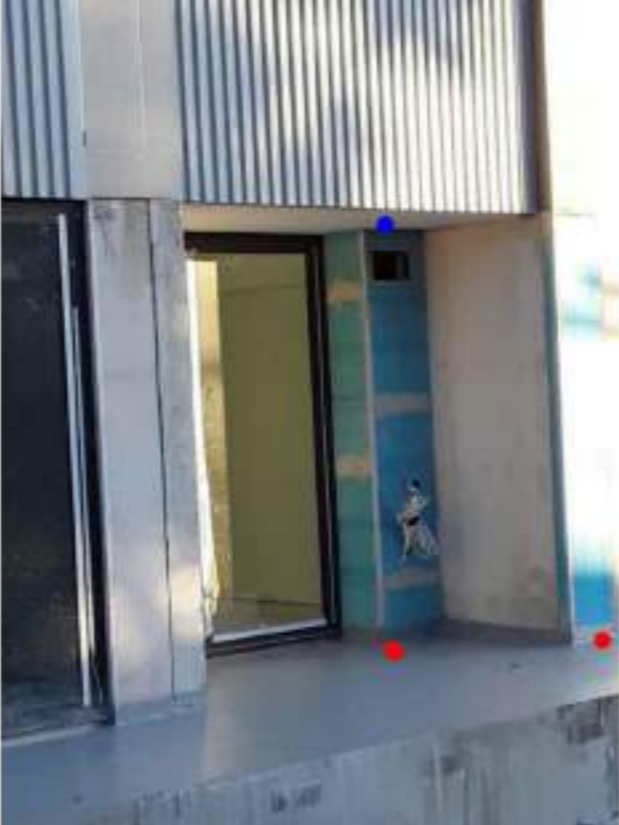
DEFECT NO.	LOCATION	AREA	BREACH	PHOTOGRAPH	DEFECT DESCRIPTION
C 12	East facade	Unit balcony	See sections 8.6 of this report.

Red - waterproofing turned up base of FC sheets. Blue - No drip groove to soffit.
C 13	East facade	Hebel cladding	See section 8.26 of this report.

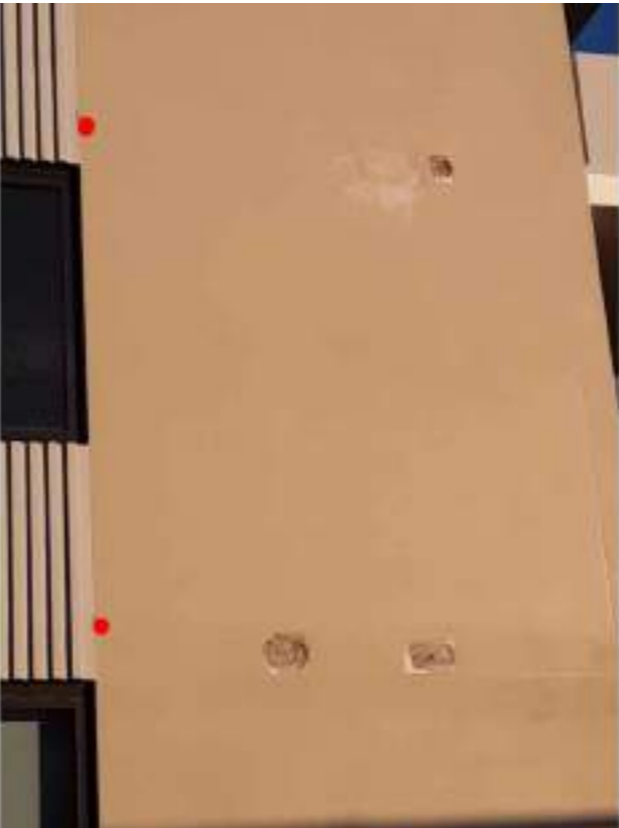
No pressure equalisation slots to wall. One weephole only visible.

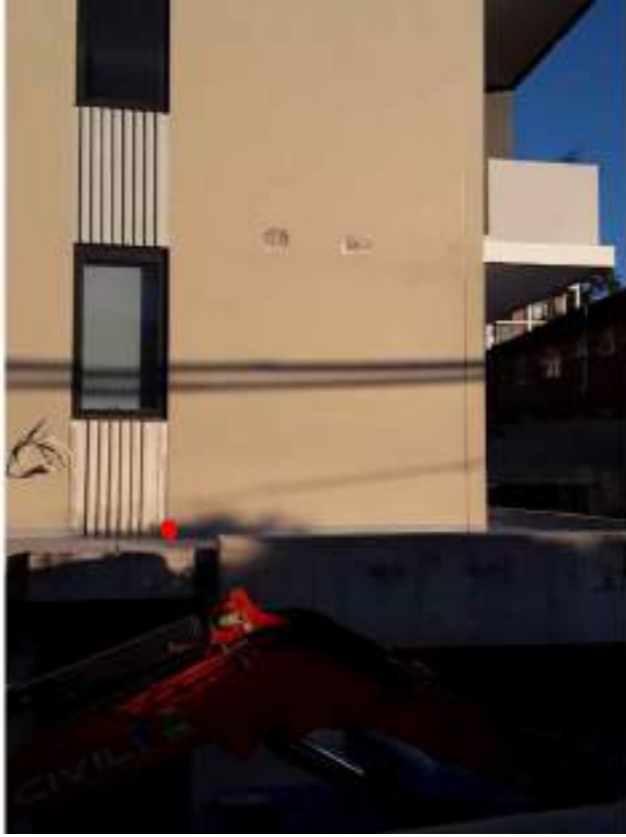
DEFECT NO.	LOCATION	AREA	BREACH	PHOTOGRAPH	DEFECT DESCRIPTION
C 16	East facade	Hebel cladding	See section 8.6 and 8.26 of this report.

Weephole has been waterproofed over, no drainage for Hebel.
C 17	East facade	Hebel cladding	See section 8.26 of this report.

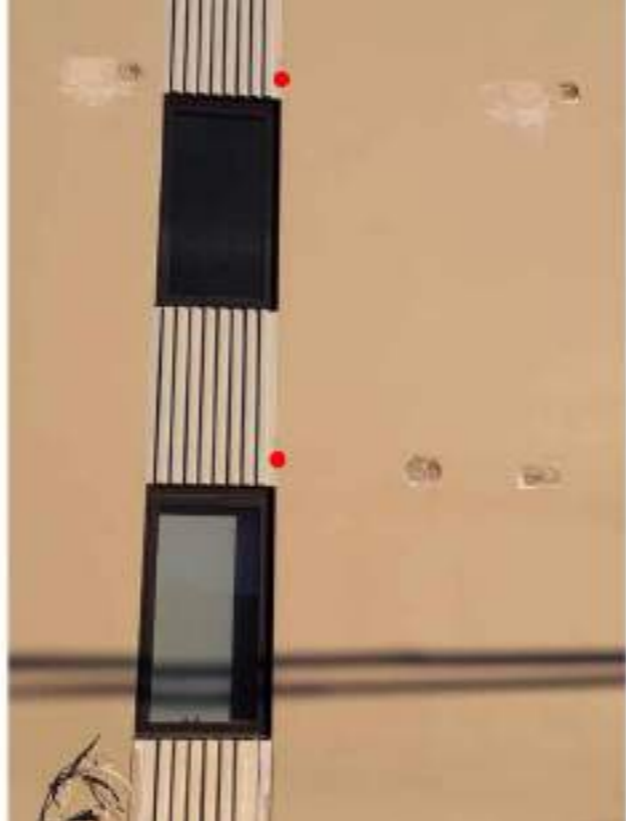
Insufficient Hebel drainage.

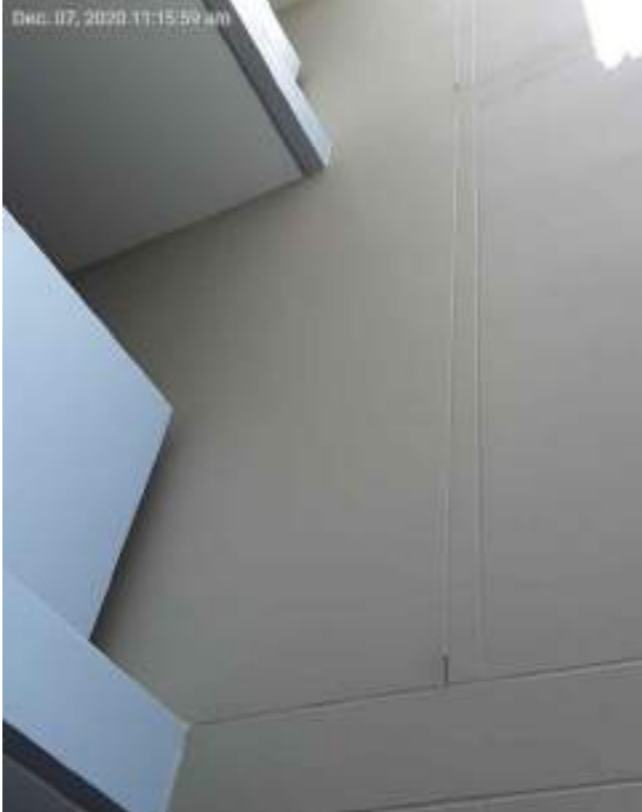
The single drainage provision has been waterproofed over.
C 19	East facade	Hebel cladding	Note

Some drainage provisions were identified at the Property.

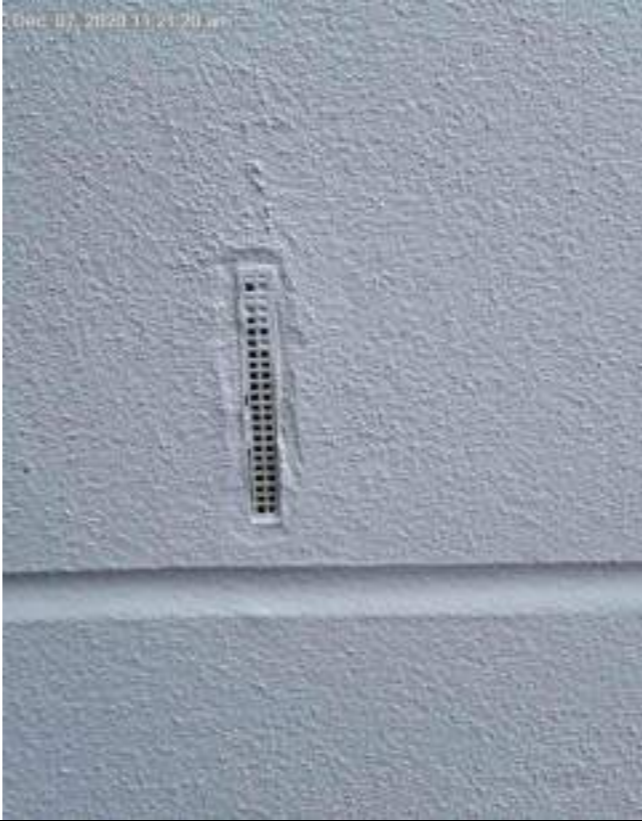
DEFECT NO.	LOCATION	AREA	BREACH	PHOTOGRAPH	DEFECT DESCRIPTION
C 21	East facade	Hebel cladding	Works have not been completed with due care and skill.

Weepholes have been partly covered.
C 22	East facade	Hebel cladding	See section 8.26 of this report.

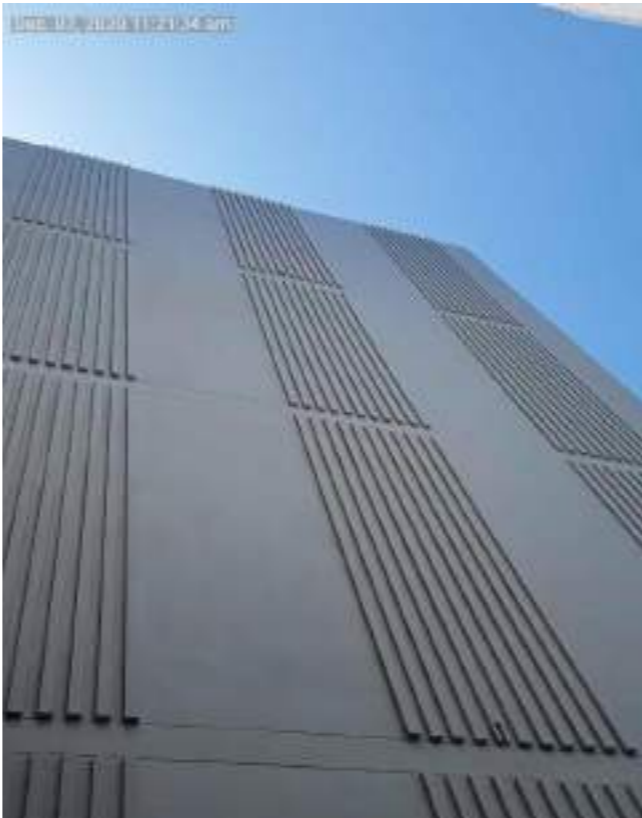
Drainage provisions are partly covered throughout the facade.

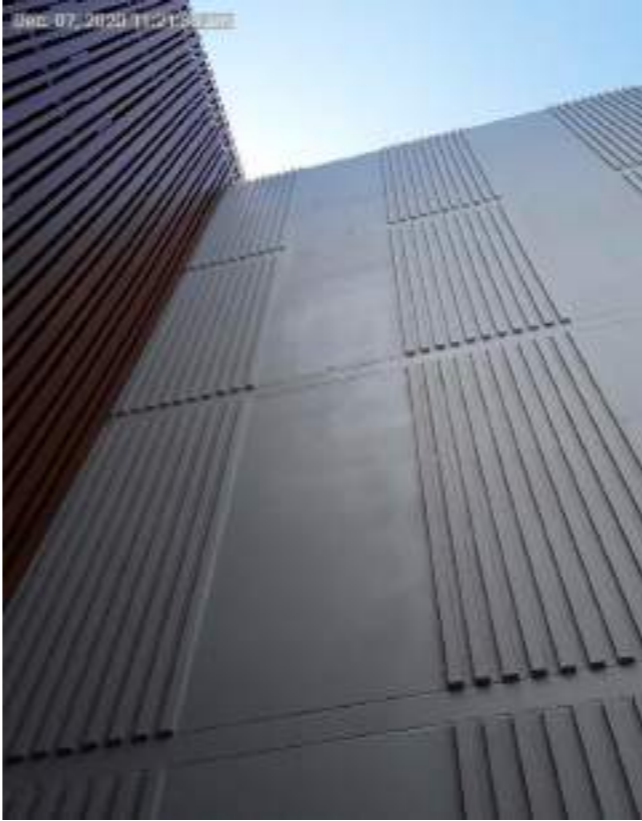
DEFECT NO.	LOCATION	AREA	BREACH	PHOTOGRAPH	DEFECT DESCRIPTION
C 23	East facade	Hebel cladding	See section 8.26 of this report.

Drainage provisions are partly covered throughout the facade.
C 24	East facade	Hebel cladding	See section 8.26 of this report.

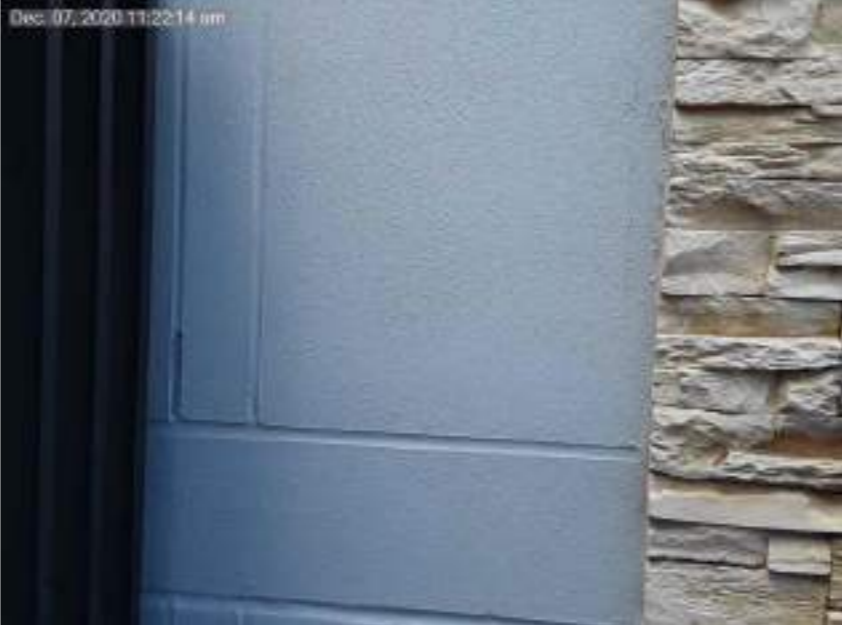
Drainage provisions are partly covered throughout the facade.

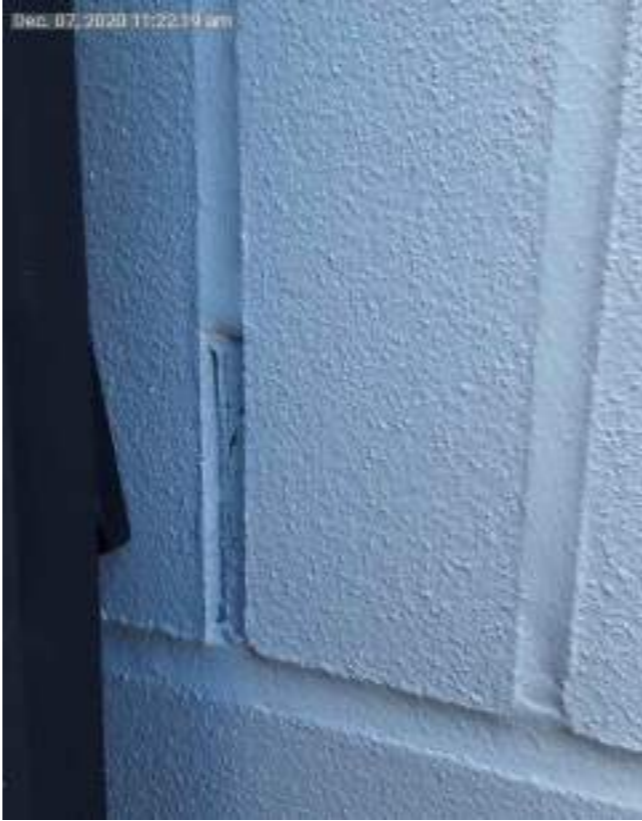
DEFECT NO.	LOCATION	AREA	BREACH	PHOTOGRAPH	DEFECT DESCRIPTION
C 25	East facade	Hebel cladding	See section 8.26 of this report.

Drainage provisions are partly covered throughout the facade.
C 26	East facade	Privacy screen	Works have not been completed with due care and skill.

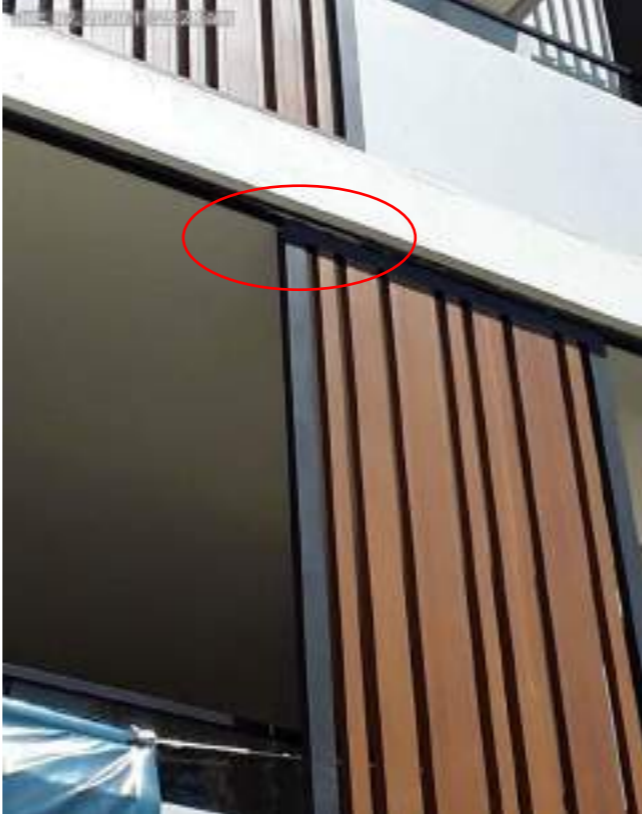
Render to aluminium track.

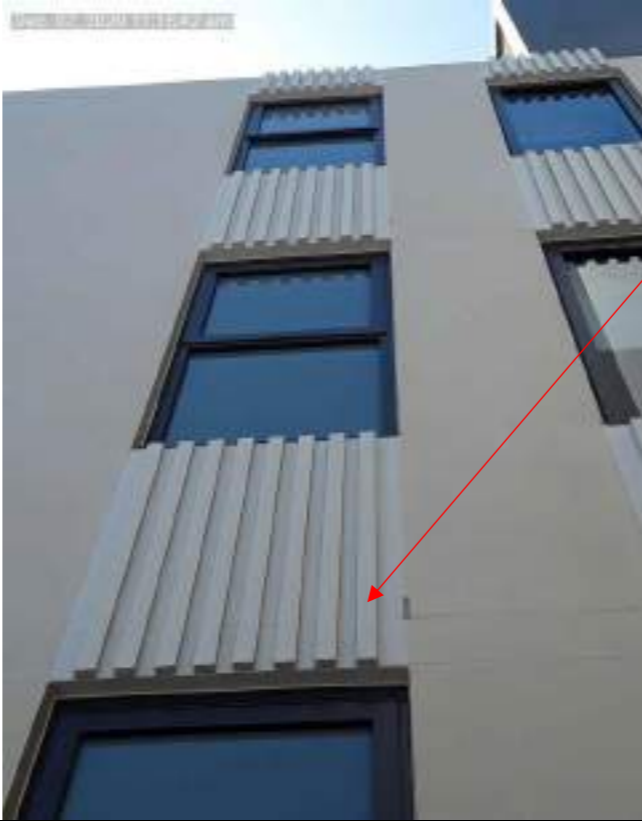
DEFECT NO.	LOCATION	AREA	BREACH	PHOTOGRAPH	DEFECT DESCRIPTION
C 35	West facade	Hebel cladding	Note.

Hebel drainage provision.
C 36	West facade	Hebel cladding	See section 8.26 of this report.

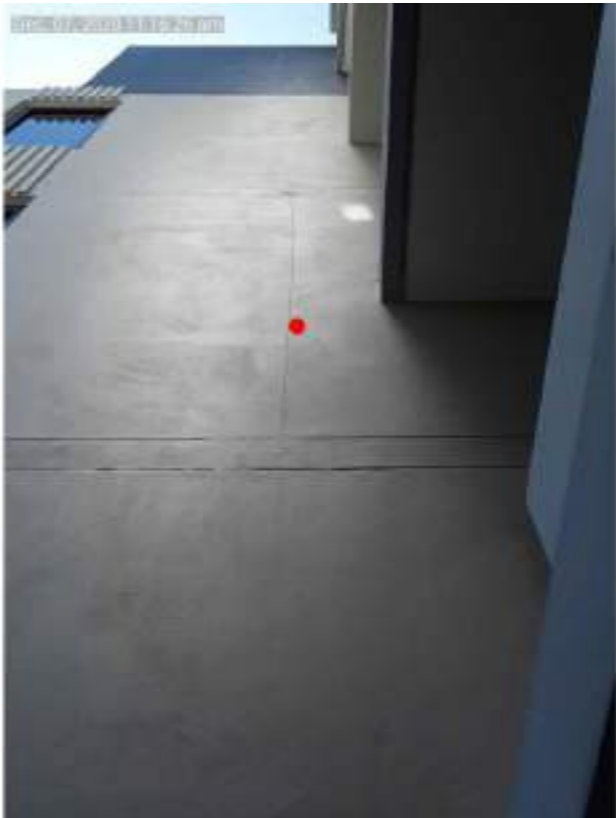
Drip from facade, as moisture has built up inside Hebel and escaping from control joint to Hebel and concrete junction.

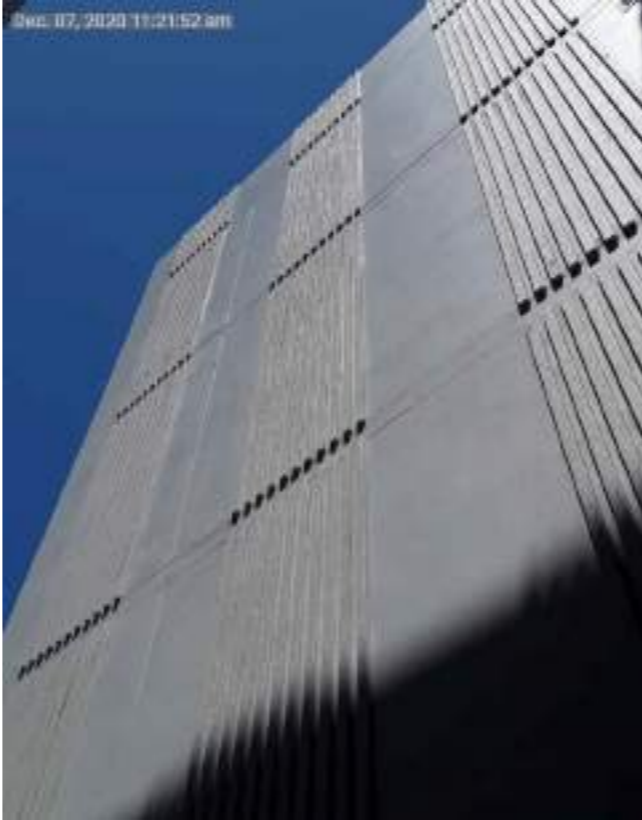
DEFECT NO.	LOCATION	AREA	BREACH	PHOTOGRAPH	DEFECT DESCRIPTION
C 37	West facade	Hebel cladding	See section 8.26 of this report.

Missing drainage provisions to Hebel.
C 38	North Facade	Planter box	See section 8.4 of this report.  Breach of 2.13 and 2.5.2 of AS4654.2 requiring falls to the base of the planter.

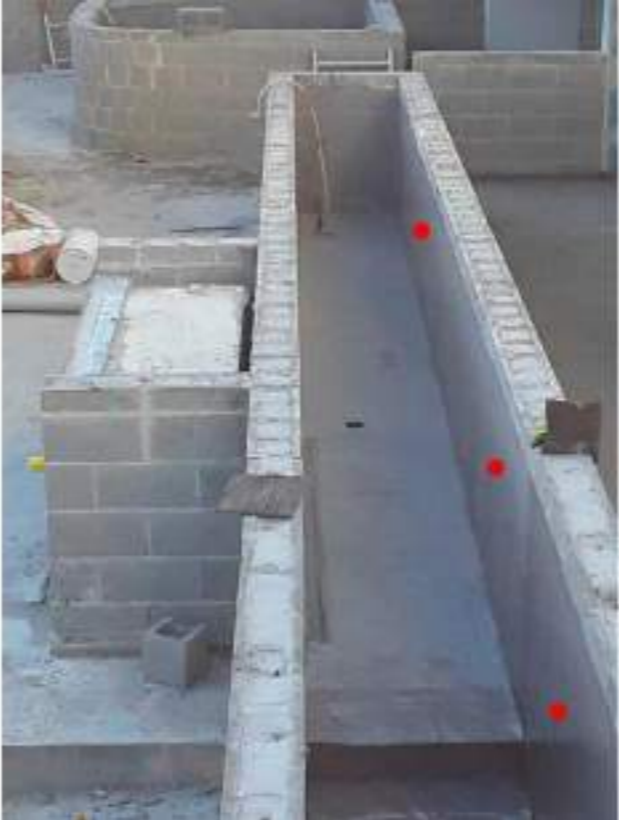
DEFECT NO.	LOCATION	AREA	BREACH	PHOTOGRAPH	DEFECT DESCRIPTION
C 39	North Facade	Planter box	Breach of 2.5.3.1 of AS4654.2 requiring a smooth substrate.

Blockwork has not been bagged prior to waterproofing. Smooth substrate required for waterproof application.
C 40	North Facade	Units balcony	See section 8.5 of this report.

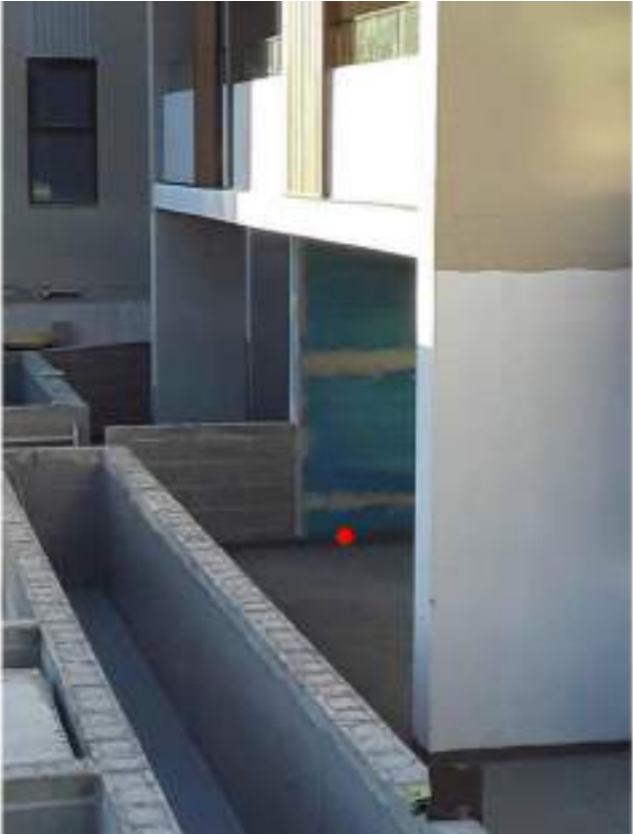
FC sheet has been installed below water level.

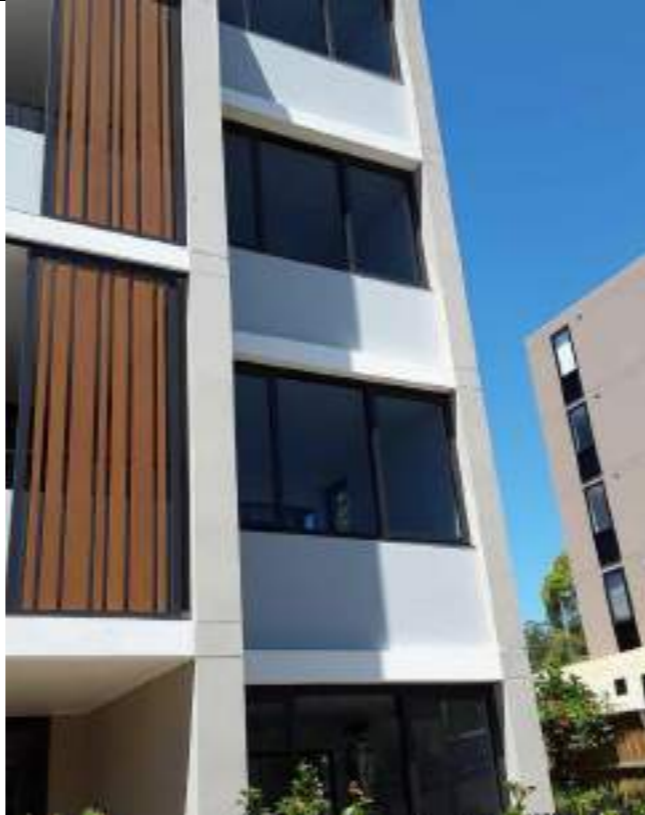
Missing pressure equalisation slots to Hebel.
C 42	North Facade	Privacy screen	See sections 8.5 and 8.26 of this report.

Missing drainage provisions to walls under windows.

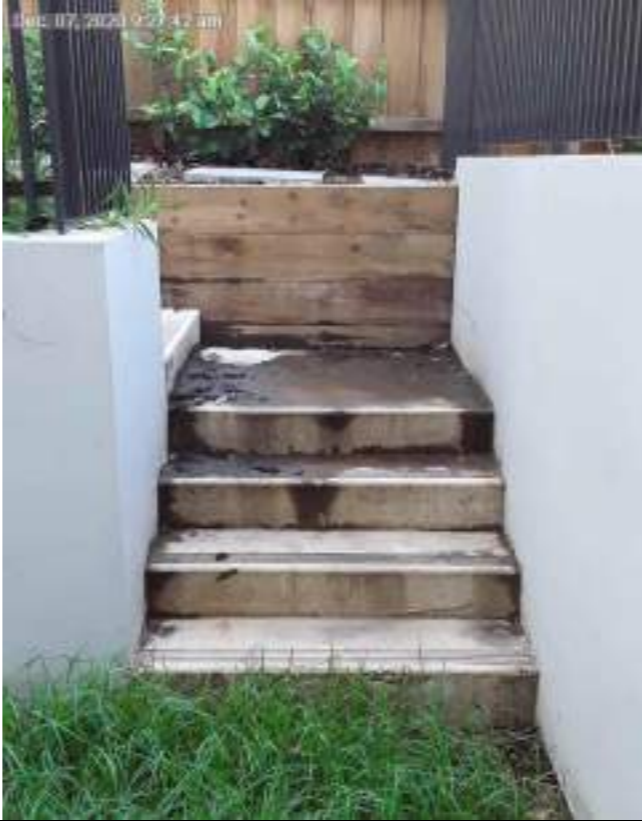
DEFECT NO.	LOCATION	AREA	BREACH	PHOTOGRAPH	DEFECT DESCRIPTION
C 49	South Facade (Mitchell Avenue)	Stair	Risk of trips and falls.

<p>Water is ponding on steps presenting a trip hazard.</p> <p>Timber sleeper retaining walls typically have a maximum height of 600mm. Engineer to confirm structural adequacy.</p>
C 50	South Facade (Mitchell Avenue)	Cladding	See section 8.9 and 8.24 of this report.

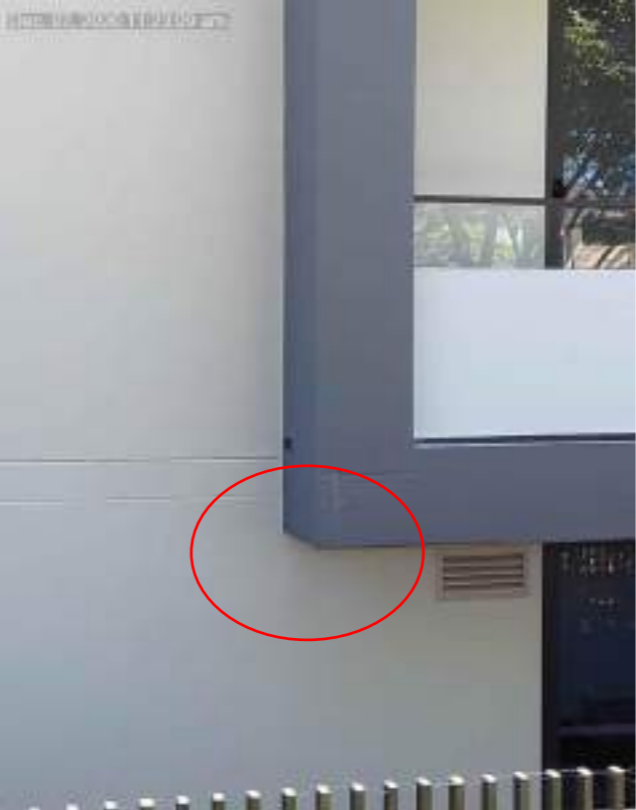
DEFECT NO.	LOCATION	AREA	BREACH	PHOTOGRAPH	DEFECT DESCRIPTION
C 51	South Facade (Mitchell Avenue)	Balcony slab edge	See section 8.9 of this report.

Efflorescence in this location is the result of failed waterproof membrane upturn.
<b>Basement Stair</b>					
C 52	Basement 1	South east fire stair to ground level	See section 8.15 of this report.

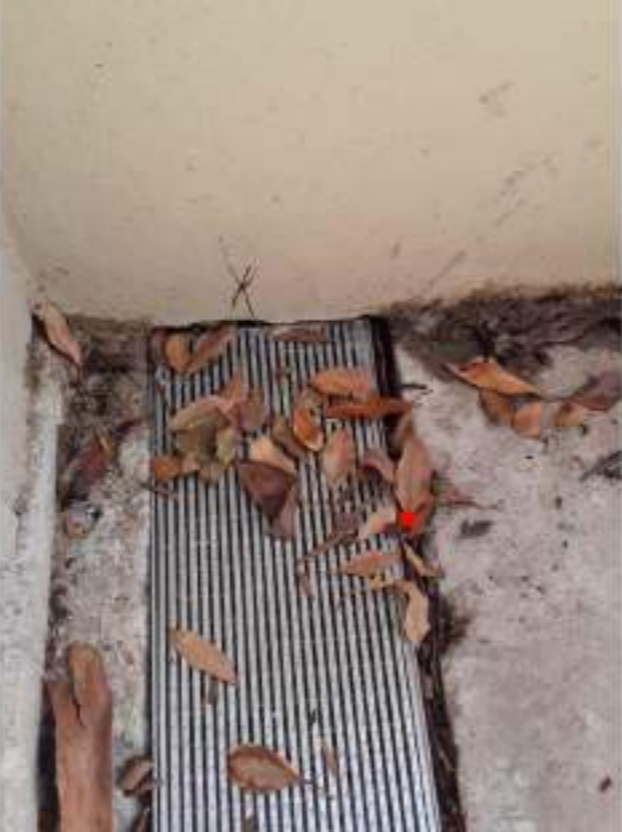
DEFECT NO.	LOCATION	AREA	BREACH	PHOTOGRAPH	DEFECT DESCRIPTION
C 53	Basement 1	South east fire stair to ground level	See section 8.23 of this report. Incomplete work.

Gap to side of grated drain.
C 54	Basement 1	South east fire stair to ground level	Incomplete works. Works have not been completed with due care and skill.

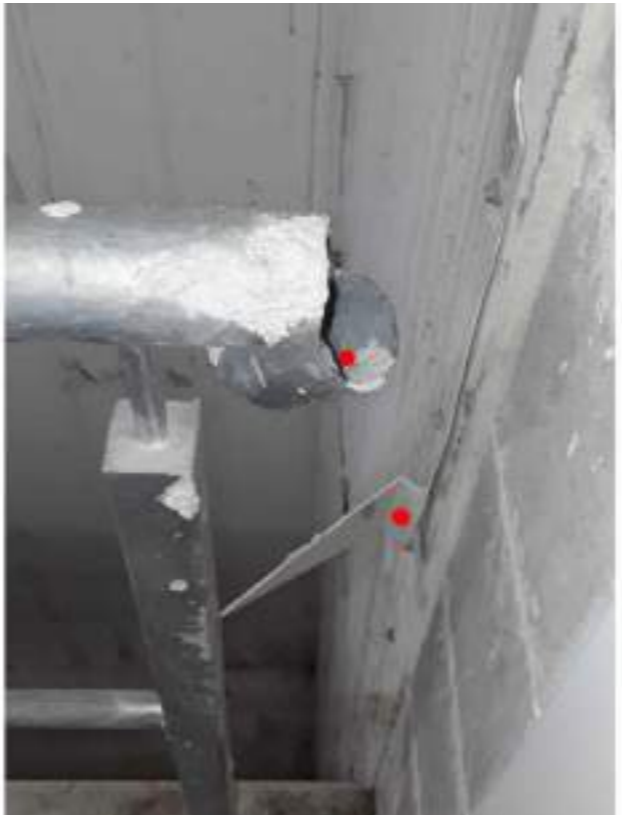
A. Handrail cut off. B. Dintel off cut.

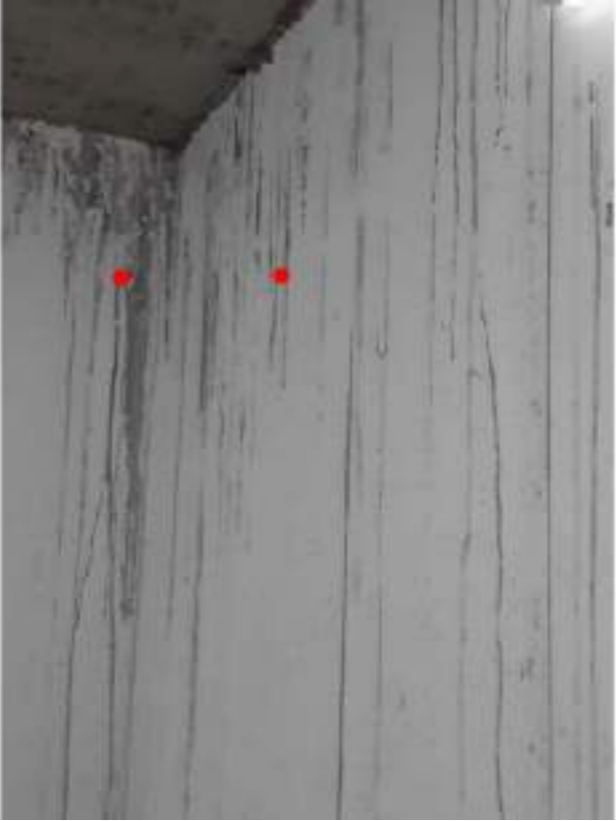
DEFECT NO.	LOCATION	AREA	BREACH	PHOTOGRAPH	DEFECT DESCRIPTION
C 55	Basement 1	South east fire stair to ground level	Works have not been completed with due care and skill.

Incomplete cleaning of concrete slurry.
C 56	Basement 1	South east fire stair to ground level	Works have not been completed with due care and skill.

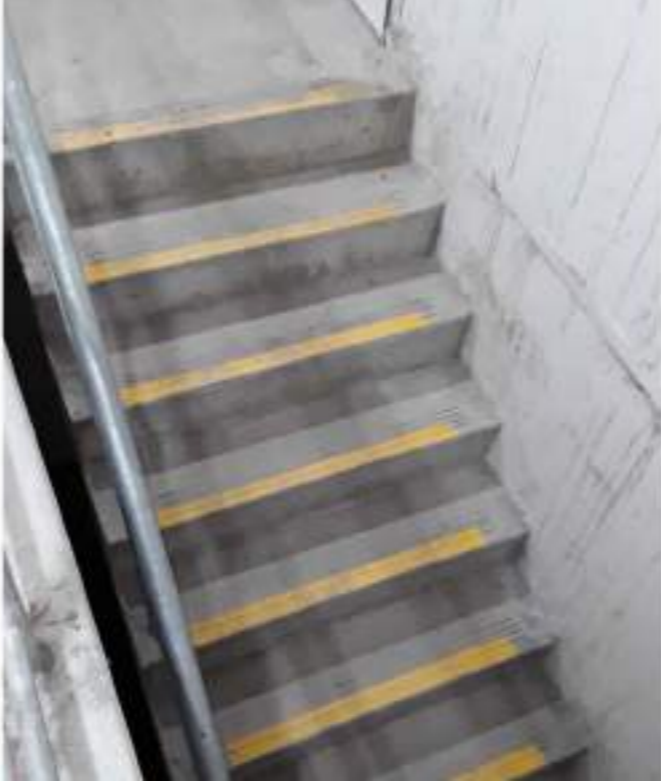
DEFECT NO.	LOCATION	AREA	BREACH	PHOTOGRAPH	DEFECT DESCRIPTION
C 57	Basement 1	South east fire stair to ground level	See section 8.15 of this report.

<p>No nosing or non-slip finish.</p> <p>Details of paint to be provided to identify if non-compliant and tested to AS4586.</p>
C 58	Basement 1	South east fire stair to ground level	Works have not been completed with due care and skill.

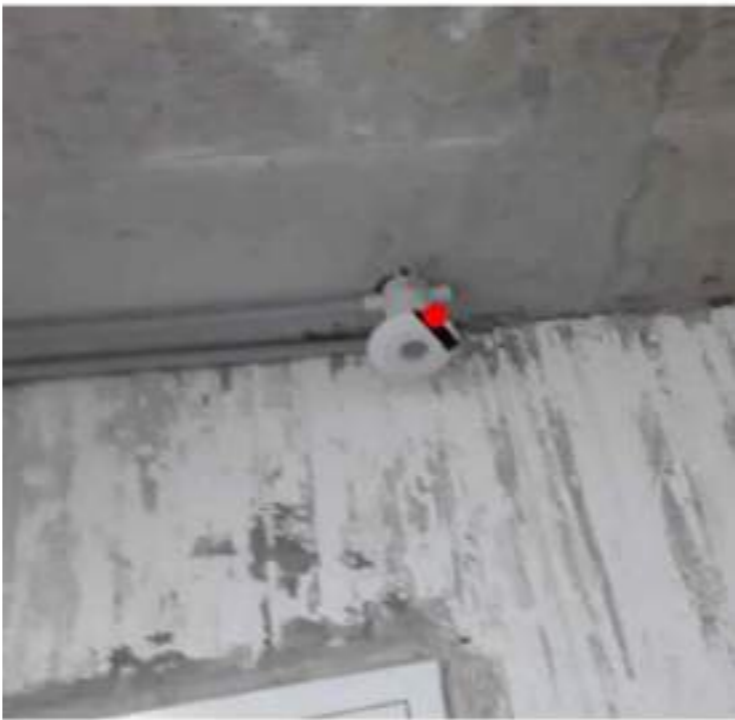
DEFECT NO.	LOCATION	AREA	BREACH	PHOTOGRAPH	DEFECT DESCRIPTION
C 59	Basement 1	South east fire stair to ground level	Works have not been completed with due care and skill.

Sensor temporarily installed.
C 60	Basement 1	South east fire stair to ground level	See section 8.15 of this report.

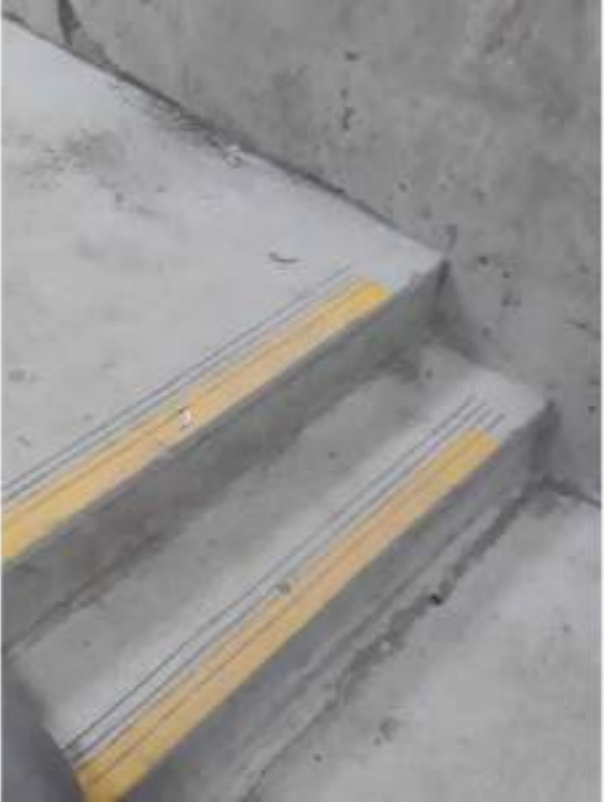
DEFECT NO.	LOCATION	AREA	BREACH	PHOTOGRAPH	DEFECT DESCRIPTION
C 69	Basement 1	North east fire stair to ground level	See section 8.15 of this report.

No nosing or non-slip finish.  Details of paint to be provided to identify if non-compliant and tested to AS4586.
C 70	Basement 1	North east fire stair to ground level	See section 8.15 of this report.

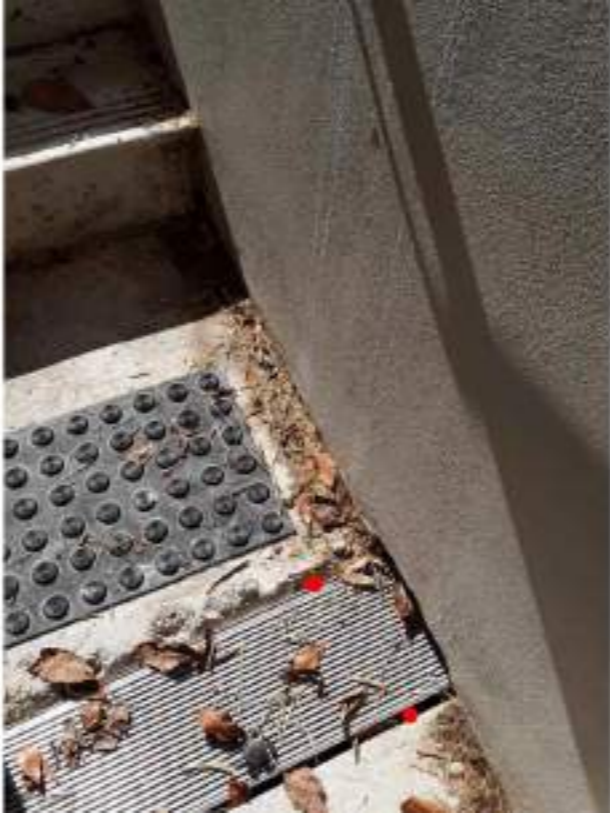
DEFECT NO.	LOCATION	AREA	BREACH	PHOTOGRAPH	DEFECT DESCRIPTION
C 71	Basement 1	North east fire stair to ground level	See section 8.23 of this report. Incomplete work.

Gap adjacent to grate.  Water can enter under grated drain.
C 72	Basement 1	North east fire stair to ground level	Fire engineer to assess.

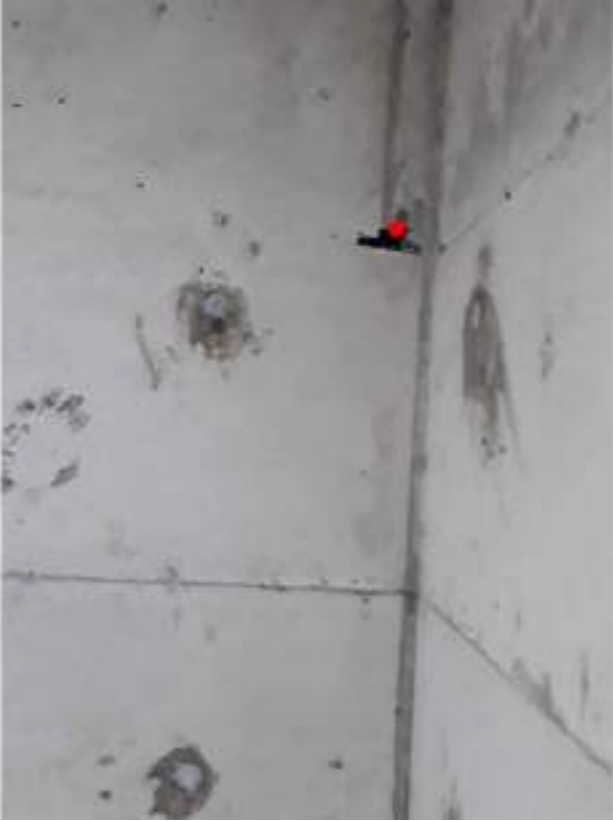
DEFECT NO.	LOCATION	AREA	BREACH	PHOTOGRAPH	DEFECT DESCRIPTION
C 73	Basement 1	North east fire stair to ground level	Incomplete work.

Void to fire rated concrete wall to fire stairs.
C 74	Basement 1	North east fire stair to ground level	See section 8.15 of this report.

C 73	Basement 1	North-east fire stairs to ground level	Void to the fire-rated concrete wall to fire stairs.	Fill with non-shrink grout.
C 75	Basement 1	North-east fire stairs to ground level	Void to concrete.	Fill with non-shrink grout.
C 77	Basement 1	North-east fire stairs to ground level	Sarking tape installed around the pipe.	Remove tape. Install no-shrink grout.
C 82	Basement 2	North-east – hydrant room	Pump not operational in fault mode.	Technician to inspect and advise.
C 83	Basement 2	North-east – hydrant room	Missing fixings throughout.	Plumber to install missing fixings.
C 84	Basement 2	North-east – hydrant room	Nail in the floor.	Remove nail.
C 85	Basement 2	North-east – hydrant room	Missing fixings.	Plumber to install missing fixings.
C 86	Basement 2	North-east – hydrant room	Water ponding under electrical back up batteries. Safety issue.	Remove equipment. Top floors to drain. Reinstall equipment.

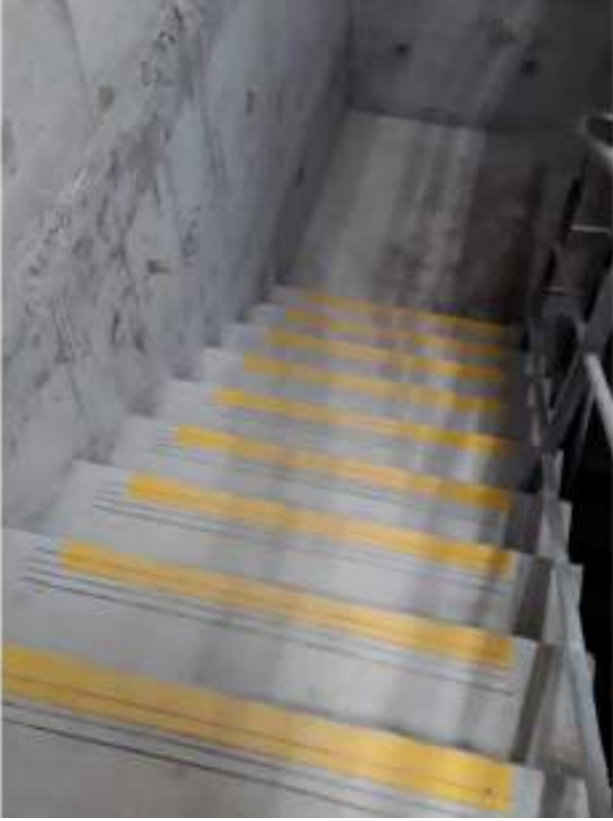
No nosing or compliant non-slip finish.  Details of paint to be provided to identify if non-compliant and tested to AS4586.

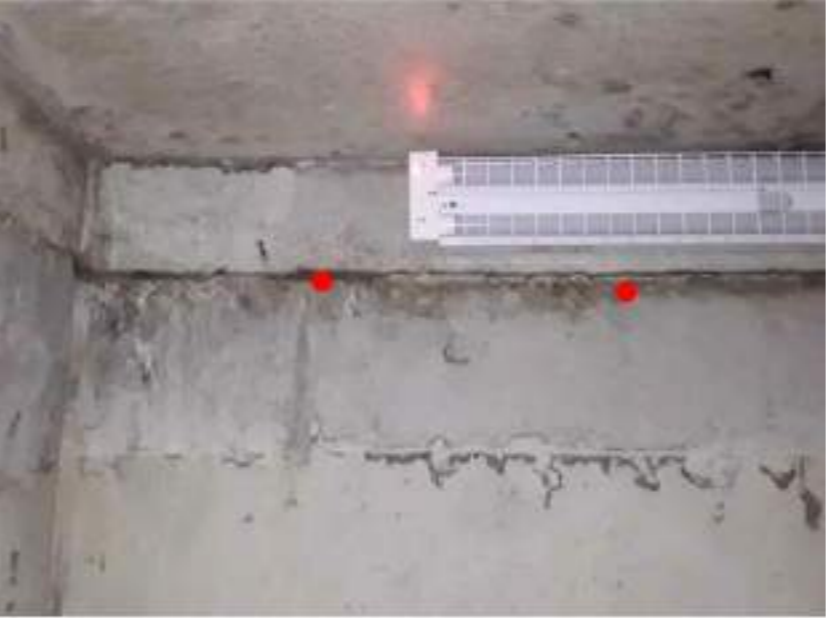
DEFECT NO.	LOCATION	AREA	BREACH	PHOTOGRAPH	DEFECT DESCRIPTION
C 75	Basement 1	North east fire stair to ground level	Works have not been completed with due care and skill.  Fire engineer to assess.

Void to concrete.  Moisture ingress.  Possible fire defect.
C 76	Basement 1	North east fire stair to ground level	See section 8.19 of this report.

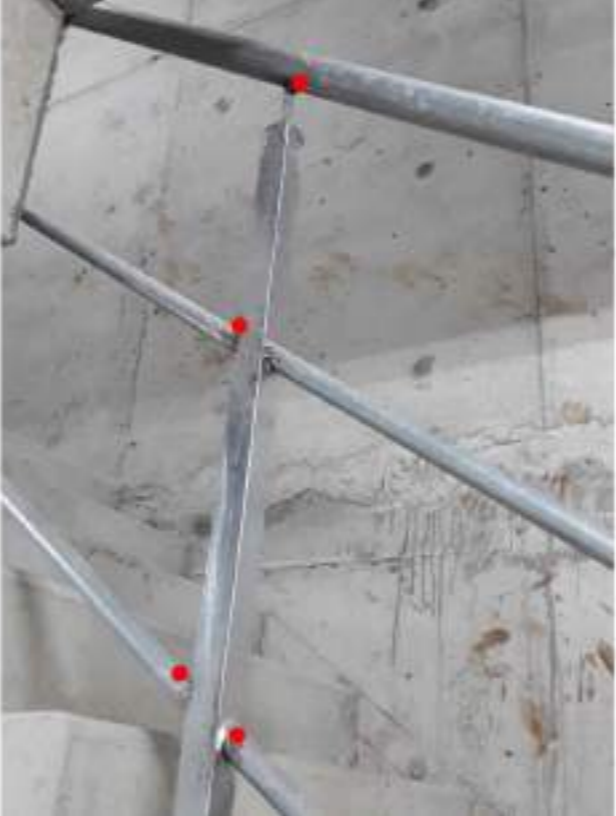
Corrosion.

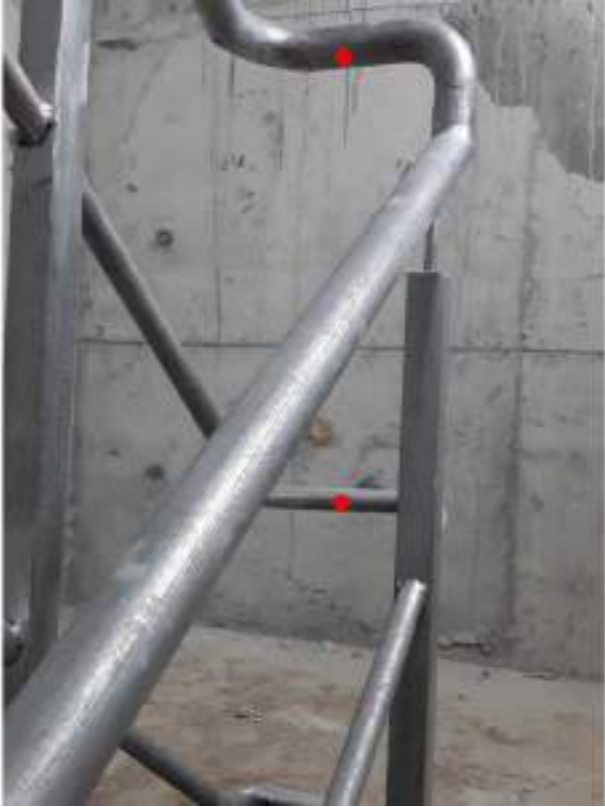
DEFECT NO.	LOCATION	AREA	BREACH	PHOTOGRAPH	DEFECT DESCRIPTION
C 79	Basement 1	North east fire stair to ground level	See section 8.18 of this report.

Non continuous handrail.
C 80	Basement 2	North east fire stair to ground level	See section 8.14 of this report.

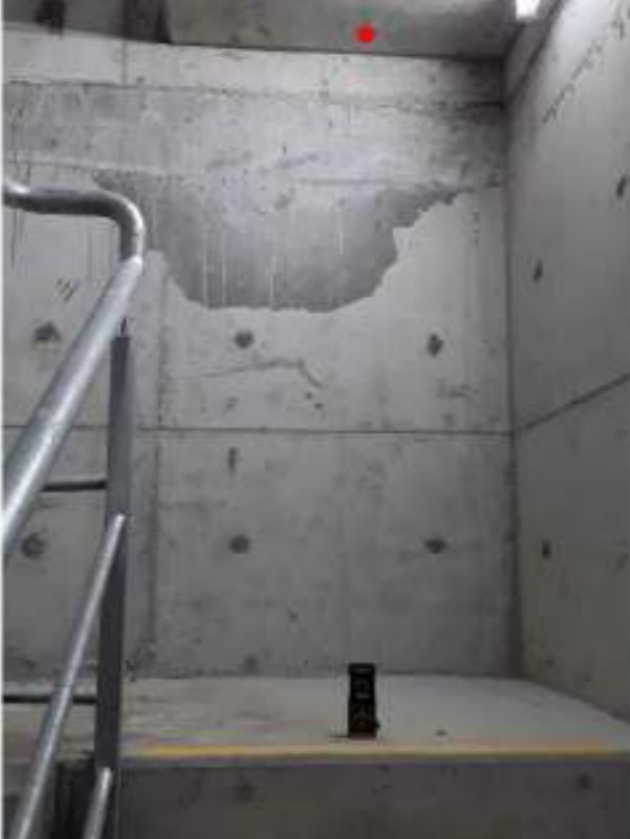
Ceiling height 1.95 metres.

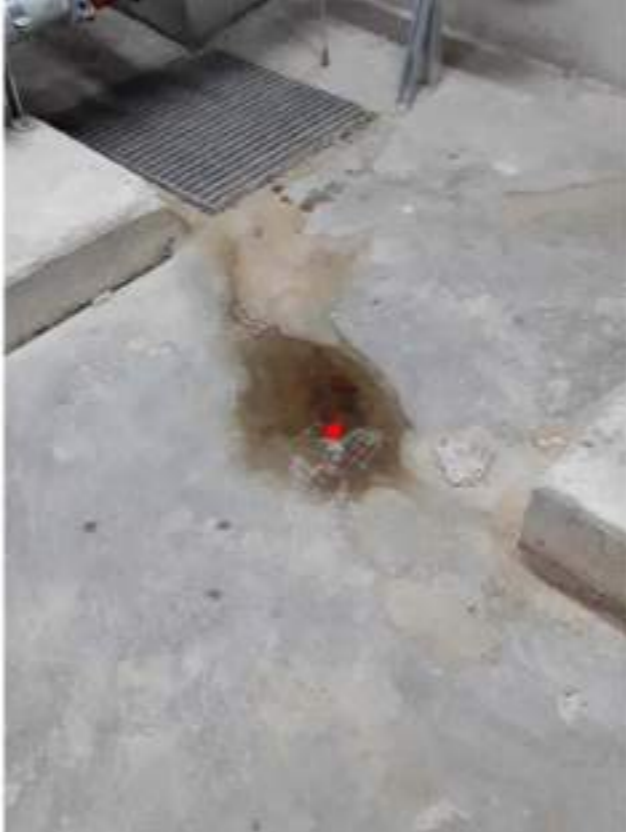
C 81	Basement 2	North east – hydrant room	See section 8.4 of this report.

Water ponding.

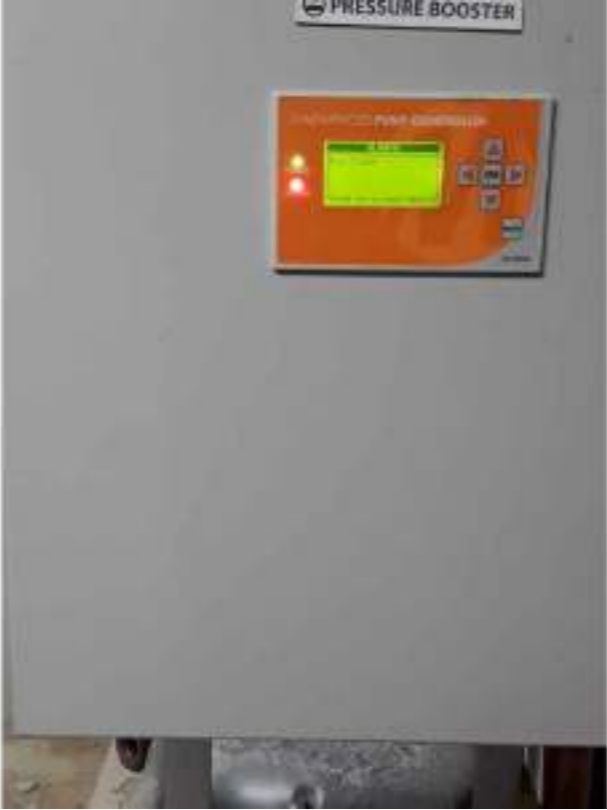
DEFECT NO.	LOCATION	AREA	BREACH	PHOTOGRAPH	DEFECT DESCRIPTION
C 82	Basement 2	North east – hydrant room	Not fit for purpose.

Pump not operational in fault mode.  Pumps have not been commissioned.
C 83	Basement 2	North east – hydrant room	Incomplete work.

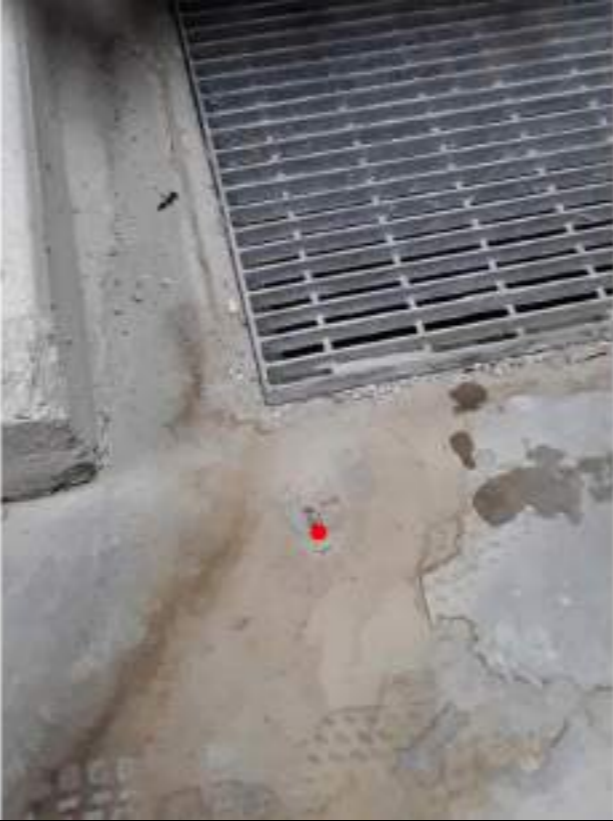
DEFECT NO.	LOCATION	AREA	BREACH	PHOTOGRAPH	DEFECT DESCRIPTION
C 84	Basement 2	North east – hydrant room	Incomplete work.

Nail in floor.  Trip and safety hazard.
C 85	Basement 2	North east – hydrant room	Incomplete work.
