Mitchell Ave Developments P/L vs Fore Sydney Constructions P/L  
Report issued: 25 February 2022  
Both Tramex and Protometre moisture meters are used to attain comparative Moisture readings

## **10.6 Attachment F - Defects Schedule**

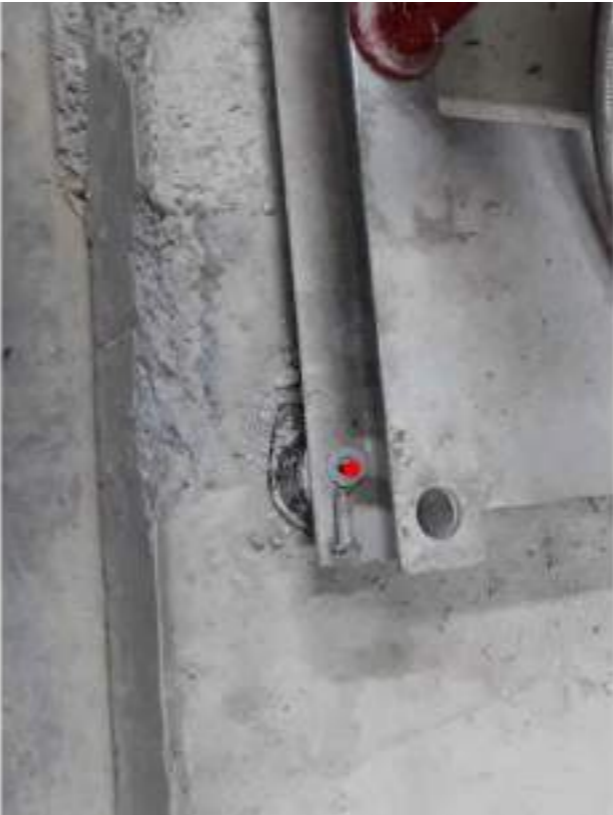
Nail in floor.  Trip and safety hazard.
C 85	Basement 2	North east – hydrant room	Incomplete work.

Missing fixings.

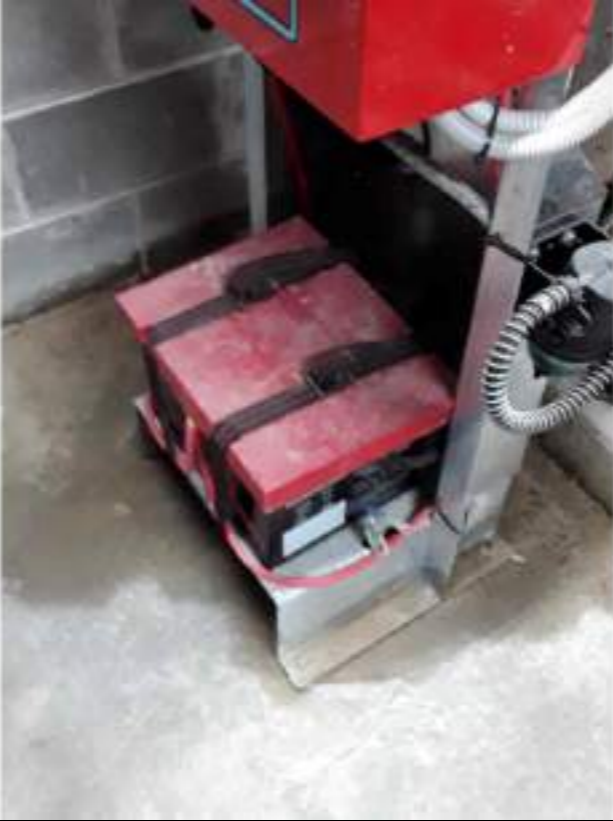
DEFECT NO.	LOCATION	AREA	BREACH	PHOTOGRAPH	DEFECT DESCRIPTION
C 86	Basement 2	North east – hydrant room	Not fit for purpose.

<p>Water ponding under electrical back up batteries. Safety issue.</p> <p>When working on electricals to pump set, a worker will be standing in water.</p>
C 87	Basement 2	North east – hydrant room	See section 8.4 of this report.

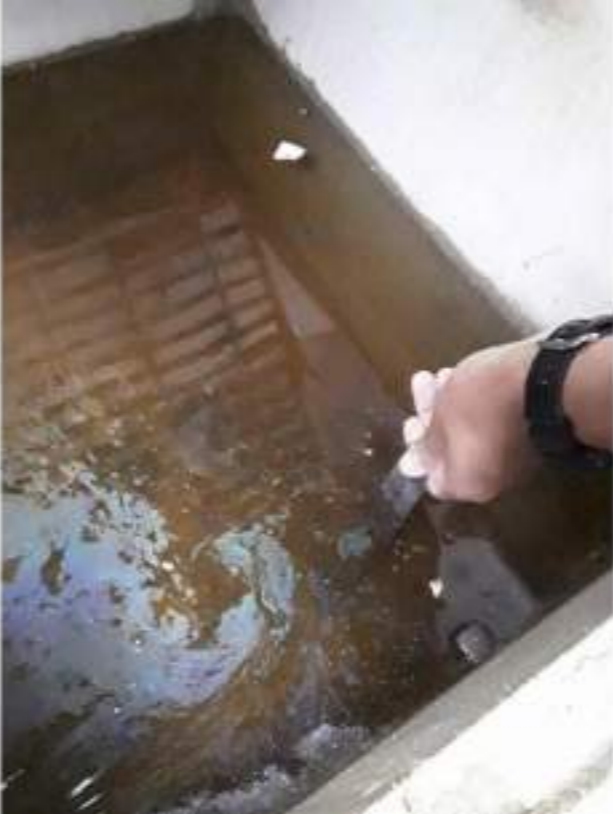
280mm water ponding in pit.

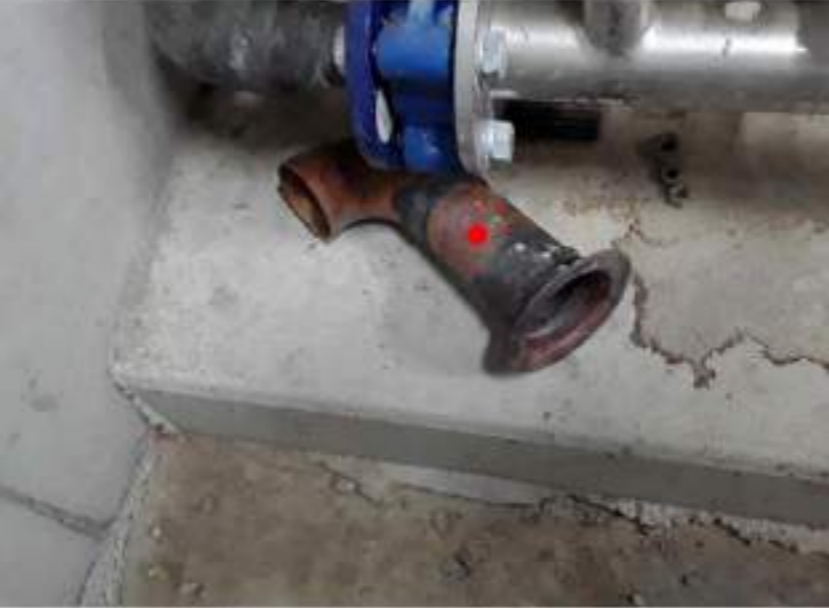
DEFECT NO.	LOCATION	AREA	BREACH	PHOTOGRAPH	DEFECT DESCRIPTION
C 88	Basement 2	North east – hydrant room	Incomplete work.

Incomplete work.
C 89	Basement 2	North east – hydrant room	Not fit for purpose. See section 8.19 of this report.

C 88	Basement 2	North-east – hydrant room	Incomplete work.	Remove redundant items.
C 89.A	Basement 2	North-east – hydrant room	Hanging rod bending and corroded and installed instead of unistrut.	Remove and install Unistrut.

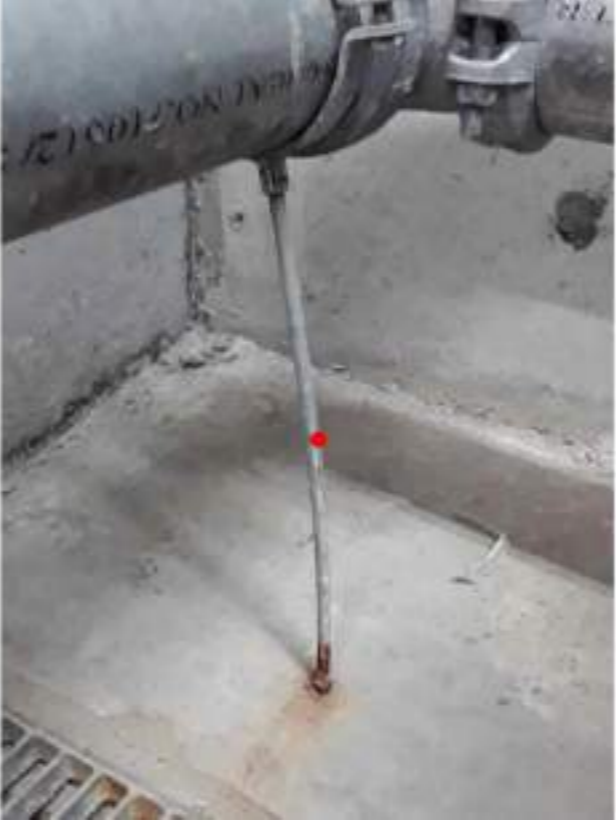
Hanging rod bending and corroded and installed instead of unistrut.  Threaded rods are used for hanging not supporting.

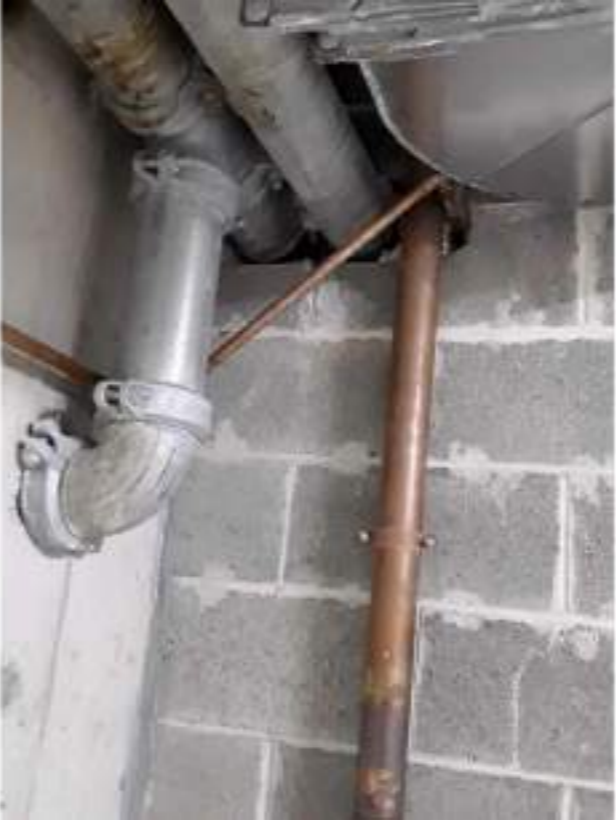
DEFECT NO.	LOCATION	AREA	BREACH	PHOTOGRAPH	DEFECT DESCRIPTION
C 90	Basement 2	North east – hydrant room	Fire engineer to inspect.

<p>A photograph showing a fire-rated wall made of grey concrete blocks. Several pipes are visible: a large grey pipe with a elbow, a smaller grey pipe, and a copper pipe. There is a gap or void between the pipes and the wall.</p>	Open void to fire rated wall.
C 91	Basement 2	North east – hydrant room	Fire engineer to inspect.

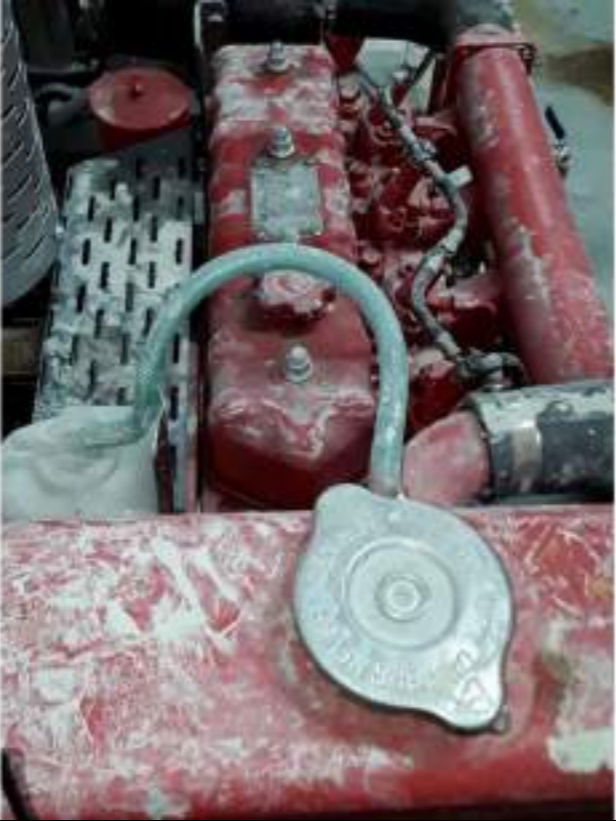
DEFECT NO.	LOCATION	AREA	BREACH	PHOTOGRAPH	DEFECT DESCRIPTION
C 92	Basement 2	North east – hydrant room	Works have not been completed with due care and skill.

Slurry over diesel pump set may void manufacturer's warranty
C 93	Basement 2	North east – hydrant room	Works have not been completed with due care and skill.

C 92	Basement 2	North-east – hydrant room	Slurry over diesel pump set may void the manufacturers' warranty	Clean slurry and equipment.
C 93	Basement 2	North-east – hydrant room	No Aust. Standard tags.	Hydraulic engineer to attend site and confirm compliance.
C 96	Basement 1	Main entry	Paper retained in the soffit.	Remove, clean, and install non-shrink grout.
C 97	Basement 1	Main entry	Power cable to be shortened and clipped to concrete.	Electrician to attend and shorten cable.
C 98	Basement 1	West wall	Builders set out has not been cleaned off.	Sand and clean marks off soffit.
C 100	Basement 1	South wall	Nails retained throughout the soffit.	Remove and patch with render.
C 102.A	Basement 1	South – over parking bay 18 (floor waste)	Nails to soffit parking bay 18	Remove and patch with render.
C 102.B	Basement 1	South – over parking bay 18 (floor waste)	Builders set out retained.	Sand and clean marks off soffit.

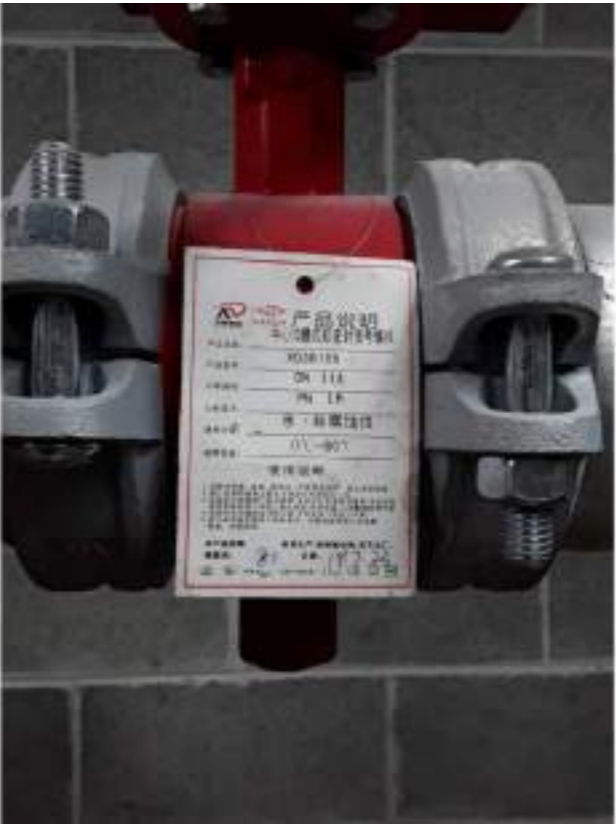
Not Australian Standard tags.

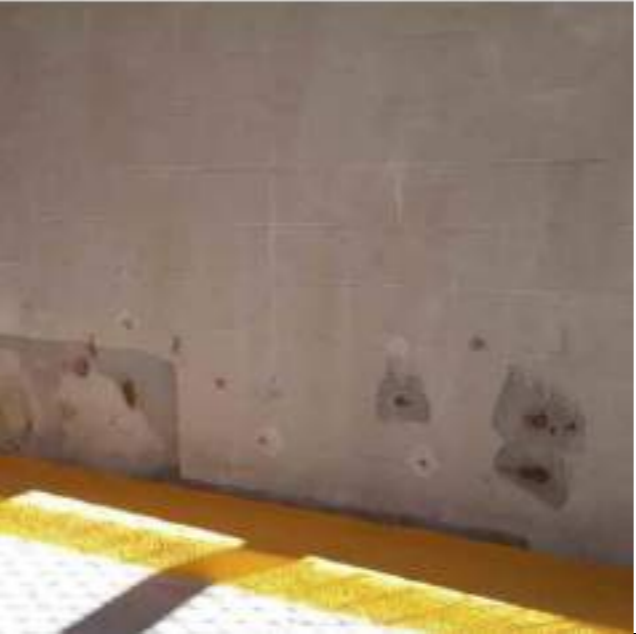
DEFECT NO.	LOCATION	AREA	BREACH	PHOTOGRAPH	DEFECT DESCRIPTION
C 95	Basement 1	Main entry	See section 8.19 of this report.

Localised waterproofing repairs.  Corrosion.
C 96	Basement 1	Main entry	Works have not been completed with due care and skill.

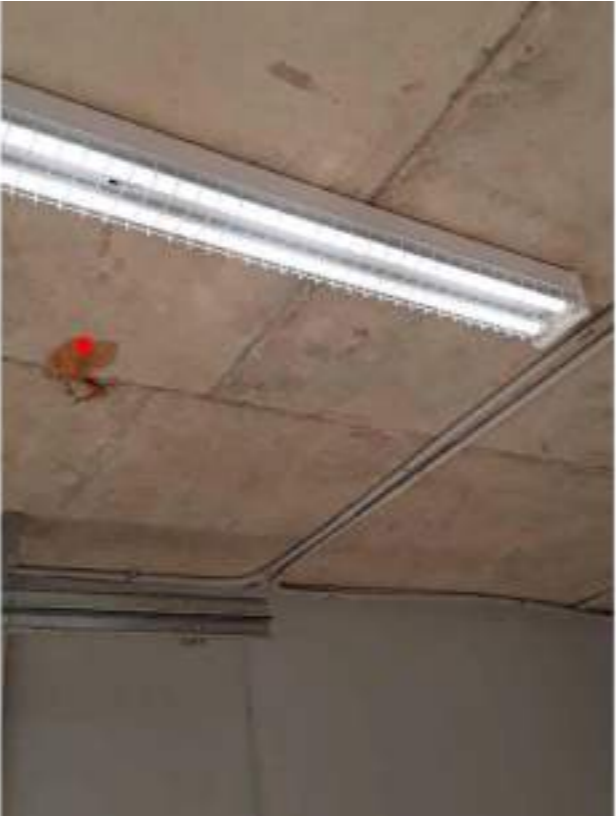
Paper retained in soffit.

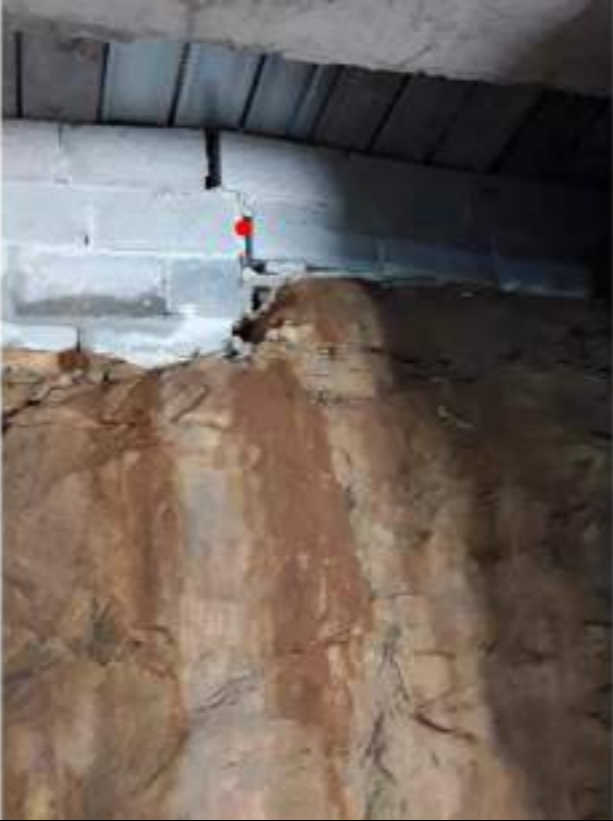
DEFECT NO.	LOCATION	AREA	BREACH	PHOTOGRAPH	DEFECT DESCRIPTION
C 99	Basement 1	South wall	Structural engineer to assess.  Not fit for purpose.

Block work wall, supporting Bondek has cracked.
C 100	Basement 1	South wall	Works have not been completed with due care and skill.  Incomplete work.

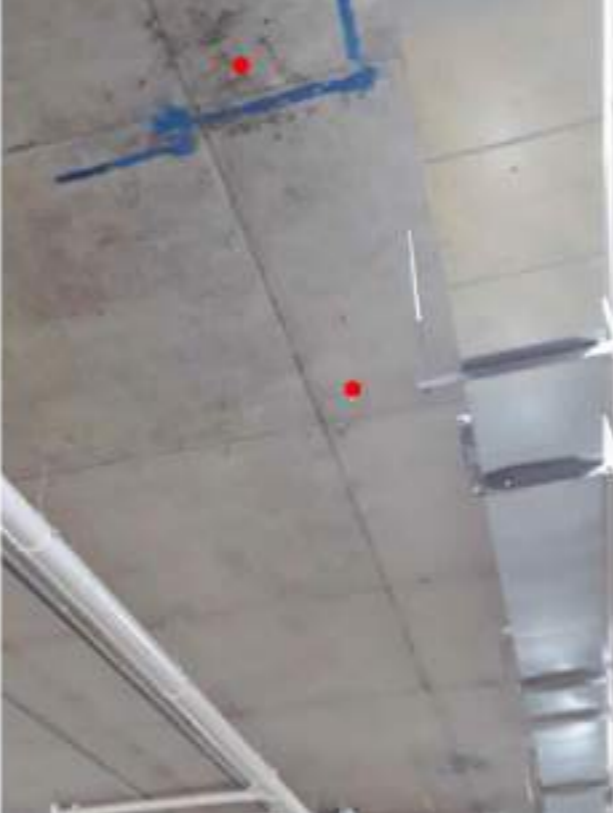
Nails retained throughout the soffit.

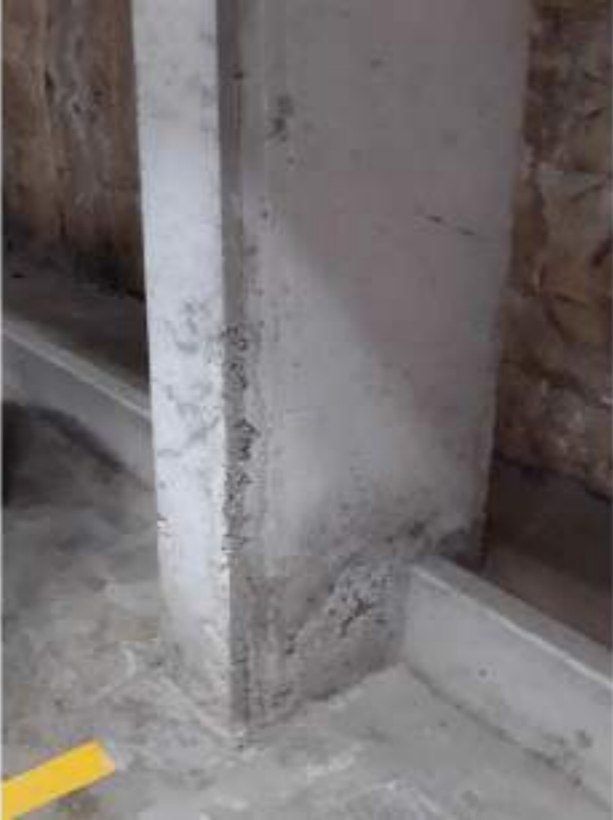
DEFECT NO.	LOCATION	AREA	BREACH	PHOTOGRAPH	DEFECT DESCRIPTION
C 101	Basement 1 Visitor parking bay.	South (Column)	See section 8.20 of this report.

Insufficiently vibrated concrete.
C 102	Basement 1	South – over parking bay 18 (floor waste)	Works have not been completed with due care and skill.

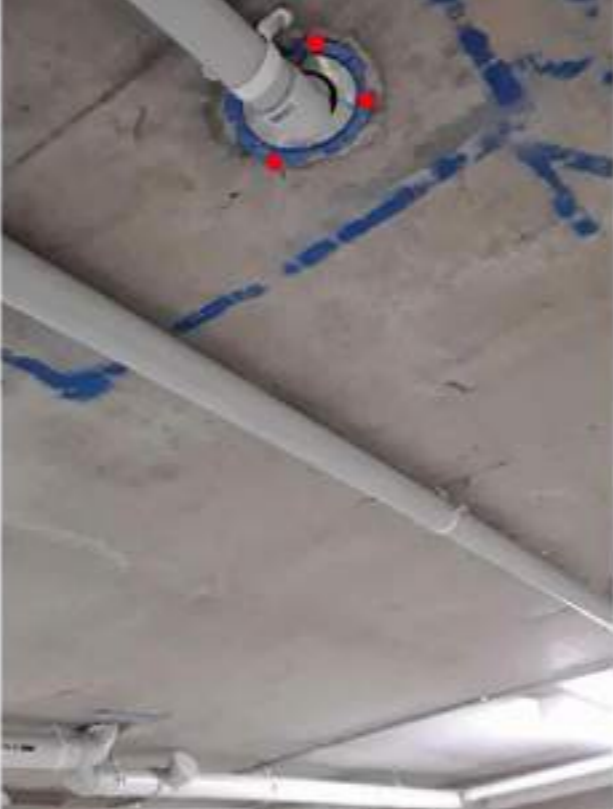
Nails to soffit parking bay 18 Builders set out retained.

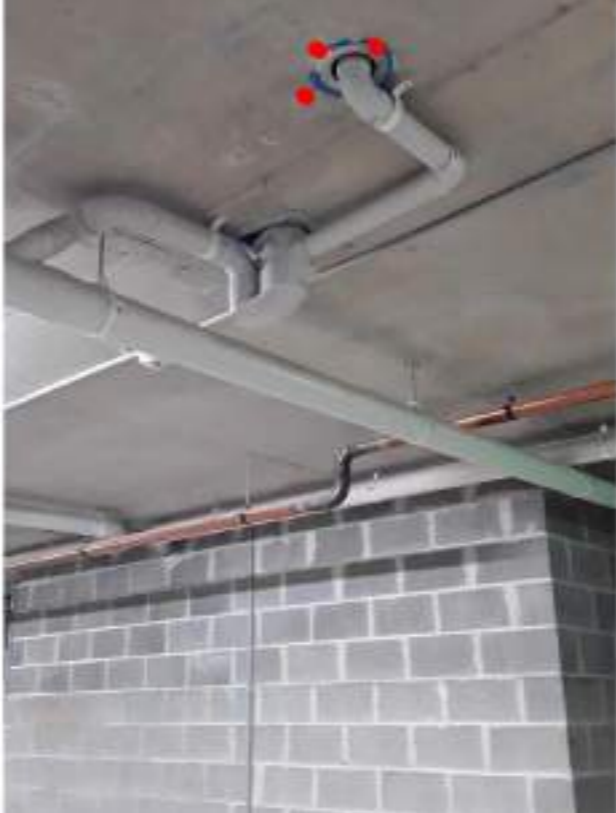
C 104	Basement 1	South	Works have not been completed with due care and skill.

Nails retained throughout soffit.

C 104	Basement 1	South	Nails retained throughout soffit.	Remove and patch with render.
C 105	Basement 1	South-east corner	Incomplete hydraulic work to the southeast corner and incomplete concreting.	
C 106	B1 and B2 ramp	Adjacent store	Nails retained in a store adjacent to B1 to B2 ramp.	Remove and patch with render.
C 108	Basement 1	Exist	The hump at lift exit.	Scabble hump and install screed.
C 109.A	Basement 1	Exist	Open conduit.	Electrician to cap off.
C 109.B	Basement 1	Exist	Formwork retained in the concrete.	Remove formwork.
C 109.C	Basement 1	Exist	Concrete patch not completed with due care and skill.	Remove and replace.
C 110.A	Basement 1	North-east floor waste	Duct tape to concrete.	Remove tape.
C 110.B	Basement 1	North-east floor waste	Concrete around the drain has not been completed with due care and skill.	Remove concrete and tape Install non-shrink grout.
C 112	Basement 1	Parking bay 2	Formwork retained to parking bay 2.	Remove formwork.

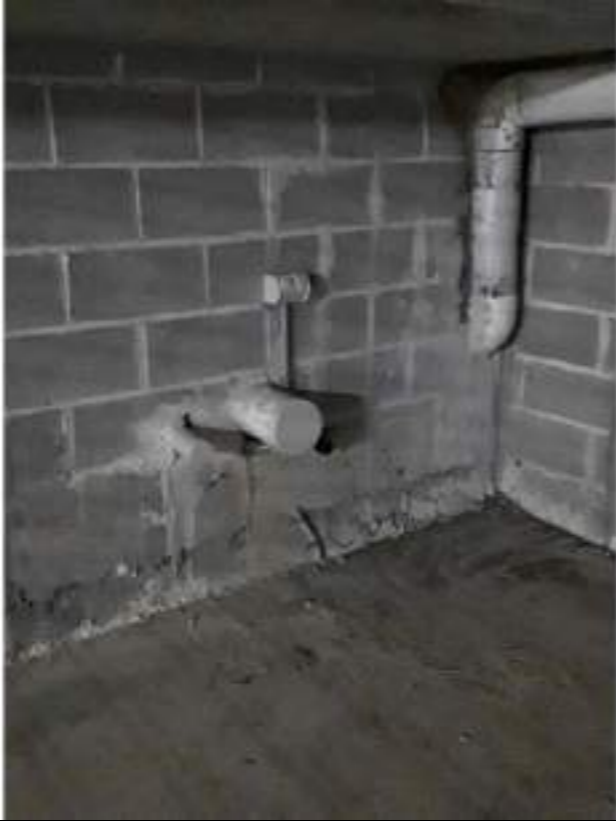
DEFECT NO.	LOCATION	AREA	BREACH	PHOTOGRAPH		DEFECT DESCRIPTION
C 105	Basement 1	South east corner	Incomplete work.

Incomplete hydraulic work to southeast corner and incomplete concreting.
C 106	B1 and B2 ramp	Adjacent store	Incomplete work.

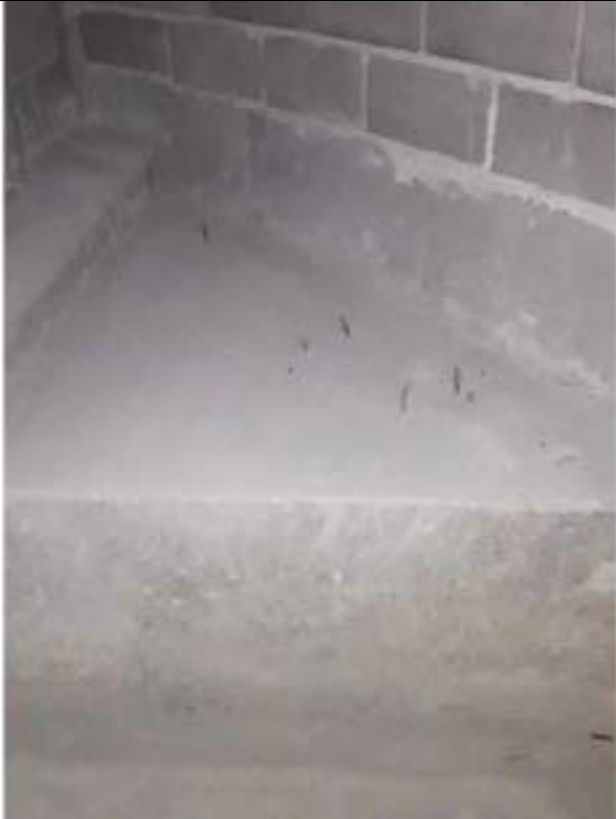
Nails retained in store adjacent to B1 to B2 ramp.

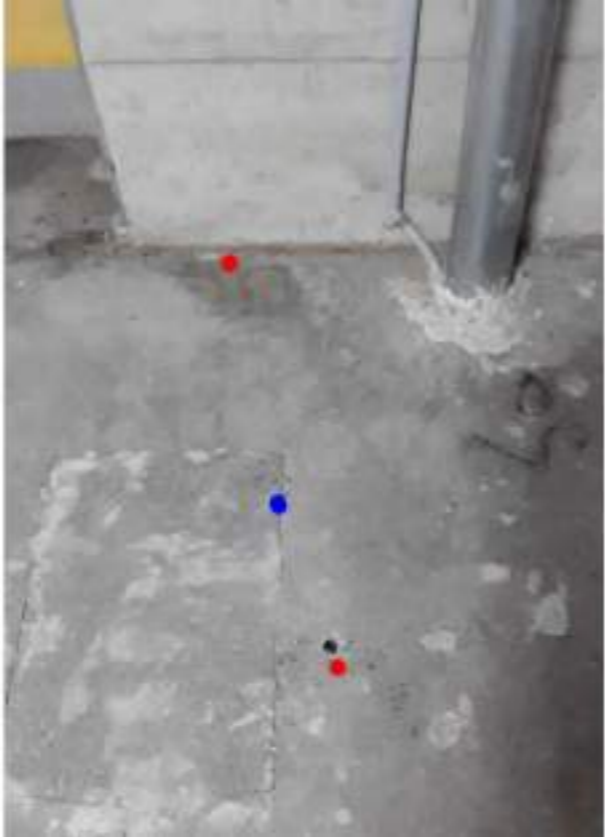
DEFECT NO.	LOCATION	AREA	BREACH	PHOTOGRAPH	DEFECT DESCRIPTION
C 109	Basement 1	Exit	Works have not been completed with due care and skill.

<ul style="list-style-type: none"> <li>A. Open conduit</li> <li>B. Formwork retained in concrete</li> <li>C. Concrete patch not completed with due care and skill</li> </ul>
C 110	Basement 1	North east floor waste	Works have not been completed with due care and skill.

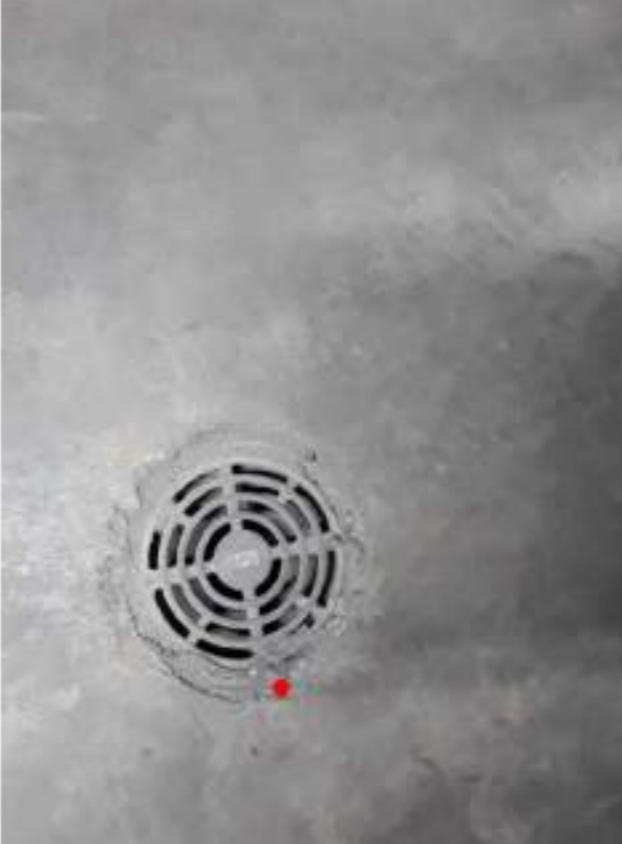
<ul style="list-style-type: none"> <li>A. Duct tape to concrete</li> <li>B. Concrete around drain has not been completed with due care and skill</li> </ul>

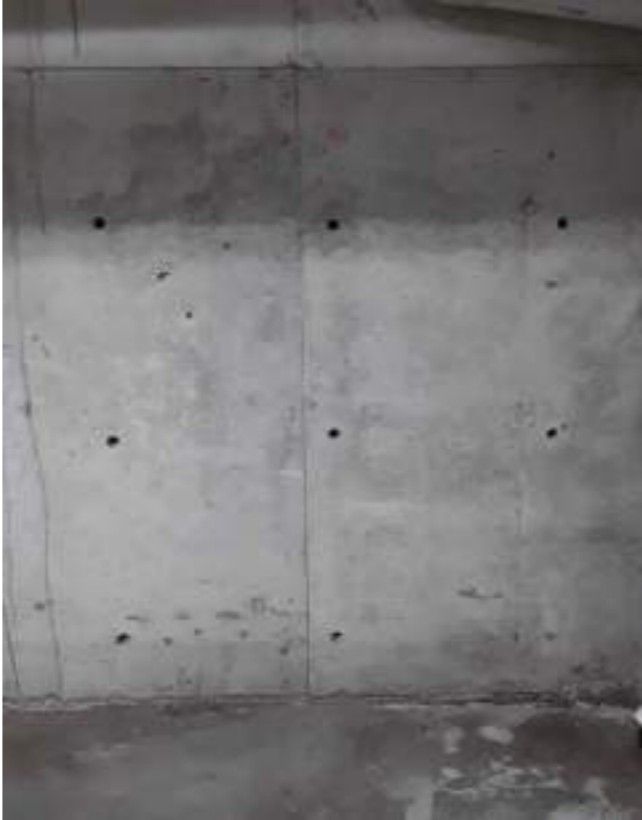
DEFECT NO.	LOCATION	AREA	BREACH	PHOTOGRAPH		DEFECT DESCRIPTION
C 111	Basement 1	North east fire stair	Incomplete work.

Missing coil tie plugs.
C 112	Basement 1	Parking bay 2	Incomplete work.

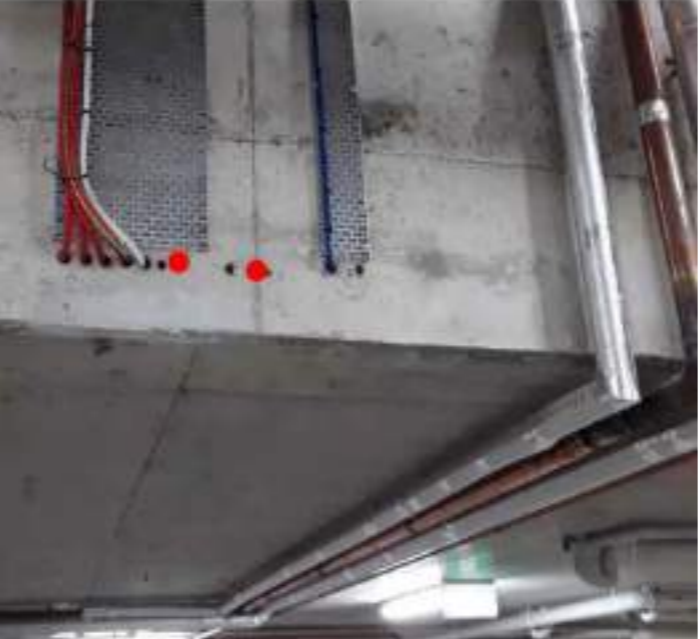
<p>A. Nails retained in soffit.</p> <p>Nails protruding from soffit are a safety hazard for maintenance plumbing work.</p> <p>B. Builders setout retained on soffit.</p>
C 114	Basement 1	B1 and B2 ramp	Incomplete work.

6 open conduits to concrete.

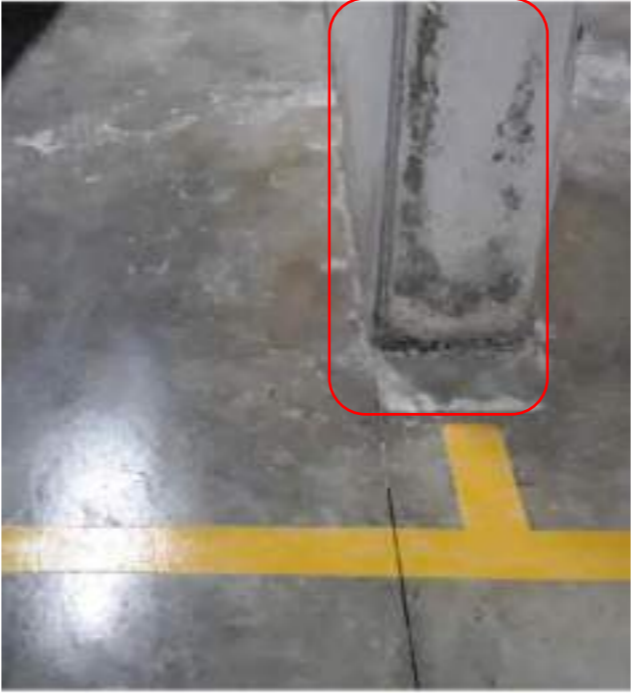
DEFECT NO.	LOCATION	AREA	BREACH	PHOTOGRAPH	DEFECT DESCRIPTION
C 119	Basement 2	Parking bay 29	See section 8.20 of this report.

Insufficient vibration of concrete.
C 120	Basement 2	Parking bay 13	See section 8.20 of this report

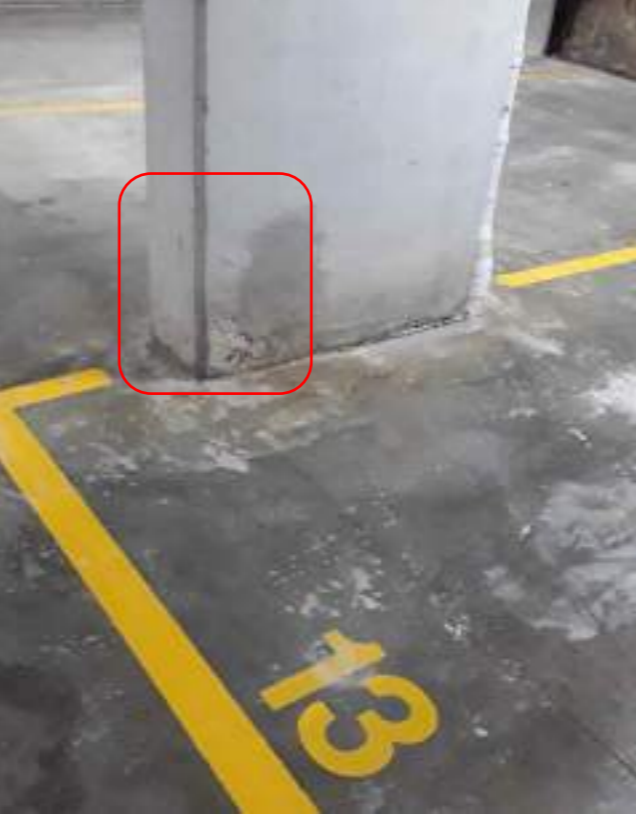
Insufficient vibration of concrete.

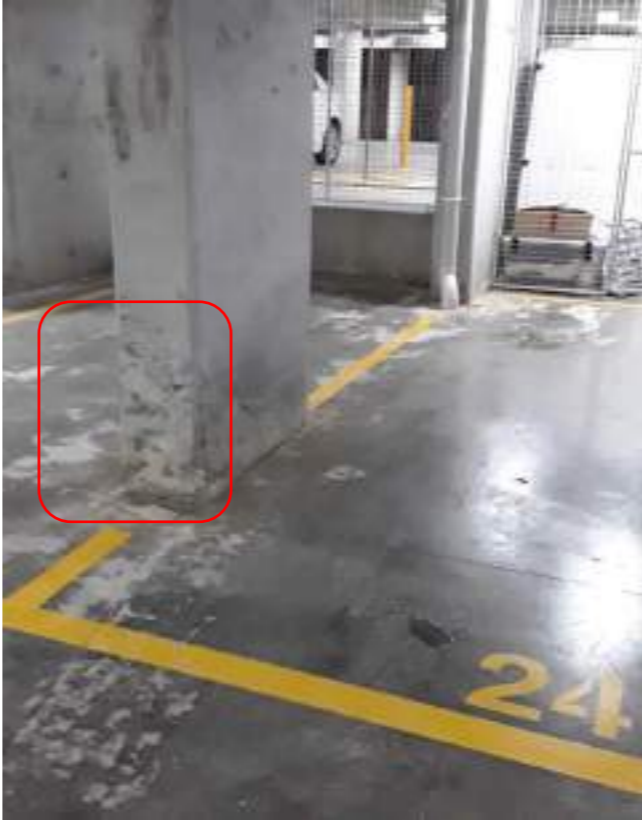
DEFECT NO.	LOCATION	AREA	BREACH	PHOTOGRAPH	DEFECT DESCRIPTION
C 121	Basement 2	Parking bay 24	See section 8.20 of this report

Insufficient vibration of concrete.
C 122	Basement 2	Behind parking bay 25	Not fit for purpose.

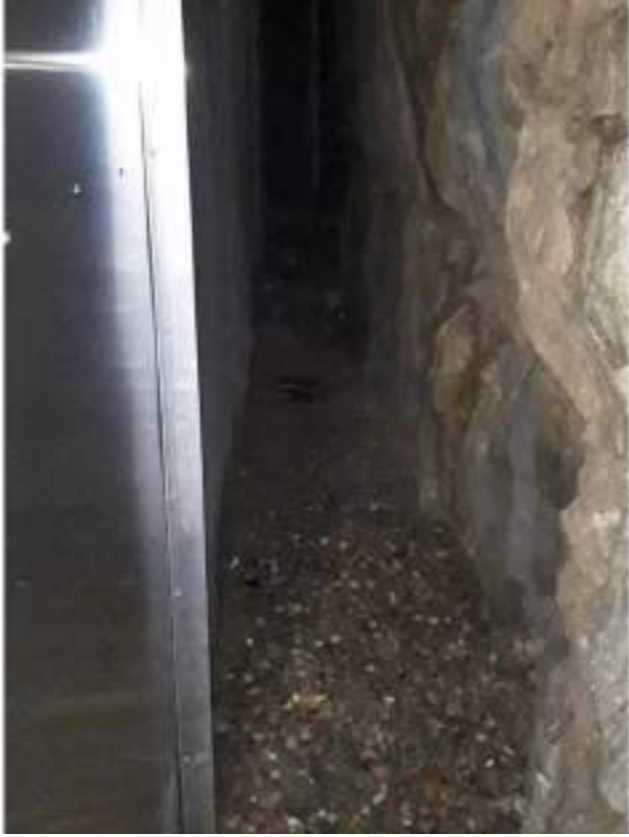
Dish drain incomplete behind parking bay 25. Restricted with rock in way of water flow.

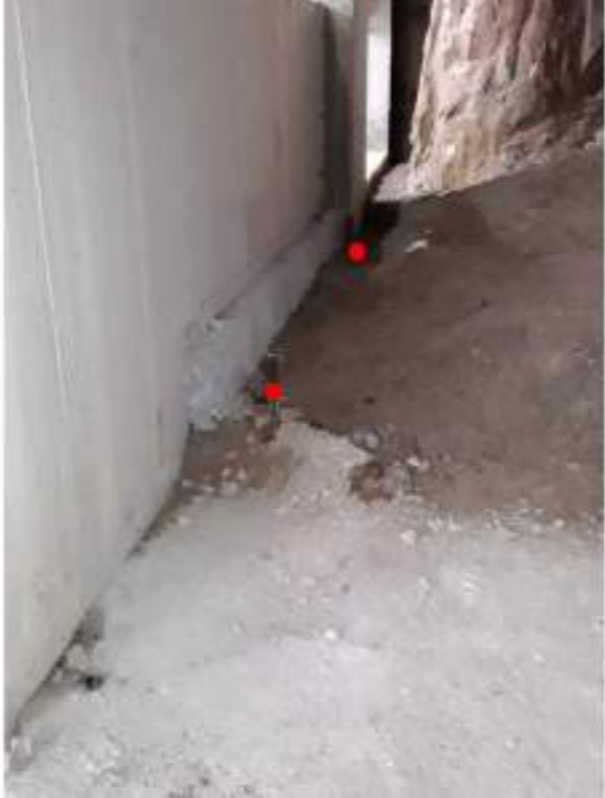
C 123	Basement 2	North of building - adjacent to ramp	Works have not been completed with due care and skill.

Exposed reinforcement bars adjacent to ramp.

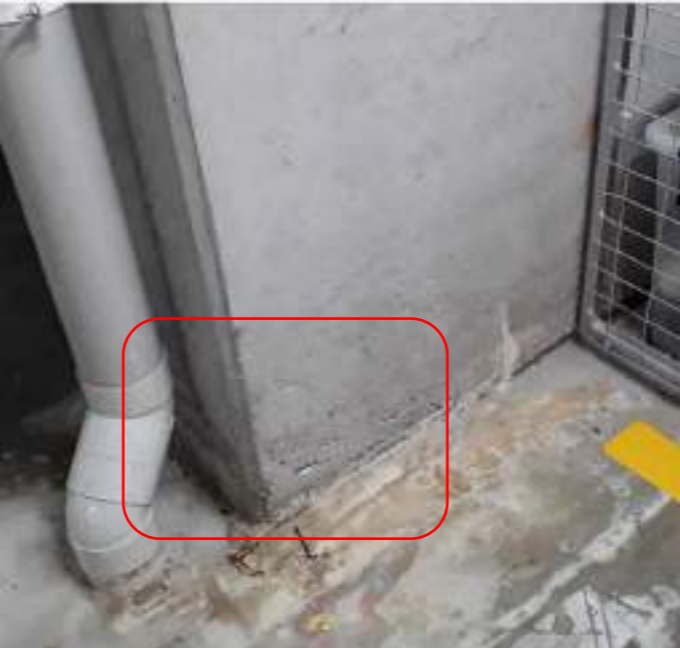
Poor concreting works adjacent to ramp.
C 125	Basement 2	Parking bay 24 (Column)	See section 8.20 of this report

Insufficient vibration of concrete to parking bay 24.

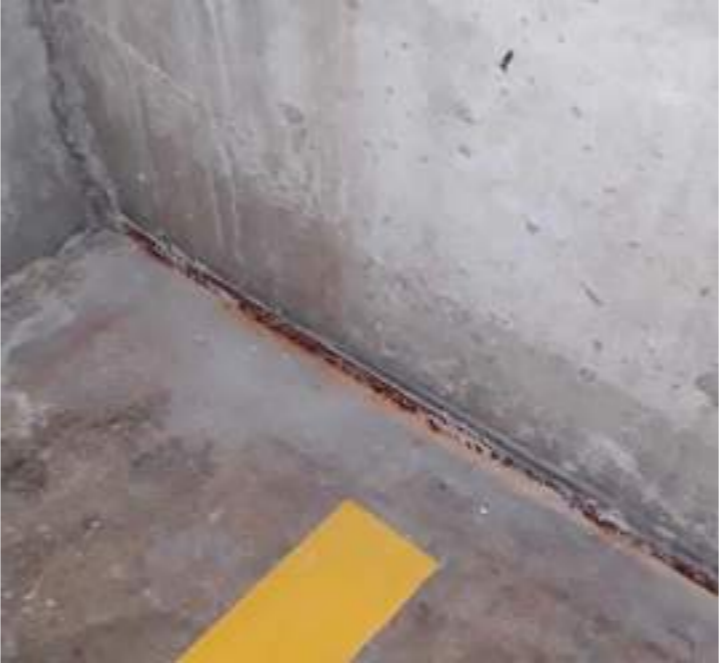
DEFECT NO.	LOCATION	AREA	BREACH	PHOTOGRAPH	DEFECT DESCRIPTION
C 126	Basement 2	Parking bay 24	See section 8.19 of this report.  Structural engineer to inspect.

Exposed reinforcement bar corroding.
C 127	Basement 2	Parking bay 24	See section 8.19 of this report.  Structural engineer to inspect.

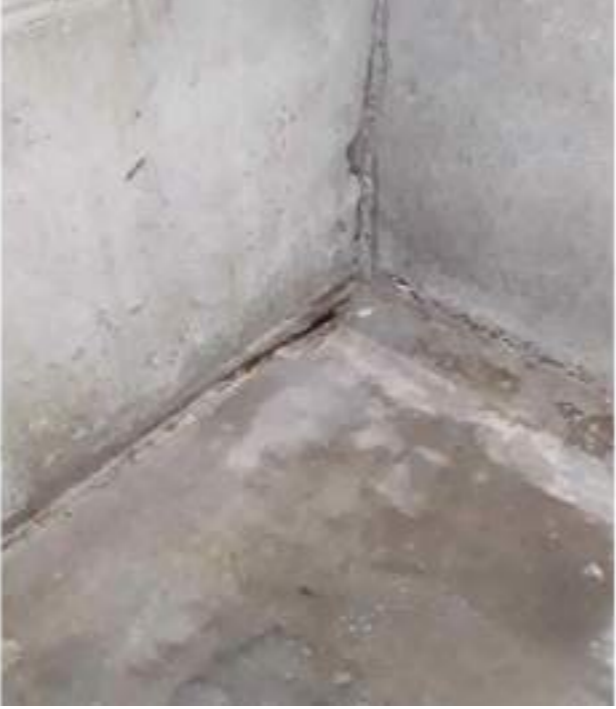
Exposed and corroding reinforcement.

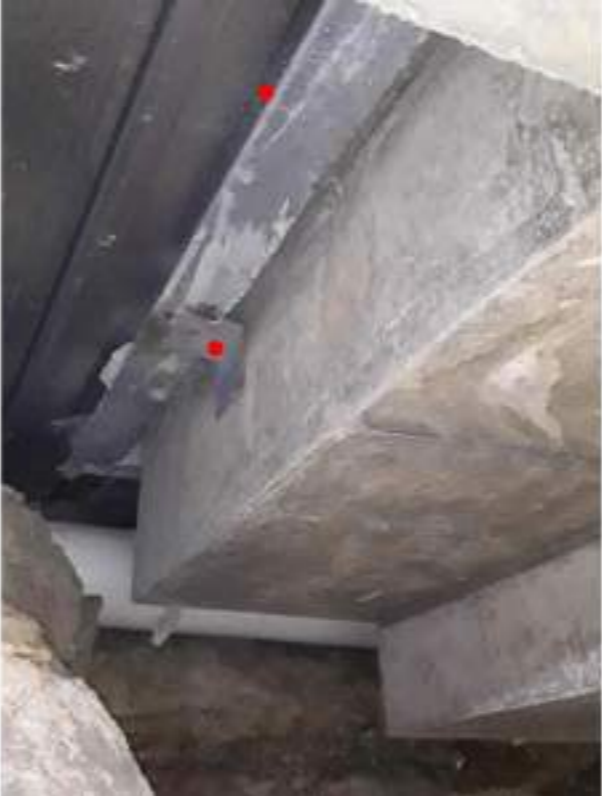
Corroding reinforcement.
C 129	Basement 2	North of building - adjacent to ramp	Structural engineer to inspect.

Shelf angle installed without fixings and not grout packed to support Bondek.

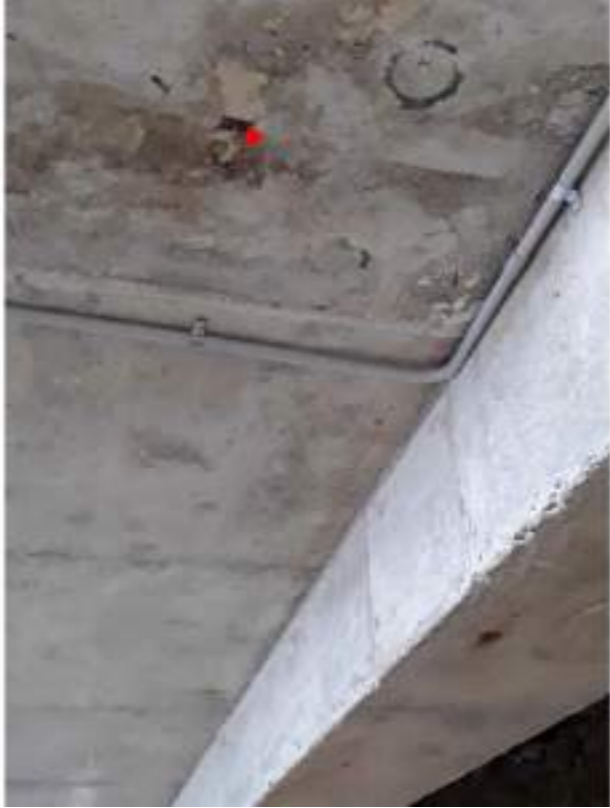
Corroded reinforcements to base of ramp.
C 131	Basement 2	North of building - adjacent to ramp	See section 8.19 of this report. Structural engineer to inspect.

Exposed reinforcement to base of ramp.

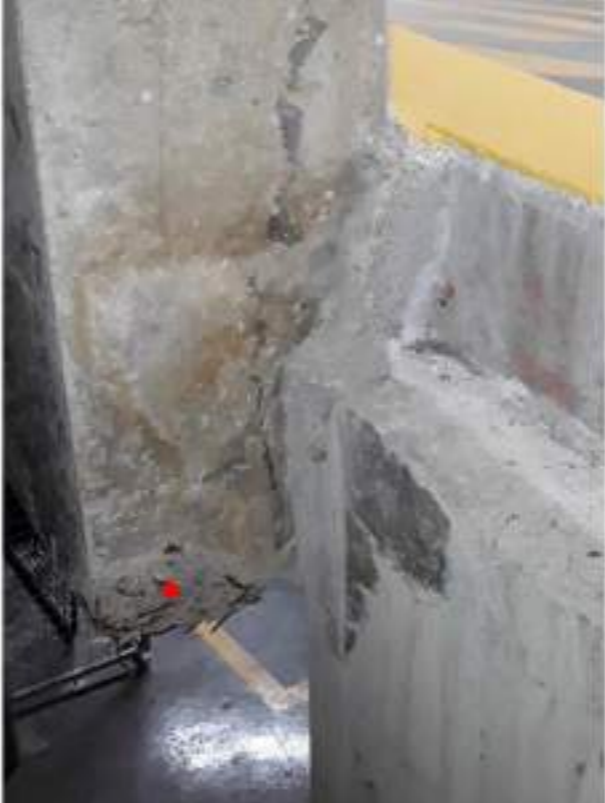
Retained formwork in moist environment. Will attract termites.
C 133	Basement 2	North of building - adjacent to ramp	Works have not been completed with due care and skill.

Concrete beam filled with the debris.

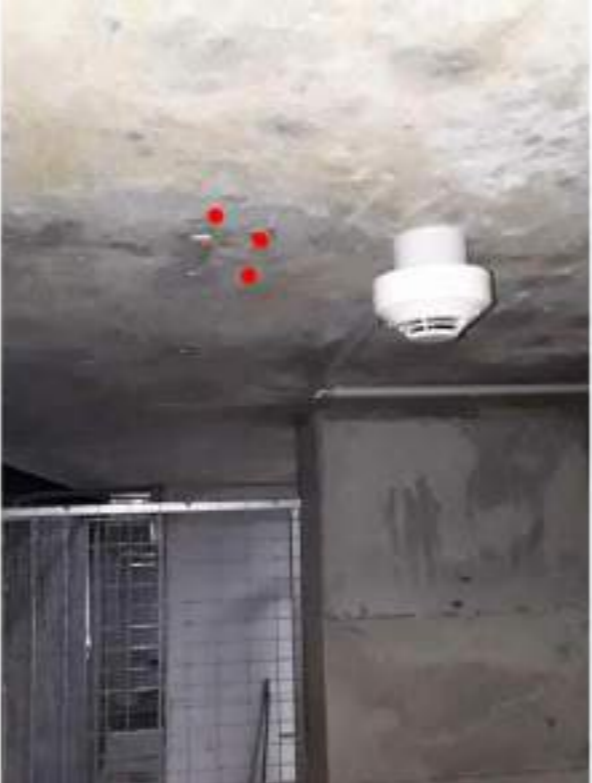
Concreting has not been completed with due care and skill.
C 135	Basement 2	North of building - adjacent to ramp	See section 8.19 of this report.  Structural engineer to inspect.

Corrosion to concrete soffit adjacent to ramp.

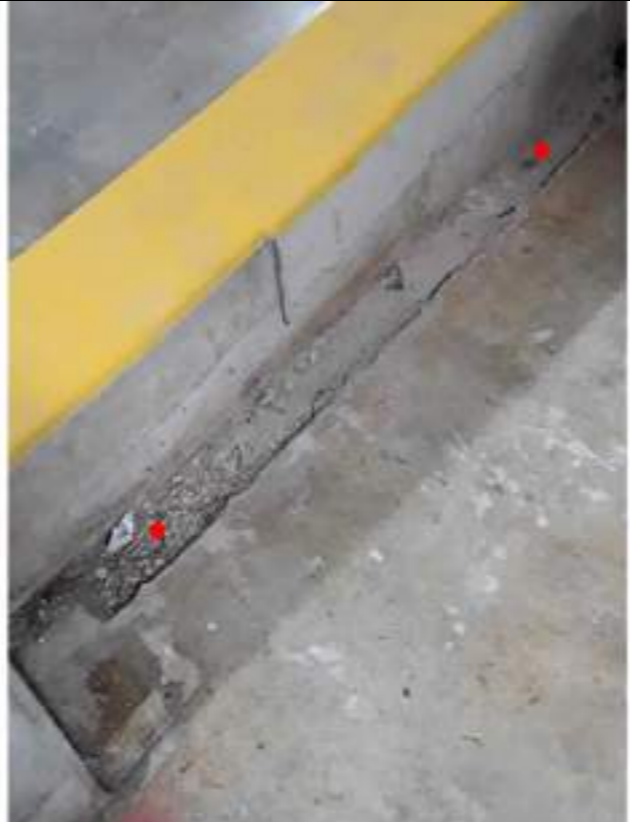
Exposed reinforcement to soffit of concrete ramp.
C 137	Basement 2	North of building - adjacent to ramp	Works have not been completed with due care and skill.

Incomplete concreting.

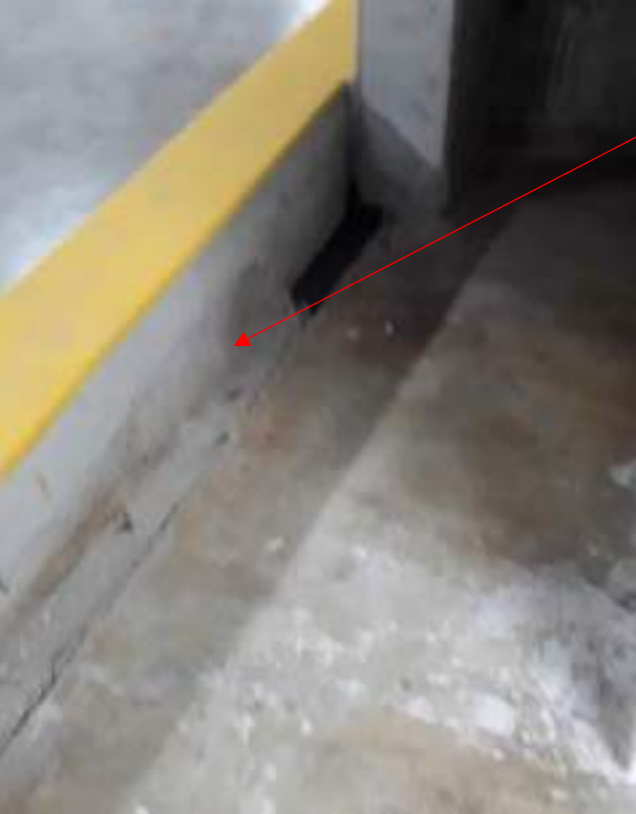
DEFECT NO.	LOCATION	AREA	BREACH	PHOTOGRAPH	DEFECT DESCRIPTION
C 138	Basement 2	North of building - adjacent to ramp	Works have not been completed with due care and skill.

Missing concrete.
C 139	Basement 2	Lift area	Incomplete work.

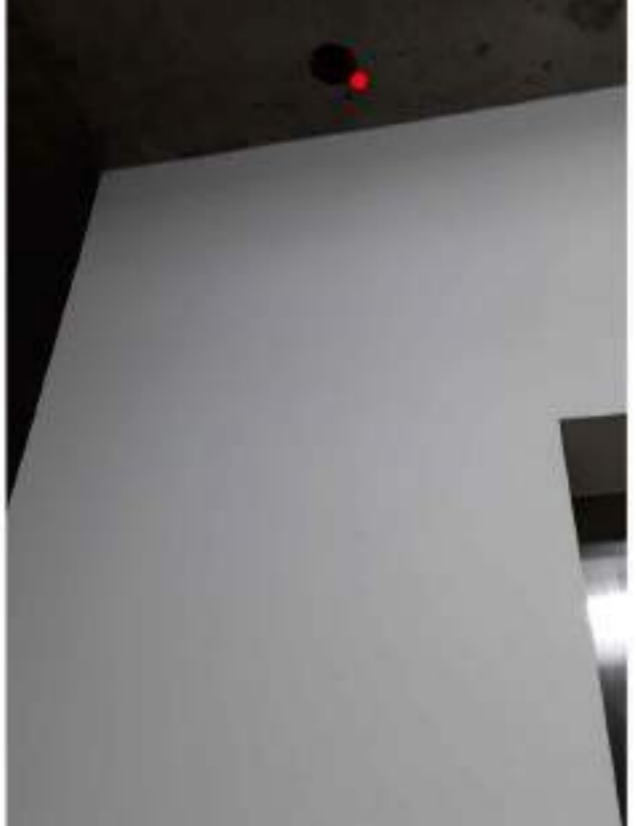
Open conduits.

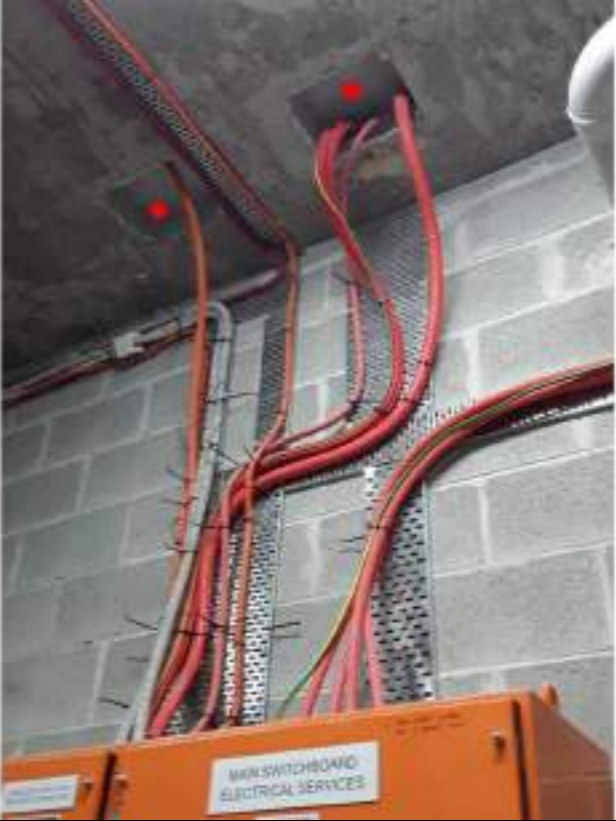
DEFECT NO.	LOCATION	AREA	BREACH	PHOTOGRAPH	DEFECT DESCRIPTION
C 140	Main switch room	Slab penetration	Fire engineer to inspect.

Open fire rated riser.
C 141	Main switch room	Slab penetration	Fire engineer to inspect.

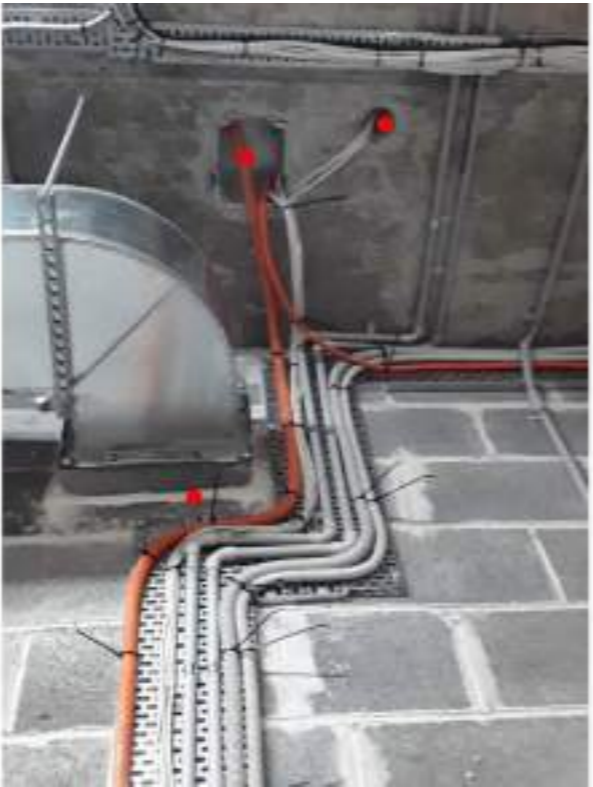
Fire safety consultant to inspect fire rating.

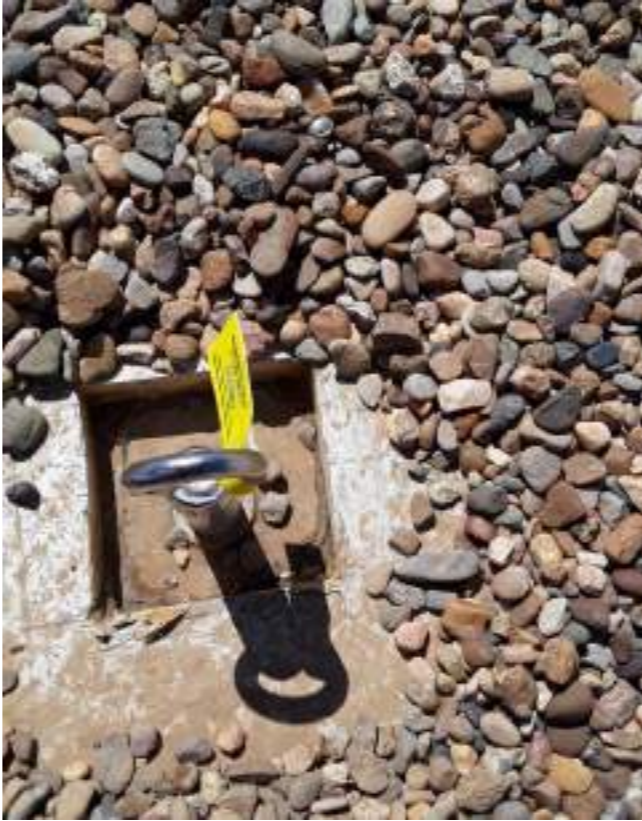
Roof anchor points.
C 145	Building L - Roof	Anchor bolt	See section 8.11 of this report.  Not fit for purpose.

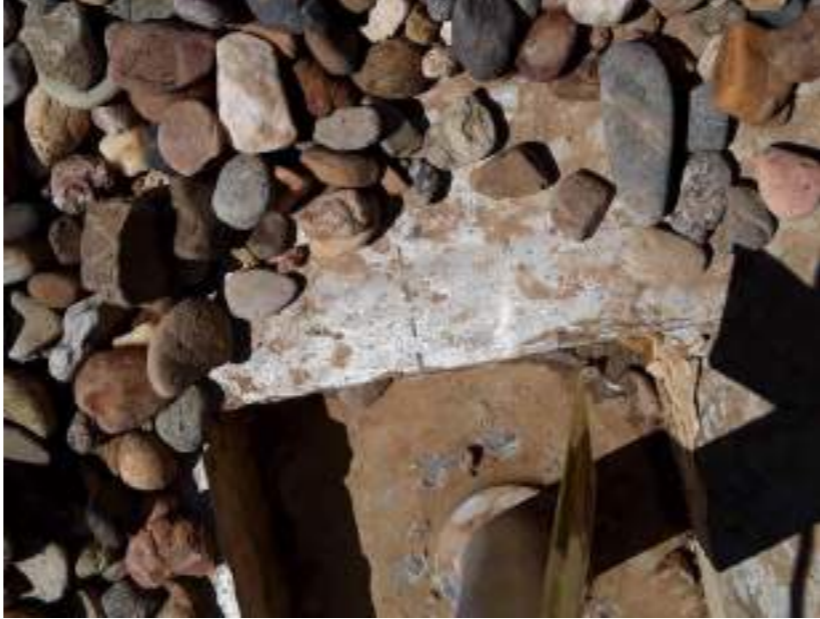
Waterproofing is failing.  Adhesion failure between layers.
