Mitchell Ave Developments P/L vs Fore Sydney Constructions P/L  
Report issued: 25 February 2022  
Both Tramex and Protometre moisture meters are used to attain comparative Moisture readings

## **10.6 Attachment F - Defects Schedule**

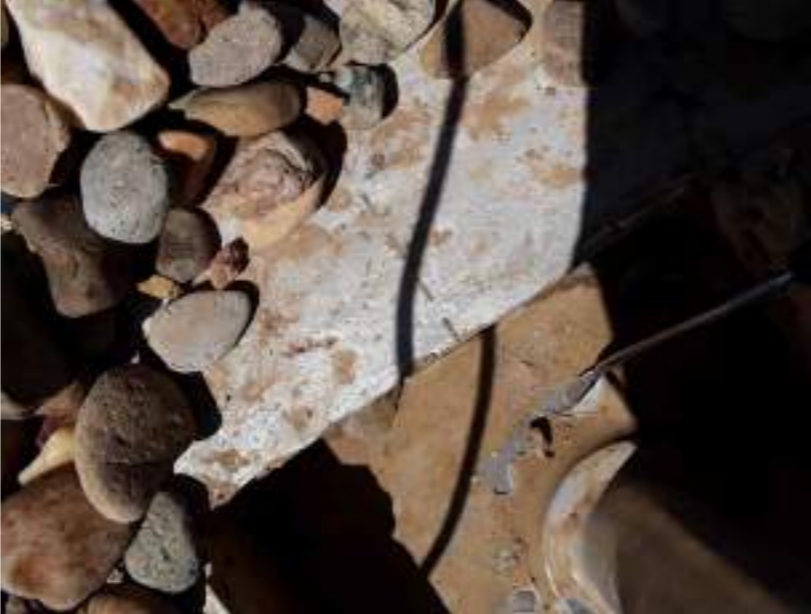
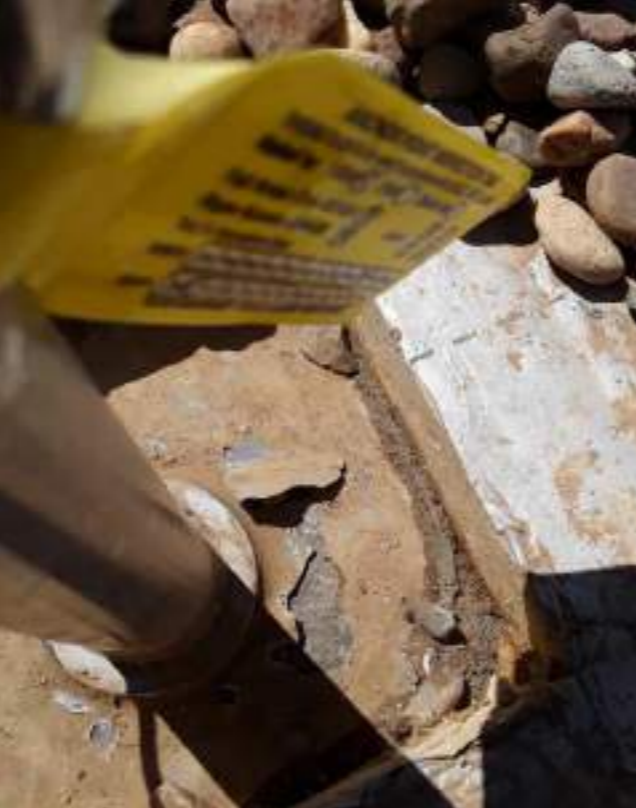
C 146	Building L - Roof	Anchor bolt	See section 8.11 of this report.  Not fit for purpose.

Waterproofing is failing.  Adhesion failure between layers.

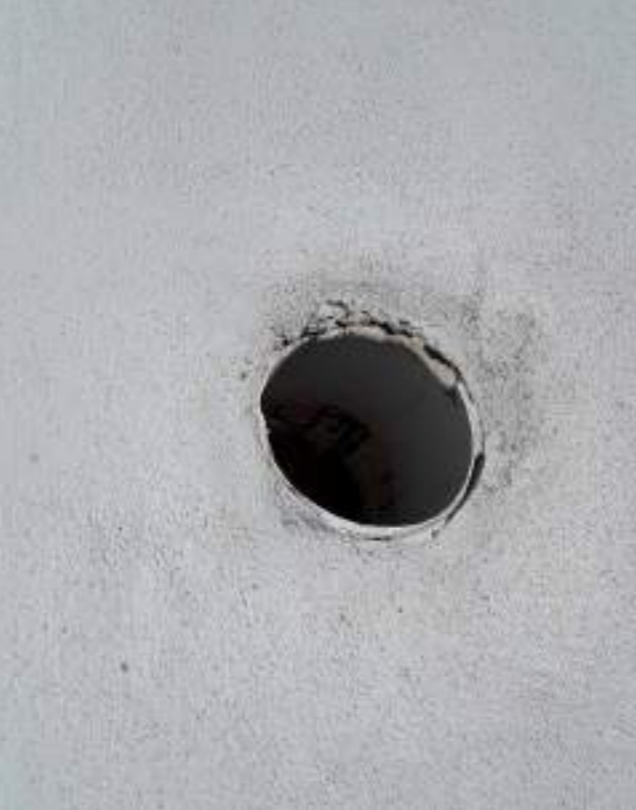
<ul style="list-style-type: none"> <li>A. Waterproofing not turned down into floor waste.</li> <li>B. Puddle flange has not been provided.</li> <li>C. Drain cover not installed as required by AS4654.2.</li> </ul>

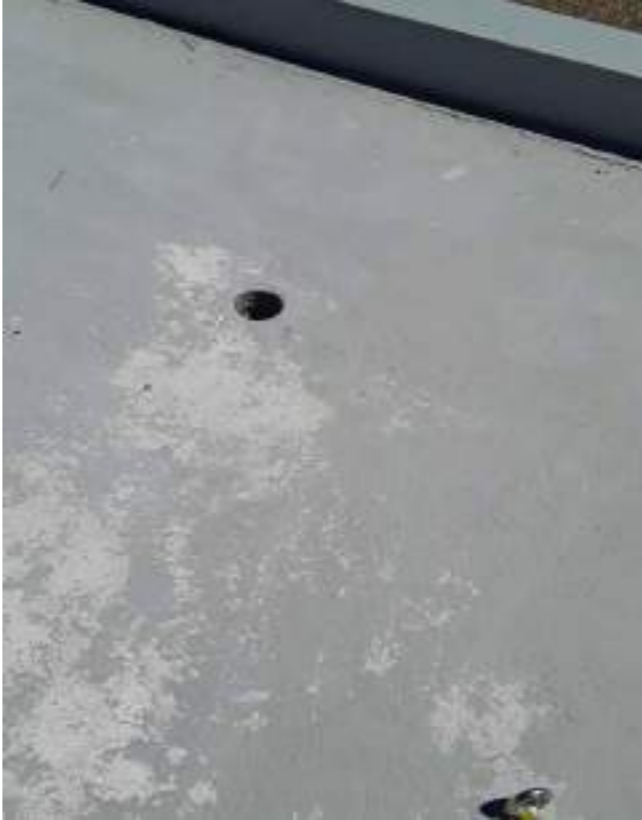
A. Waterproofing not turned down into floor waste. B. Puddle flange has not been provided. C. Drain cover not installed as required by AS4654.2.
C 150	Building L - Roof	Floor waste	See section 8.11 of this report.

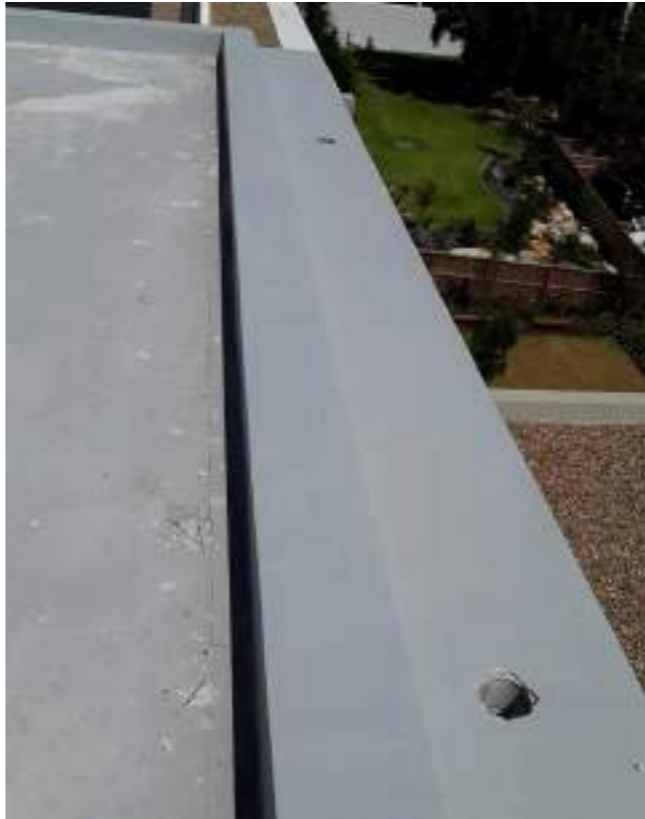
<ul style="list-style-type: none"> <li>A. Waterproofing not turned down into floor waste.</li> <li>B. Puddle flange has not been provided.</li> <li>C. Drain cover not installed as required by AS4654.2.</li> </ul>

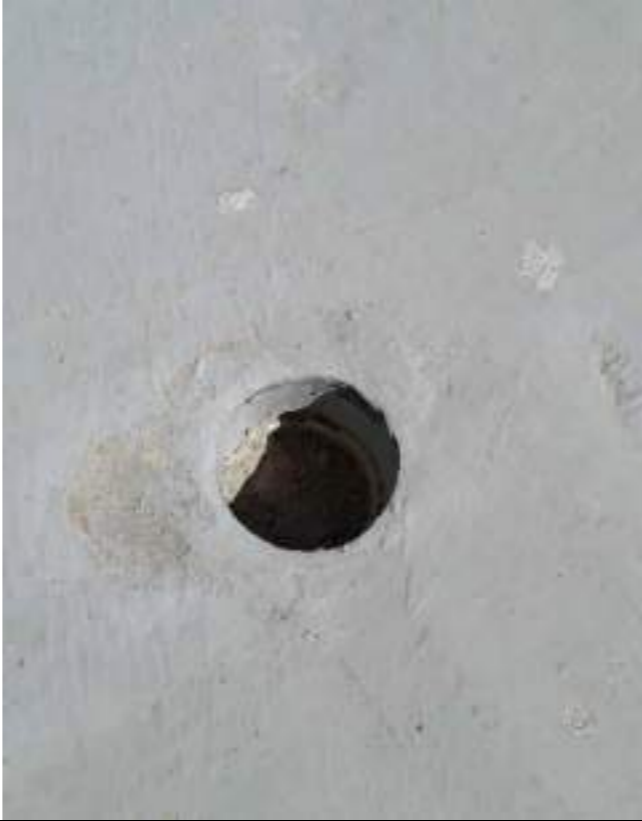
<ul style="list-style-type: none"> <li>A. Waterproofing not turned down into floor waste.</li> <li>B. Puddle flange has not been provided.</li> <li>C. Drain cover not installed as required by AS4654.2.</li> </ul>
C 154	Building L - Roof	Floor waste	See section 8.11 of this report.

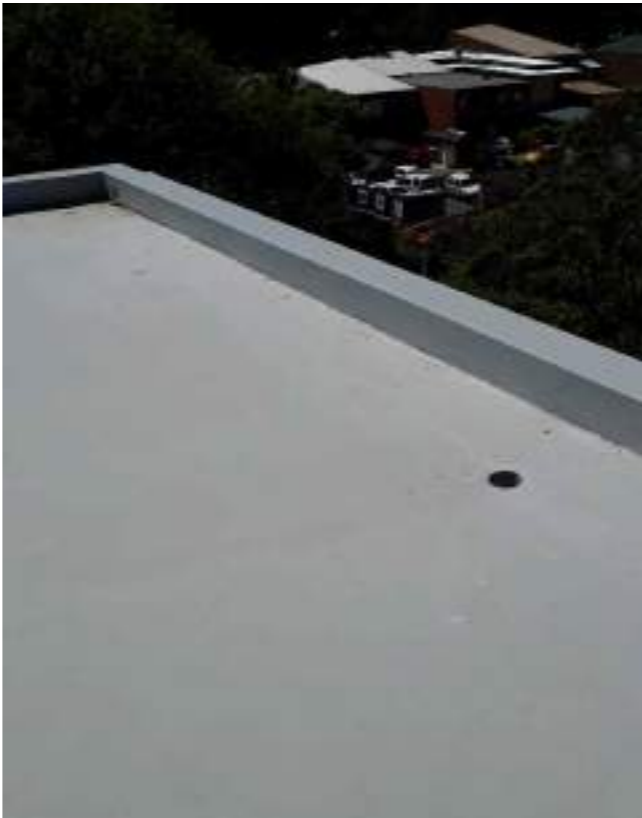
<ul style="list-style-type: none"> <li>A. Waterproofing not turned down into floor waste.</li> <li>B. Puddle flange has not been provided.</li> <li>C. Drain cover not installed as required by AS4654.2.</li> </ul>

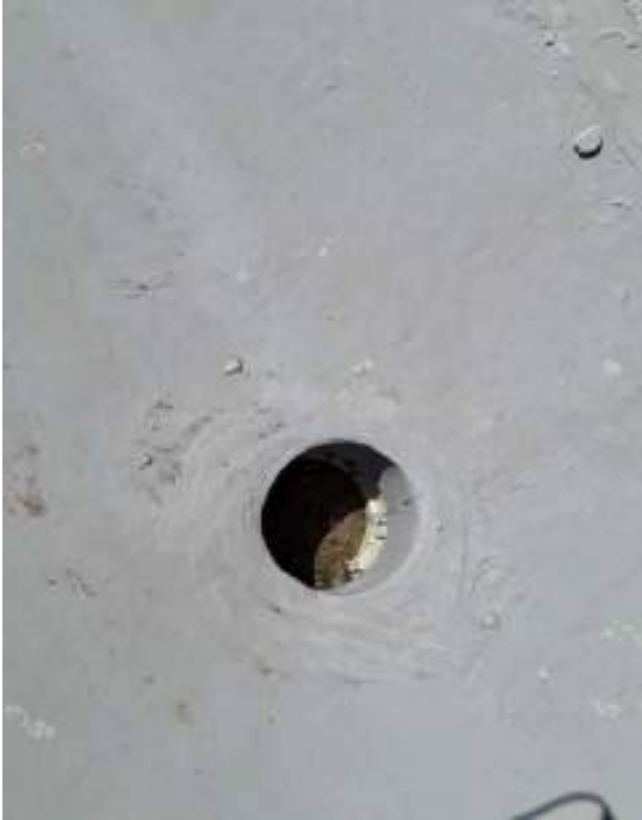
A. Puddle flange has not been provided. B. Drain cover not installed as required by AS4654.2.
C 156	Building L - Roof	Overflow	See section 8.8 of this report.

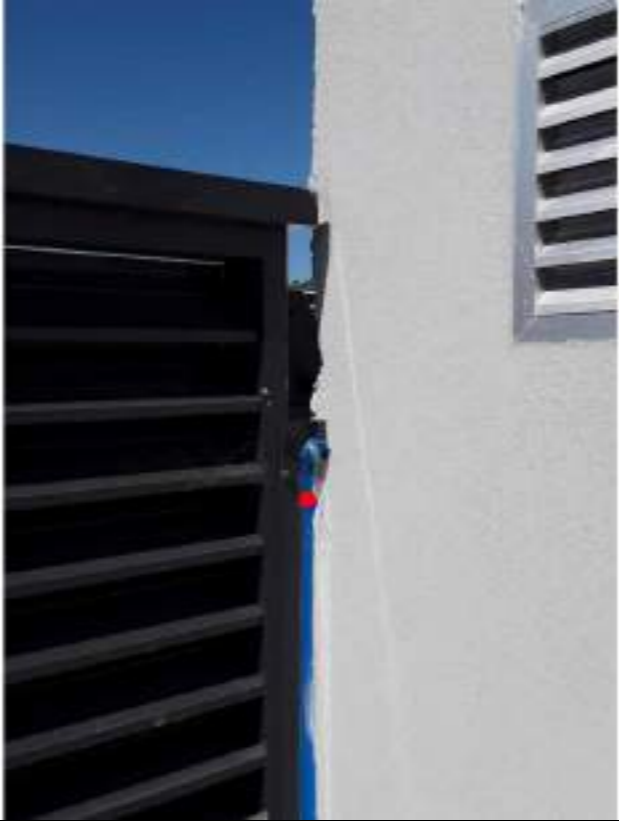
Render protection tape left in position. Incomplete work.
C 160	Building U - Roof	Base of wall	Works have not been completed with due care and skill.

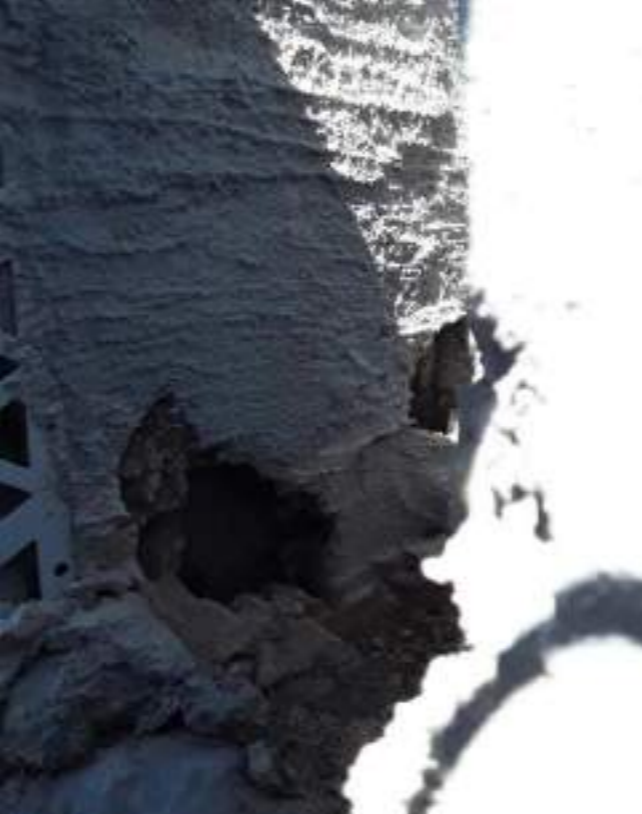
Voids in render finish.

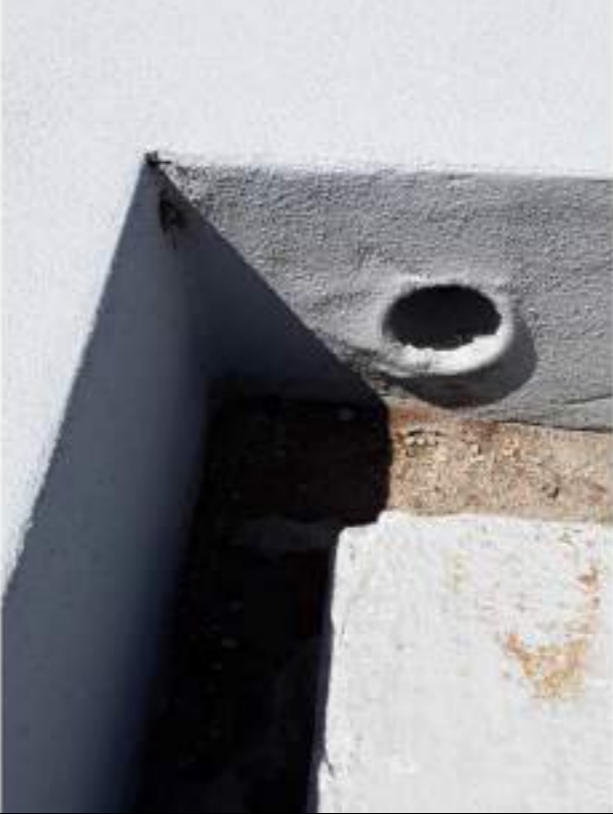
Waterproofing has not been turned into overflow.
C 162	Building U - Roof	Concrete hob	Works have not been completed with due care and skill.

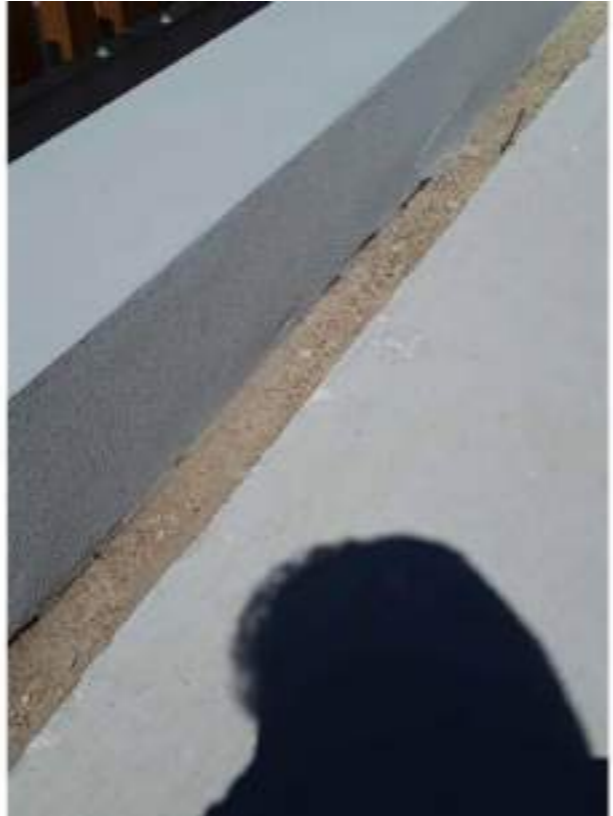
Concrete hob formwork timber has created set down to perimeter of roof which will allow water to pond in recess.

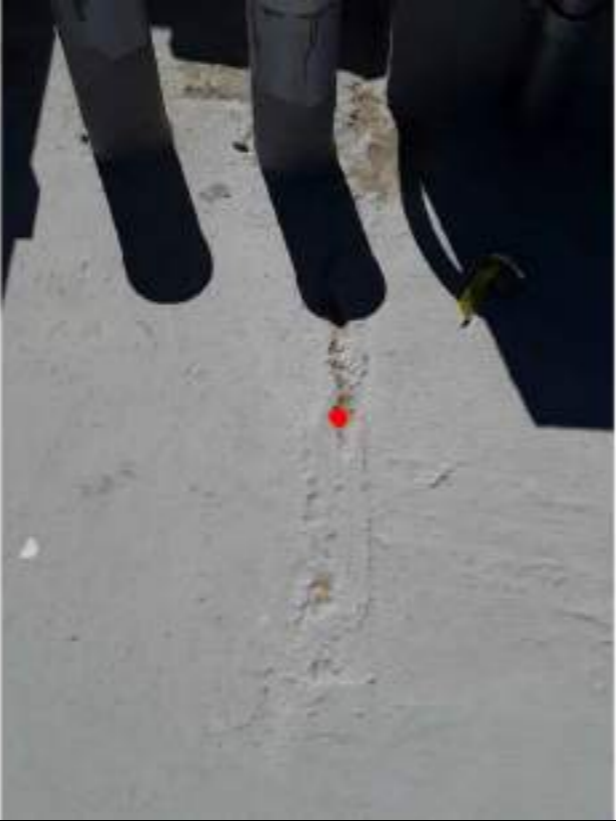
Rough substrate not suitable for waterproofing.  AS4654.2 requires a smooth substrate.
C 164	Building U - Roof	Concrete hob	Works have not been completed with due care and skill.

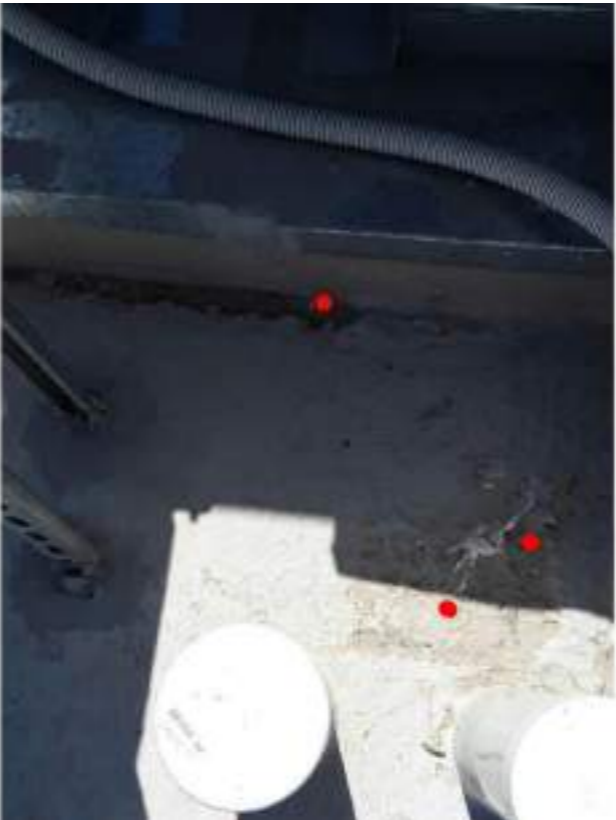
Rough substrate not suitable for waterproofing.  AS4654.2 requires a smooth substrate.

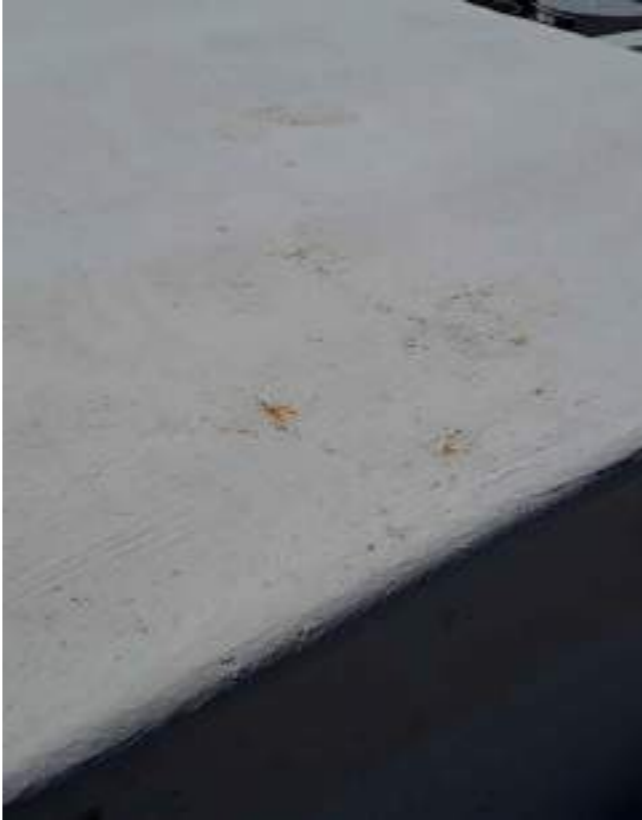
Corrosion.
C 166	Building U - Roof	Pipe penetration	See section 8.11 of this report.

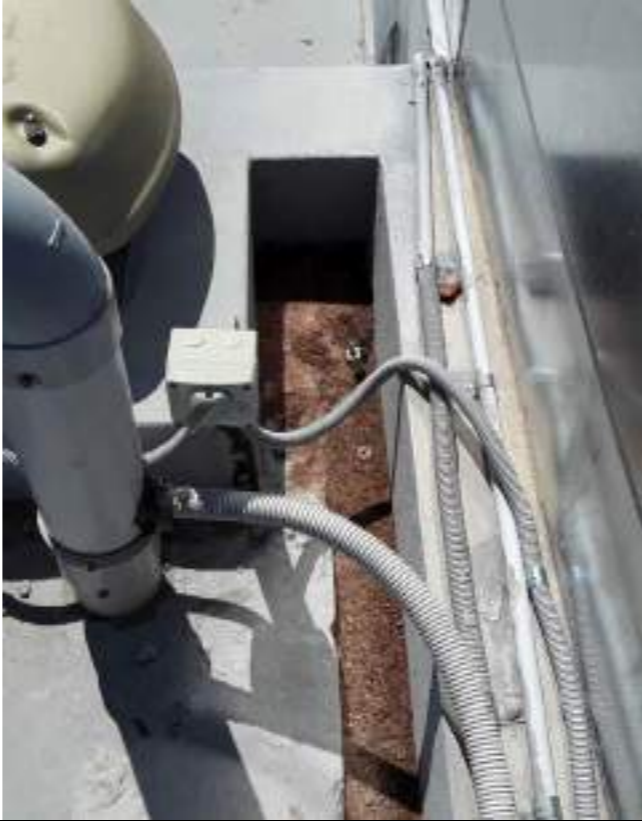
Concrete hob formwork timber has created set down to perimeter of roof which will allow water to pond in recess.
C 168	Building U - Roof	Open drain	See section 8.11 of this report.

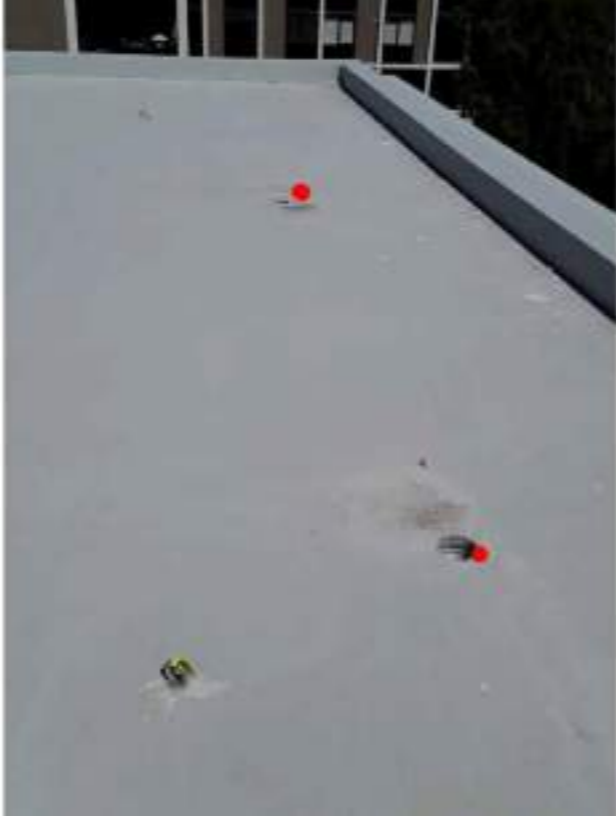
Open drains throughout rooftop. Waterproofing not turned down into floor waste.

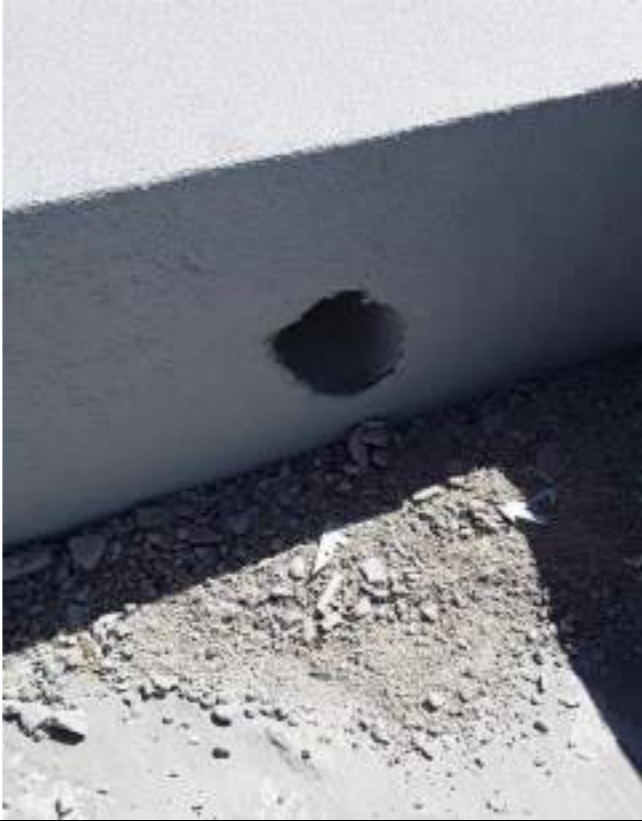
Overflows were filled with render debris.
C 170	Building U - Roof	Open drain	Works have not been completed with due care and skill.

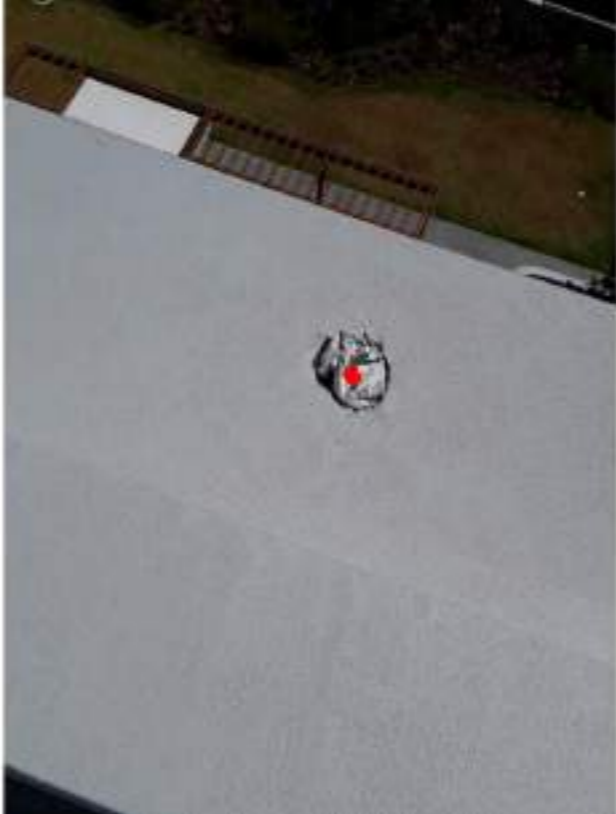
Paper bags stuffed into drain outlets throughout eave area.

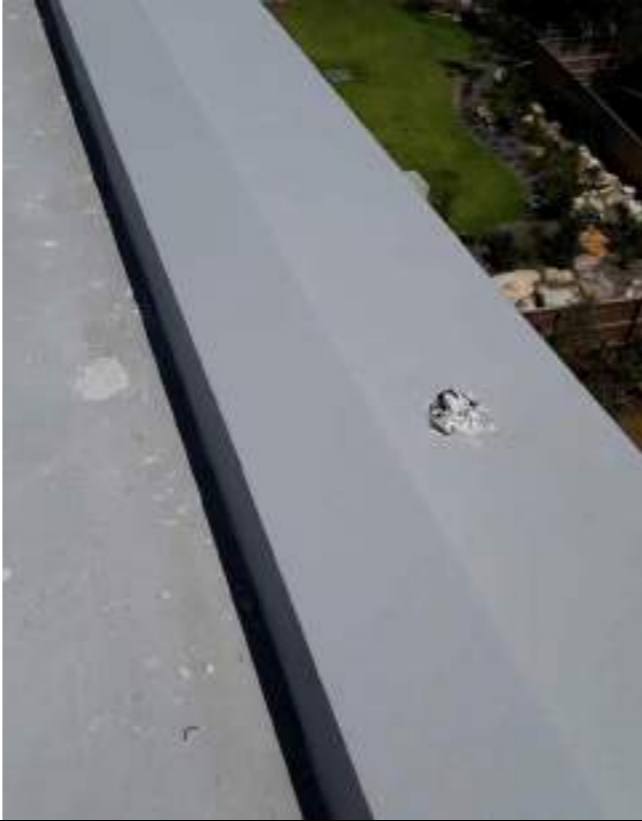
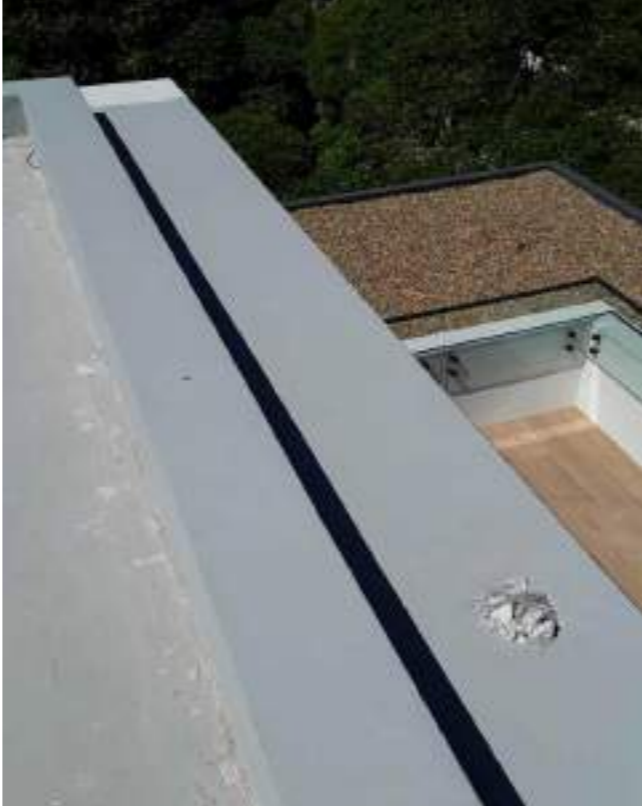
Paper bags stuffed into drain outlets throughout eave area.

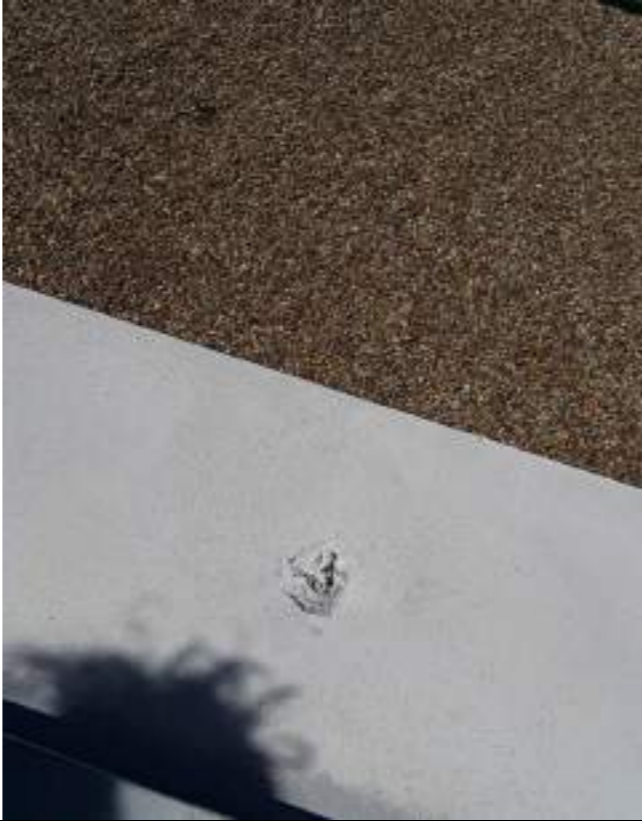
Paper bags stuffed into drain outlets throughout eave area.
C 173	Building U - Roof	Floor waste (spot 1)	See section 8.11 of this report.

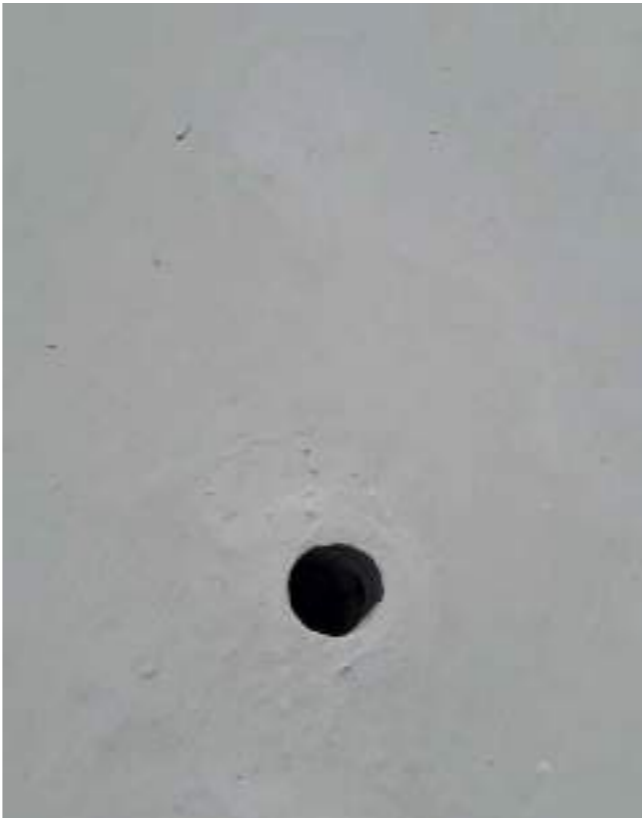
<ul style="list-style-type: none"> <li>A. Waterproofing not turned down into floor waste.</li> <li>B. Puddle flange has not been provided.</li> <li>C. Drain cover not installed as required by AS4654.2.</li> </ul>

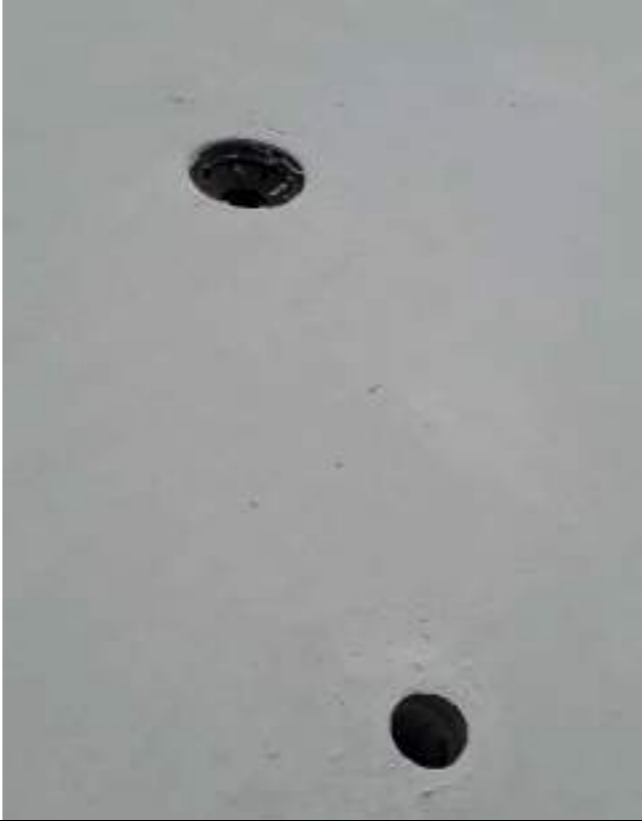
A. Waterproofing not turned down into floor waste. B. Puddle flange has not been provided. C. Drain cover not installed as required by AS4654.2.
C 175	Building L - Roof	Entry access ladder	Not fit for purpose.

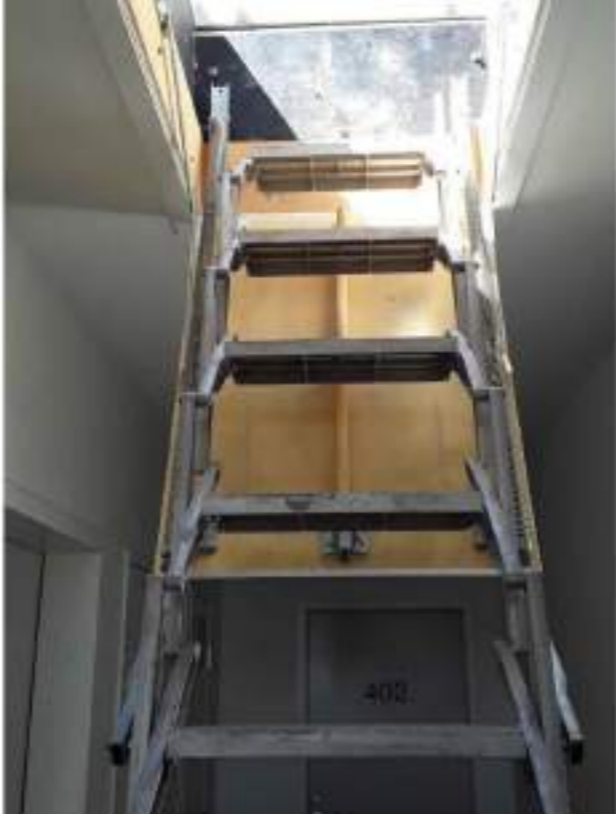
Domestic access ladder not to AS1657.

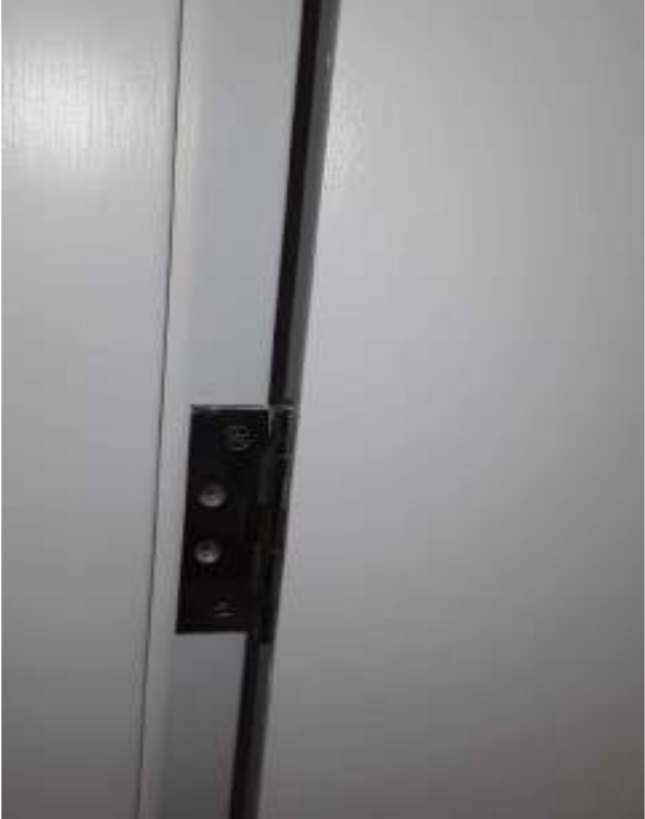
Missing screws to door hinge.

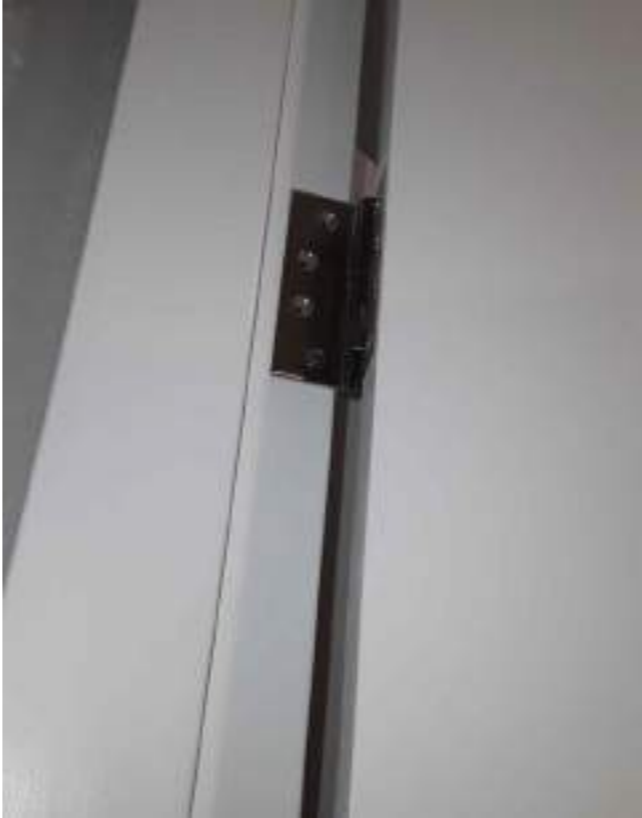
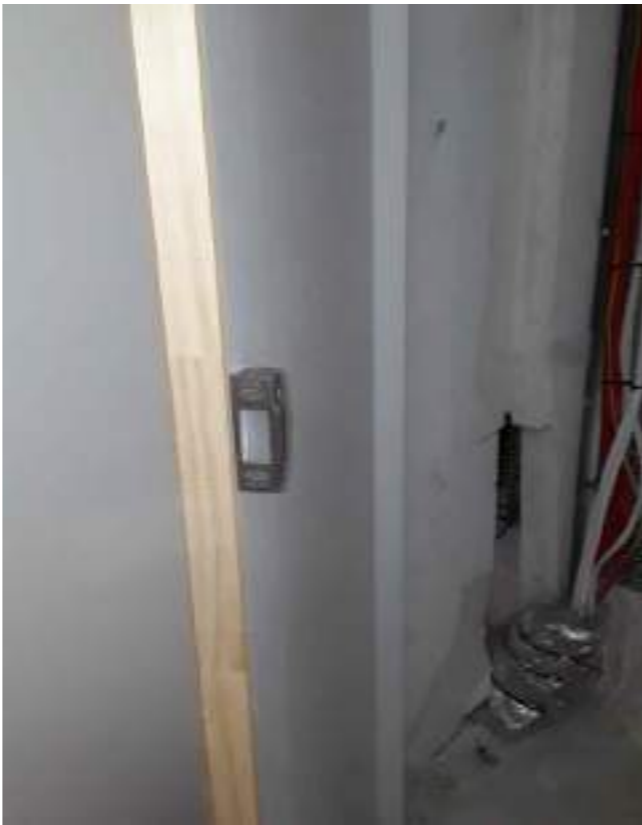
Incomplete plasterboard.

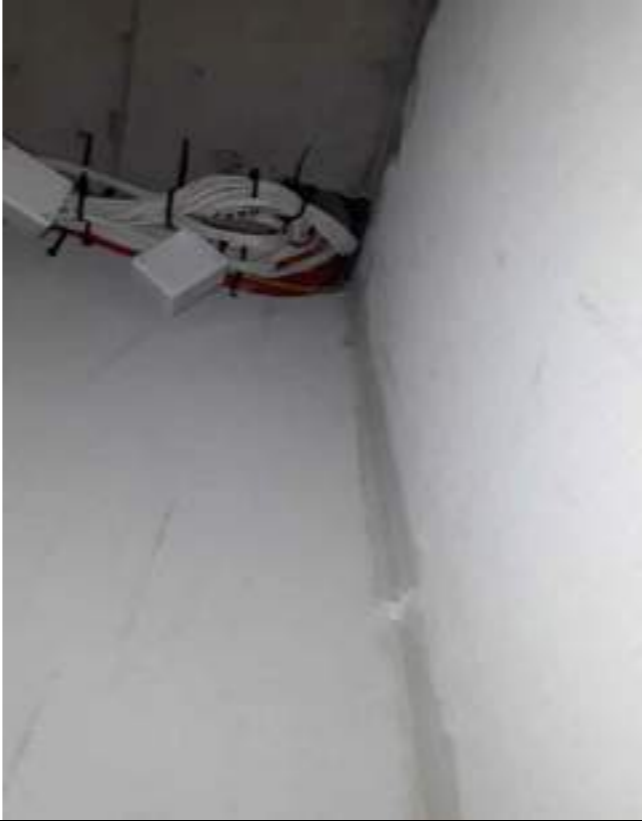
DEFECT NO.	LOCATION	AREA	BREACH	PHOTOGRAPH	DEFECT DESCRIPTION
C 181	Level G lobby	Service riser	Fire engineer to inspect.

Possible non-compliant fire rating.
C 182	Level G lobby	Service riser	Fire engineer to inspect.

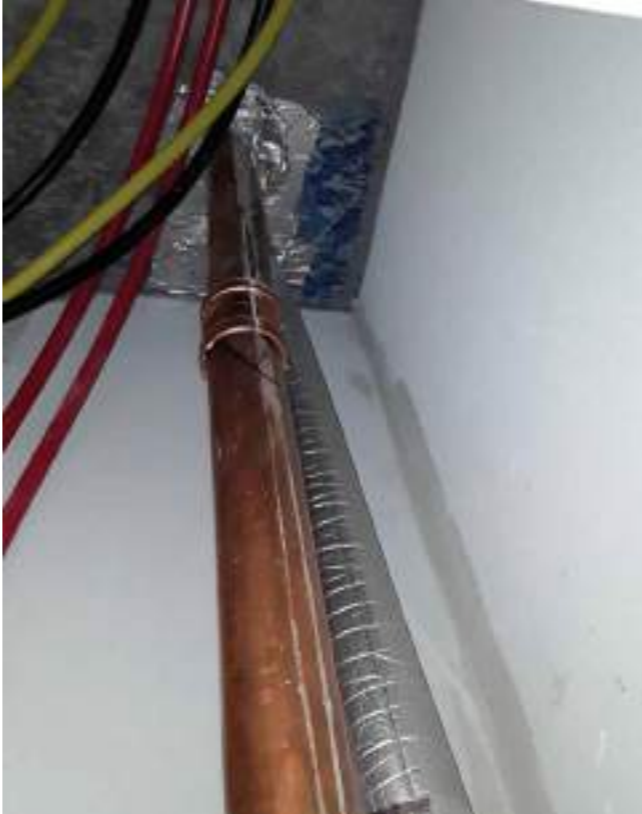
Possible non-compliant fire rating.

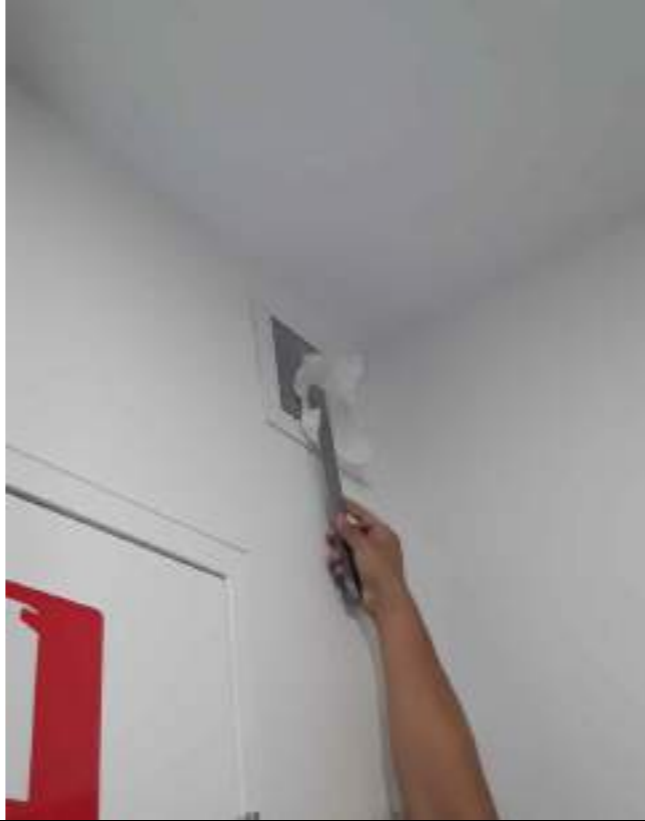
DEFECT NO.	LOCATION	AREA	BREACH	PHOTOGRAPH	DEFECT DESCRIPTION
C 183	Level G lobby	Exhaust fan	Not fit for purpose.

Lobby area ventilation not operational.
C 184	Level G lobby	Service room	Incomplete work.

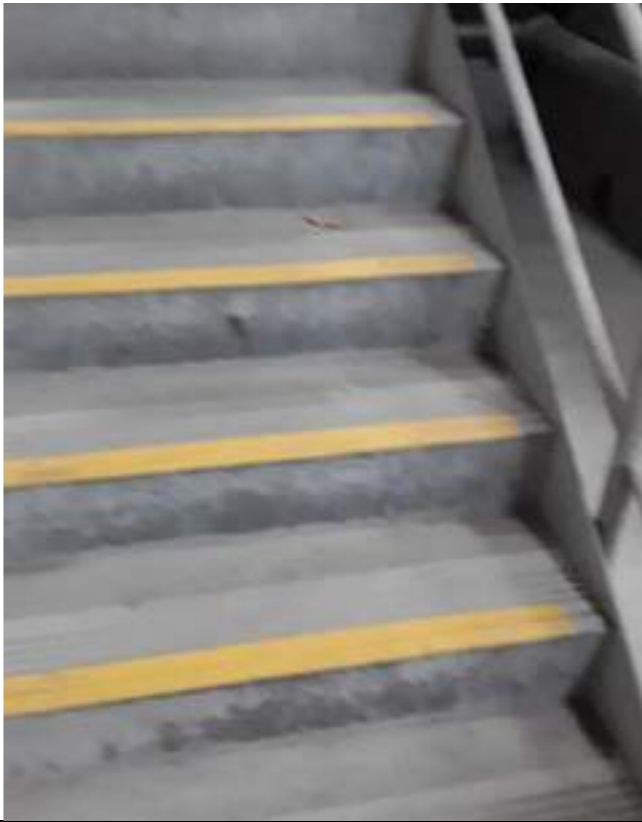
DEFECT NO.	LOCATION	AREA	BREACH	PHOTOGRAPH	DEFECT DESCRIPTION
C 185	Fire stair south of lift	Stair case nosing	See section 8.15 of this report.

<p>No nosing or compliant non-slip finish.</p> <p>Details of paint to be provided to identify if non-compliant and tested to AS4586.</p>
C 186	Upper ground level	Entry door threshold	See section 8.3 of this report.

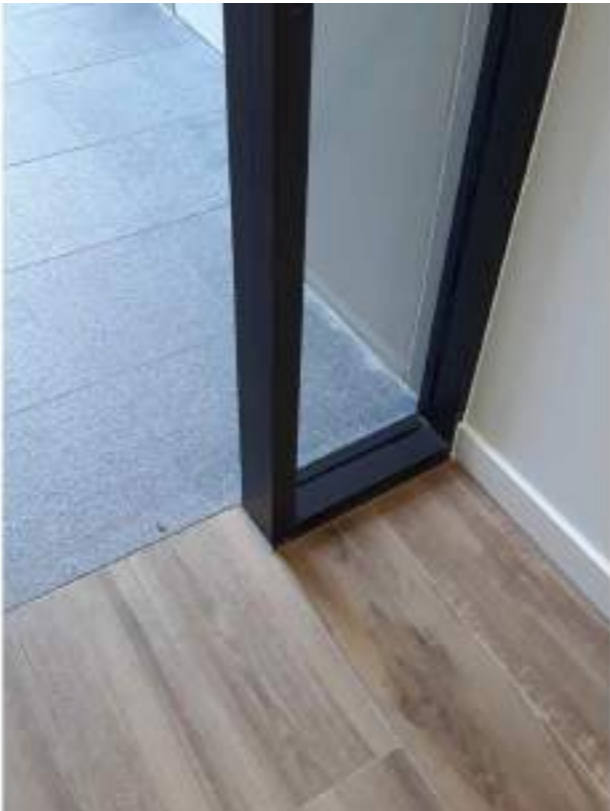
<p>No compliant threshold detail.</p>

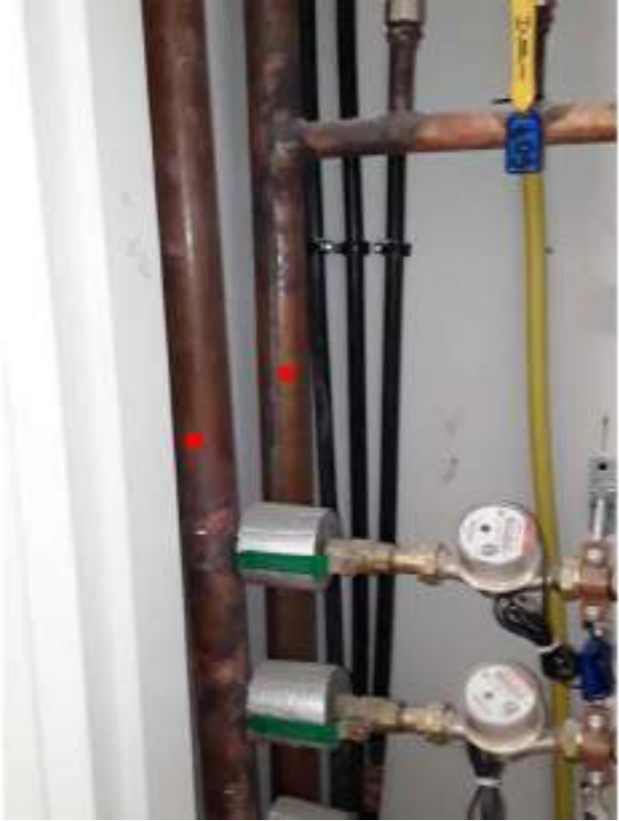
DEFECT NO.	LOCATION	AREA	BREACH	PHOTOGRAPH	DEFECT DESCRIPTION
C 189	Upper ground level	Service riser	Hydraulic engineer to inspect.

No insulation to hot pipes.
C 190	Upper ground level	Service riser	Fire engineer to inspect.

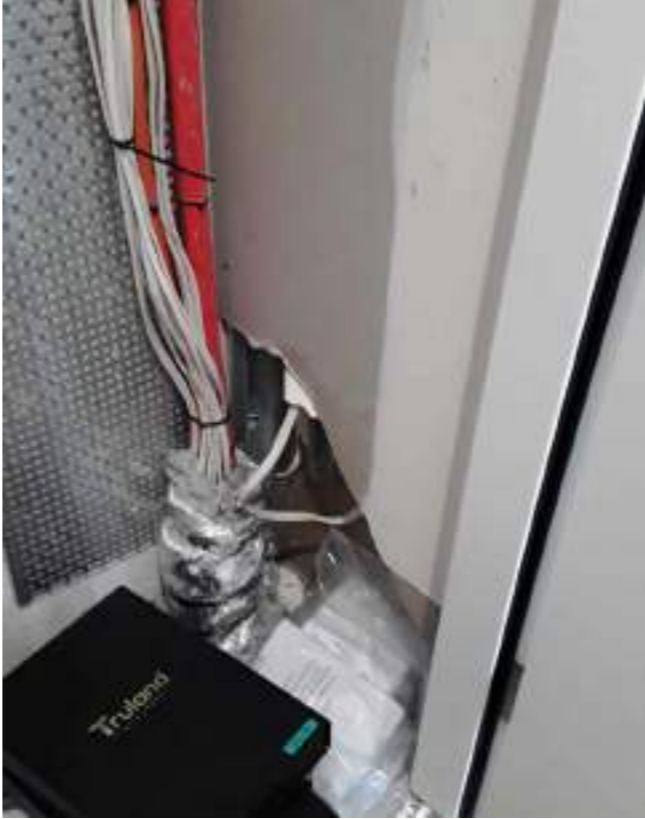
Incomplete plasterboard.

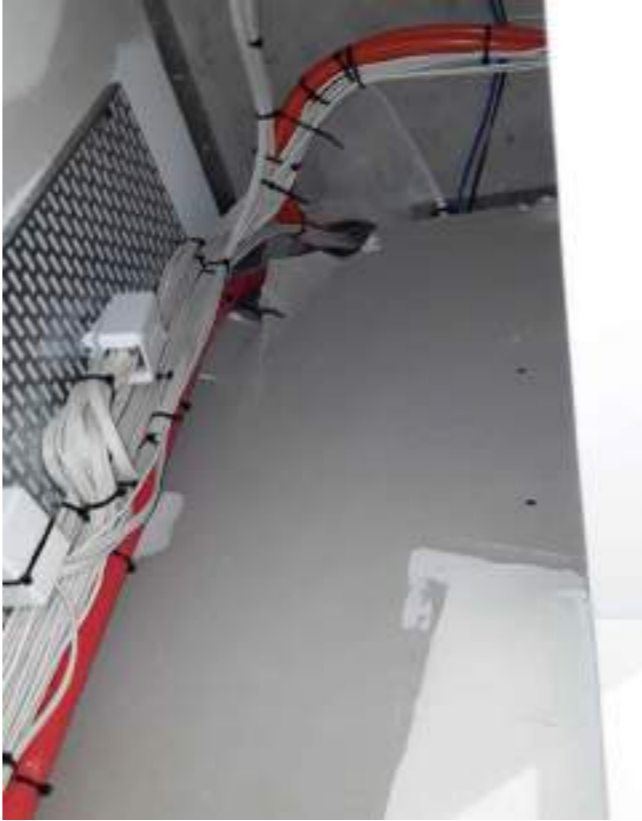
DEFECT NO.	LOCATION	AREA	BREACH	PHOTOGRAPH	DEFECT DESCRIPTION
C 191	Upper ground level	Service riser	Fire engineer to inspect.

Services penetrations in service riser.
C 192	Upper ground level	Service riser	Fire engineer to inspect.

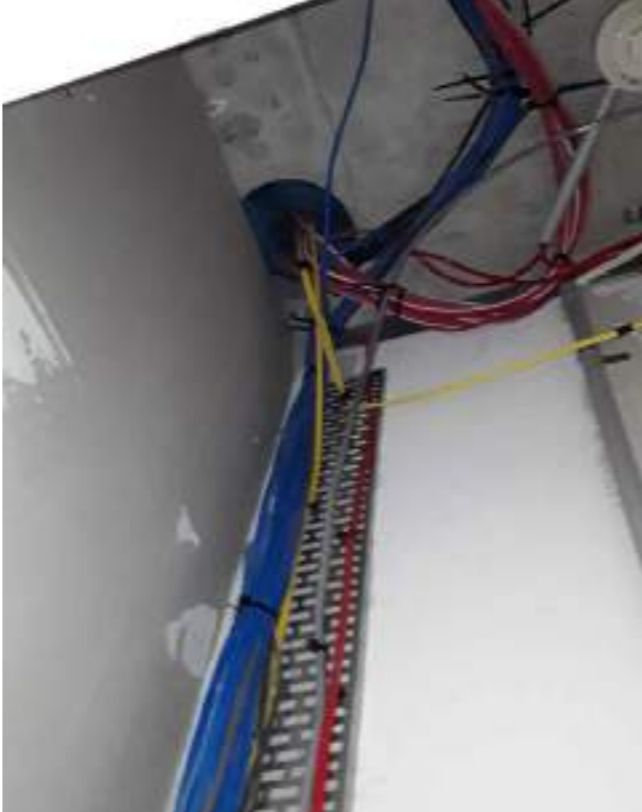
Services penetrations in service riser.

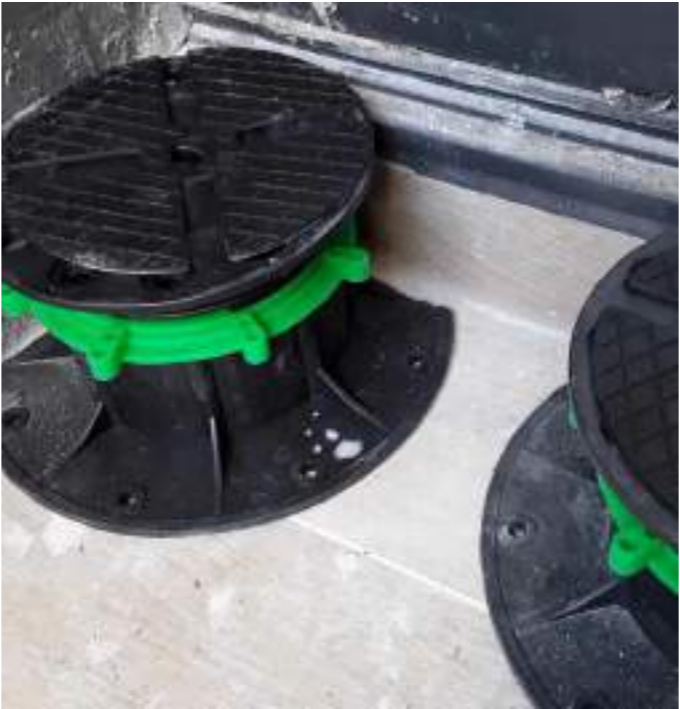
DEFECT NO.	LOCATION	AREA	BREACH	PHOTOGRAPH	DEFECT DESCRIPTION
C 193	Level U4 lobby	Balcony – door threshold	Note.

Paving pedestals installed over tiled surface.
C 194	Level U4 lobby	Balcony - handrail	See sections 8.5 and 8.26 of this report.

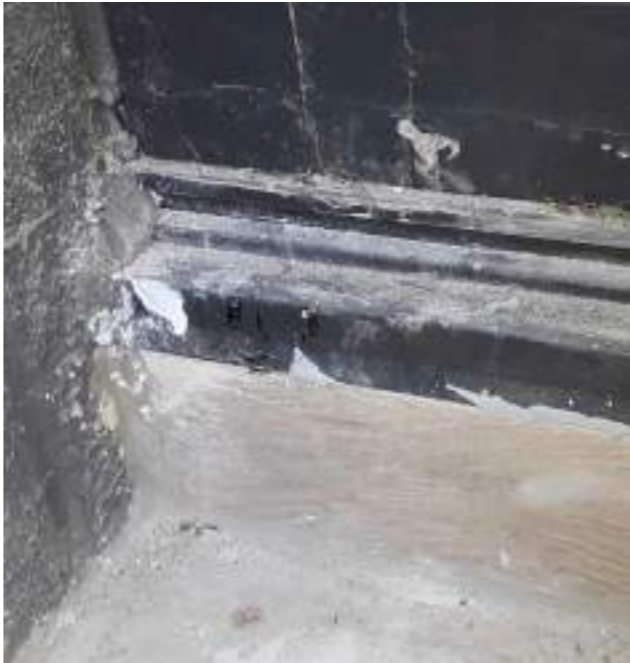
No waterstop.  Aluminium in contact with cement which will cause deterioration.
C 196	Level U4 lobby	Balcony – door threshold	See section 8.3 of this report.

No waterstop.  Aluminium in contact with cement which will cause deterioration.

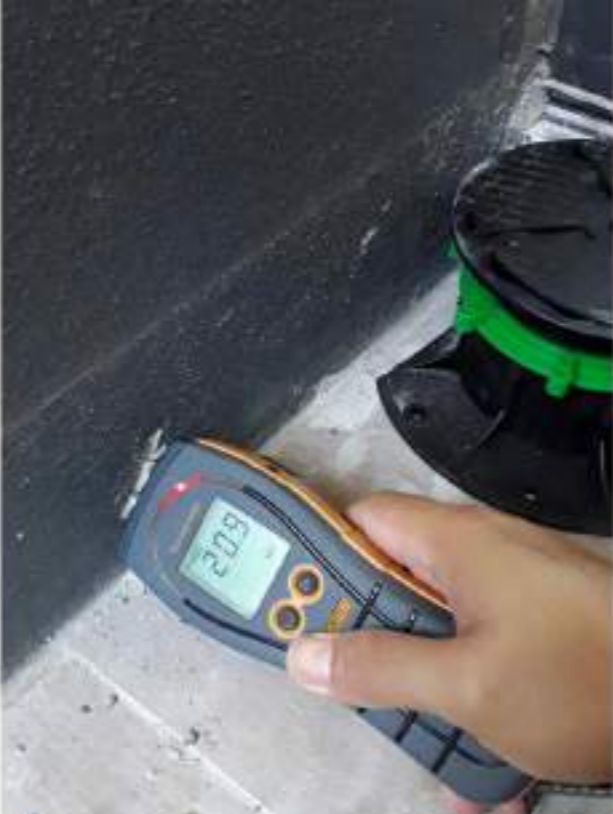
DEFECT NO.	LOCATION	AREA	BREACH	PHOTOGRAPH	DEFECT DESCRIPTION
C 197	Level U4 lobby	Balcony - handrail	See sections 8.5 and 8.26 of this report.

Elevated moisture to base of rendered wall.
C 198	Level U4 lobby	Balcony – overflow	See section 8.8 of this report.

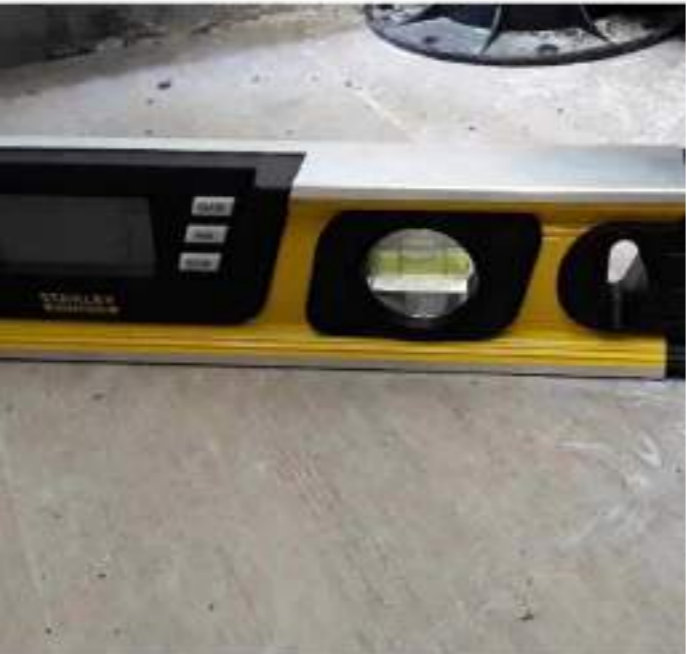
C 199	Level U4 lobby	Balcony – floor tiles	See section 8.4 of this report.

Fall of 3mm per m in tiled substrate.

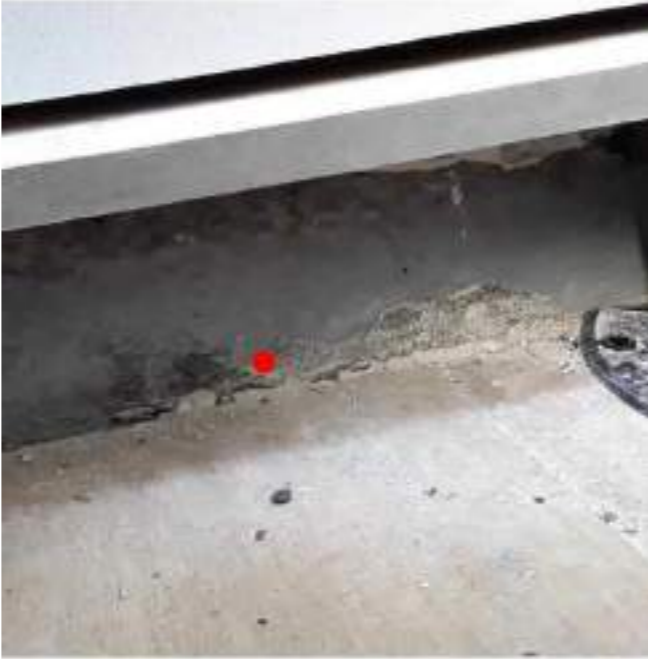
DEFECT NO.	LOCATION	AREA	BREACH	PHOTOGRAPH	DEFECT DESCRIPTION
C 200	Level U4 lobby	Balcony – door threshold	Note.

Visible upturned waterproof membrane.
C 201	Level U4 lobby	Balcony – Floor tiles	Not fit for purpose.
