Mitchell Ave Developments P/L vs Fore Sydney Constructions P/L  
Report issued: 25 February 2022  
Both Tramex and Protometre moisture meters are used to attain comparative Moisture readings

## **10.6 Attachment F - Defects Schedule**

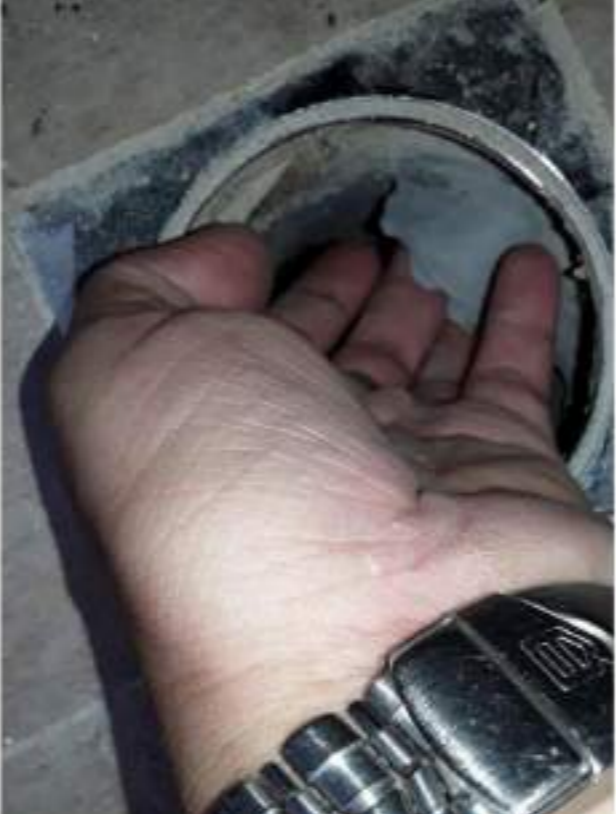
Visible upturned waterproof membrane.
C 201	Level U4 lobby	Balcony – Floor tiles	Not fit for purpose.

Adhesion failure of waterproof membrane.

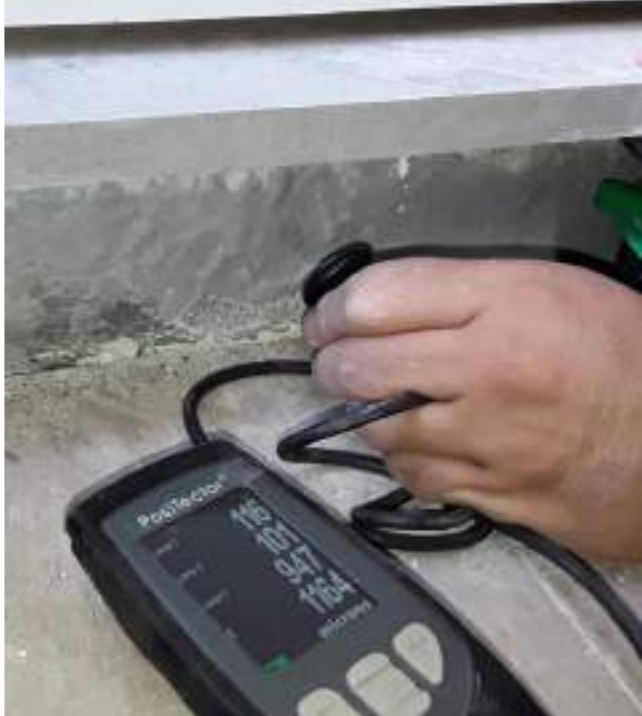
DEFECT NO.	LOCATION	AREA	BREACH	PHOTOGRAPH	DEFECT DESCRIPTION
C 202	Level U4 lobby	Balcony – door threshold	Note.

Membrane thickness of 1164 microns to upturn.
C 203	Level U4 lobby	Service risers	Fire engineer to inspect.

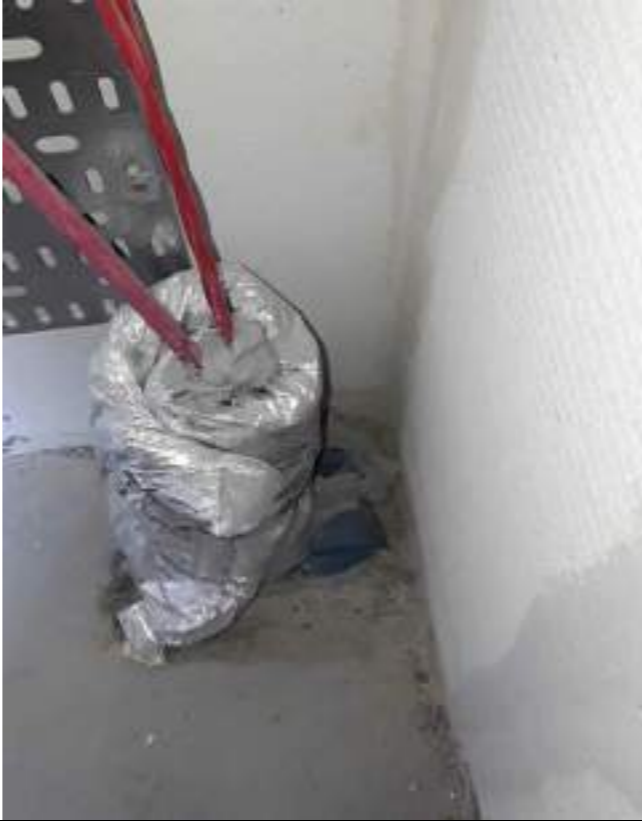
DEFECT NO.	LOCATION	AREA	BREACH	PHOTOGRAPH	DEFECT DESCRIPTION
C 204	Level U4 lobby	Service risers	Fire engineer to inspect.

Fire pillow and wrapping.
C 205	Level U4 lobby	Service risers	Fire engineer to inspect.	 	Black sealant used as fire rating.

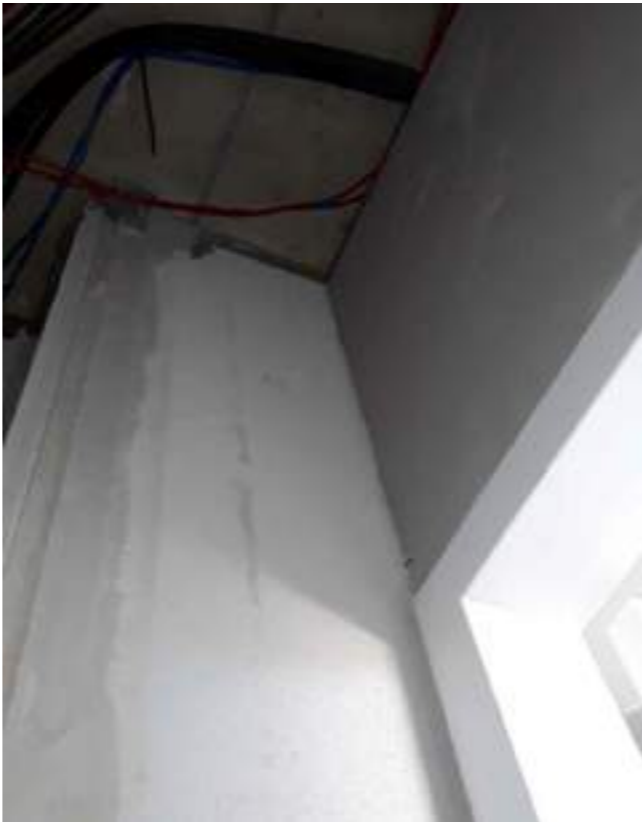
DEFECT NO.	LOCATION	AREA	BREACH	PHOTOGRAPH	DEFECT DESCRIPTION
C 210	Level 4 Lobby	Service risers	Fire engineer to inspect.

Services over wall.
C 211	Level 4 Lobby	Service risers	Fire engineer to inspect.

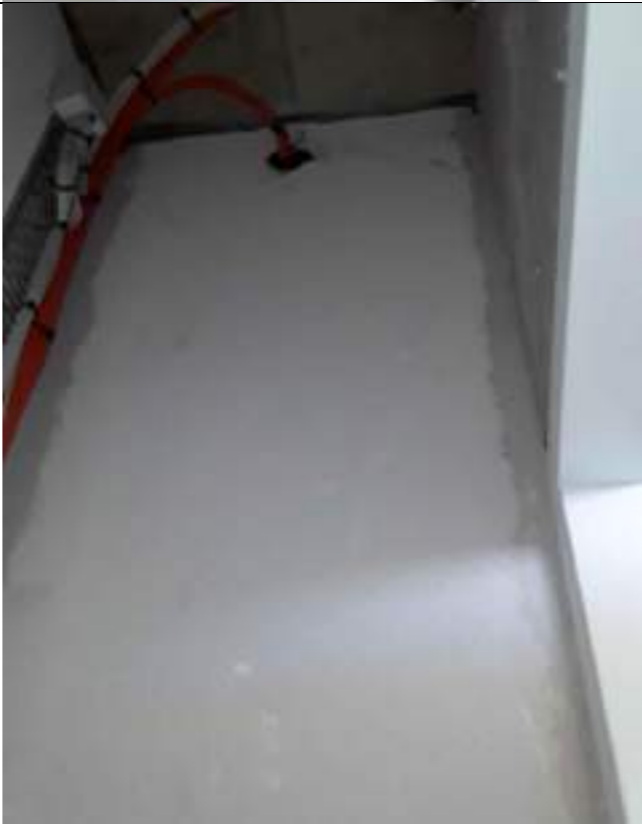
Black sealant in Hebel wall.

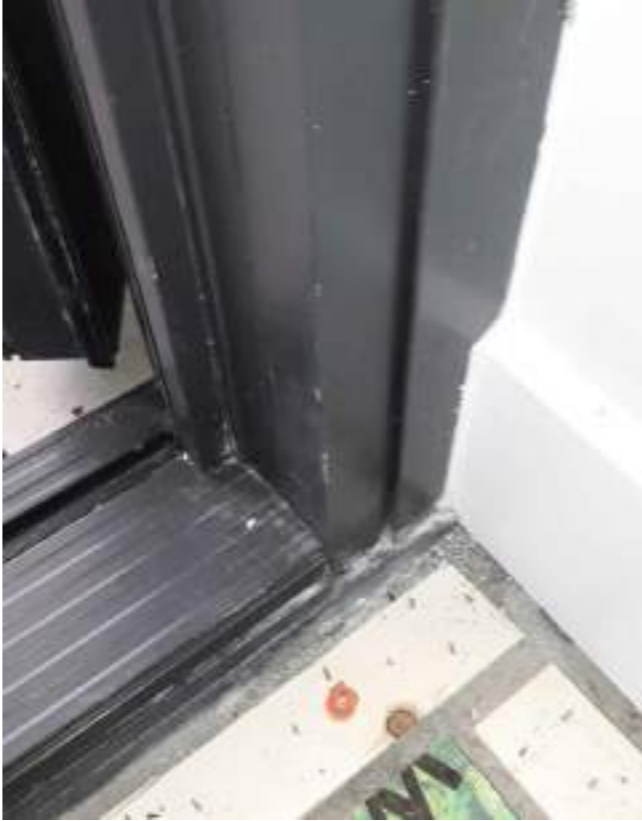
DEFECT NO.	LOCATION	AREA	BREACH	PHOTOGRAPH	DEFECT DESCRIPTION
C 212	Level 4 Lobby - balcony	Door threshold	See section 8.3 of this report.

A. No waterstop. B. Sliding door installed in contact with cement.
C 213	Level 4 Lobby - balcony	Cladding	See sections 8.5 and 8.26 of this report.

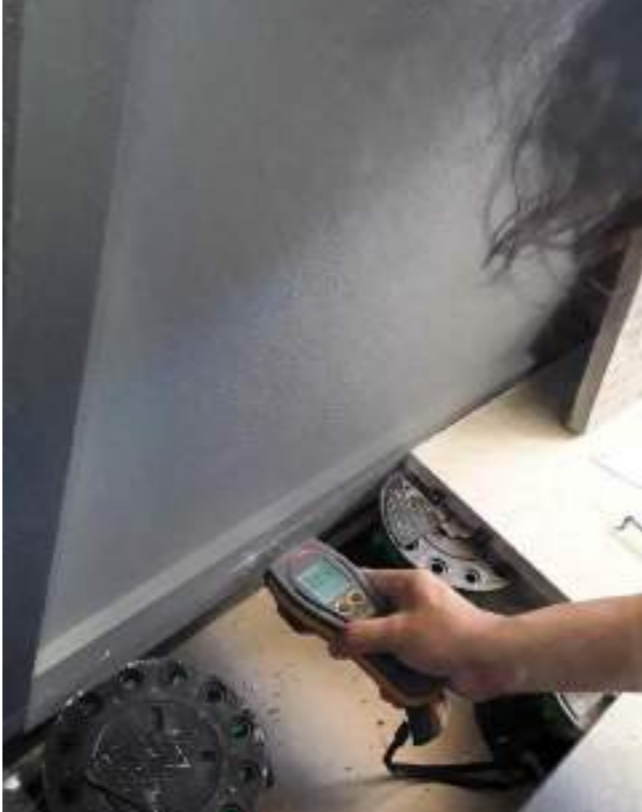
Elevated moisture to wall below tile pedestals.

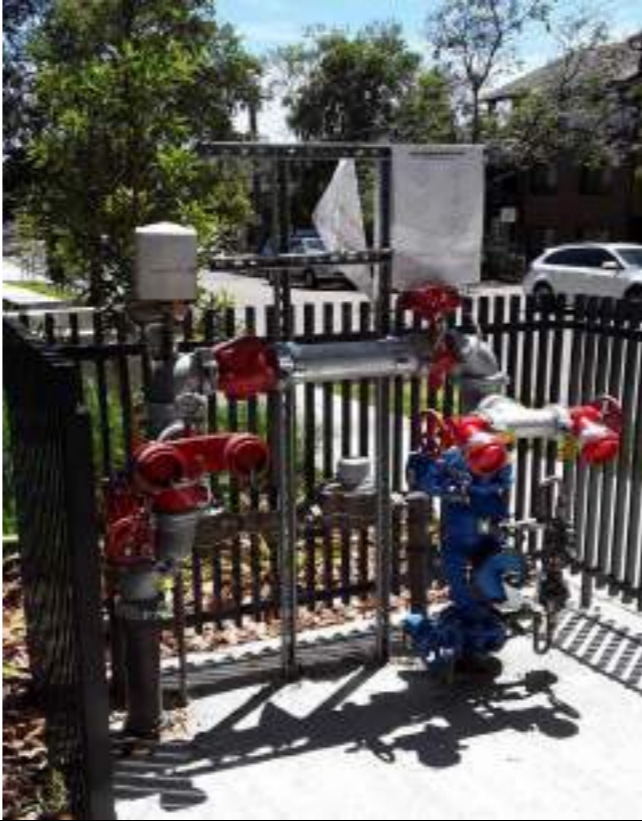
DEFECT NO.	LOCATION	AREA	BREACH	PHOTOGRAPH	DEFECT DESCRIPTION
C 214	Hydrant	South east of site	Incomplete work.

Hydraulic engineer to inspect hydrant assembly.
C 215	Hydrant	South east of site	Incomplete work.

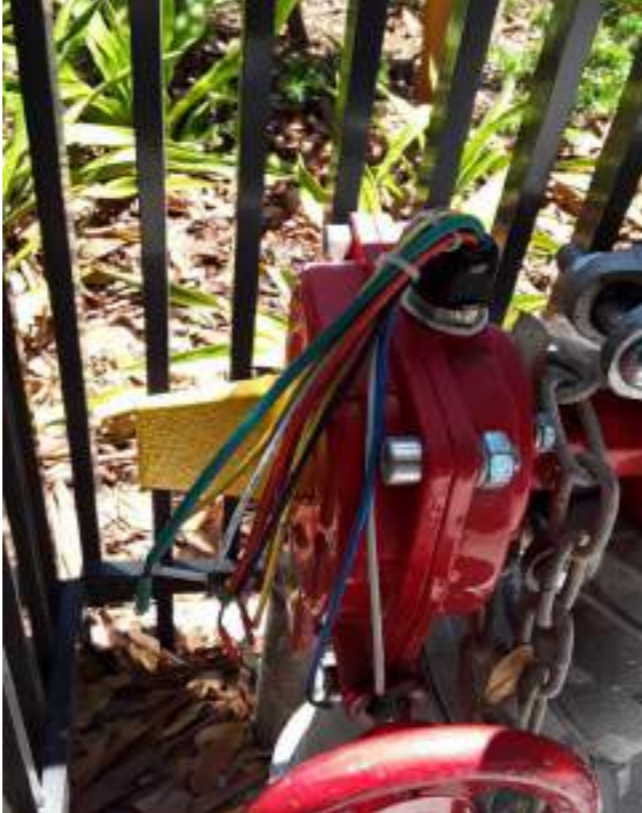
Wiring not connected.

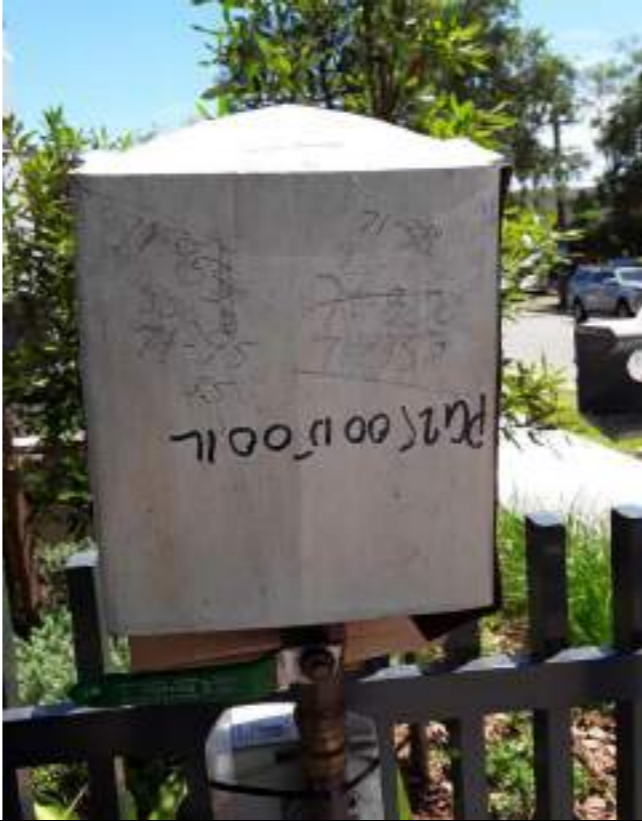
DEFECT NO.	LOCATION	AREA	BREACH	PHOTOGRAPH	DEFECT DESCRIPTION
C 216	Hydrant	South east of site	Incomplete work.

Cardboard box covering elements.
C 217	Hydrant	South east of site	Not fit for purpose.	 	Temporary signage.

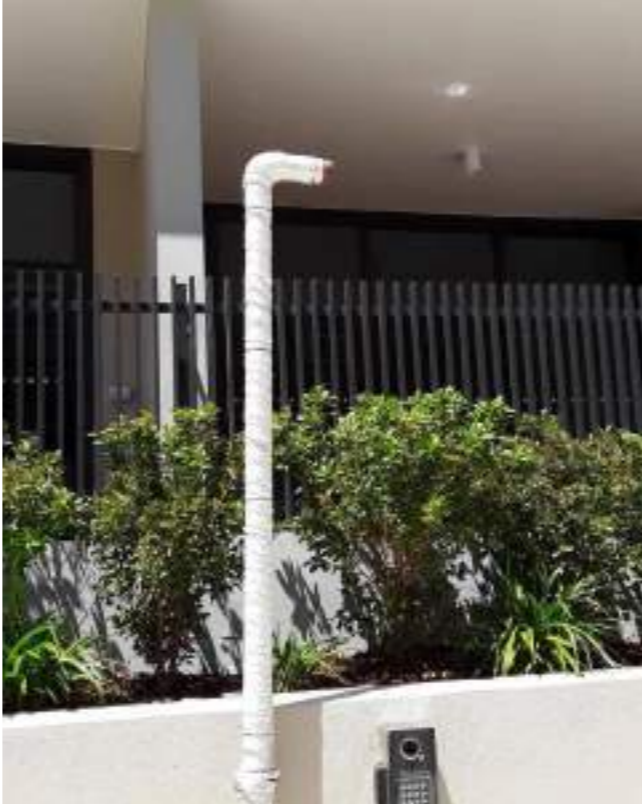
C 220	Drive way	Pipe	Not fit for purpose.

Diesel pump vent pipe when running will blow smoke into habitable spaces (see balconies in back ground).

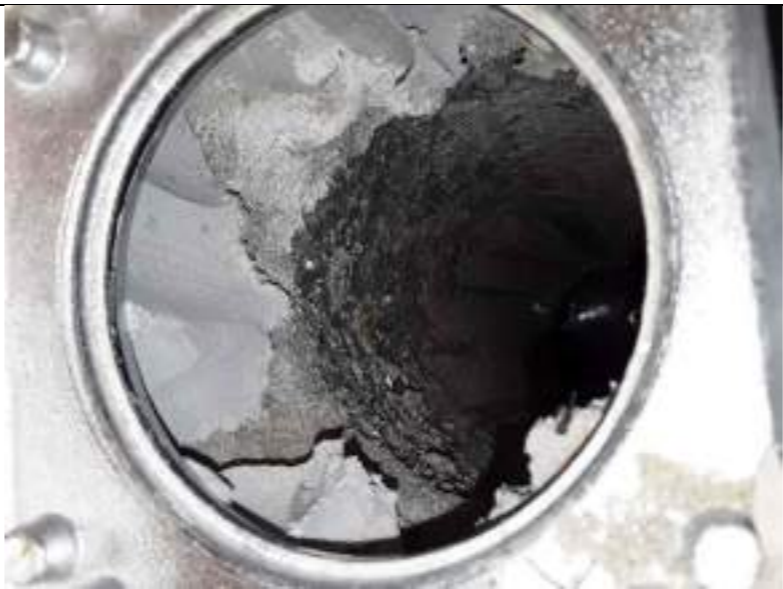
Exhaust not operational.
U G05.8	Bathroom	Floor waste	See section 8.12 of this report. Works not completed with due care and skill. Inadequate substrate preparation.

Adhesion failure of waterproofing in drain.

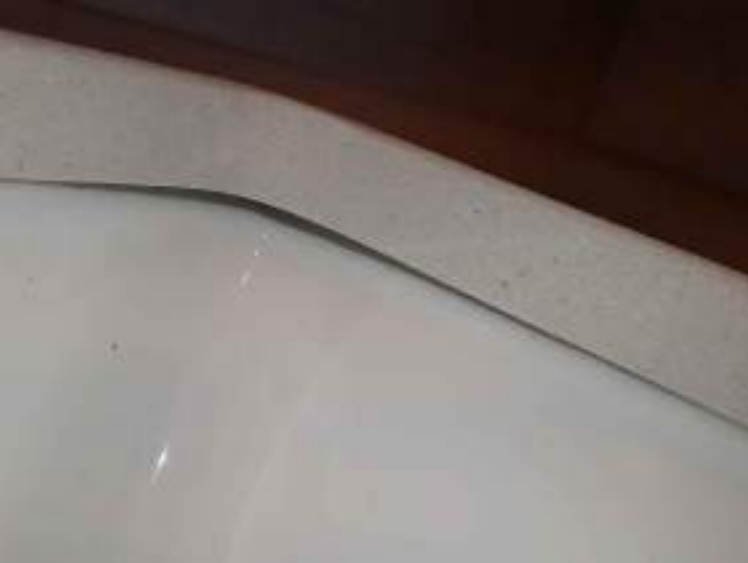
U G05.13	Ensuite	Vanity (Sink)	Water entering concealed space is a breach of FP1.7 of the BCA.

Void to under mount sink.
U G05.14	Ensuite	Mechanical exhaust	See section 8.25 of this report.

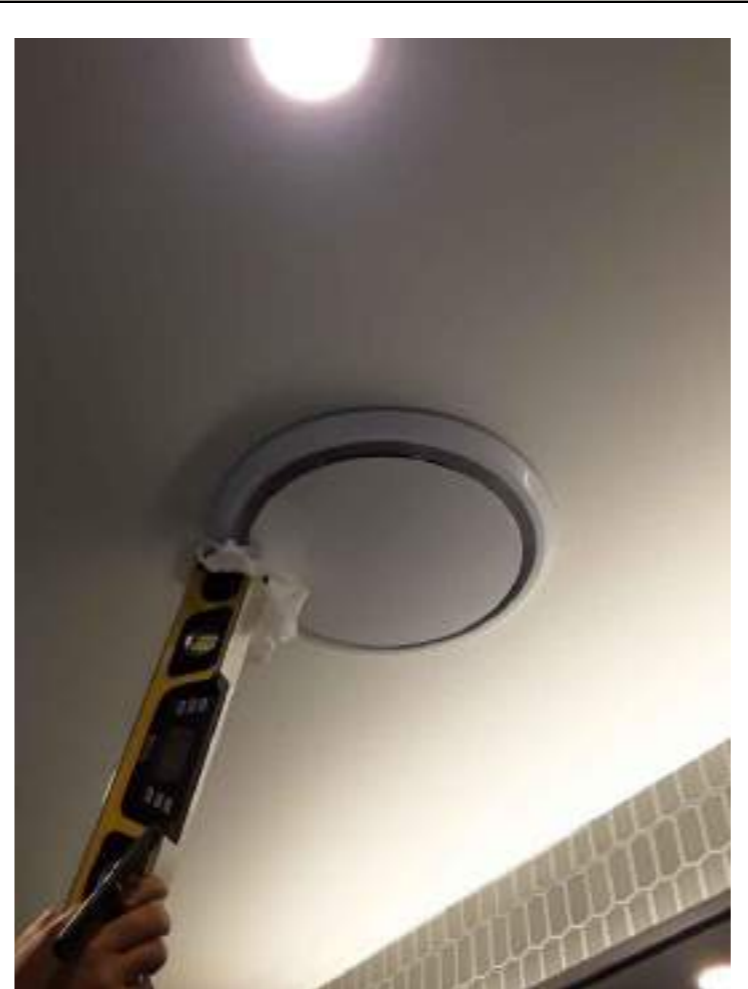
Mechanical exhaust not operational.

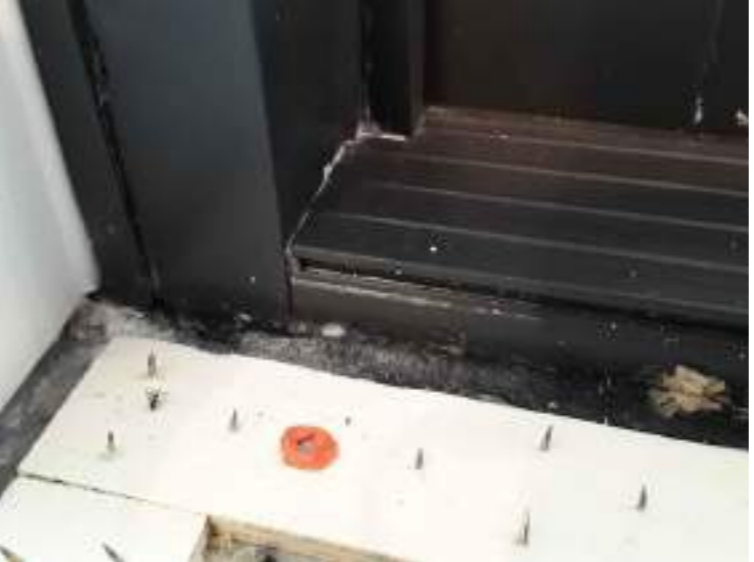
U G05.15	Main bedroom	Sliding door threshold	See section 8.3 of this report.

<p>A. No waterstop.                  B. Sliding door installed in contact with cement.</p>
U G05.16	Main bedroom	Carpet smooth edge rear to balcony	See section 8.7 of this report.

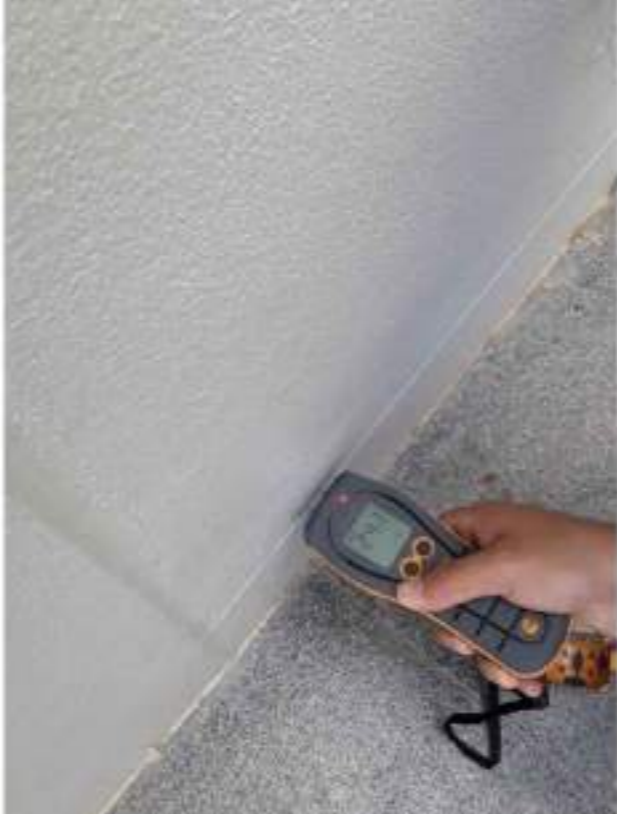
<p>U G05.21</p>	<p>Bedroom 2 wall outside</p>	<p>Ground floor south entry</p>	<p>See section 8.7 of this report.</p>

<p>External face of unit G05 wall.  500mm higher and elevated moisture to base of wall.</p>
<p>U G05.22</p>	<p>Balcony - South (Mitchell Avenue)</p>	<p>Hebel cladding</p>	<p>See section 8.6 of this report.</p>	 	<p>Hebel wall missing pressure equalisation slots.</p>

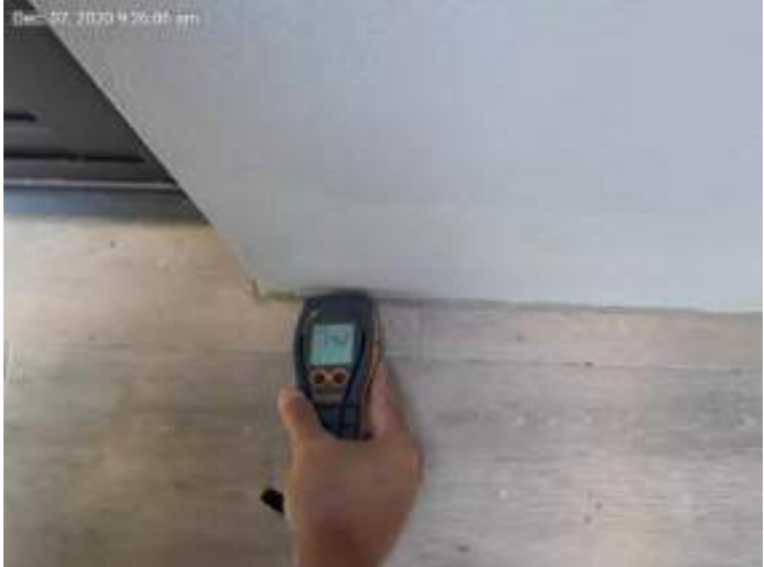
U G05.25	Balcony - South (Mitchell Avenue)	Hebel cladding (West wall)	Note.

Base reading to Hebel of 14.2%.
U G05.26	Balcony - South (Mitchell Avenue)	Floor waste	No waterproofing as required by AS4654.2.

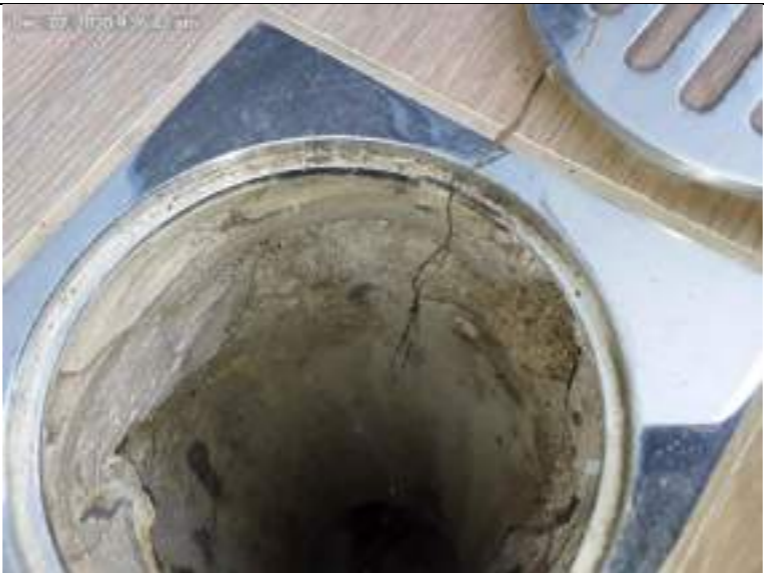
No visible waterproofing has been turned down the floor waste.
U G05.27	Balcony - South (Mitchell Avenue)	Hebel cladding	See section 8.6 of this report.

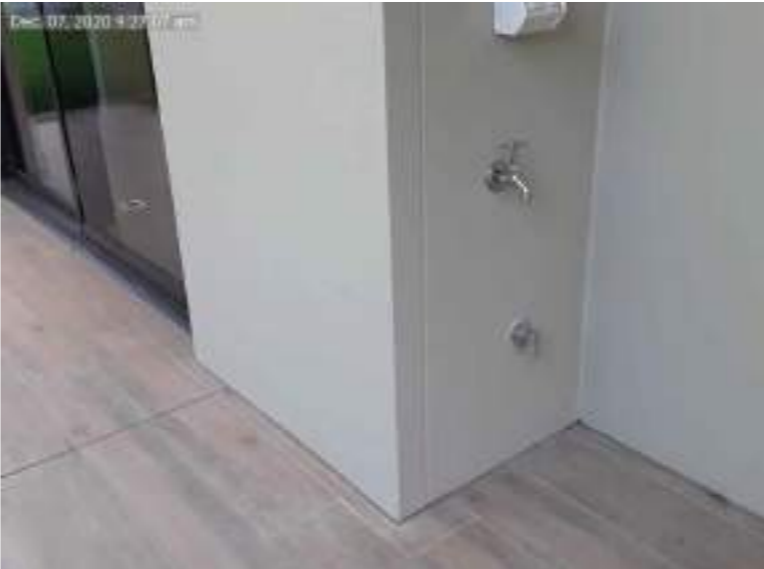
No drainage provision to facade.

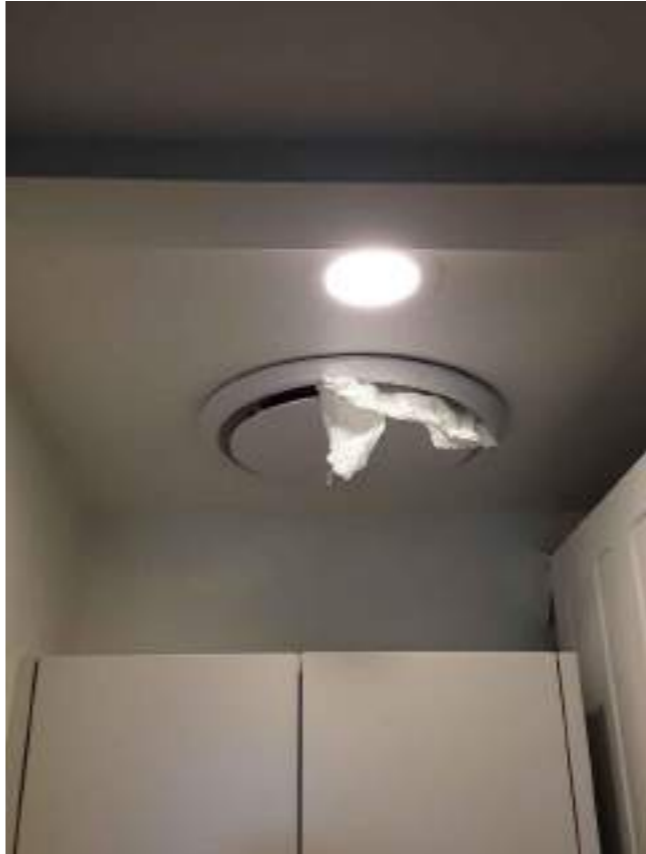
U 304.4	Laundry	Mechanical exhaust	Note.

Exhaust operational.

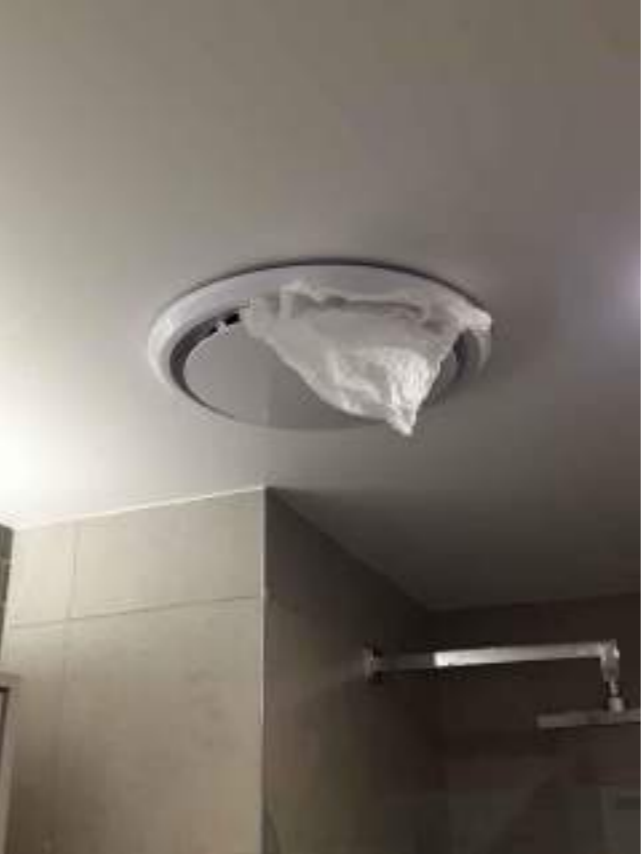
U 304.5	Bathroom	Mechanical exhaust	Note.

Exhaust operational.
U 304.6	Bathroom	Top of door	See section 8.16 of this report.

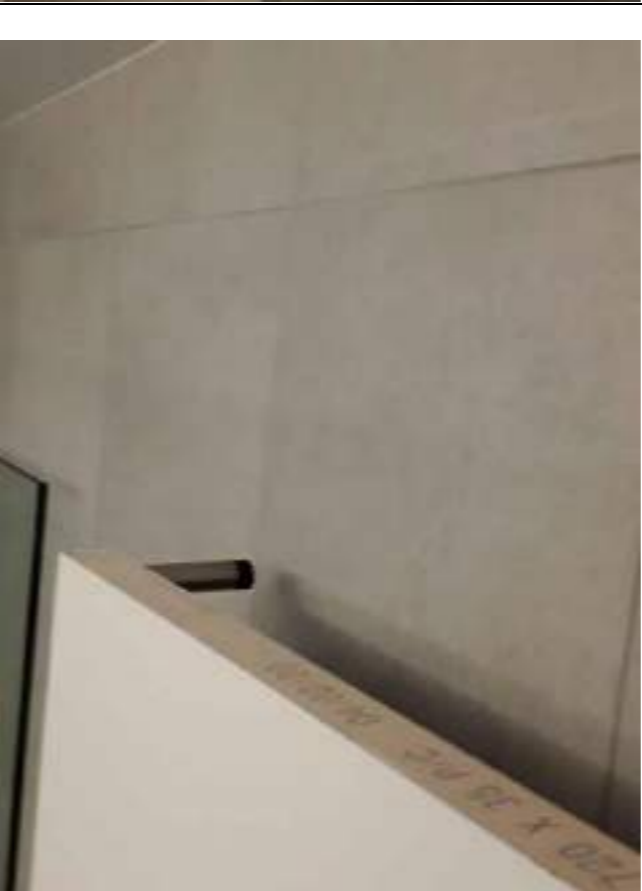
Top of door has not been sealed.

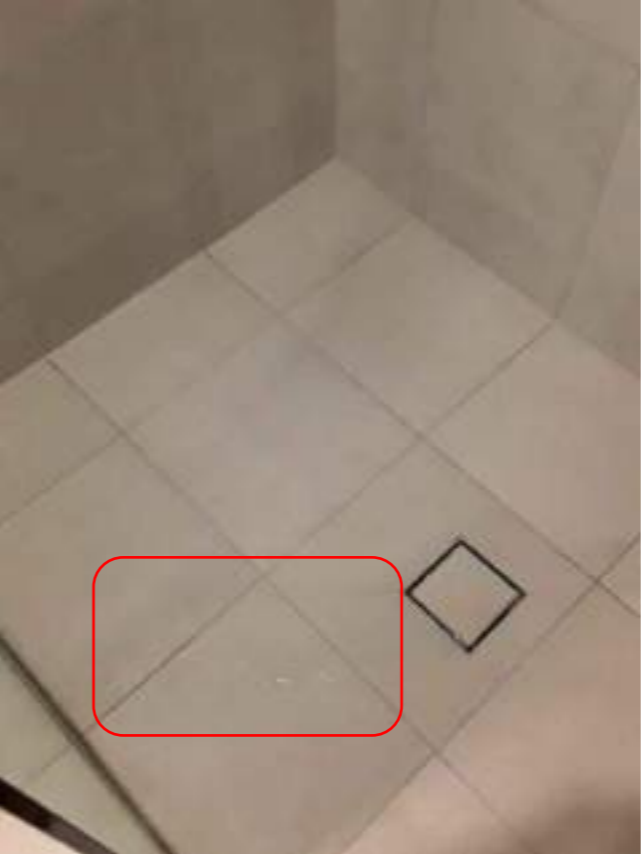
U 304.7	Ensuite	Floor tile	See section 8.4 of this report.

Water is ponding
U 304.8	Ensuite	Mechanical exhaust	See section 8.25 of this report.

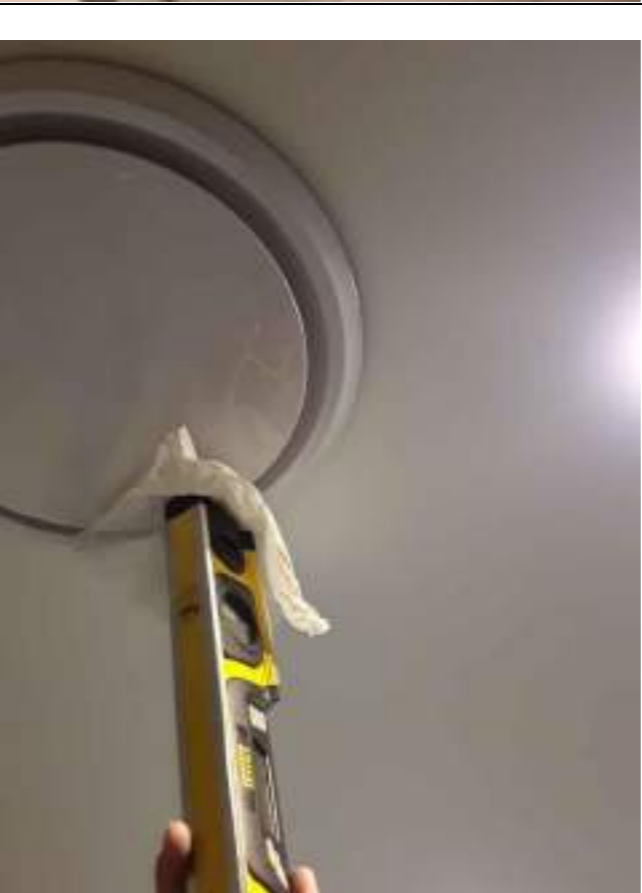
Mechanical exhaust not operational.

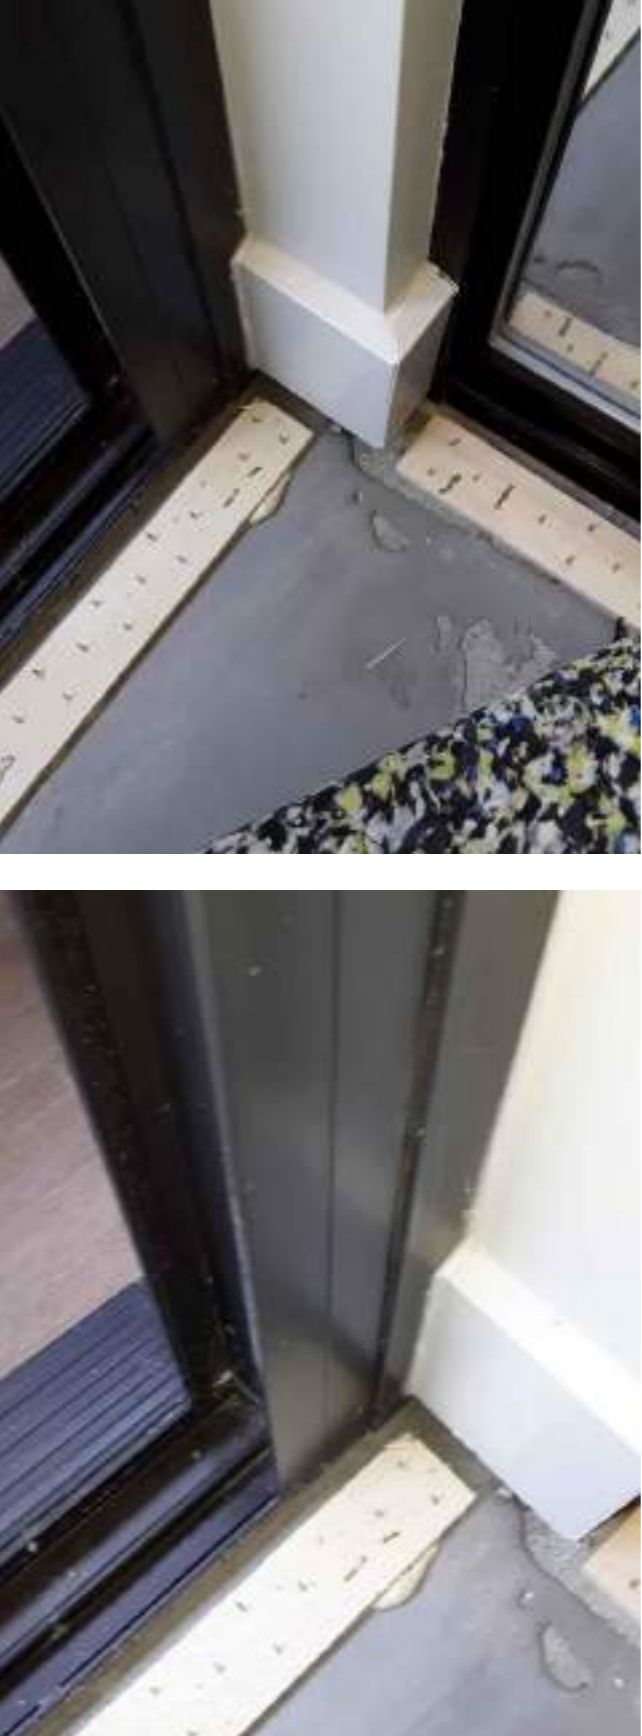
U 304.11	Bedroom 2	Door threshold	See section 8.3 of this report.

<ul style="list-style-type: none"><li>A. No waterstop.</li><li>B. Sliding door installed in contact with cement.</li></ul>
----------	-----------	----------------	---------------------------------	--	--

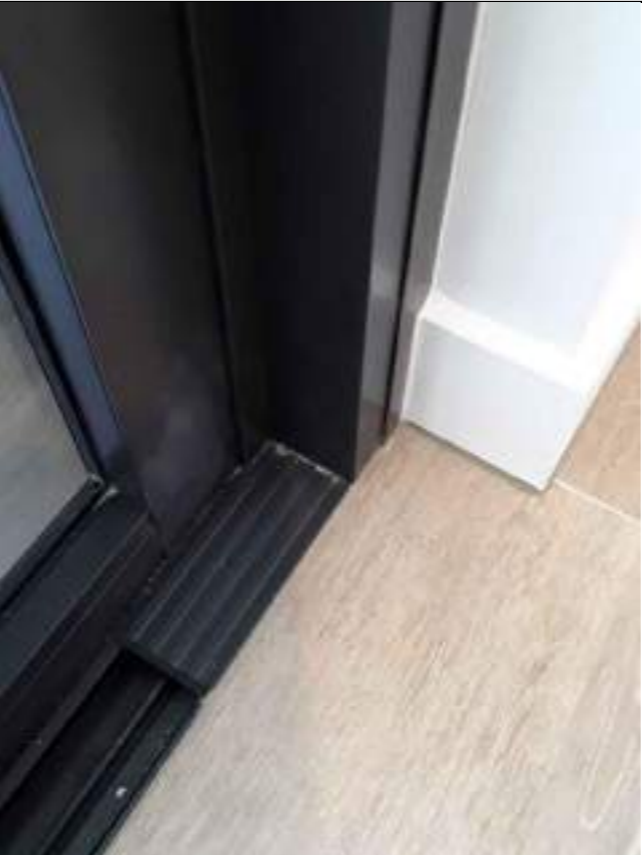
Unit 306					
U 306.1	Lounge	Sliding door threshold	See section 8.3 of this report.

<p>A. No waterstop.                      B. Sliding door installed in contact with cement.</p>
U 306.2	Laundry	Clothes dryer	Works have not been completed with due care and skill.

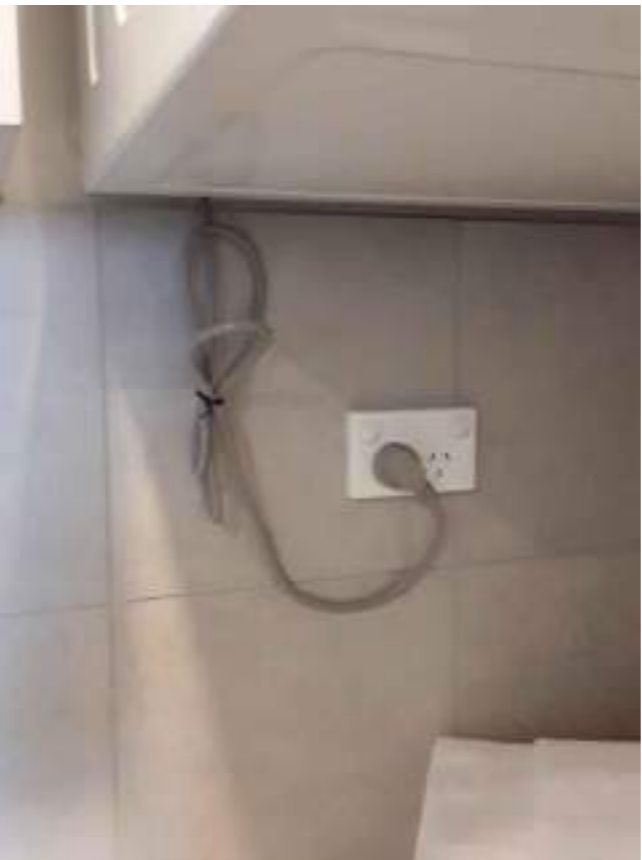
<p>Instead of shortening the length of the cable, a twist tie has been used to retain the extra length of cable.</p>

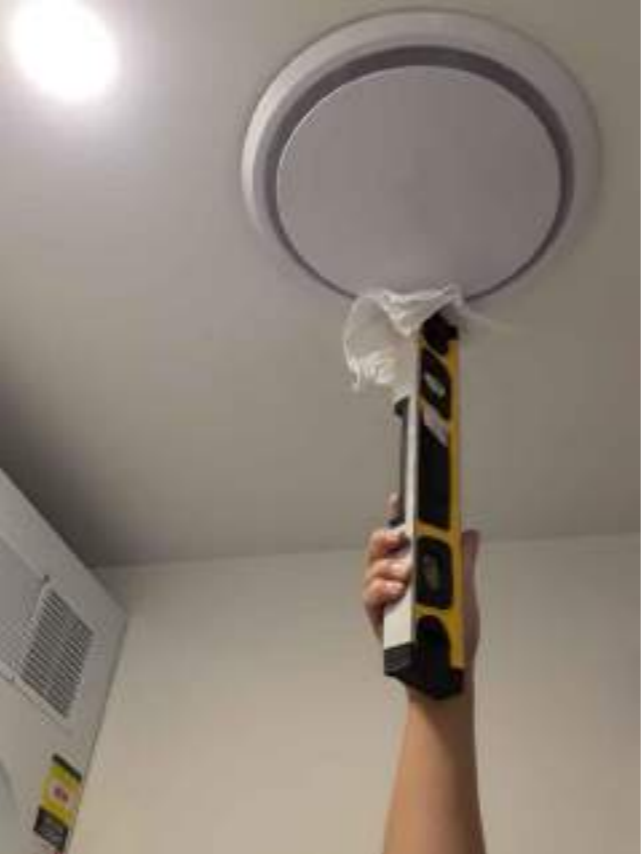
U 306.3	Laundry	Mechanical exhaust	See section 8.25 of this report.

Mechanical exhaust not operational.
U 306.4	Laundry	Top of door	See section 8.16 of this report.

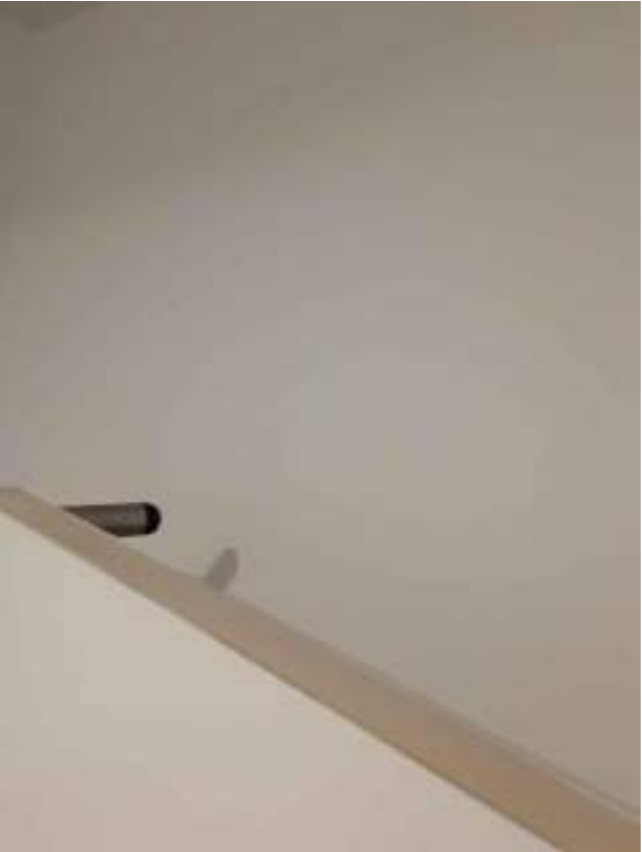
Top of door has not been sealed.

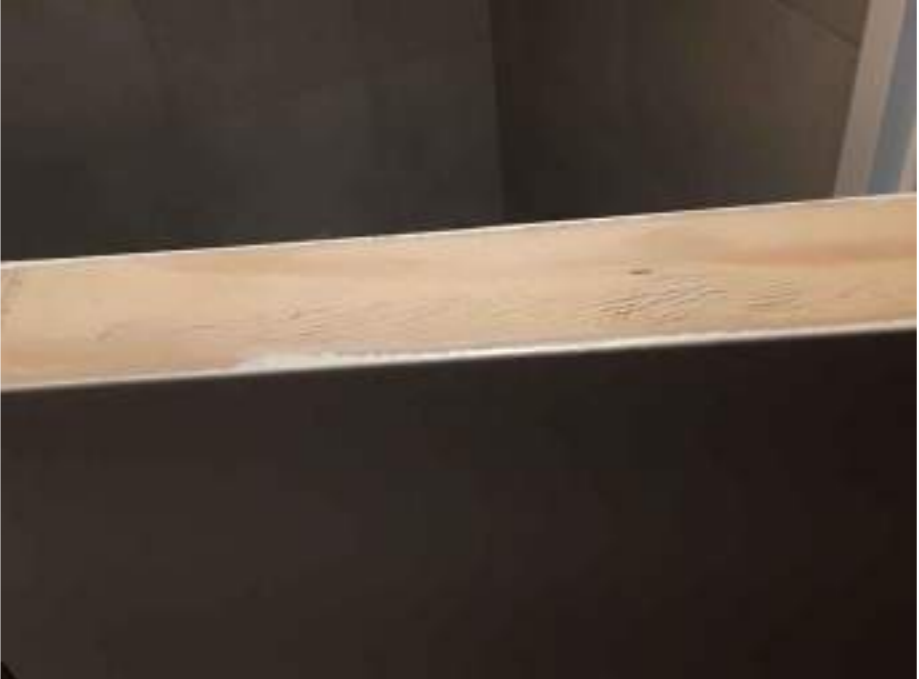
U 306.9	Ensuite	Top of door	See section 8.16 of this report.

Top of door has not been sealed.
U 306.10	Ensuite	Mechanical exhaust	See section 8.25 of this report.

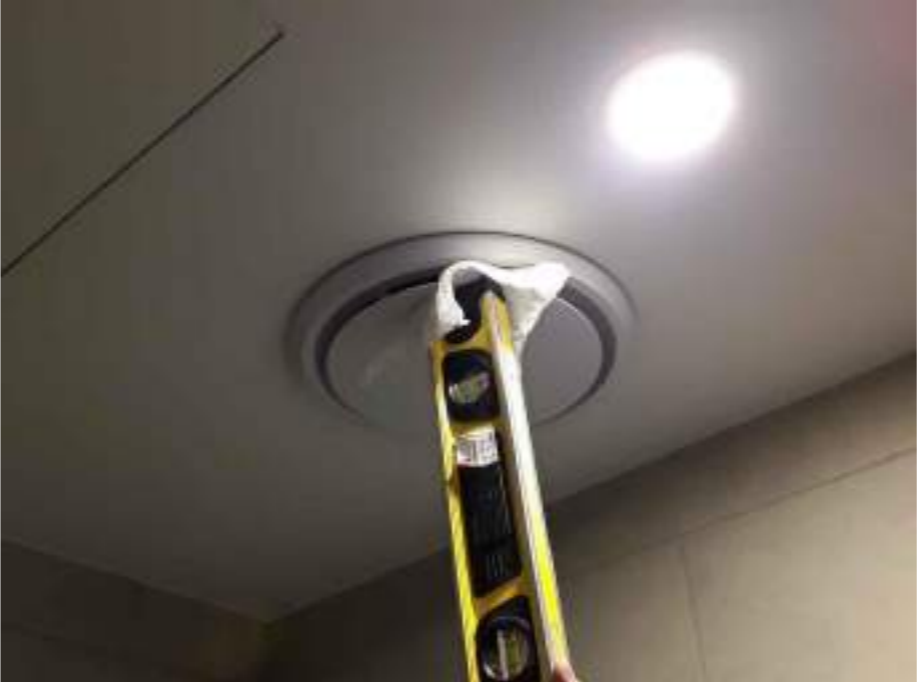
Mechanical exhaust is not operational.

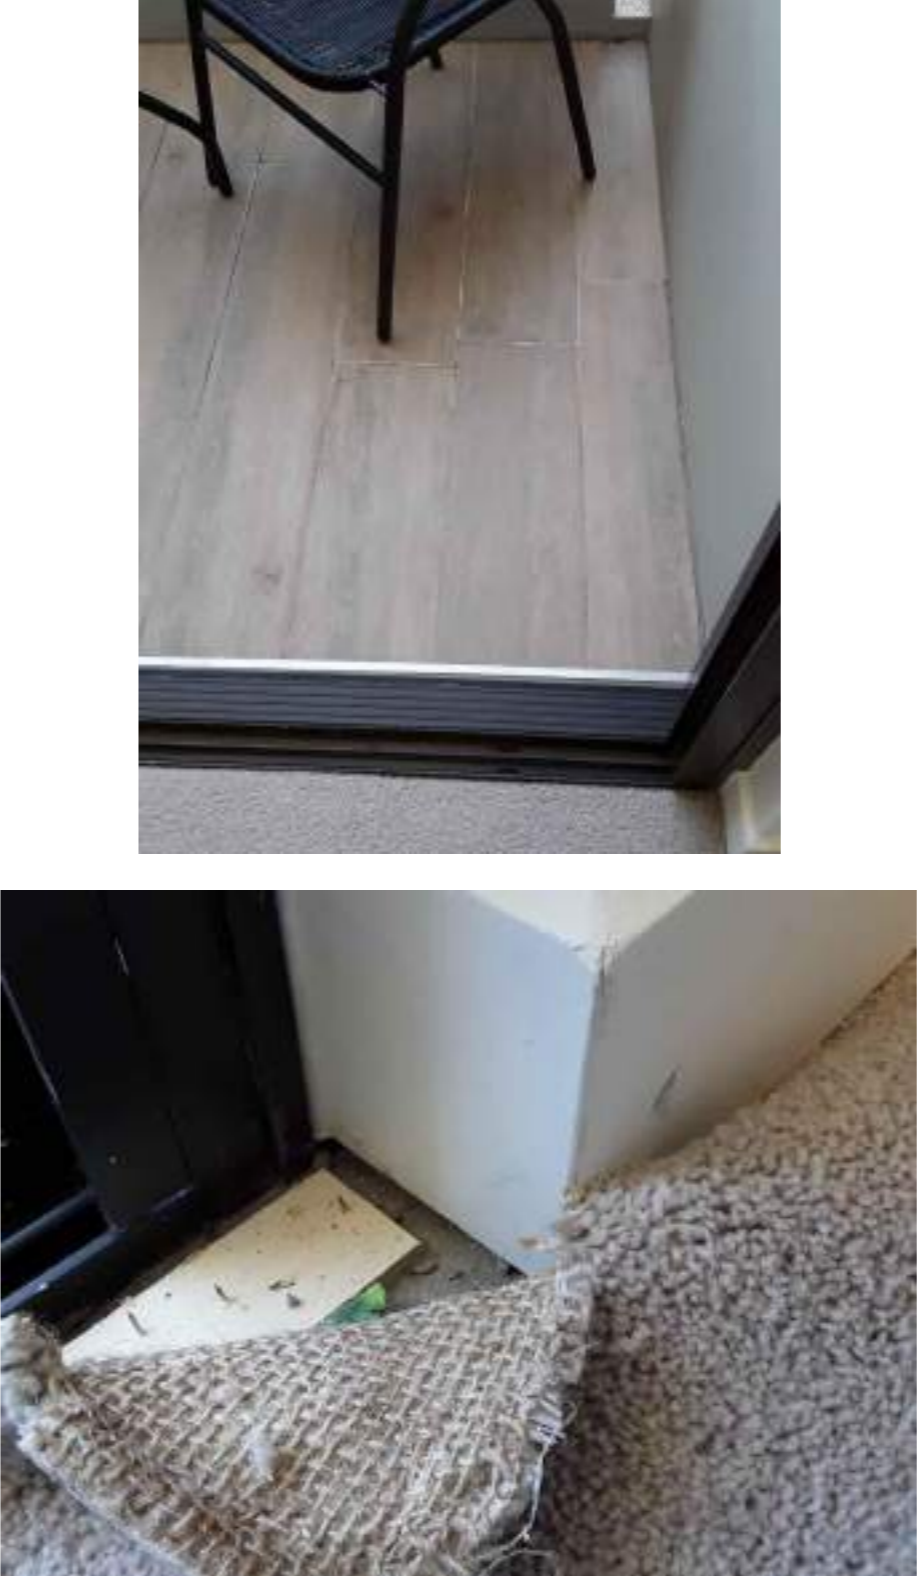
U 306.11	Main bedroom balcony	Door threshold	See section 8.3 of this report.

<ul style="list-style-type: none"><li>A. No waterstop.</li><li>B. Sliding door installed in contact with cement.</li></ul>
----------	----------------------	----------------	---------------------------------	--	--

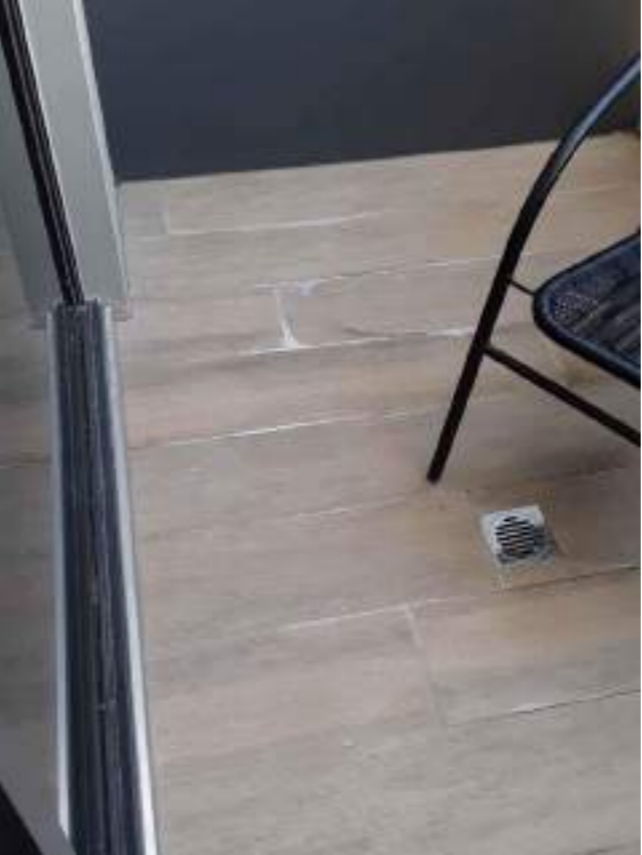
<p>U 306.12</p>	<p>Main bedroom balcony</p>	<p>Floor tiles</p>	<p>See section 8.3 and 8.9 of this report.</p>

<ul style="list-style-type: none"> <li>A. No waterstop.</li> <li>B. Sliding door installed in contact with cement.</li> <li>C. Efflorescence.</li> </ul>
<p>U 306.13</p>	<p>Main bedroom balcony</p>	<p>Sliding door threshold</p>	<p>See section 8.3 of this report.</p>
