BUILDING CONSULTANCY GROUP

Visual Pre-Purchase Building Inspection Report

CLIENT DETAILS	
Inspection address:	9 Bandain Avenue, Kareela, NSW 2232
Inspection date & time:	Date: 23/04/2019 Arrival time: 8:30AM
Approximate age of this property (Excluding extensions):	35-45 Years (Properties built before 1986 may contain asbestos)
Weather conditions at the time of this inspection:	Fine
Whether building is furnished:	Yes
Building tenancy:	Property Occupied
Persons present at the time of this inspection:	Vendor

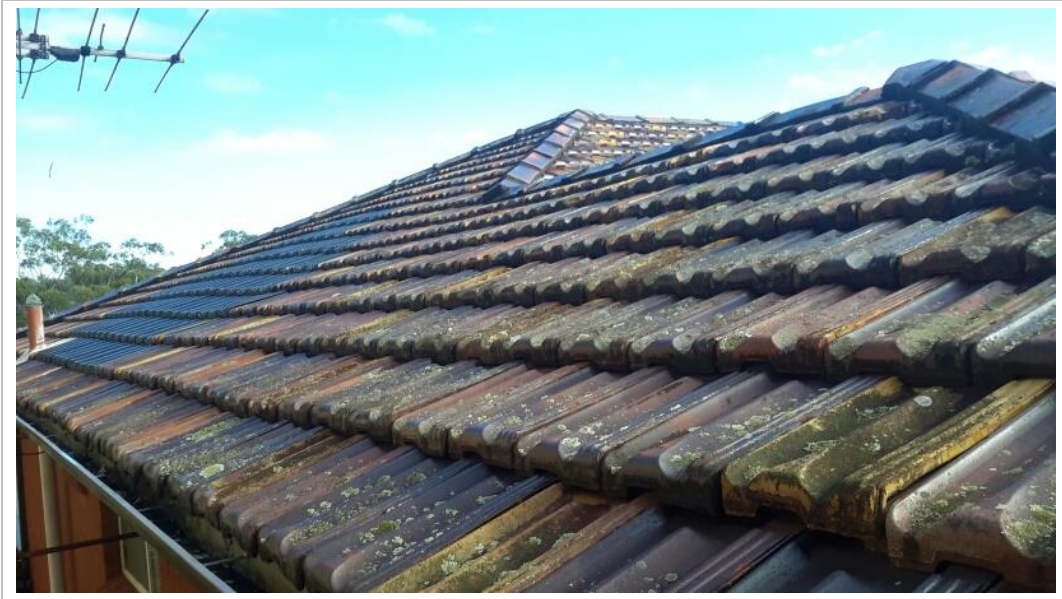
THE ROOF EXTERIOR OF THIS BUILDING

1. Chimneys: Is there a chimney present: **Yes - Fireplaces are not tested. This test is outside the scope of this inspection and it is recommended that you have these units fully tested.**
If evident, all flashings, and brick deterioration, any mortar erosion and any lack of support or loss of vertical plumbness may not be visible due to this dwelling's height and access restrictions.
