# Visual Pre-Purchase Building Inspection Report

To comply with Australian Standard AS4349.1-2007

CLIENT DETAILS	
<b>Client:</b>	Matt Jinks
<b>Contact details:</b>	<b>Ph:</b>
<b>Inspection address:</b>	65 Cremona Road, Como NSW 2226
<b>Inspection date &amp; time:</b>	<b>Date:</b> 19/11/2019 <b>Arrival time:</b> 2:30 PM
<b>Approximate age of this property (Excluding extensions):</b>	30-40 years (Properties built before 1986 may contain asbestos)
<b>Weather conditions at the time of this inspection:</b>	Fine
<b>Whether building is furnished:</b>	Yes
<b>Building tenancy:</b>	Property Occupied
<b>Persons present at the time of this inspection:</b>	Tenant

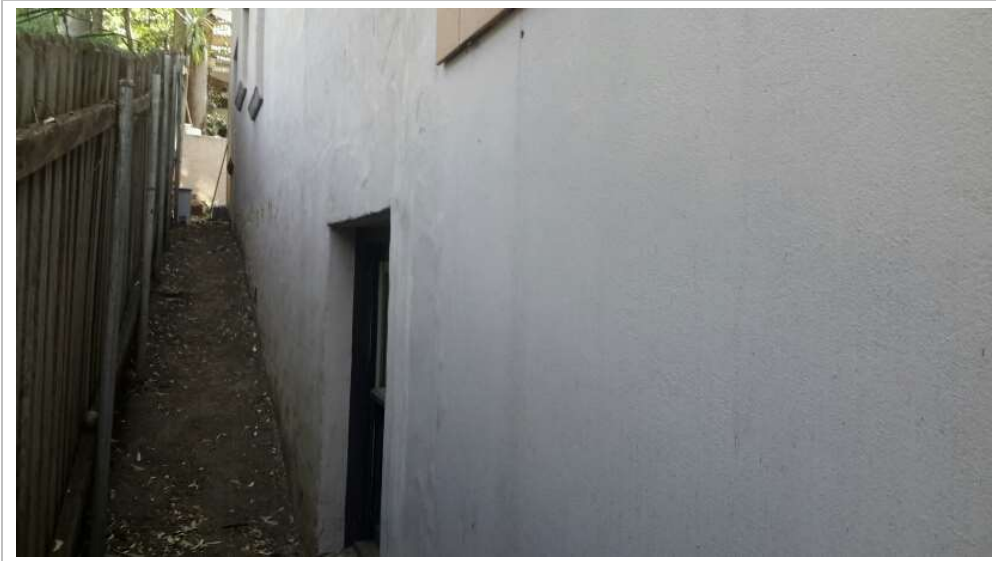
## THE SUB-FLOOR OF THIS BUILDING

This inspected property is built on a concrete slab on ground construction and therefore, there is no accessible void to inspect.
