Visual Timber Pest Inspection and Report in Accordance with AS 4349.3-2010

65 Cremona rd, Como NSW 2226

Name Of Inspection Firm:	Target Pest Control
Contact Phone:	02 9528 0452
Technician Name:	Anthony Lee
Report Prepared Date:	20/11/2019

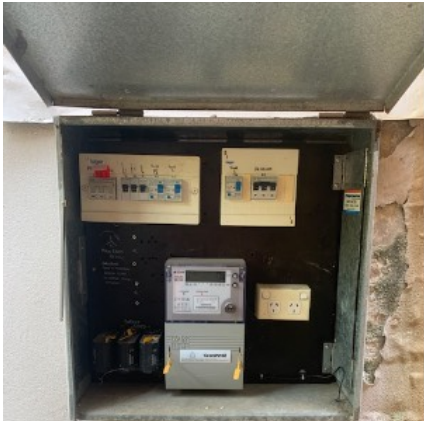
Photo Of Durable Notice

TERMITE MANAGEMENT STICKER	
Is there a Termite Management Sticker?	No WARNING: This firm can give no assurances with regard to work that may have been previously performed by other firms. You should obtain copies of all paperwork and make your own inquiries as to the quality of the treatment, when it was carried out and warranty information. In most cases you should arrange for a treatment in accordance with 'Australian Standard 3660' be carried out to reduce the risk of further attack.
Environmental Termite Pressure:	Level of Termite Pressure: Medium Overall Degree of Risk of Timber Pest Infestation: Moderate
