Pre-Purchase Building & Pest Inspection Report

63 Oyster Bay Road, Oyster Bay

Date: 03/08/20

Reference: 20084

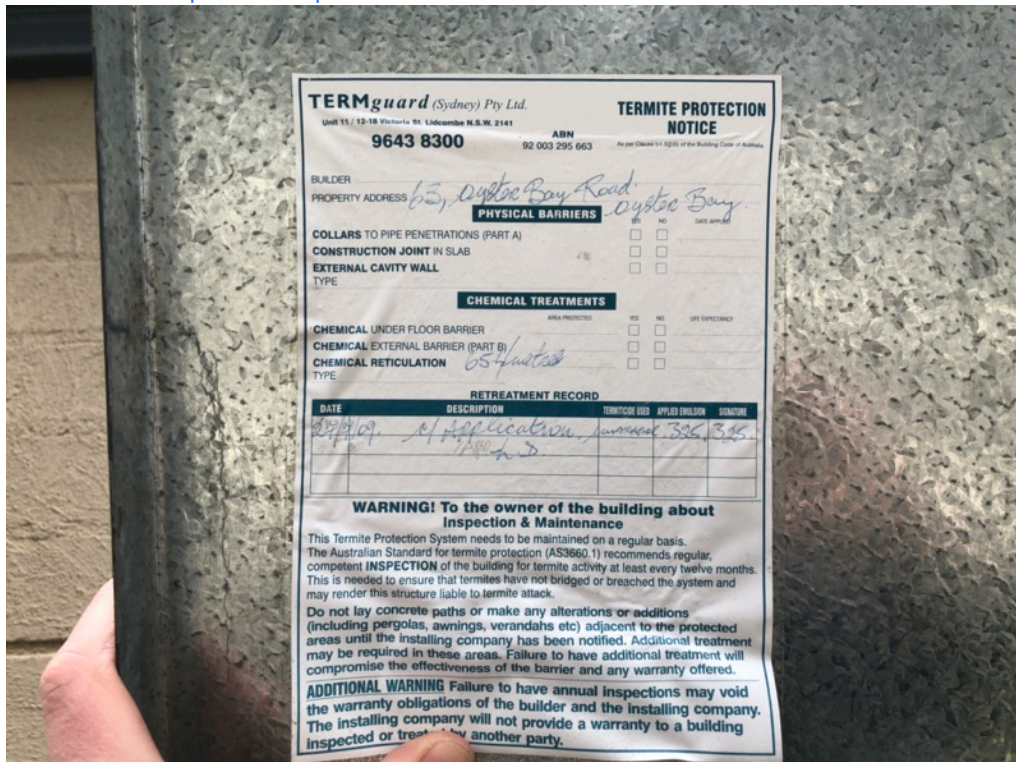
10.1 Evidence of past timber pest treatment

TERMguard (Sydney) Pty Ltd.
Unit 11 / 12-18 Victoria St, Lindcombe N.S.W. 2141
9643 8300 ABN 92 003 295 663

TERMITE PROTECTION NOTICE
As per Clause 5.1 (2)(b) of the Building Code of Australia
