Pre-Purchase Building & Pest Inspection Report

3 Armentieres Avenue, Milperra

Date: 06/04/21

Reference: 21031

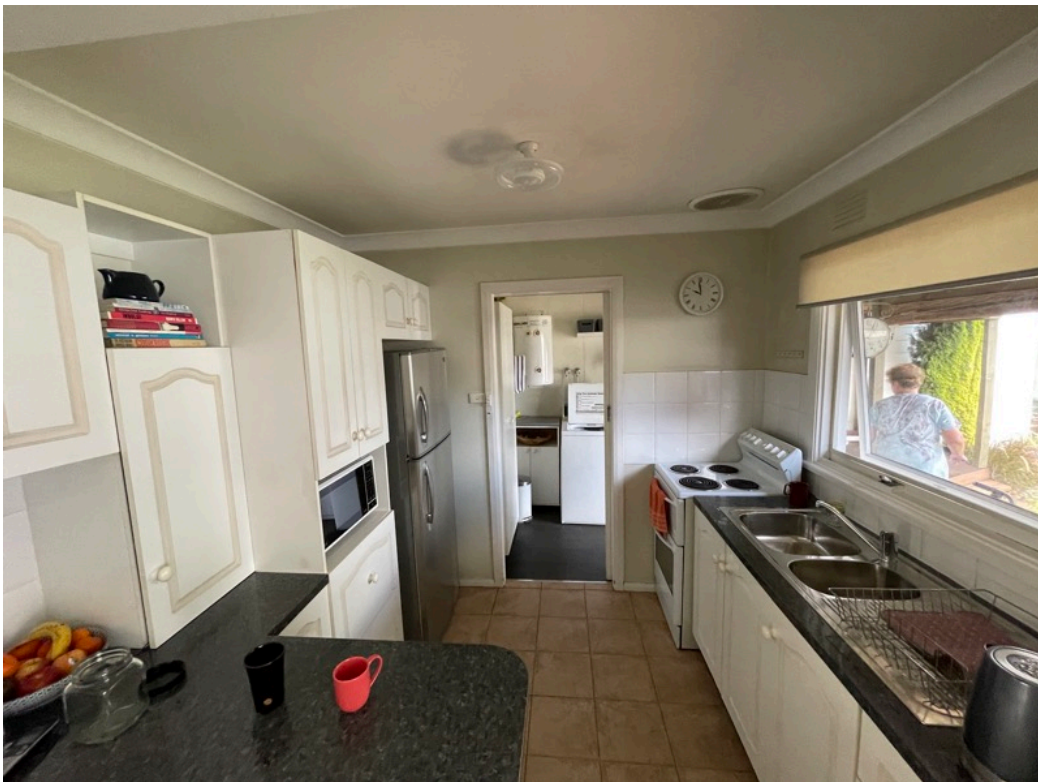
5. Kitchen

1. Cracked floor tile in kitchen. No further damage anticipated.

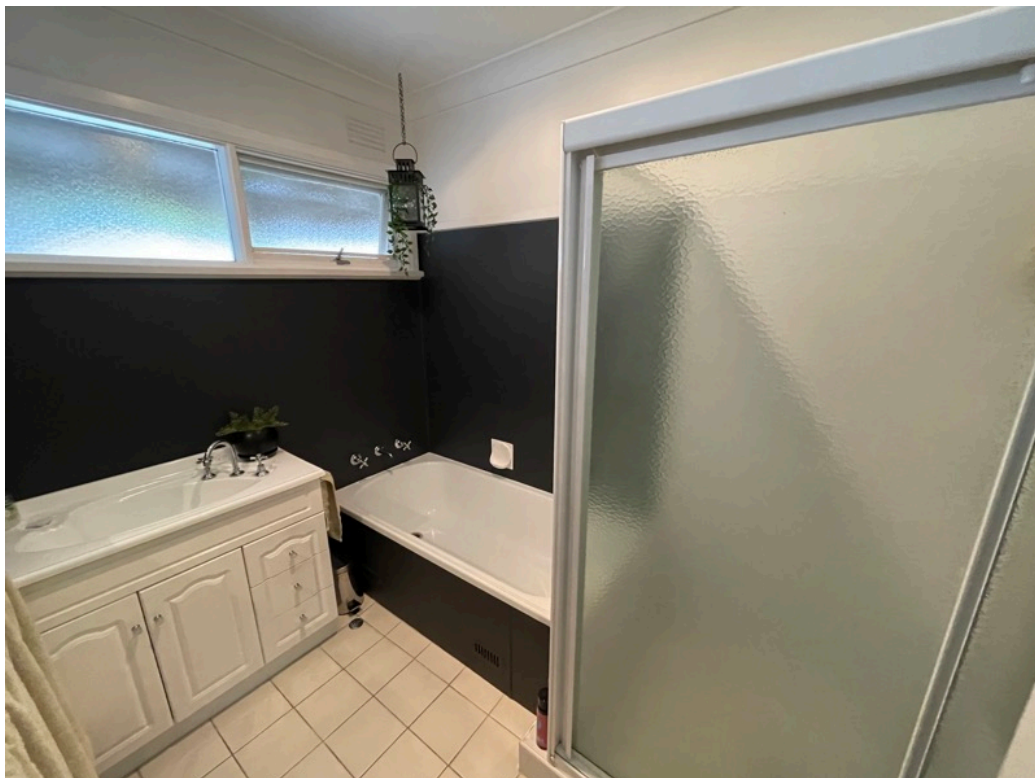
11. Bathroom

2. Deteriorating grout in floor tiles around shower drain in bathroom. Potential for further deterioration.

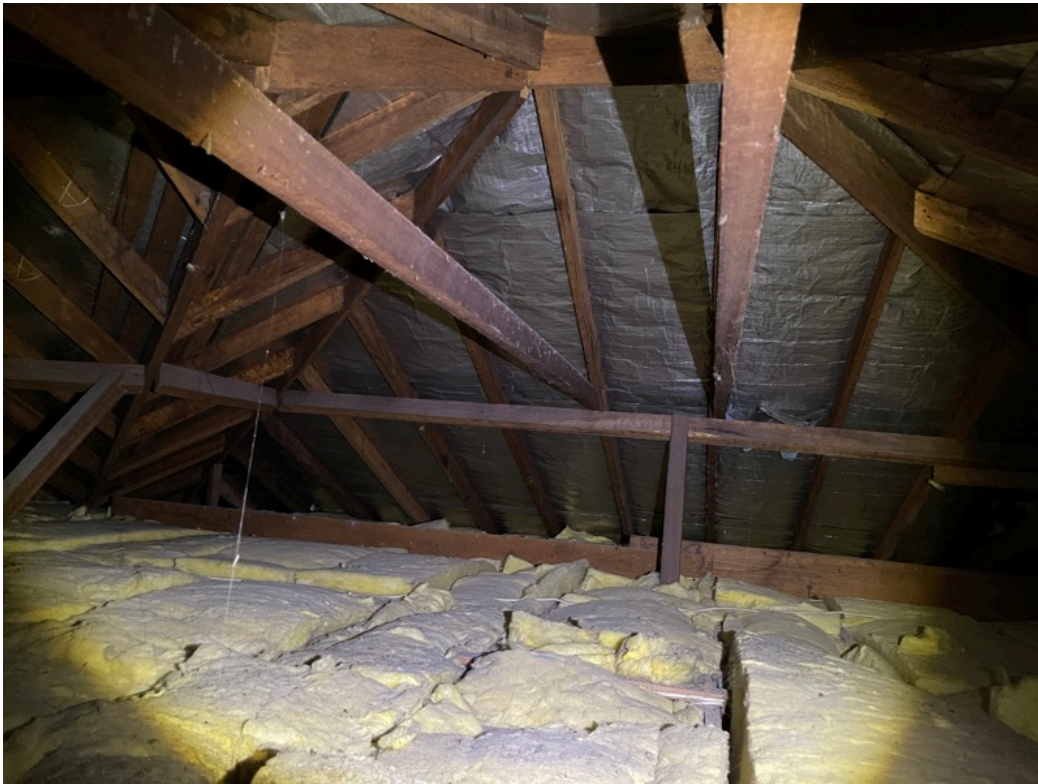
12. Roof void

3. Torn sarking in multiple locations in roof void. Potential for water ingress if nearby tiles become broken.

1. Torn sarking in roof void. Potential for water ingress if nearby tiles become broken. Moisture increases chance of timber pest activity.
