Building Report

96 Prince Edward Park Rd, Woronora

BUILDING & TIMBER PEST INSPECTION REPORT TO AS4349.1 2007 & AS4349.3 2010

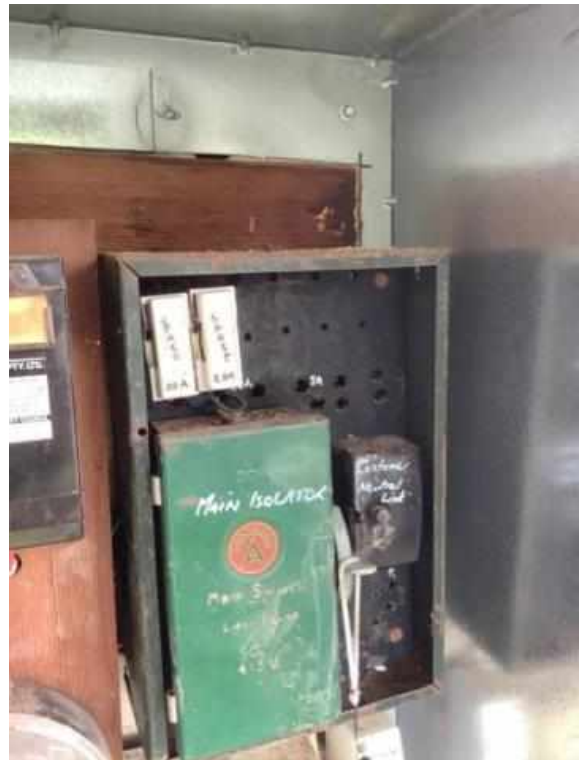
Note: Porcelain fuses have been identified to the switchboard. We recommend an electrician be engaged to remove the fuses and upgrade as required.

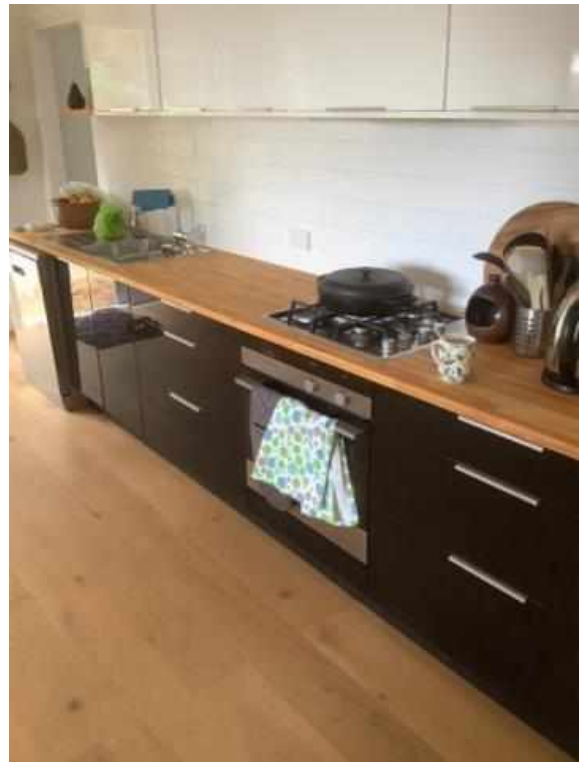
**Lifting**

Satisfactory.
