COMBINED BUILDING AND PEST INSPECTION

11 Leichhardt Cres
Sylvania, NSW 2224

03/08/2023

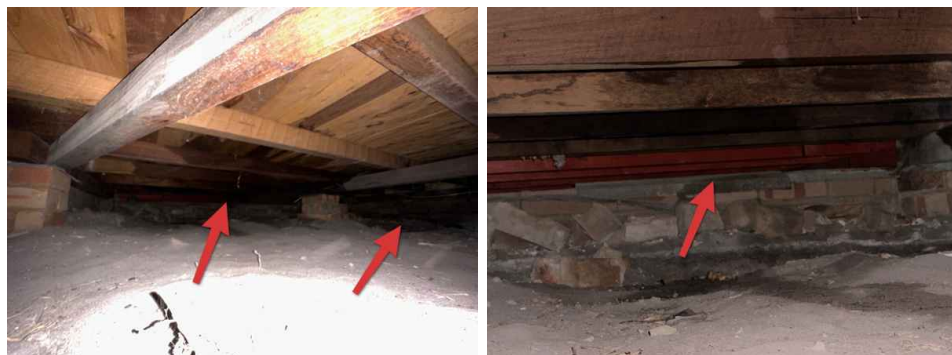
LOW ACCESS

Low access in areas restricted a full visual inspection.

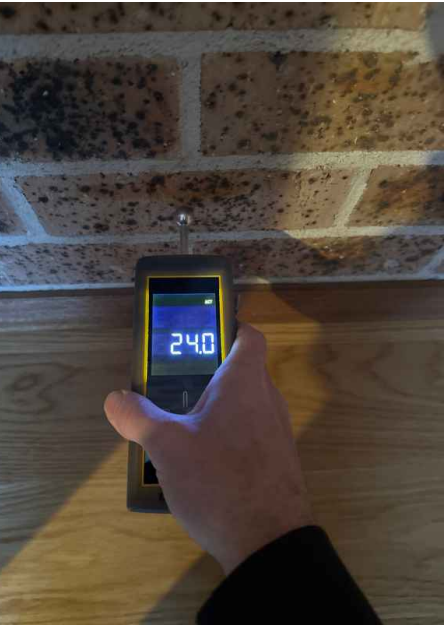
Walls: Moisture test - walls below ground level

Some walls appear to be below ground level. We have moisture tested these areas and normal moisture readings were obtained at the time of the inspection. Please refer to section 11 of our standards of practice for further information.

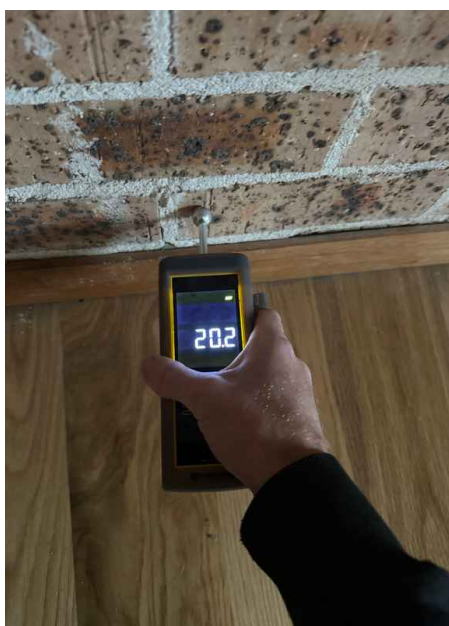
Walls: Moisture test - walls below ground level

Some walls appear to be below ground level. We have moisture tested these areas and normal moisture readings were obtained at the time of the inspection. Please refer to section 11 of our standards of practice for further information.

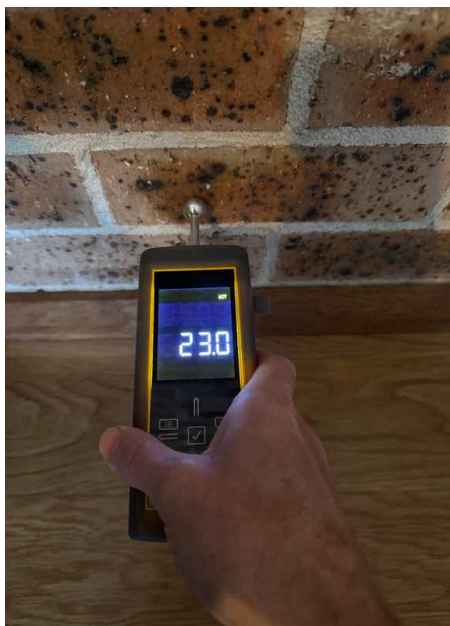
Walls: Moisture test - walls below ground level

Some walls appear to be below ground level. We have moisture tested these areas and normal moisture readings were obtained at the time of the inspection. Please refer to section 11 of our standards of practice for further information.

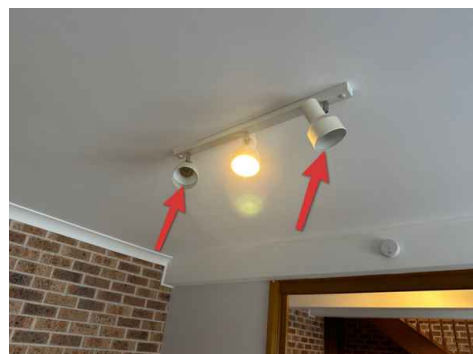
17.6.1 Lighting Fixtures, Switches & Receptacles

Minor Defect/Recommendations

Contact a qualified electrical contractor.

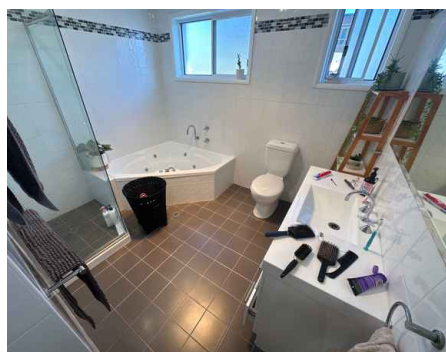
General view at the time of inspection

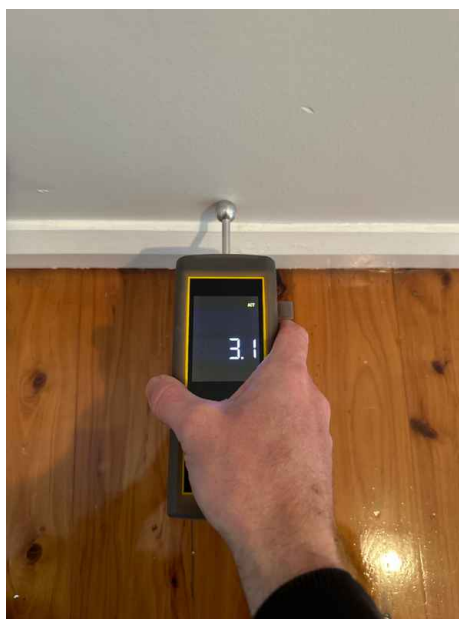
Shower & Bath: Was there high moisture readings to the walls adjacent to the shower recess

No

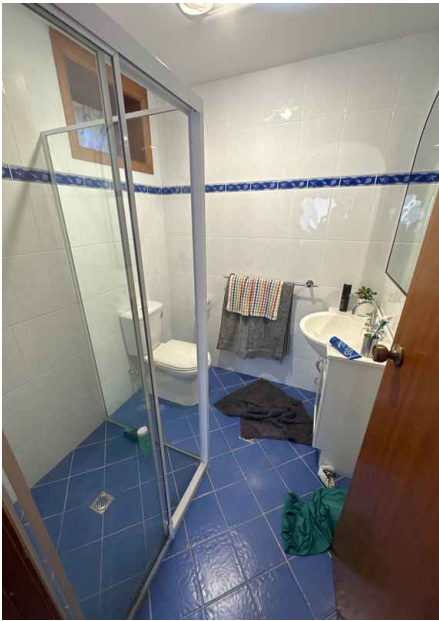
General view at the time of inspection

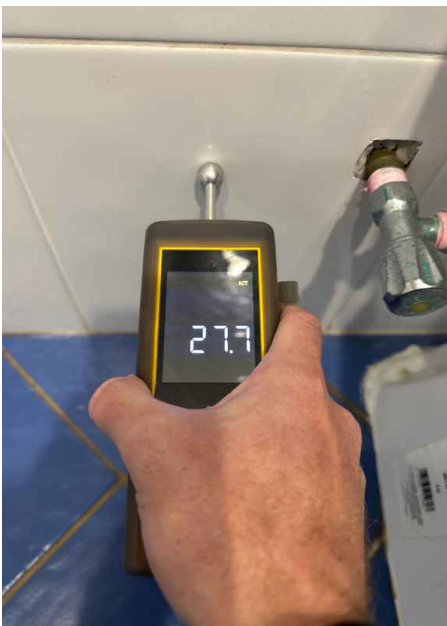
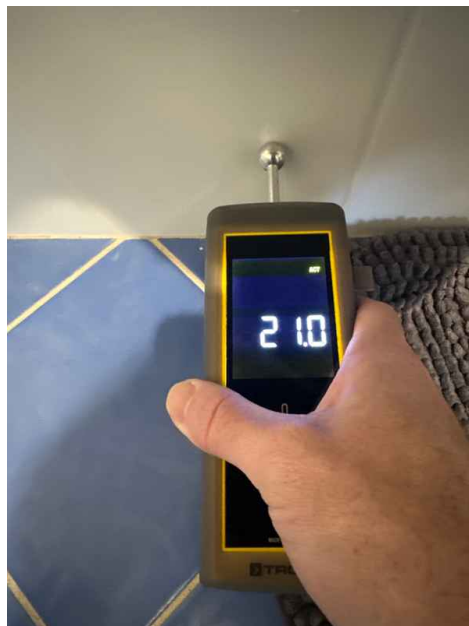
Walls: Moisture test - walls below ground level

Some walls appear to be below ground level. We have moisture tested these areas and normal moisture readings were obtained at the time of the inspection. Please refer to section 11 of our standards of practice for further information.

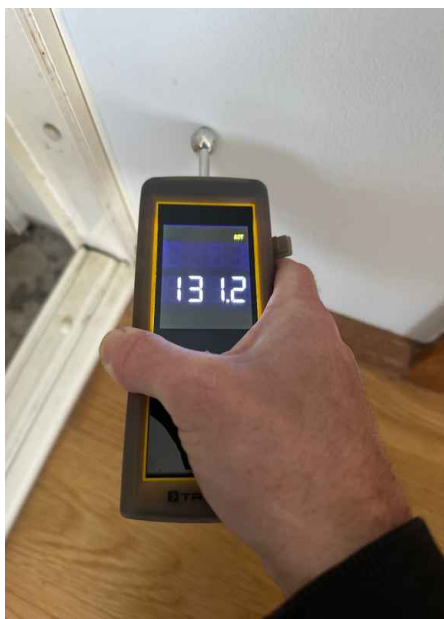
19.9.1 Shower & Bath

Shower & Bath: Was there high moisture readings to the walls adjacent to the shower recess

Yes

HIGH MOISTURE TO WALLS ADJACENT TO SHOWER

High moisture readings to wall adjacent to the shower recess. This indicates a waterproofing failure. It is recommended this be fixed asap as the water can damage the surrounding materials.

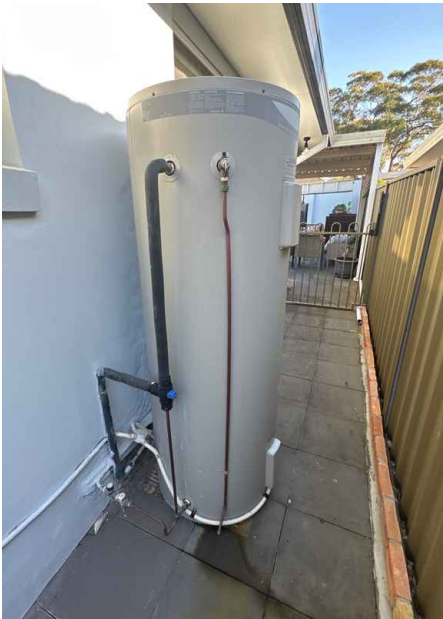
Hot Water Unit: General view of hotwater system

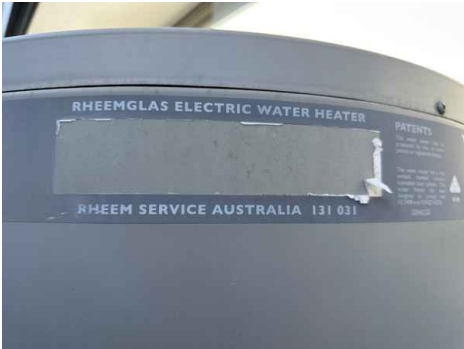
Hot Water Unit: System Location
Outside

Hot Water Unit: System Make
Rheem

Hot Water Unit: System Type
Electrical Storage

Hot Water Unit: System Capacity
Unknown

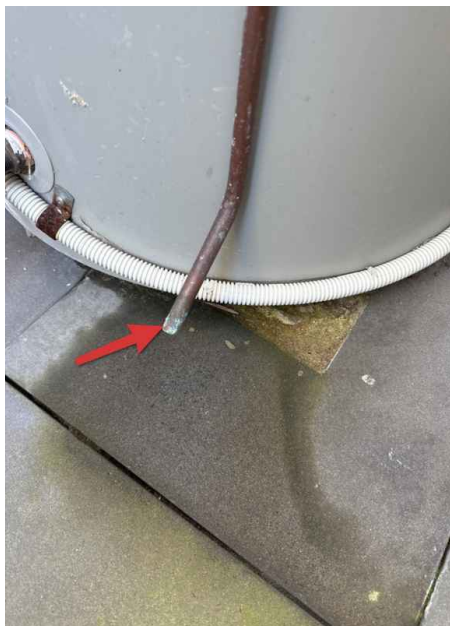
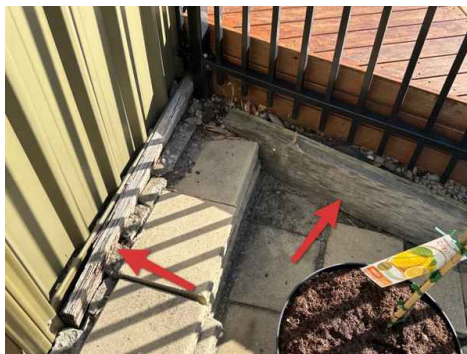
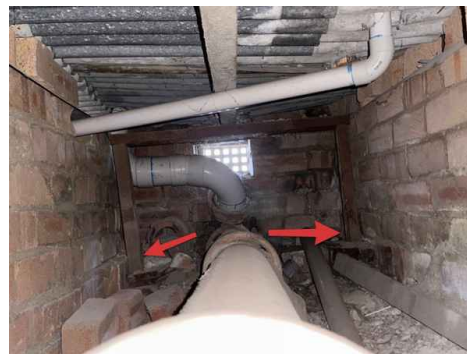
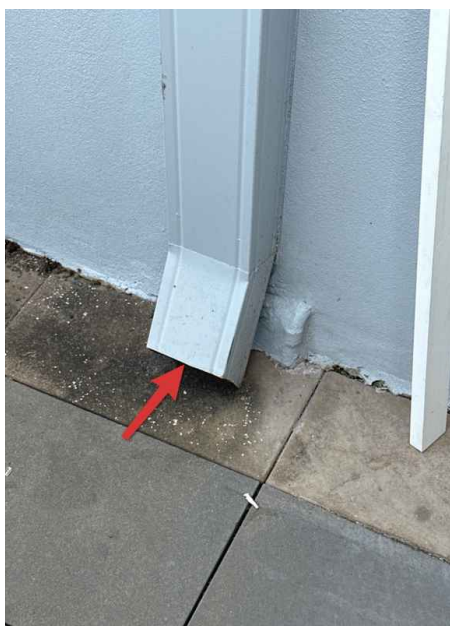
Hot Water Overflow, Timber Sleepers, Old Form Work, D/P Connection, Subfloor access, Timber Debris, Slab Edge

Conductive conditions are areas that promote termite activity. The above areas are recommended that repairs be completed to help minimise the risk of termite attacks.
