Strata Inspection Report

Prepared for:	Calyssa Manolaros
Matter of:	Manolaros Sale
C/-	Sanders Property Agents Andrew Mills / Daneke Wright
Address:	30/63-69 President Avenue Caringbah
Lot No:	30
Strata Plan No:	17885
Date of Inspection:	1 Aug 2023

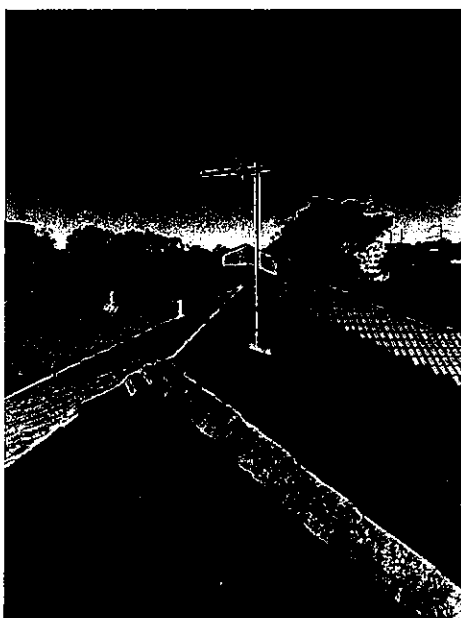
Roof Tiles Report

Good condition
