HOMESAFE INSPECTIONS

COMBINED BUILDING AND PEST INSPECTION

6 Argyle Pl
Kareela, NSW 2232

24/10/2023

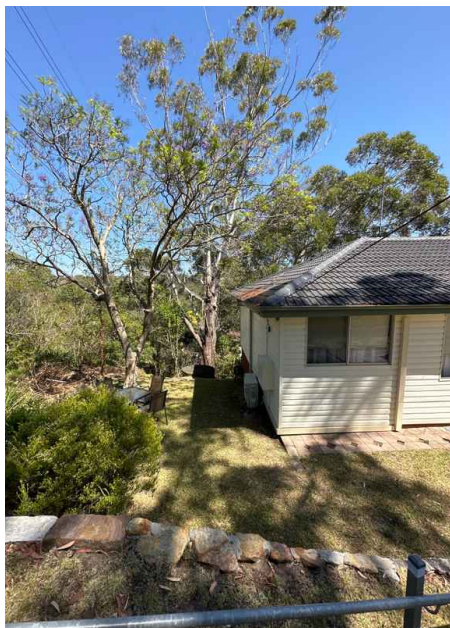
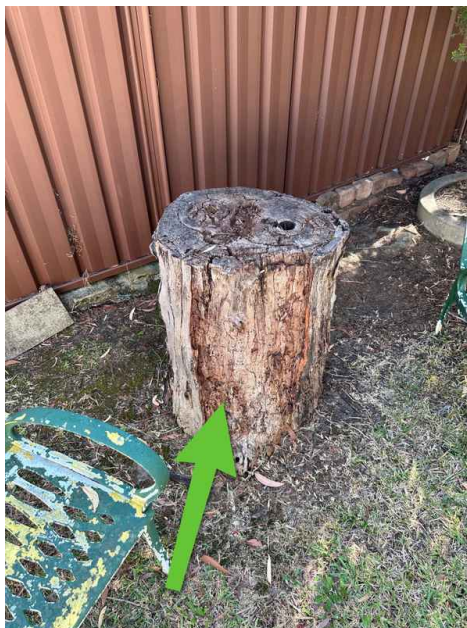
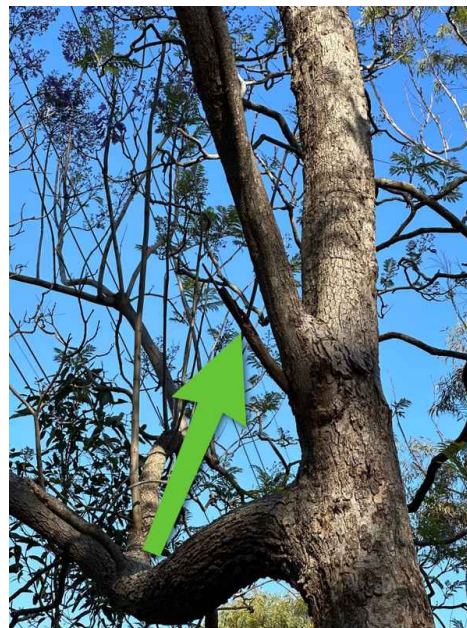
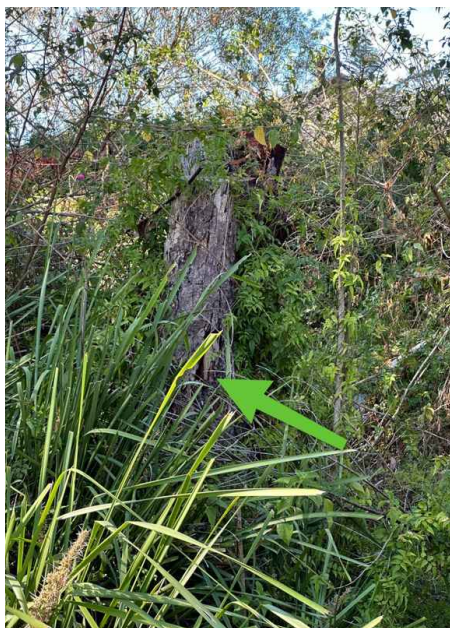
Tree/Leafy Environment, Tree Stumps

Are trees close to home - Yes

Trees are in close proximity to the dwelling and within the termite foraging area. These are a favourable influence for termite infestation and I recommend you liaise with neighbours to have trees regularly checked and if on your site, organise regular inspections for termite infestation.
