COMBINED BUILDING AND PEST INSPECTION

4 Sixth Ave
Loftus, NSW 2232

19/10/2023

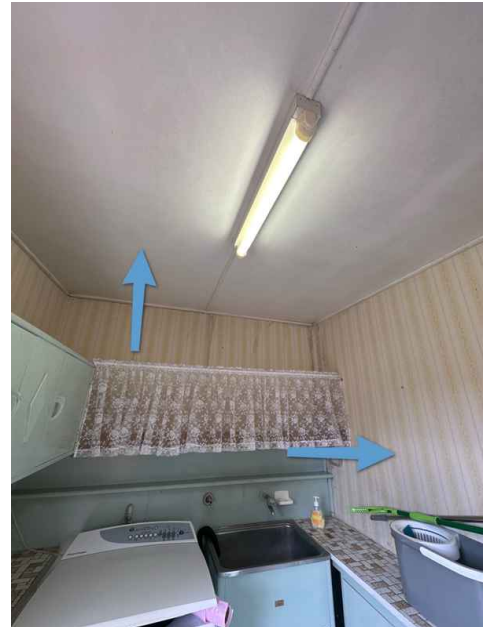
13.4.2 Walls

POSSIBLE MOULD

Possible mould noted. Low moisture readings detected.

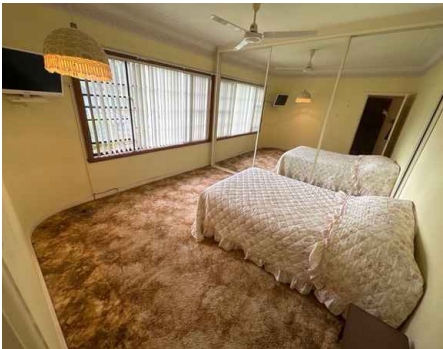
14.4.1 Walls

SHEET JOIN CRACKS

Sheet join cracks noted. This is probably due to thermal expansion. Patch and paint will suffice

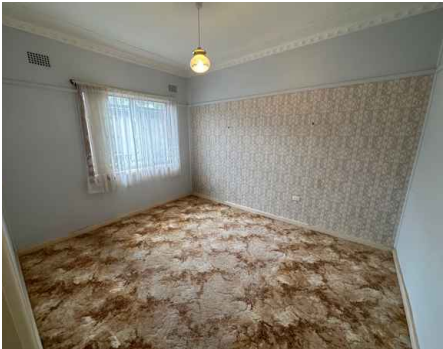
15.4.1 Walls

Possible mould noted.

Contact a qualified mold inspection professional.

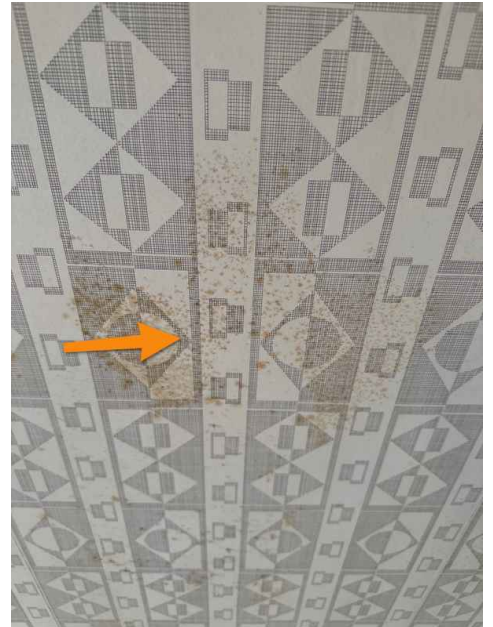
15.5.1 Ceilings

STAINS - DRY

Ceiling stains - No elevated moisture readings obtained. Recommendations: These may have been repaired, however, you will need to monitor after a prolonged period of rainfall - If leaking persists, a qualified plumber should be engaged for advice and recommendations. All water-damaged plaster replaced by a qualified plasterer.

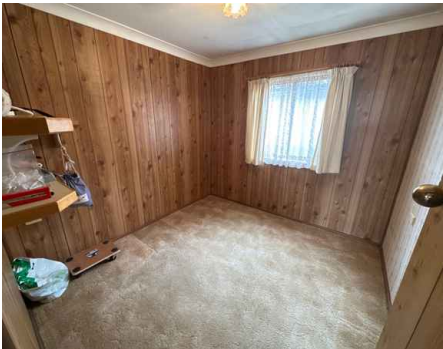
16.5.1 Ceilings

Ceiling sheet joins cracks evident. This is likely due to thermal expansion

Contact a qualified professional.

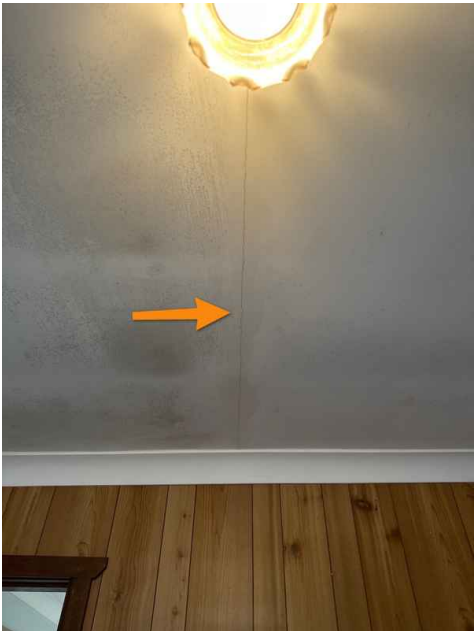
16.5.2 Ceilings

POSSIBLE MOULD

There are possible signs of fungi growth on ceiling. Recommend a qualified mold inspector evaluate.

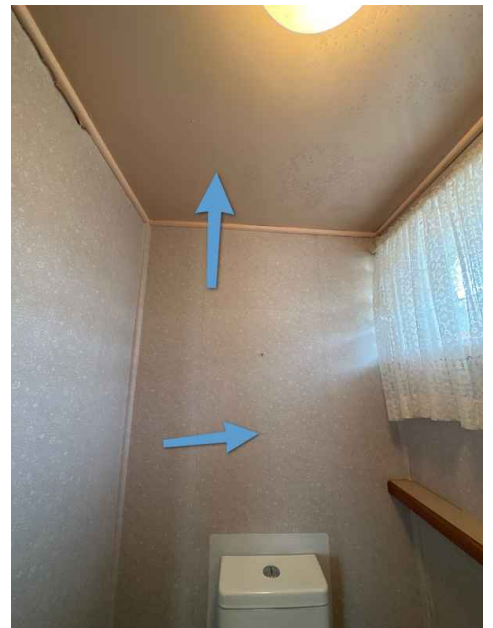
18.5.1 Ceiling

POSSIBLE MOLD

There are possible signs of fungi growth on ceiling. It is unknown if this is a safety hazard. Recommend a qualified mold inspector evaluate.
