FOURTEENTH REPORT - STORM AND WATER DAMAGE CLAIM

TABLE 1 – 68-70 ETON & 51-53 MERTON STREET, SUTHERLAND

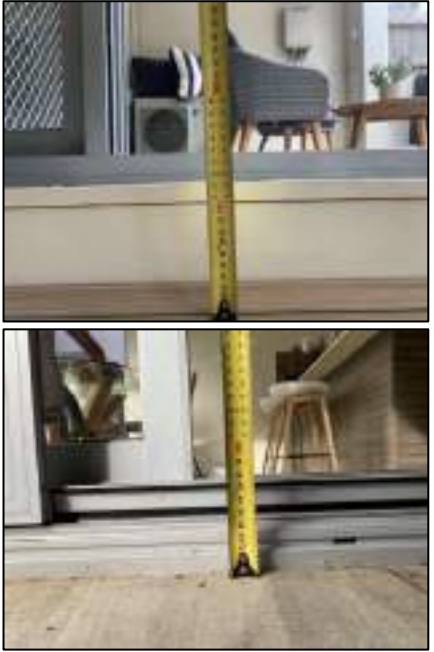
ITEM	LOCATION	DESCRIPTION	PHOTOGRAPH(S)
		The internal finished floor level is approximately 70mm <u>lower</u> than the external tiled floor surface, indicating the absence of a step down between the internal and external areas of the unit.

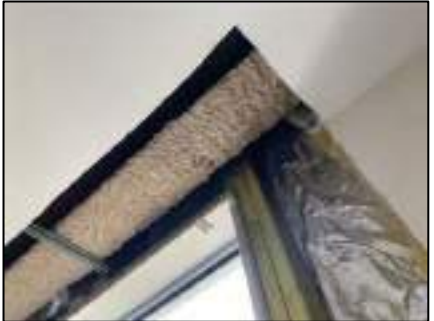
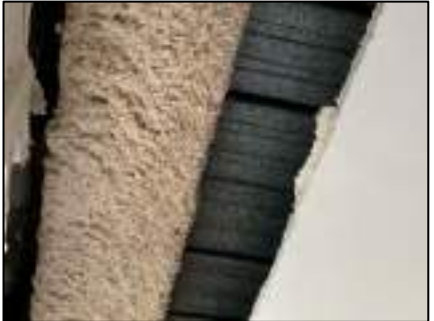
ITEM	LOCATION	DESCRIPTION	PHOTOGRAPH(S)
		<p>The steel universal beam (UB) within the ceiling cavity appears to be supporting the <i>bondek</i> formed concrete floor slab. The UB has been surfaced with a vermiculate protective fire rated coating.</p> <p>The vermiculite protective coating appears to be generally deteriorated and moisture damaged.</p> <p>Approximately 1.0mm wide cracking to the external sill reveal on the east facing window.</p>

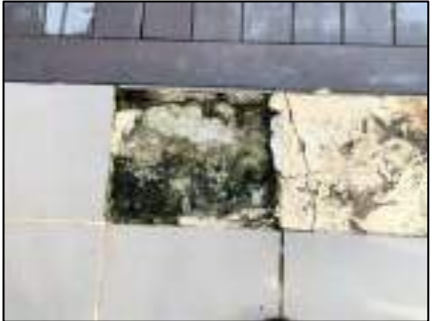
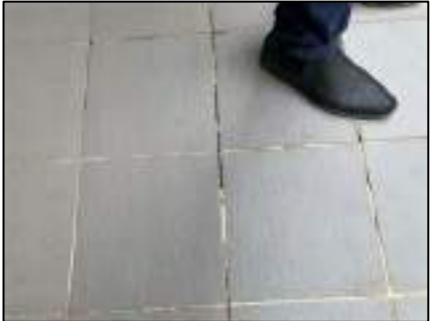
ITEM	LOCATION	DESCRIPTION	PHOTOGRAPH(S)
4.2	Terrace	<p>Cracked and delaminated tiling on the eastern side of the terrace, adjacent to the hardwood timber deck.</p> <p>Isolated cracked and displaced grout throughout the tile joints.</p> <p>Insufficient falls (1mm/m) recorded at the junction between the floor tiling and metal cladding enclosing the bay windows.</p>

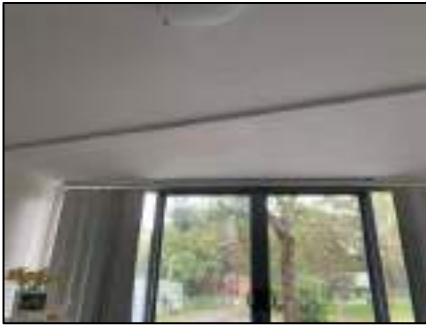
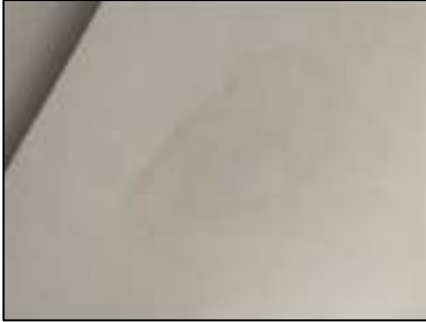
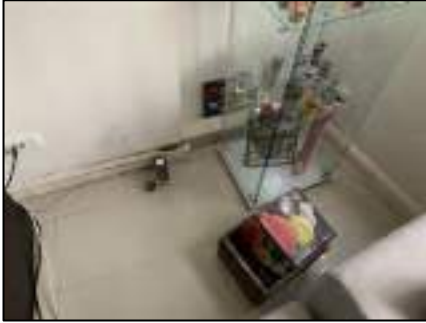
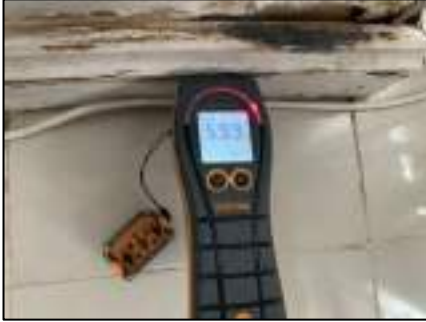
ITEM	LOCATION	DESCRIPTION	PHOTOGRAPH(S)
5.0	UNIT 108 (68 ETON)		
5.1	Living Room	<p>Evidence of water penetration in the form of moisture staining to the ceiling, located beneath the protruding roof.</p> <p>Evidence of water penetration in the form of rotting and moisture damaged timber skirting boards along the northern and southern sides of the living room, at the junction of the protruding bay window.</p> <p>High level moisture meter readings were recorded from same.</p>

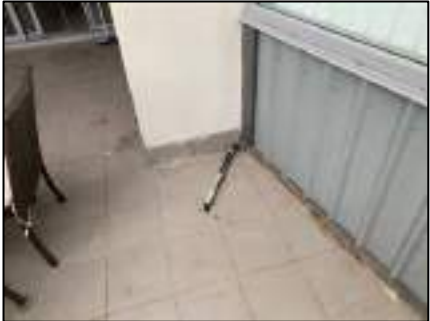
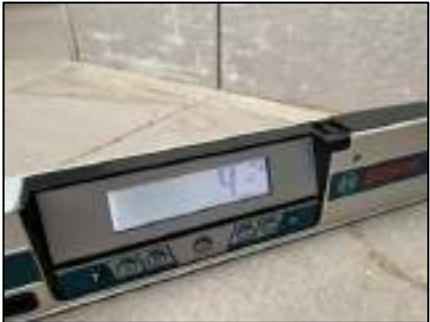
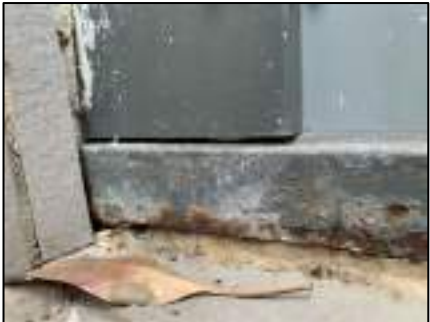
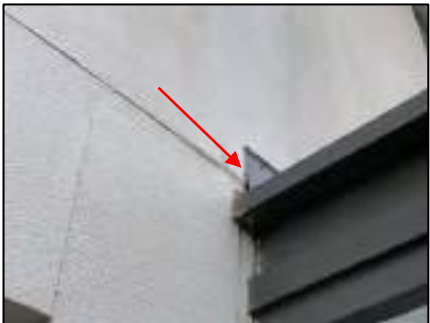
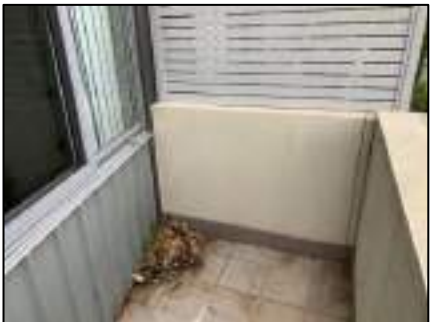
ITEM	LOCATION	DESCRIPTION	PHOTOGRAPH(S)
1.2	Terrace	<p>Insufficient falls (4mm/m) on the tiled surface at the interface with the protruding bay window wall.</p> <p>Corrosion is developing at the base of the roof sheeting utilised as cladding panels beneath the protruding bay window.</p> <p>A pressure sealed apron flashing is located at the junction of the roof and the façade.</p> <p>Vegetation and leaf debris at the interface between the balcony surface and protruding bay window at the western corner of the balcony.</p>

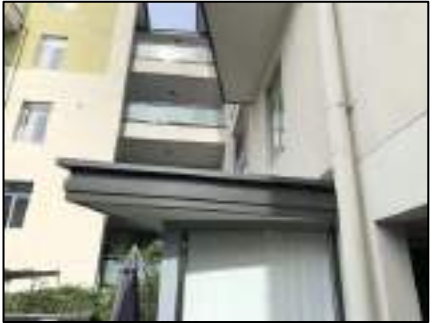
6.2	Terrace	A pressure sealed apron flashing is located at the junction of the roof and the façade.

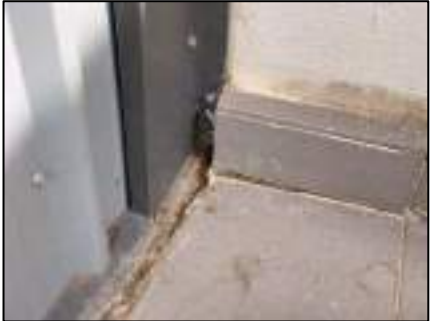
ITEM	LOCATION	DESCRIPTION	PHOTOGRAPH(S)
		The perimeter skirting tiles appear to be generally poorly detailed onto the external wall cladding.

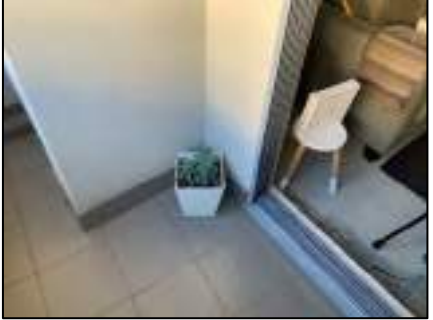
ITEM	LOCATION	DESCRIPTION	PHOTOGRAPH(S)
		A clad steel support column is located where the water ingress occurred.	
8.3	Balcony	The balcony waterproofing membrane upturn extends along and around a fibre-cement sheeted riser on the northern end of the balcony.

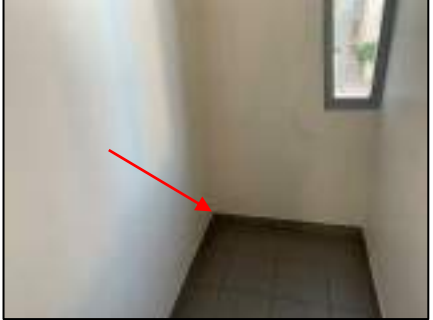
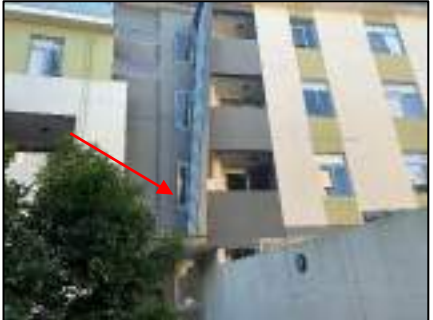
8.4	Common Foyer - Level 2	<p>Advised by the resident of Unit 201 (68 Eton St) of previous water penetration occurring through the base of the eastern wall of the common foyer (adjacent to the fixed pane window).</p> <p>The resident described the water penetration to predate the remaining issues within the unit.</p> <p>The advised area of water penetration is adjacent to the balcony of Unit 201 (68 Eton Street).</p>

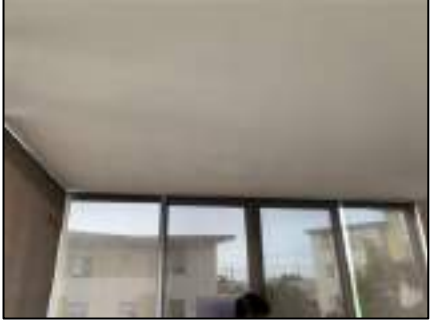
9.0	UNIT 203 (68 ETON)		
9.1	Living Room	<p>Evidence of water penetration in the form of moisture staining to the ceiling, located beneath the junction between the bay window roof and eastern façade wall, in addition to the outer southern edge of the ceiling.</p> <p>A man-hole opening was cut into the ceiling circa 2016 to undertake a visual assessment of the water penetration. We are not aware of any investigative or repair works that may have been undertaken.</p>

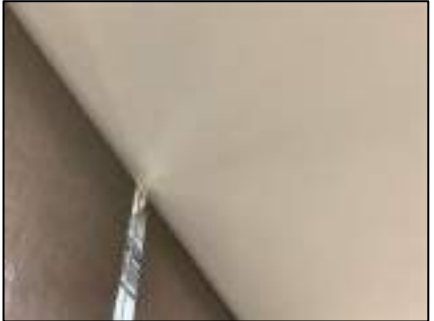
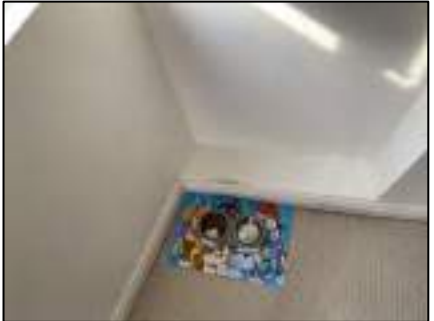
ITEM	LOCATION	DESCRIPTION	PHOTOGRAPH(S)
		<p>Evidence of water penetration in the form of moisture damaged skirting boards and carpet in the south-eastern corner of the room.</p> <p>Elevated moisture meter readings were recorded from the base of the southern wall and timber skirting boards.</p>

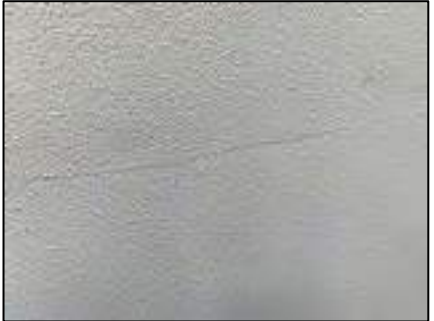
ITEM	LOCATION	DESCRIPTION	PHOTOGRAPH(S)
		Isolated cracking and separation along the joints in the fibre-cement 'blue board' façade sheeting. The façade coating membrane applied to same is consequently tearing in these locations.

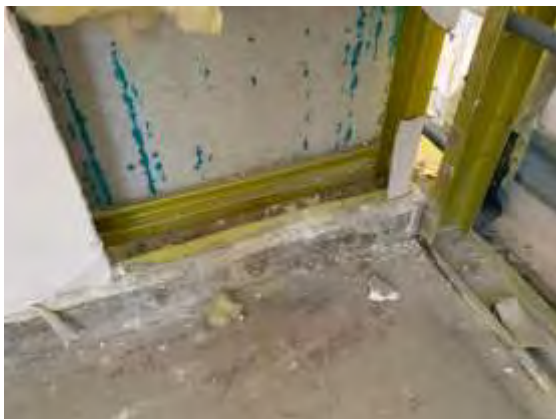
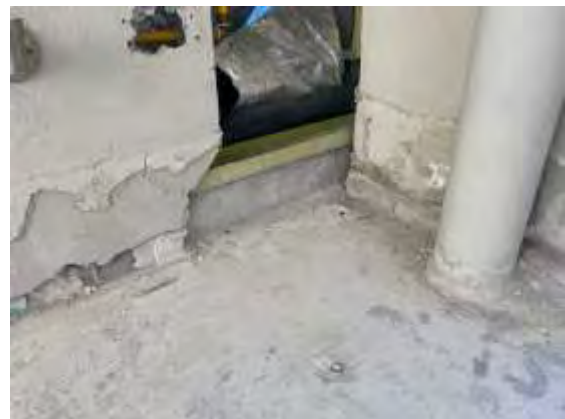
- The facades of the building are constructed of a combination of *Hebel* wall panels and lightweight fibre cement cladding which has been rendered/coated.
- A perimeter concrete hob is situated around the perimeter of the lower balcony.

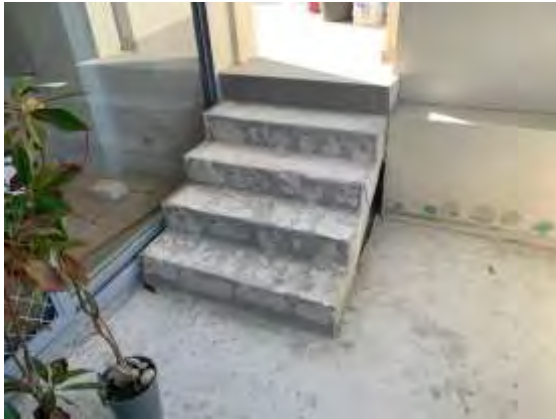
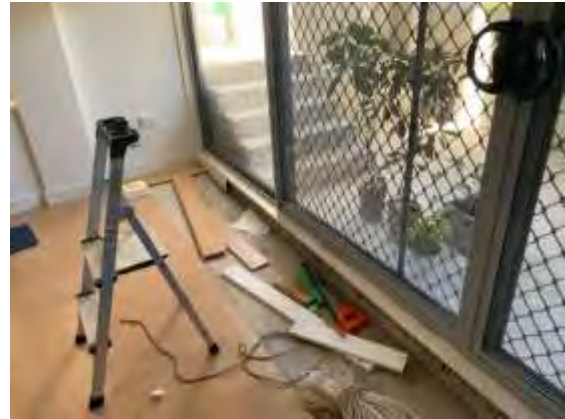
- A large 5.5-metre-long sliding door provides access from the living room to the lower balcony.
- A set of stairs provides access to the upper balcony from the northern side of the lower balcony.
- The stairs are in close proximity to the eastern balcony sliding doors of the lower balcony.

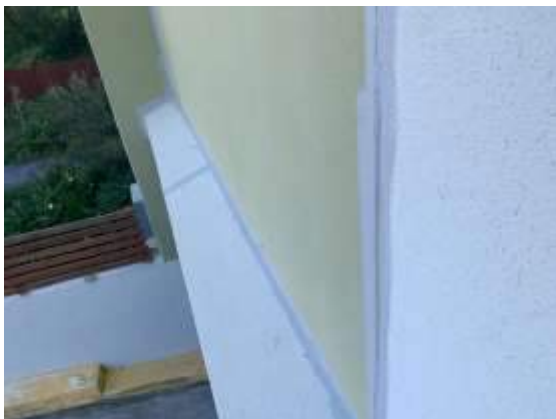
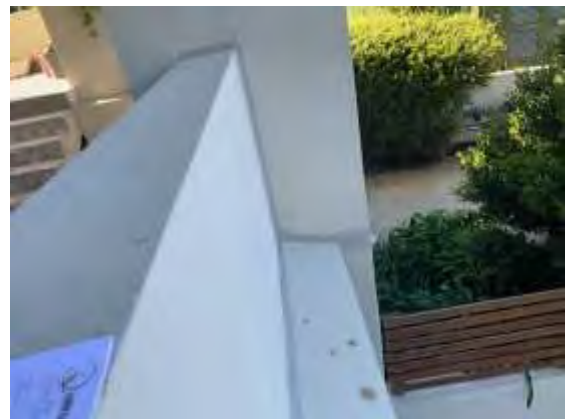
- All cladding junctions on the eastern façade and balustrade adjoining the lower balcony and main bedroom have been sealed with a polyurethane sealant. We are not aware when the sealant was installed.

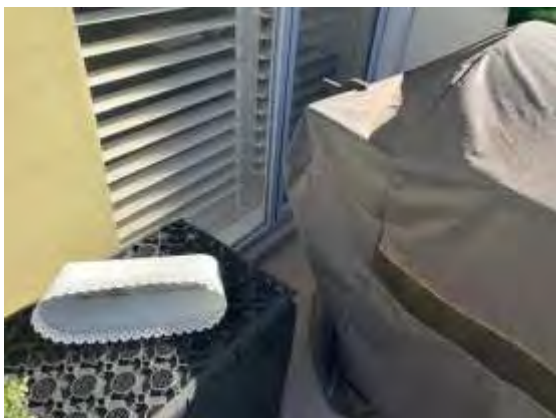
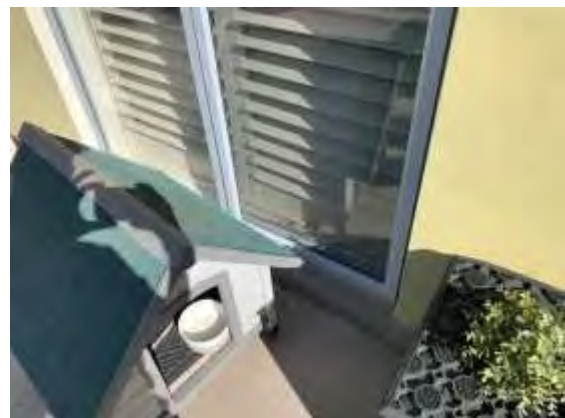
- Two windows are located on the northern façade of the living room. The sills of the windows correspond to the finished tile level of the upper balcony. There is no sub sill on the windows. It is unclear how the existing upper balcony waterproof membrane is detailed behind the windows.

As is the case with the doors, due to the windows not having sub-sill drainage on the upper balcony, these will likely have to be replaced also.

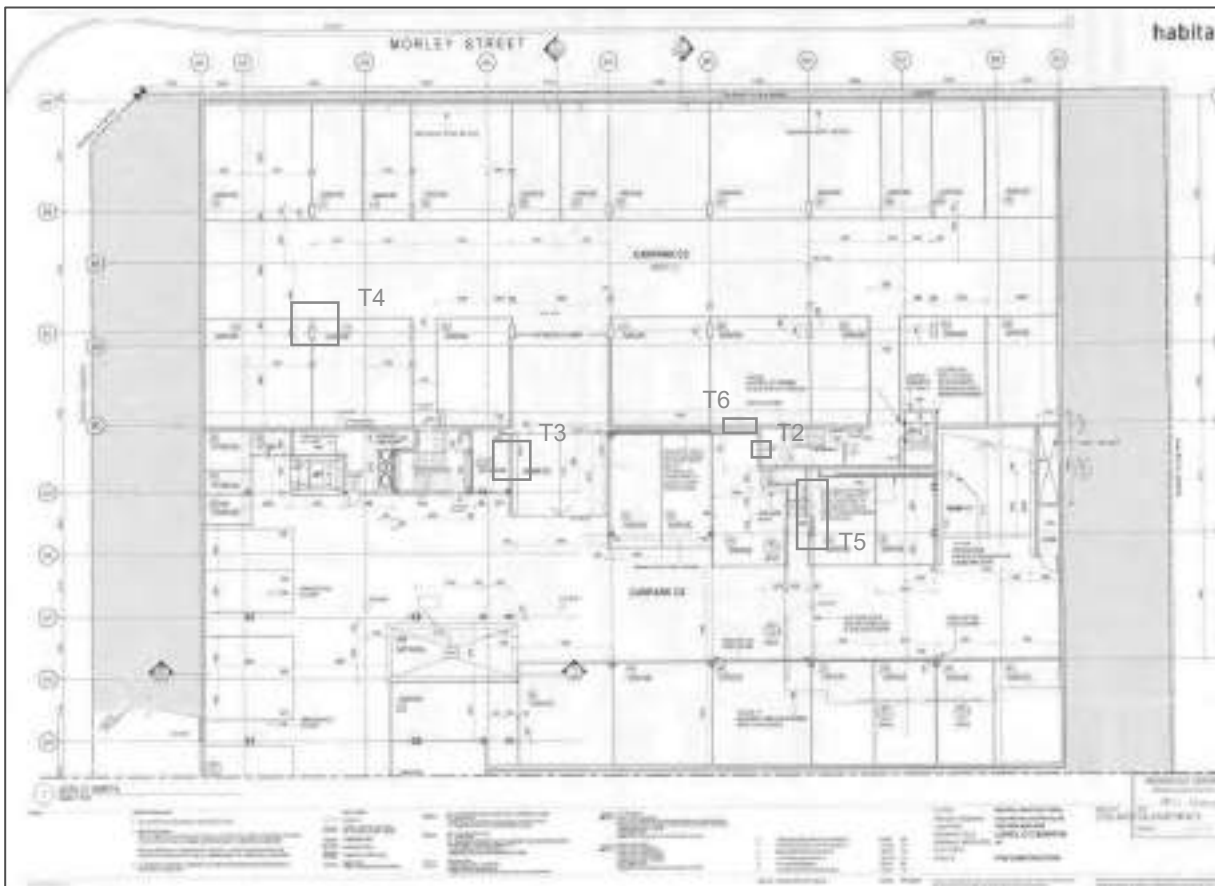
Figure 1 - testing locations 1

Since all steel components are covered with vermiculite – a fireproofing coating - it is impractical to uncover each individual member for examination. Based on this limitation, the choice of testing locations was representative in nature, and focused on areas with evidence of active corrosion only. Two particular areas presented evidence of active corrosion. Additionally, we have inspected four extras randomly locations, and meticulously removed the fireproofing materials to enable access to the steel surface to conduct the intended testings. The results obtained from these four locations offer insights into the condition of the rest of the steel elements, providing a representative overall state of the steel members.

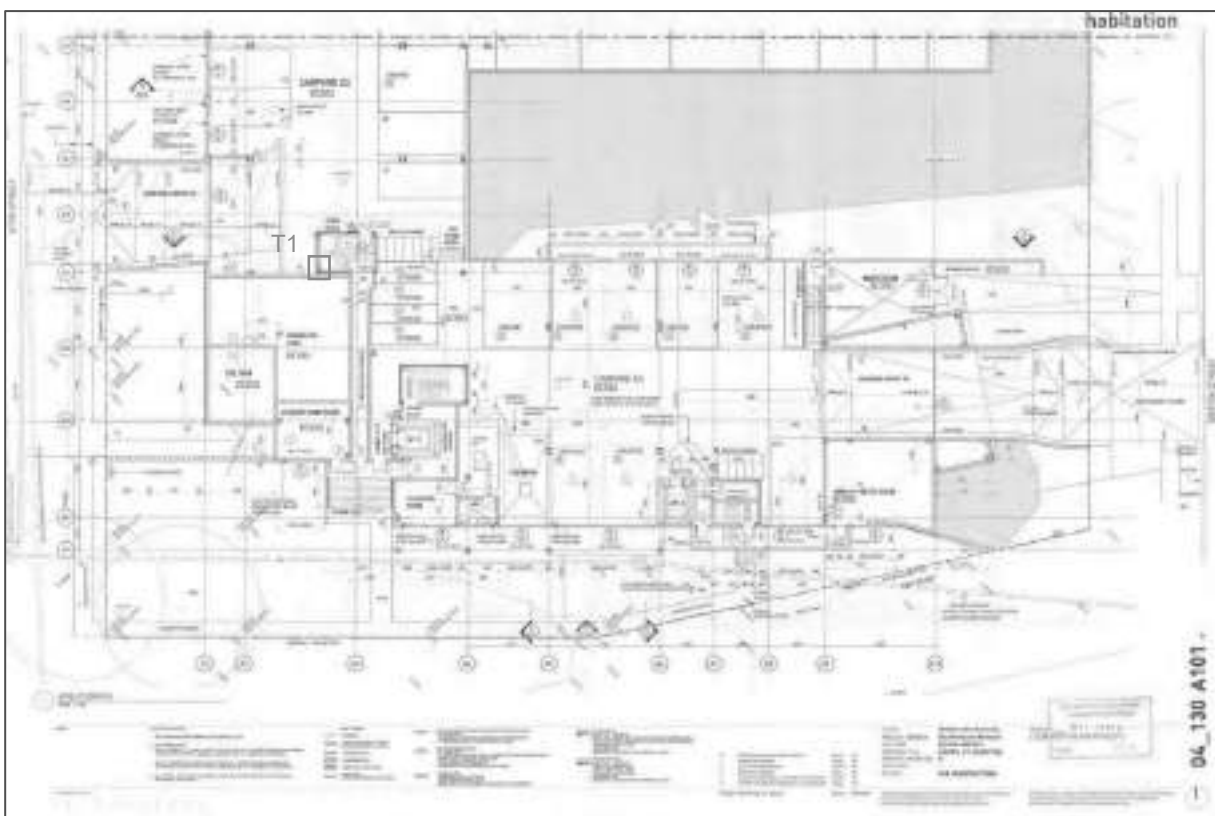
Figure 2 - testing locations 2

The UTG testing and tangible measurements, including measuring tape and calibrator, took place on the 10th of August, 2023. The designed locations are labelled T1 to T5 and indicated in Figure 1 and Figure 2.

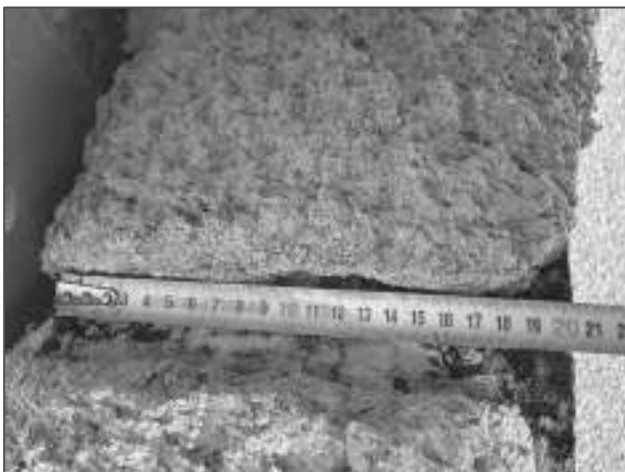
Photograph 5 – measure tape representing a 200 UC column

Based on collected measurements, this steel element is identified as 200UC46, with an anticipated flange thickness of approximately 11mm. Our measurements on the upper section, conducted using ultrasound and a calibrator, validate this dimension.

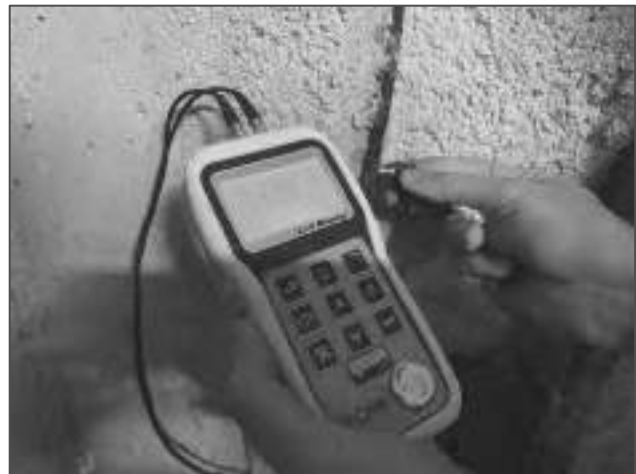
Upon removing the flaking rust, and all loose material, from the lower section and subjecting it to impact with a hammer, a solid sound was emitted, accompanied by a consistent vibration. These outcomes collectively suggest that the column is in a robust and stable condition. The results from multiple ultrasound readings consistently indicated that the flange thickness has not undergone substantial reduction from its intended measurement, despite the present evidence of superficial corrosion. This phenomenon could potentially be attributed to the fact that the discrepancy error of the initial thickness of the steel falls within the higher range of the spectrum, typically varying from -0.5mm to 0.5mm, and the corrosion is mostly causing delamination of the coating layer.

Photograph 9 – UTG reading of the flange thickness on the lower part, 2nd reading.

3. The steel column in T1 is structurally sufficient by the time of inspection, even with signs of structural corrosion. However, waterproofing issues should be resolved in a short term to prevent further corrosion.

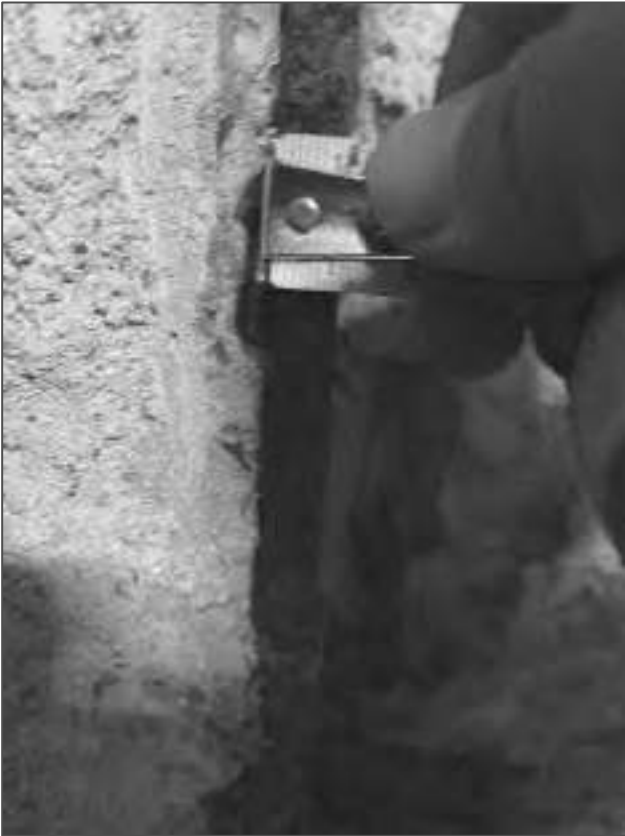
Photograph 10 – measure tape confirming the thickness

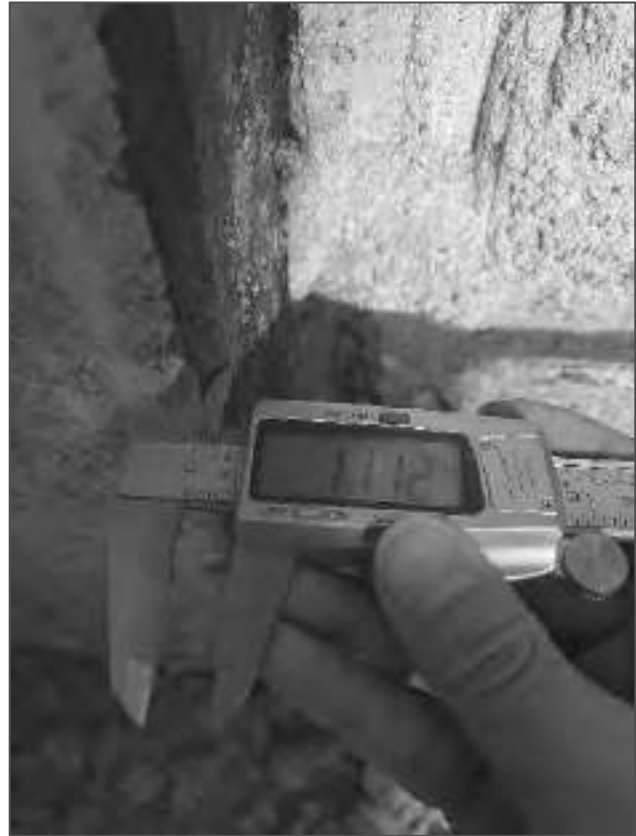
Photograph 11 – calibrator estimation, confirmation of the thickness

At the time of inspection, this member demonstrated structural integrity. Following the removal of the rust layer and the elimination of corroded sections, the steel member remains robust, exhibiting minimal - and neglectable - material loss in comparison to its designed design thickness. However, it is crucial to promptly tackle the root cause of the waterproofing problems that led to the corrosion. This immediate action is vital to avert subsequent deterioration and potential adverse effects on the structural stability.

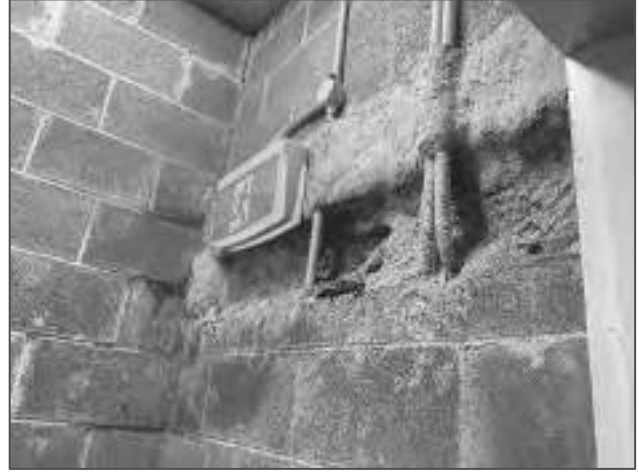
The steel beam T2 with evidence of severe corrosion is located within the stair well near axis B4 and AD. Water stain, and general organic growth, was observed to be present to surrounding building materials, such as blockwork and mortars. Water infiltration from the exterior, originating at the top of the steel element, is evident across the entire beam length.

Photograph 13 – water marks and algae near the beam.

Nevertheless, it remains crucial to promptly rectify the underlying waterproofing problems that triggered the structural corrosion. This action is essential to prevent additional deterioration of the structural component.

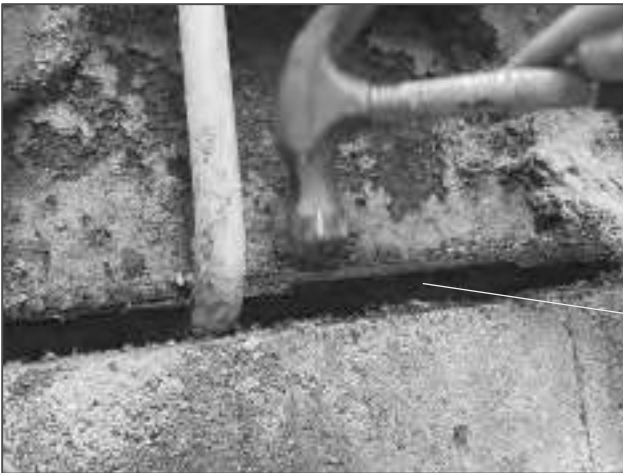
Photograph 14 – substantial material loss on the bottom flange

At the time of the inspection, it was noticeable that this structural member has experienced notable material degradation; however, owing to the relatively light load that this beam carries, the remaining section retains sufficient structural integrity.

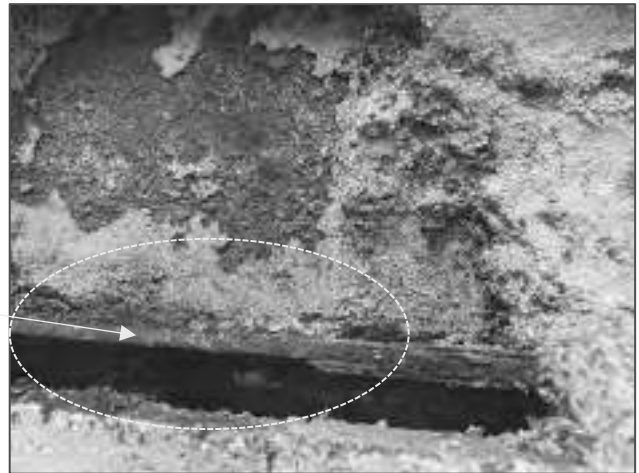
Photograph 15 – closeup image of the material loss on the bottom flange

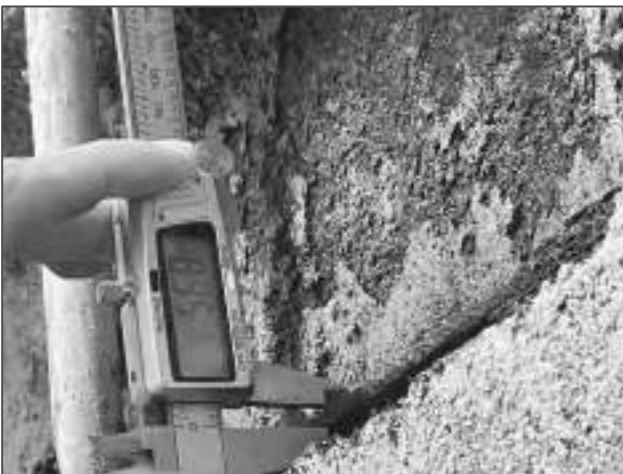
4. The steel beam in T2 is experiencing considerable material losses. Due to the light load on the beam, the structural integrity is still adequate. However, waterproofing issues should be resolved in a short term to prevent further corrosion.

Photograph 16 – remaining thickness of the beam, 1st reading

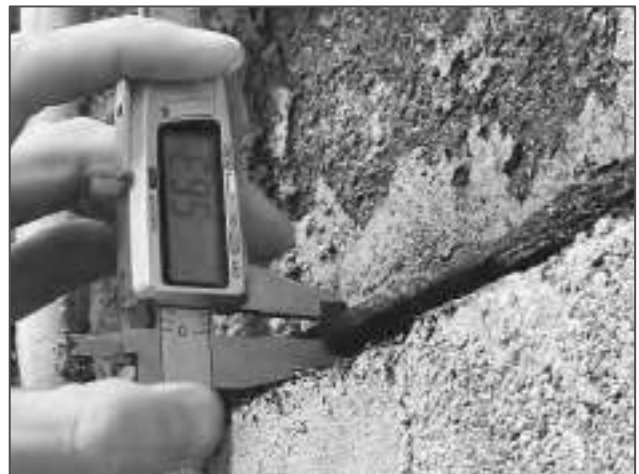
Photograph 17 – remaining thickness of the beam flange, 2nd reading

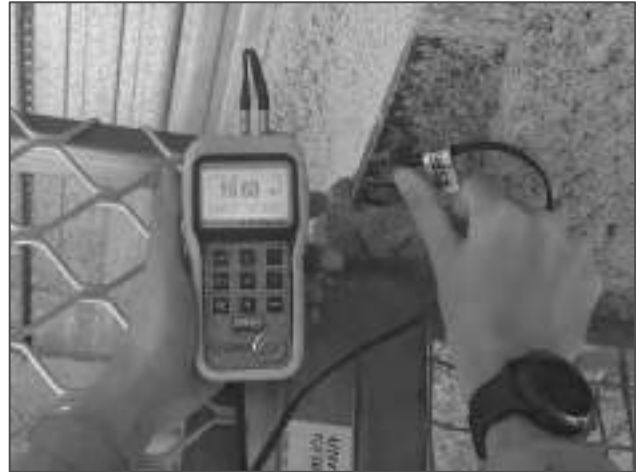
Photograph 19 – UTG reading, T4

Minor surface corrosion has been detected on the flanges of T3, T4 and T5, indicating a reasonable likelihood that a similar condition prevails among most steel members within the garage. The presence of light corrosion indicate the failure of – or the absence – passive protective layer. Due to the applied fireproofing vermiculite coating across the surface of all steel members, the prospect of recoating the entire set of members is not a practical option.

We advise implementing a routine inspection schedule, preferably every 6 to 12 months, to monitor the condition of the steel members and ensure timely intervention if needed.

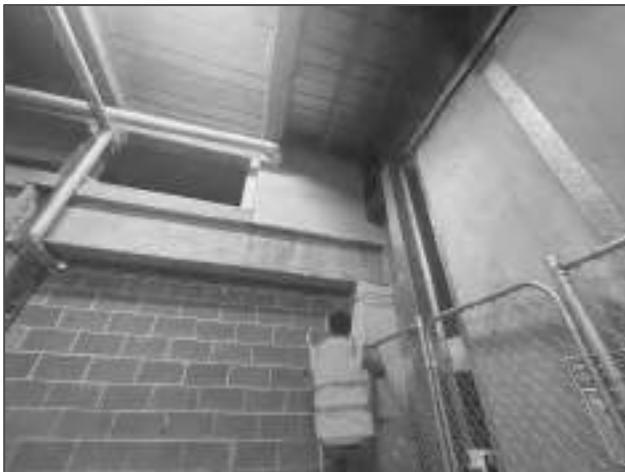
All of these specific sites display signs of minor surface corrosion, with remnants of the original coating still discernible on the surfaces. Throughout the inspection period, no evidence of structural deterioration was identified. These chosen areas provide a representative glimpse into the general condition of the steel components within the garage.

Photograph 20 – general view of T5

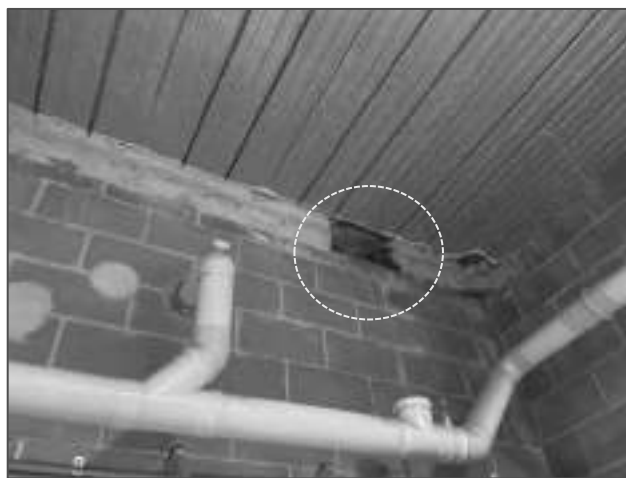
At the time of the inspection, we have observed the occurrence of active corrosion near the permanent-steel formwork slab and the adjacent supporting angle bars. These angle bars are coated with vermiculite, which was found to be saturated wet during our assessment. Upon the removal of the vermiculite coat, we identified widespread surface corrosion on the angle bars. Additionally, the permanent slab formwork sheets that are in direct contact with the angle bars exhibits signs of corrosion. The corrosion had spread a few centimetres from the edge of the angle bars. Notably, at the edges of the corrosion lines, we detected the presence of green and white powdery residues. These residues are indicative of zinc oxidation, suggesting that the galvanic layer, which serves as a barrier against corrosion, has experienced deterioration.

The angle bars primarily bear shear loads from the slab, and the extent of corrosion observed at the time of our inspection did not appear to be severe at that point. As a result, we hold the view that the angle bars retain their structural adequacy for their intended shear load-bearing function. Nevertheless, it is worth noting that due to the relatively slender profile of the slab formwork-sheet system, any degree of material loss can be of significance.

Photograph 25 – T6 after removal of the vermiculite coating

- 1) Clean back the corrosion and assess the condition of the slab steel formwork sheet.
- 2) Ironbridge to examine the shear capacity of the slab in the event that the material is no longer present.
- 3) Rectification of all problems related to water ingress and associated waterproofing deficiencies.
