**THE OWNERS - STRATA PLAN NO. 85881 | 68-70 ETON STREET & 51-53 MERTON STREET,
SUTHERLAND NSW 2232 | BUILDING DEFECTS**

BUILDING INSPECTION REPORT 100838 - REV D.2

68 Eton Street Sutherland New
South Wales 2232
Report Date: 6th October 2023

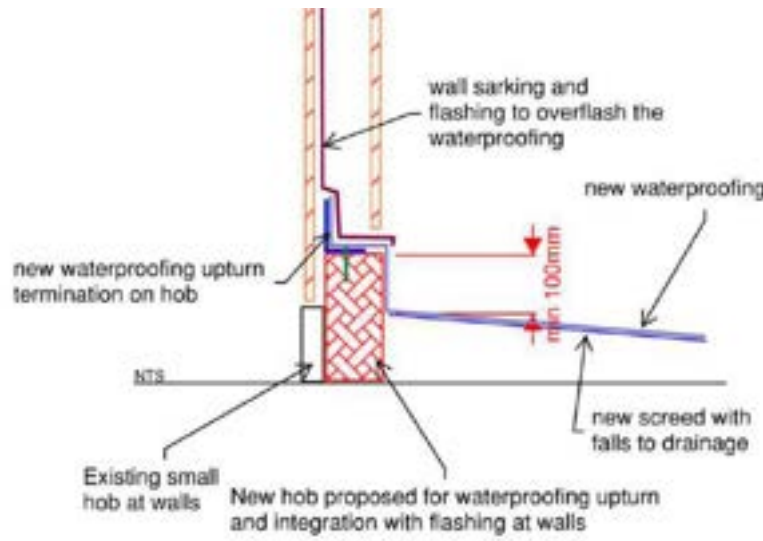
1.5	Waterproofing termination downturn into the central drainage point on the balcony. <i>Refer to Photo 12</i>	
1.6	<p>The new hob detail has been installed as per the general detail below.</p>

<p>A similar detail has been implemented at the cladded wall section. Tiling will include a skirting tile to cover the membrane upturn.</p>

1.7	<p>CBS is to flood test the balcony for approximately 12-24 hours. Ensuring no water leaks are reported in the unit below during the testing and when the water is released.</p> <p>CBS to provide written advice confirming the results of the flood test.</p>	CBS

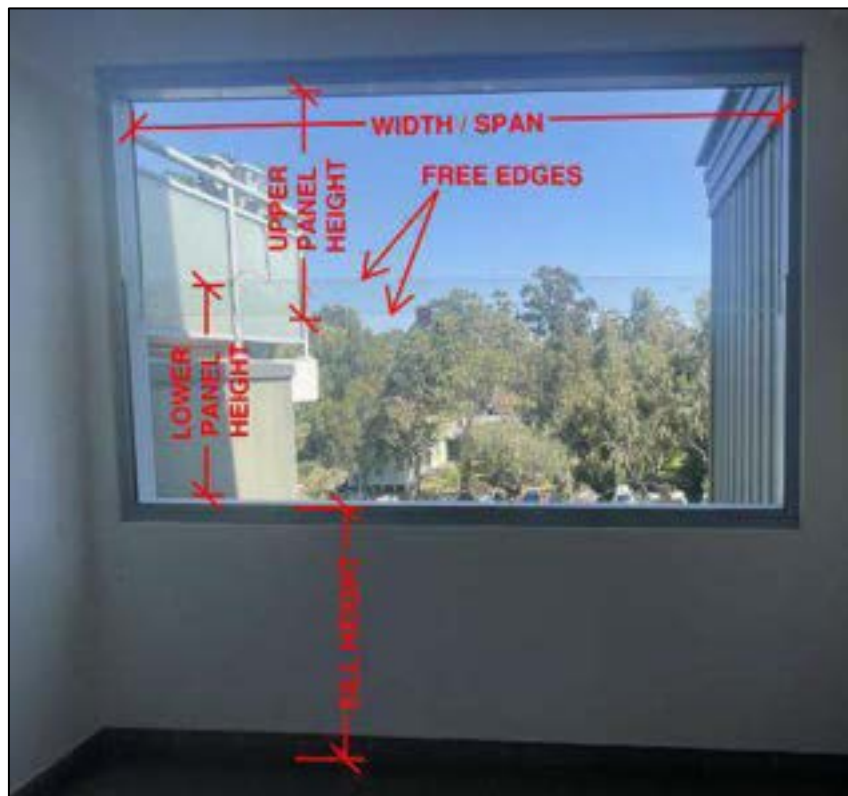
Figure 1 - glazing units' configuration

The 11 glazing units are uniform in construction materials and vary in size and shape. As depicted in Figure 1, each unit consists of two matching glazing panels. The upper glazing is supported on three edges: the top, left, and right edges. Similarly, the bottom glazing is supported on three edges: the bottom, left, and right edges. There is an approximately 100mm overlap between the upper and bottom glazing panels, and they are horizontally separated by approximately 70mm with the upper panel located on the outside to mitigate water ingress. The glazing panels are secured to the aluminium frames with rubber gaskets on the three supported sides.

ID	Remedial actions
U1	Replace with Grade A safety glass
U2	Replace with Grade A safety glass
U3	Replace with Grade A safety glass
U4	Replace with Grade A safety glass
U5	Replace with Grade A safety glass
U6	Replace with Grade A safety glass
U7	Apply safety film
U8	Apply safety film
U9	Apply safety film
U10	Replace with Grade A safety glass
U11	Replace with Grade A safety glass

- New panels are to be formed of Grade A safety glass, with the specific makeup to be confirmed by structural analysis.
- Glazing film is to be SCL ER PS4 produced by MEP Films or approved equal.
