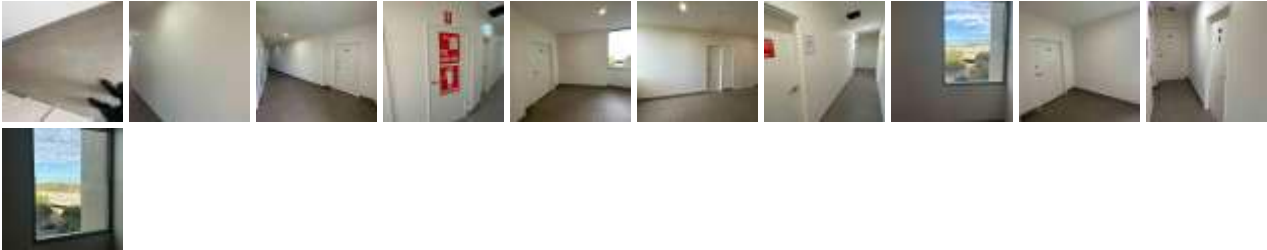
Level 3/53 Merton St

| <p><b>Good</b></p> <p><a href="#">ID: D-03085</a></p> <p><a href="#">🔗</a></p> | <p><b>Description:</b></p> <p>Observed to be in good condition</p> <p><b>Resolution:</b></p> <p>Monitor condition of building element and complete general cleaning and repaint (where applicable).</p> <p><b>Location:</b></p> <p>Level 3 Lobby</p> |

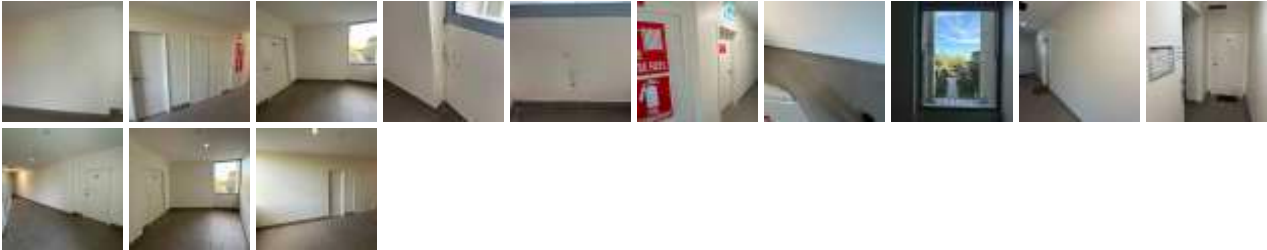
Level 2/53 Merton St

**Description:**  
Possible ingress of water Through window, façade, flashings affecting wall. Check window glazing compliance, maybe to much deflection.  
Observed to be in fair condition with partial signs of deterioration and potential structural failure

**Resolution:**  
Consult with Structural Engineer to review and provide design advice (where applicable), rectify any structural issues, undertake repairs to finishes and repaint.

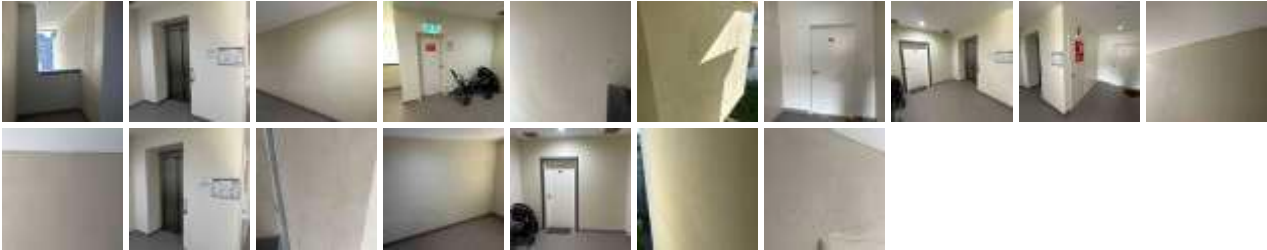
Level 4/51 Merton St

**Description:**  
Observed to be in fair condition with partial signs of deterioration and potential structural failure

**Resolution:**  
Consult with Structural Engineer to review and provide design advice (where applicable), rectify any structural issues, undertake repairs to finishes and repaint.

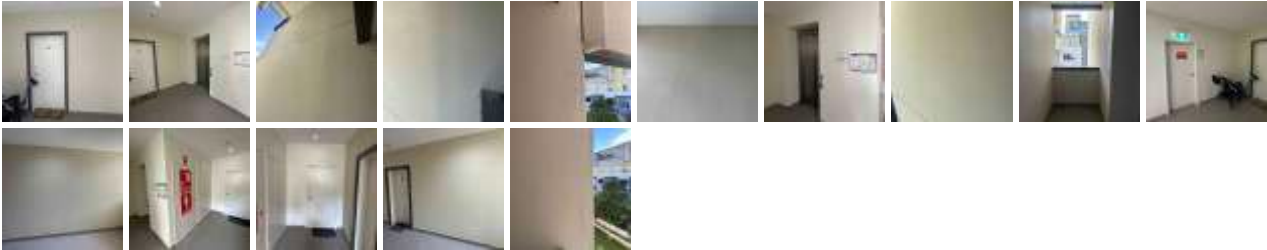
Level 3/51 Merton St

**Description:**  
Observed to be in fair condition with partial signs of deterioration and potential structural failure

**Resolution:**  
Consult with Structural Engineer to review and provide design advice (where applicable), rectify any structural issues, undertake repairs to finishes and repaint.

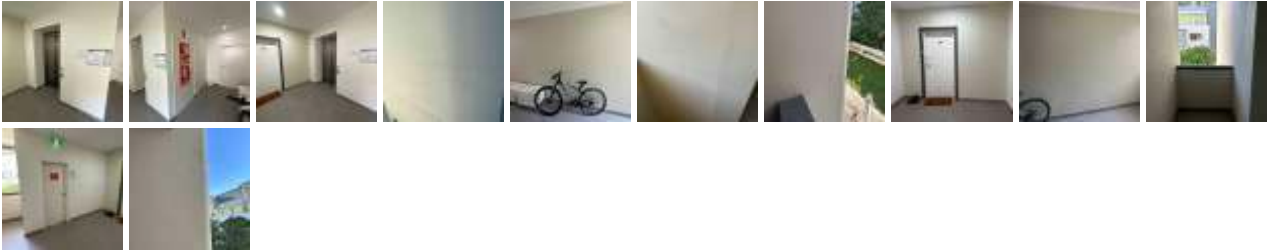
Level 2/51 Merton St

**Description:**  
Observed to be in fair condition with partial signs of deterioration and potential structural failure

**Resolution:**  
Consult with Structural Engineer to review and provide design advice (where applicable), rectify any structural issues, undertake repairs to finishes and repaint.

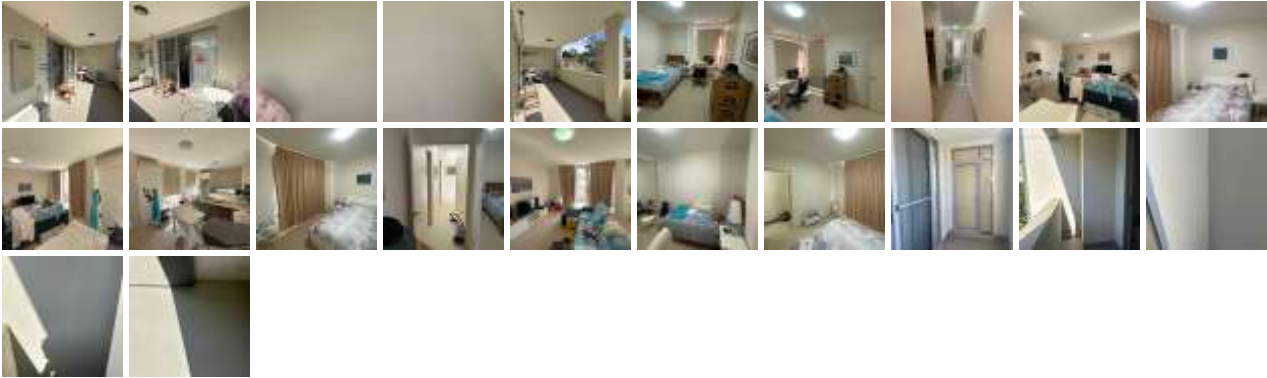
301/68 Eton St

**Description:**  
Observed to be in fair condition with partial signs of deterioration and potential structural failure

**Resolution:**  
Consult with Structural Engineer to review and provide design advice (where applicable), rectify any structural issues, undertake repairs to finishes and repaint.

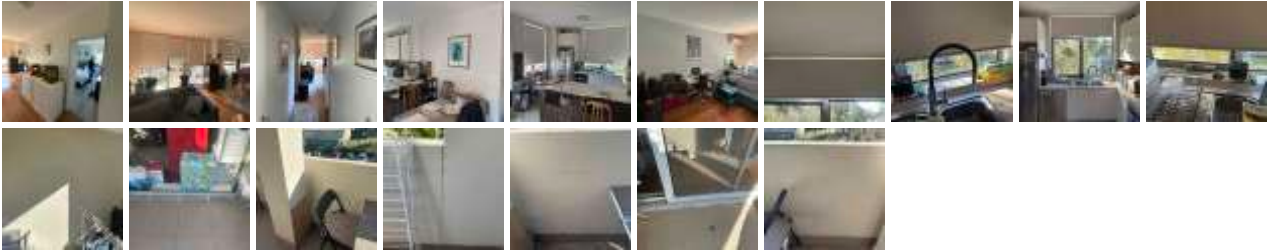
301 /51 Merton St

Tenant been in Unit for 4 years. Water ingress under hob. Observed to be in poor condition with significant signs of deterioration and structural failure

Consult with Structural Engineer to review and provide design advice (where applicable), rectify any structural issues, undertake repairs to finishes and repaint.

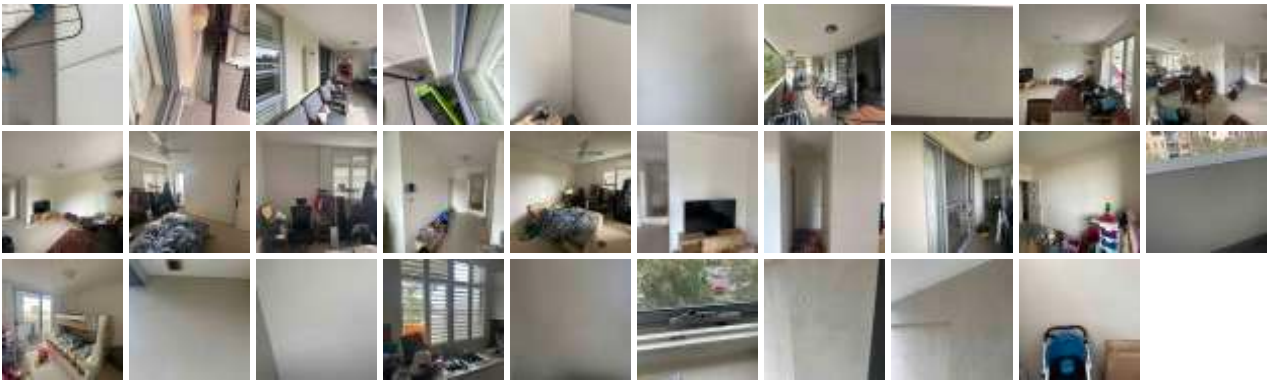
401 /51 Merton St

**Description:**  
Observed to be in poor condition with significant signs of deterioration and structural failure

**Resolution:**  
Consult with Structural Engineer to review and provide design advice (where applicable), rectify any structural issues, undertake repairs to finishes and repaint.

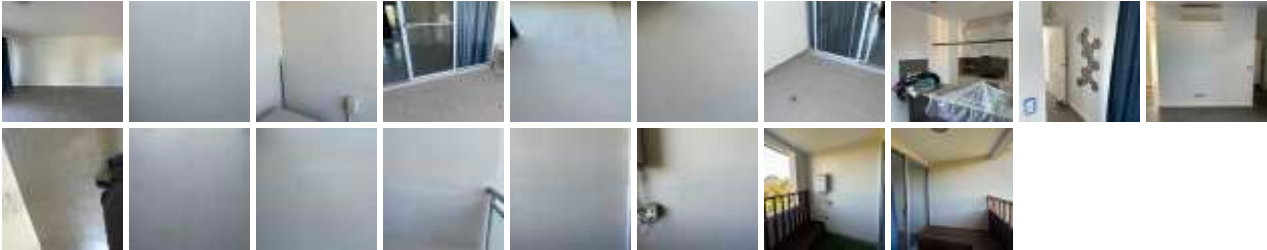
503/70 Eton St

**Description:**  
Observed to be in fair condition with partial signs of deterioration and potential structural failure

**Resolution:**  
Consult with Structural Engineer to review and provide design advice (where applicable), rectify any structural issues, undertake repairs to finishes and repaint.

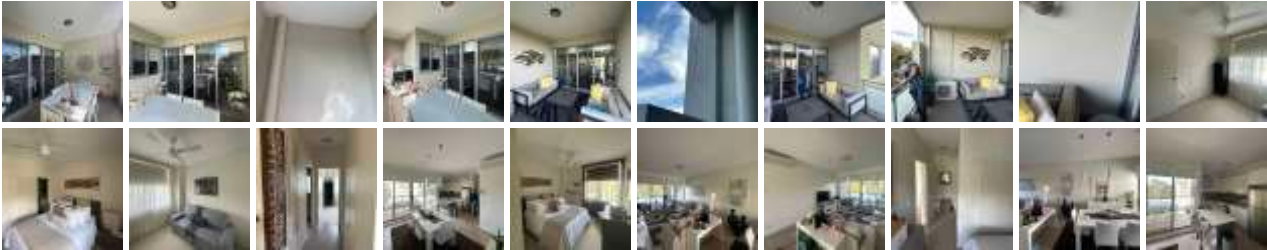
401/70 Eton St

Observed to be in fair condition with partial signs of deterioration and potential structural failure

Consult with Structural Engineer to review and provide design advice (where applicable), rectify any structural issues, undertake repairs to finishes and repaint.

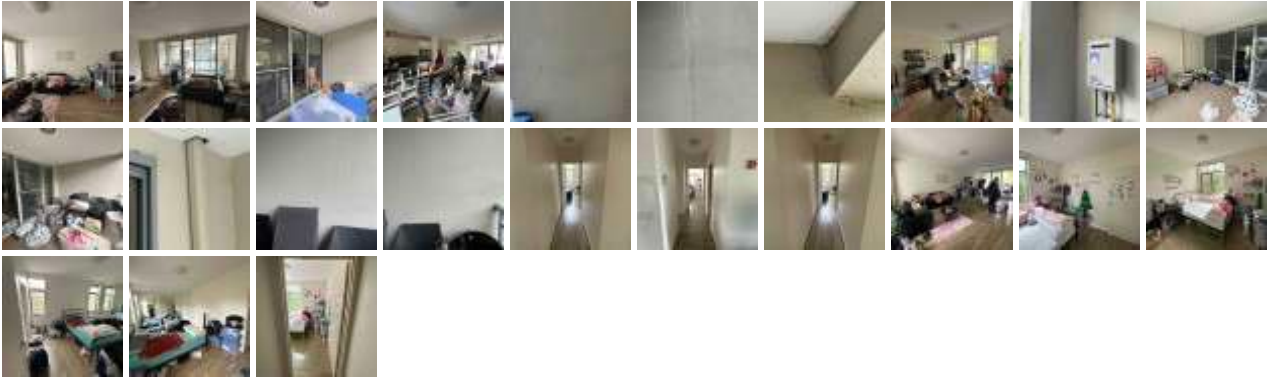
**Description:**  
Observed to be in fair condition with partial signs of deterioration and potential structural failure

**Resolution:**  
Consult with Structural Engineer to review and provide design advice (where applicable), rectify any structural issues, undertake repairs to finishes and repaint.

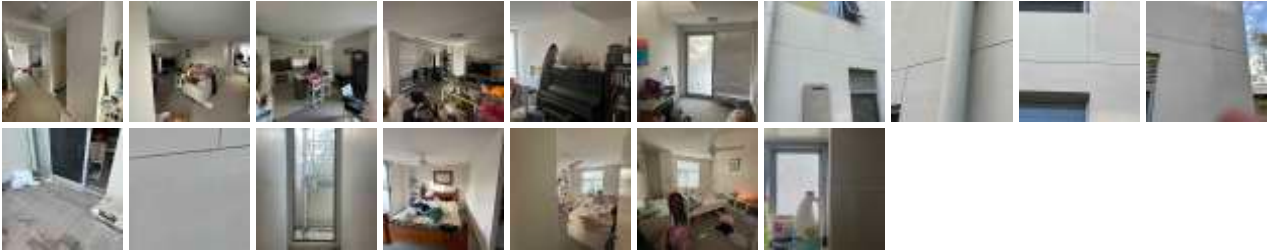
104/51 Merton St

Observed to be in poor condition with significant signs of deterioration and structural failure

Consult with Structural Engineer to review and provide design advice (where applicable), rectify any structural issues, undertake repairs to finishes and repaint.

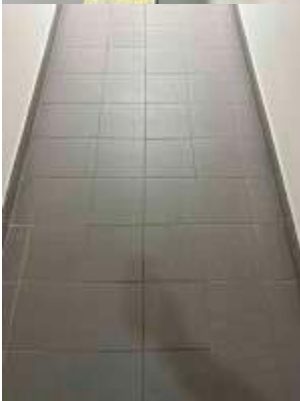
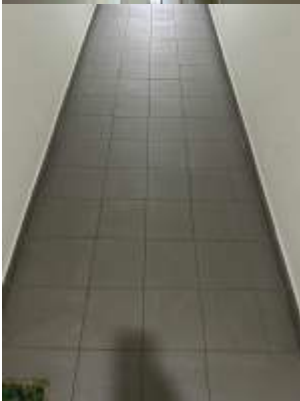
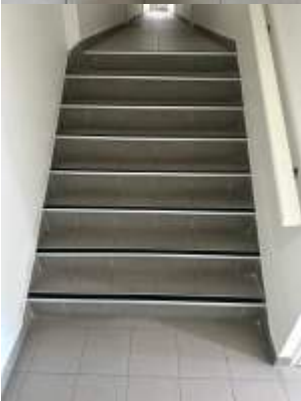
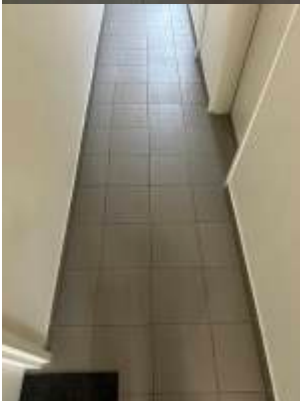
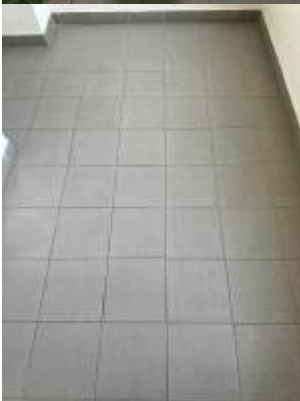
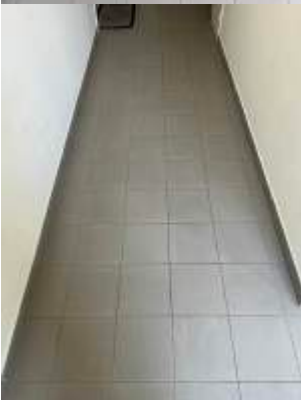
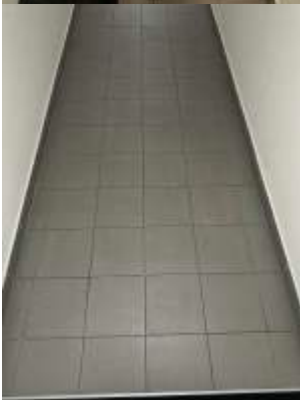
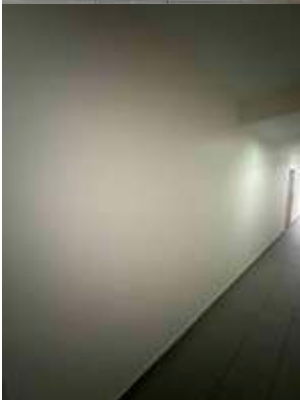
(D-03169)

Good - Water  
Ingress  
[ID: D-03169](#)

**Description:**  
Observed to be in good condition. Minor non-structural deterioration.

**Location:**  
Level 2 Lobby

**Resolution:**  
Monitor condition of building element (over proceeding 6 months) and complete general cleaning and maintenance to finishes (where applicable).

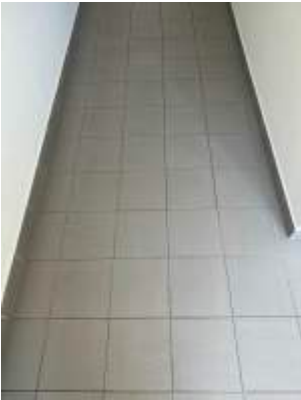
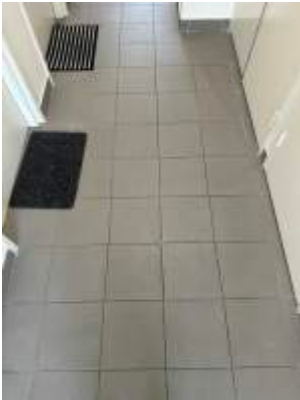
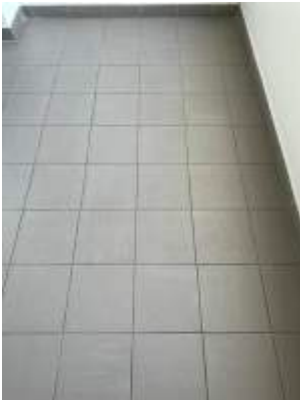
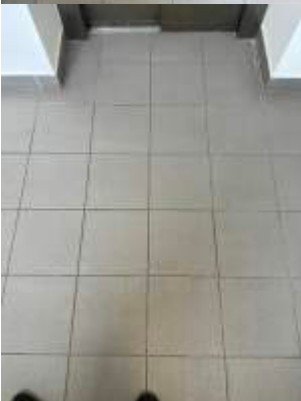
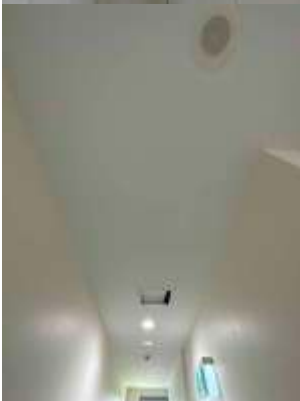
(D-03174)

Good - Water  
Ingress  
[ID: D-03174](#)

**Description:**  
Observed to be in good condition. Minor non-structural deterioration.

**Location:**  
Level 3 Lobby

**Resolution:**  
Monitor condition of building element (over proceeding 6 months) and complete general cleaning and maintenance to finishes (where applicable).
