## Building Report

4 Barana Pl Kareela

# BUILDING & PEST INSPECTION

## **BUILDING & TIMBER PEST INSPECTION REPORT TO AS4349.1 2007 & AS4349.3 2010**

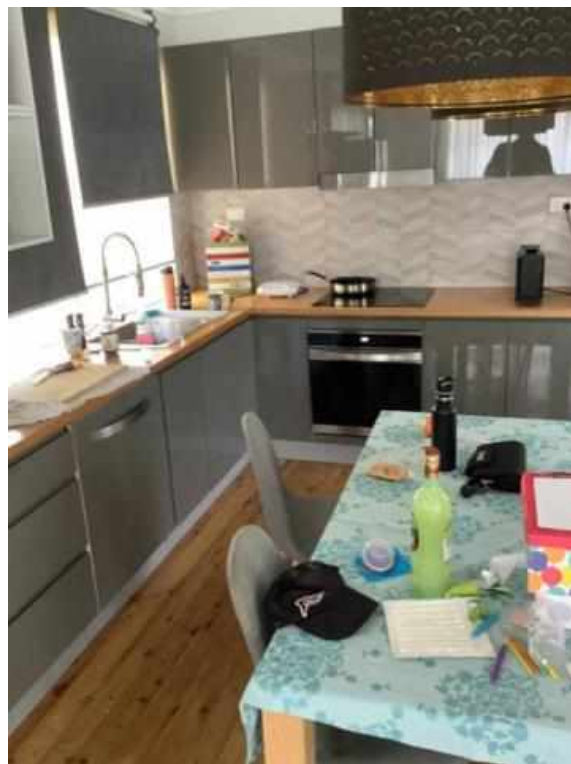
All kitchen electrical appliances and wiring need to be checked by a qualified electrician. The checking of any electrical item is outside the scope of this report. It is recommended that a licensed electrician be consulted for further advice.

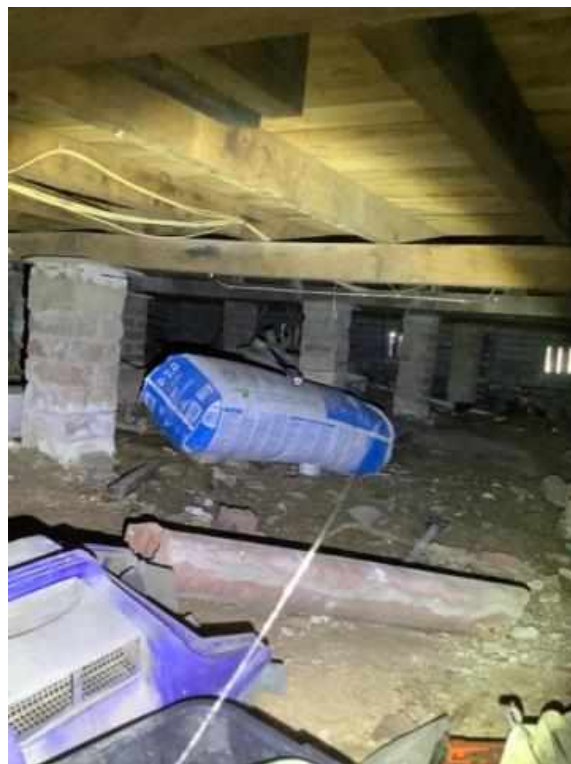
#### **PIERS / STUMPS / POSTS - CONDITION**

Satisfactory.
