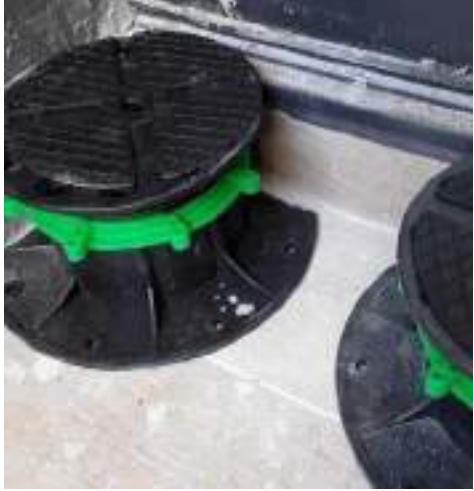
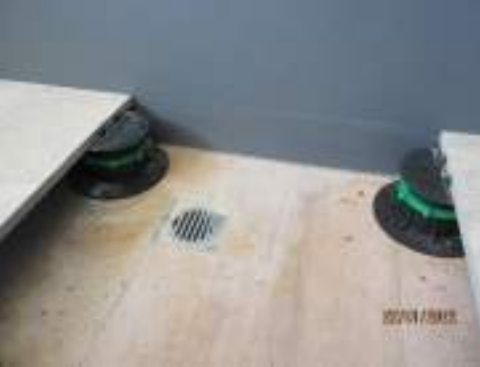
<p>Paving pedestals installed over tiled surface.</p>

<p>HARPER OBSERVATION AND COMMENTS – NOT A DEFECT AS TILED SURFACE SUITABLE FOR PEDESTAL SYSTEM.</p>
C 194	Level U4 lobby	Balcony - handrail	See sections 8.5 and 8.26 of this report.

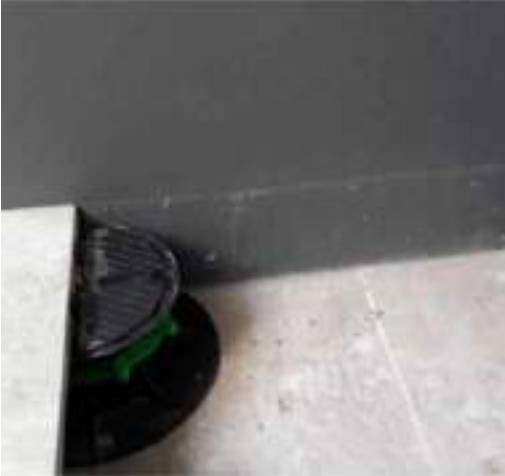
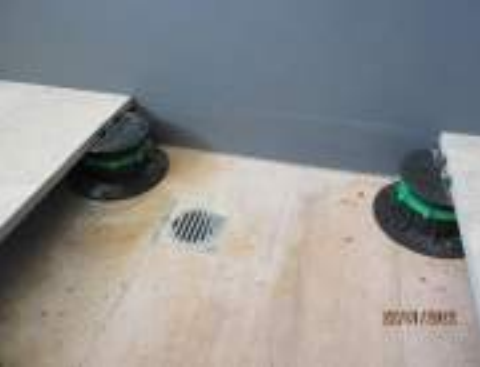
<p>Crack at line of possible DPC</p> <p>No visible DPC</p>

<p>HARPER OBSERVATION AND COMMENTS – NO EVIDENCE OF CRACK</p>

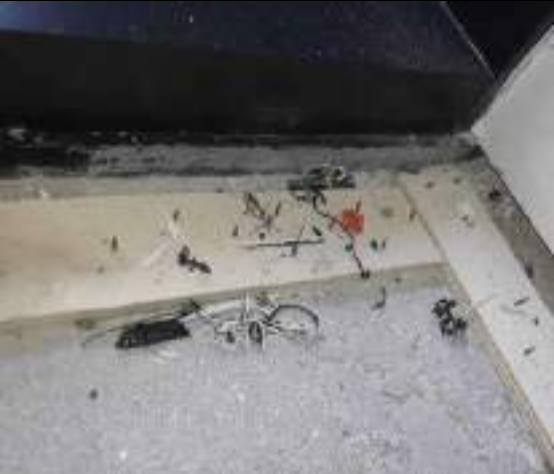
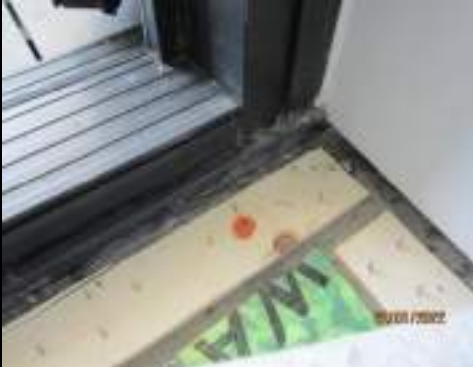
No waterstop. Aluminium in contact with cement which will cause deterioration.

HARPER OBSERVATION AND COMMENTS – CONCUR NO EVIDENCE OF WATER STOP, HOWEVER HARPER IS OF THE VIEW THE DOOR IS WEATHERPROOF DUE TO ADEQUATE ROOF COVER. REFER ITEM C-1 SECTION 10 HARPER DEFECT SCHEDULE
C196	Level U4 lobby	–	See section 8.3 of this report.

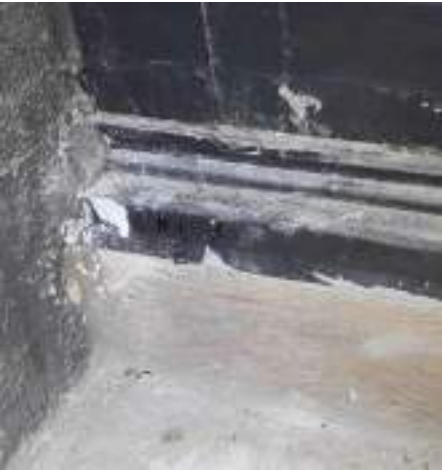
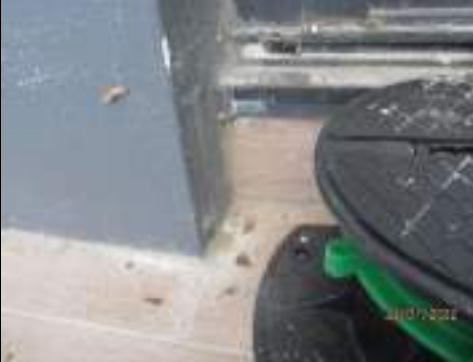
No waterstop Aluminium in contact with cement which will cause deterioration.

HARPER OBSERVATION AND COMMENTS – RESOLVED – SEALANT APPLIED

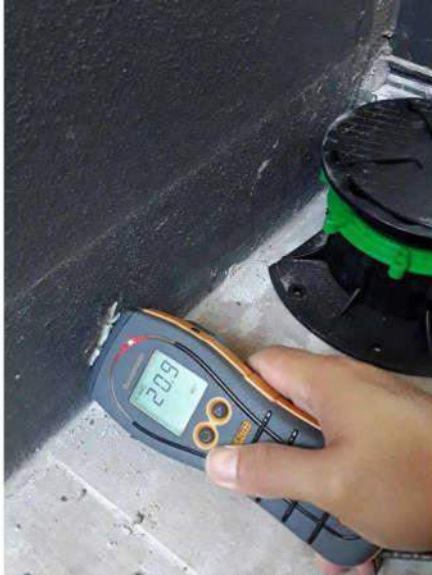
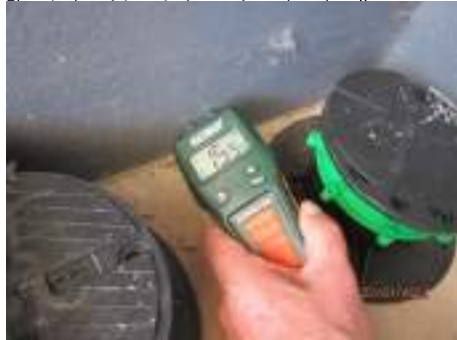
HARPER OBSERVATION AND COMMENTS – LOW LEVEL OF MOISTURE INDICATED
C 198	Level U4 lobby	Balcony overflow	See section 8.8 of this report.

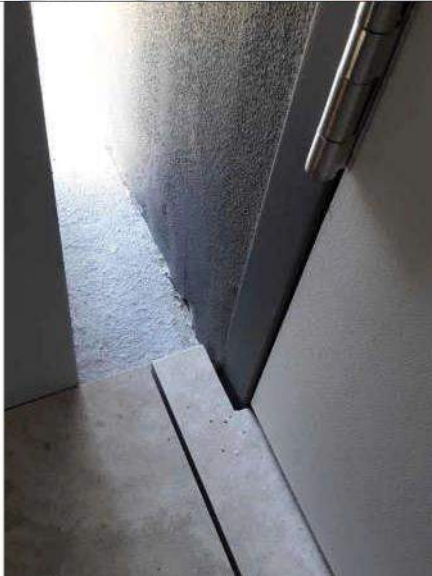
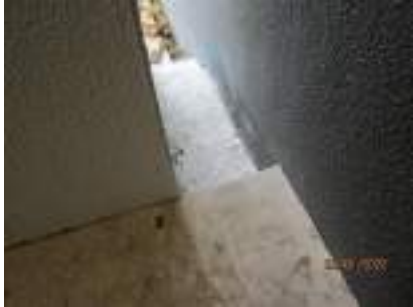
No visible waterproof membrane to overflow.

HARPER OBSERVATION AND COMMENTS – NO ISSUE AS ADEQUATE ROOF COVER PROVIDED

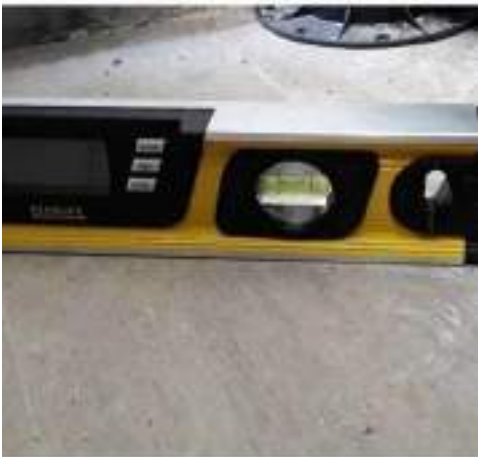
<p>Fall of 3mm insufficient</p> <p>HARPER OBSERVATION AND COMMENTS – DISAGREE FALL IS SUFFICIENT.</p>

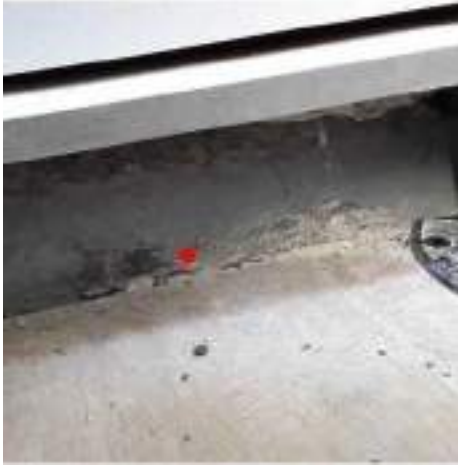
Visible upturned waterproof membrane. HARPER OBSERVATION AND COMMENTS – NOTED
C 201	Level U4 lobby	Balcony – Floor tiles	Not fit for purpose.

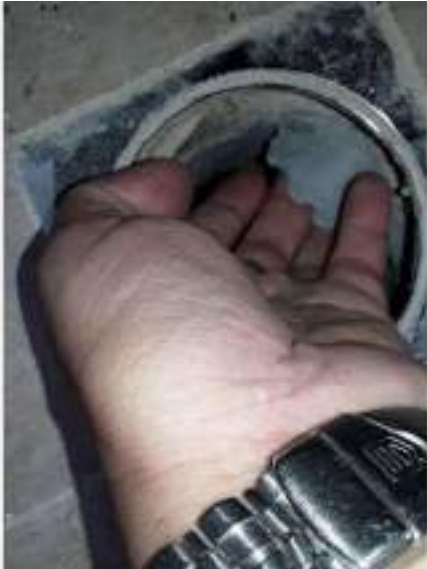
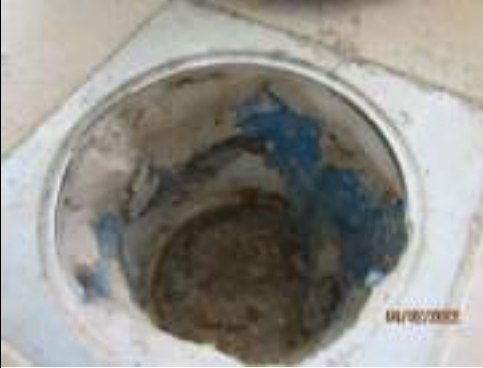
Adhesion failure of waterproof membrane

HARPER OBSERVATION AND COMMENTS – DISAGREE MEMBRANE BONDED.

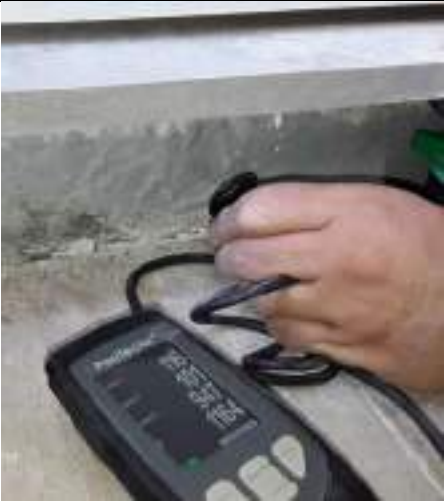
Membrane thickness of 1164 microns to upturn. HARPER OBSERVATION AND COMMENTS – NOTED – SATISFACTORY THICKNESS
C 203	Level U4 lobby	Service risers	Fire engineer to inspect

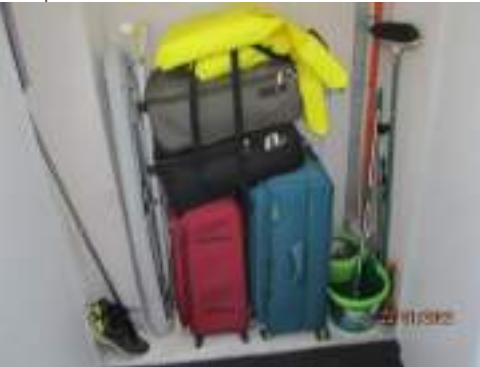
Fire pillow installation.

HARPER OBSERVATION AND COMMENTS – NO INSPECTED DUE TO RESTRICTIONS

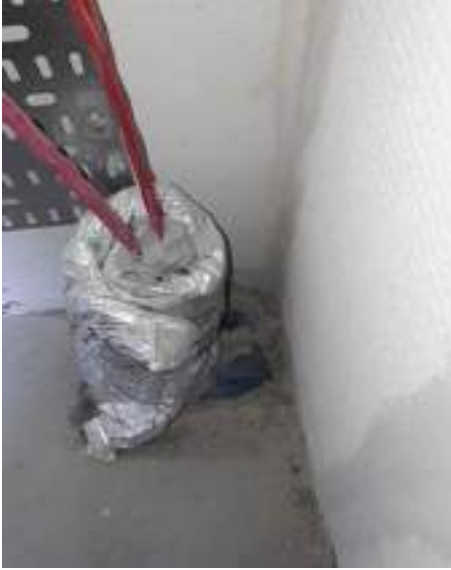
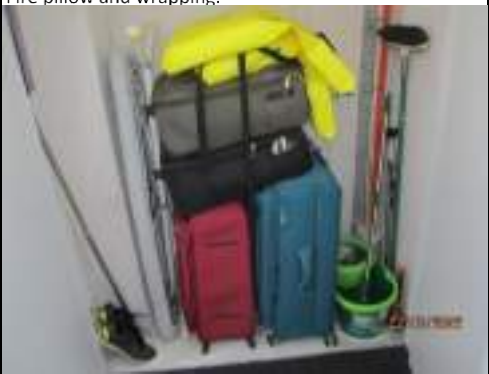
Fire pillow and wrapping.

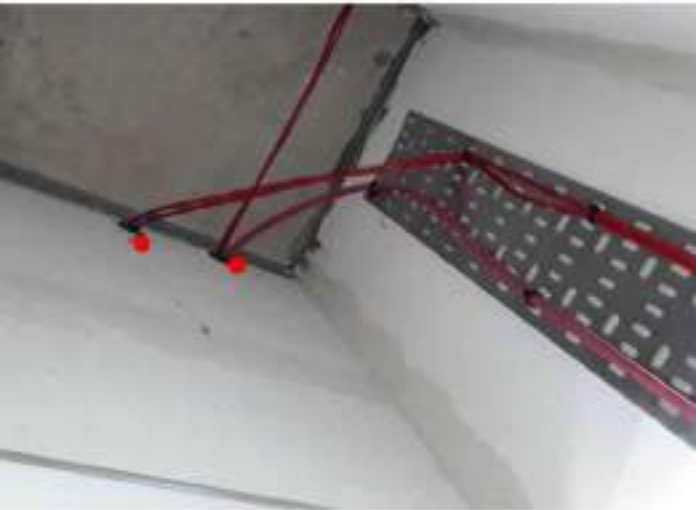
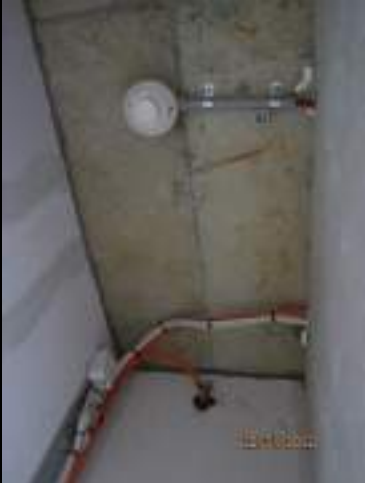
Black sealant used as fire rating

HARPER OBSERVATION AND COMMENTS – RESOLVED FIRE SAFETY COMPLIANCE CERTIFICATE PROVIDED.

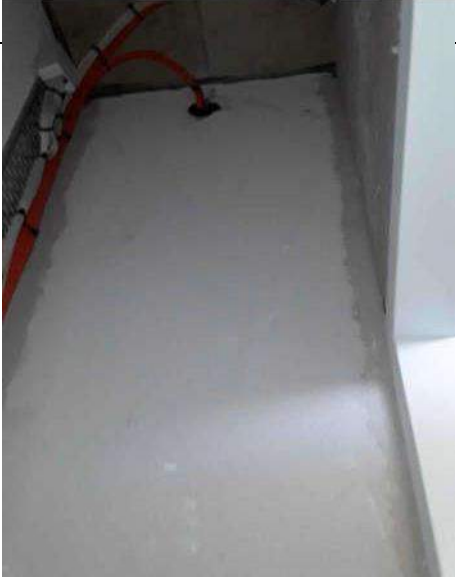
Black sealant in Hebel wall . HARPER OBSERVATION AND COMMENTS – RESOLVED FIRE SAFETY COMPLIANCE CERTIFICATE PROVIDED.

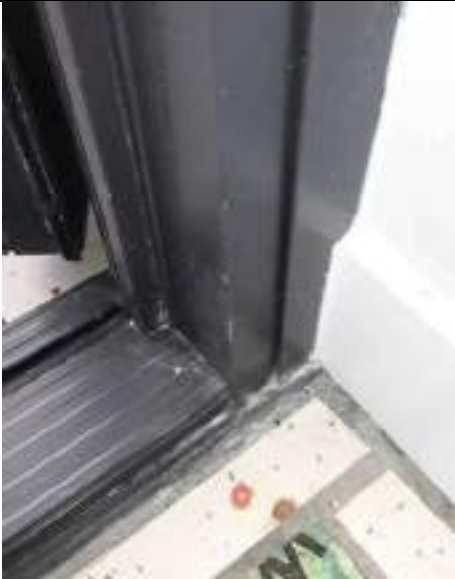
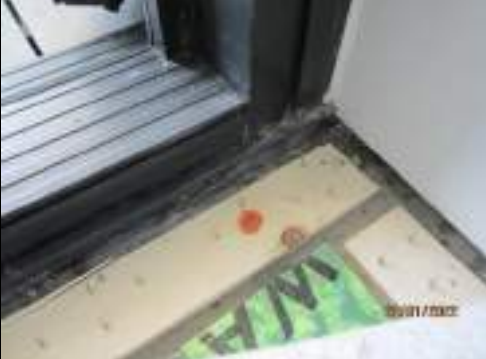
<p>A. No waterstop. B. Sliding door installed in contact with cement.</p>

<p>HARPER OBSERVATION AND COMMENTS – CONCUR, HOWEVER DOOR WEATHERPROOF DUE TO ROOF COVER</p> <p>REFER ITEM C-1 SECTION 10 HARPER DEFECT SCHEDULE</p>
C 213	Level 4 Lobby - balcony	Cladding	See sections 8.5 and 8.26 of this report.

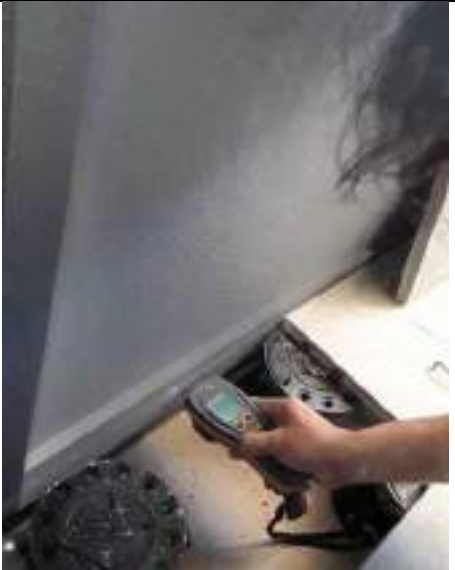
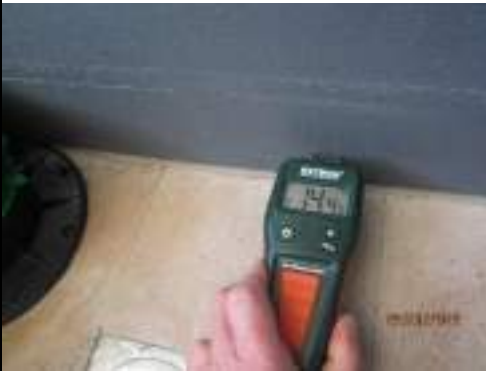
<p>Elevated moisture to wall below tile pedestals</p>

<p>HARPER OBSERVATION AND COMMENTS – LOW LEVEL OF MOISTURE INDICED</p>

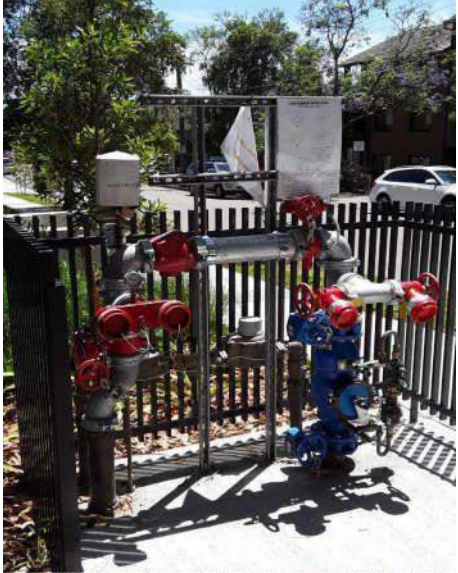
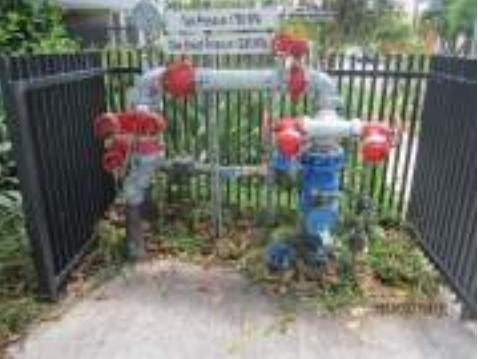
Hydraulic engineer to inspect hydrant assembly.

HARPER OBSERVATION AND COMMENTS – FIRE SAFETY COMPLIANCE CERTIFICATE PROVIDED.
C 215	Hydrant	South east of site	Incomplete work

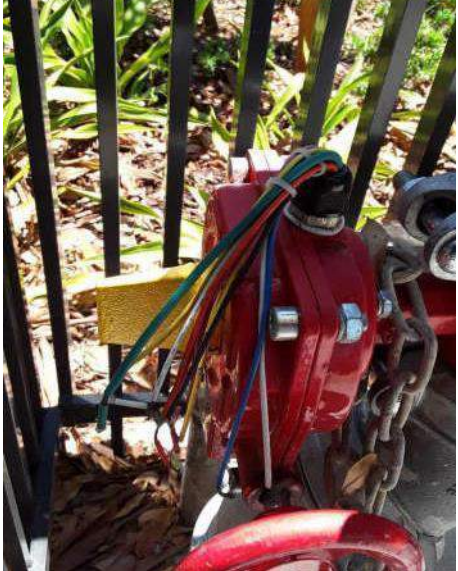
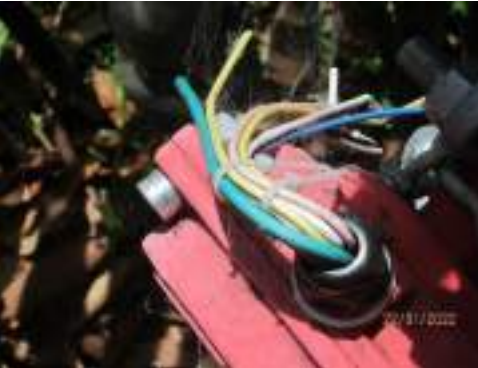
wiring not connected.

HARPER OBSERVATION AND COMMENTS – FIRE SAFETY COMPLIANCE CERTIFICATE PROVIDED.

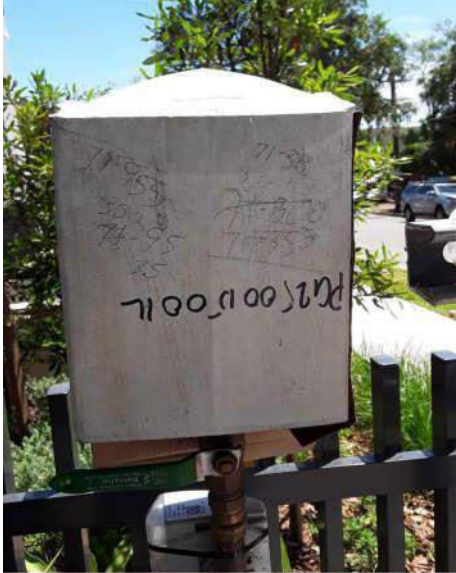
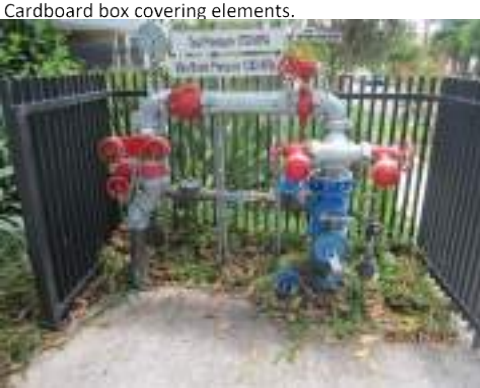
<p>Cardboard box covering elements.</p>

<p>HARPER OBSERVATION AND COMMENTS – RESOLVED</p>
C217	Hydrant	South east of site	Not fit for purpose

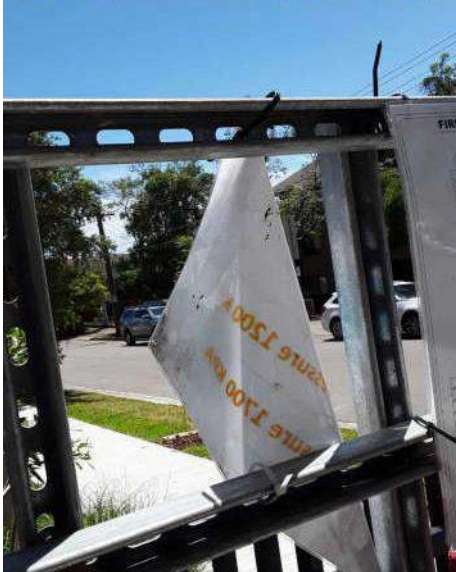
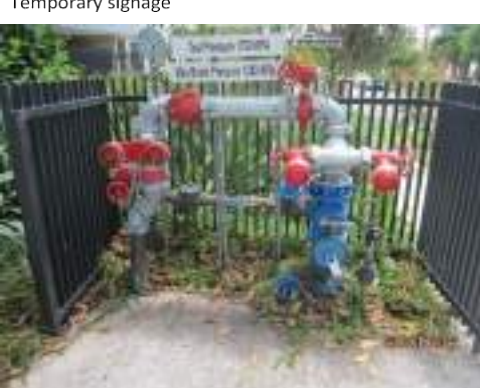
<p>Temporary signage</p>

<p>HARPER OBSERVATION AND COMMENTS – RESOLVED</p>

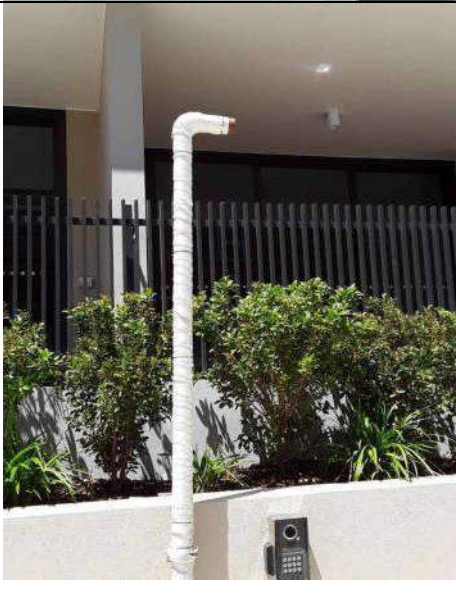
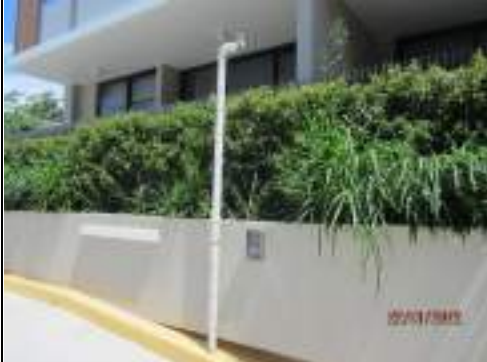
<p data-bbox="1610 804 2094 852">Diesel pump vent pipe when running will blow smoke into habitable spaces (see balconies in back ground).</p>

<p data-bbox="1610 1283 2094 1401">HARPER OBSERVATION AND COMMENTS – NOT A DEFECT AS FREQUENCY OF USE IS MINIMAL AND EXHAUST PIPE IS LOCATED AT A SAFE DISTANCE FROM THE GROUND FLOOR BALCONIES.</p>

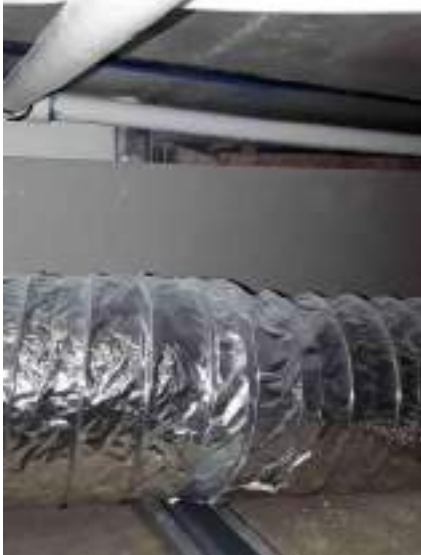
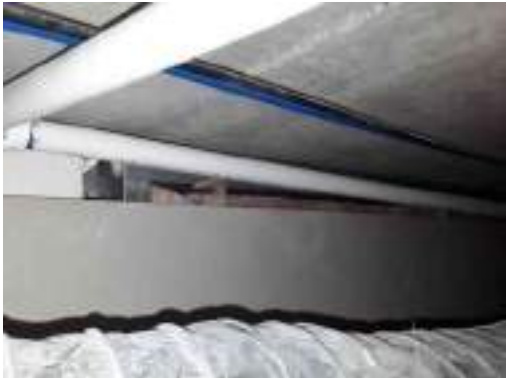
<p>Fire rating between SOC not installed to slab soffit.</p> <p>Fire engineer to inspect and advise</p>

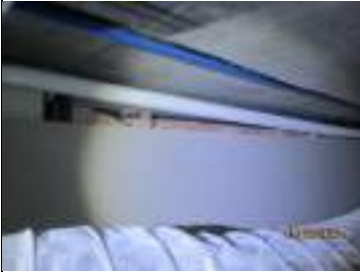
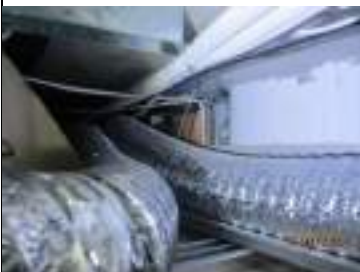
<p>HARPER OBSERVATION AND COMMENTS – OUTSTANDING</p> <p>CONCUR FIRE SEPARATION IS NOT IN ACCORDANCE WITH C2.7 NCC VOLUME 1 2019.</p> <p>REFER ITEM 3-GO5 SECTION 10 HARPER DEFECT SCHEDULE</p>

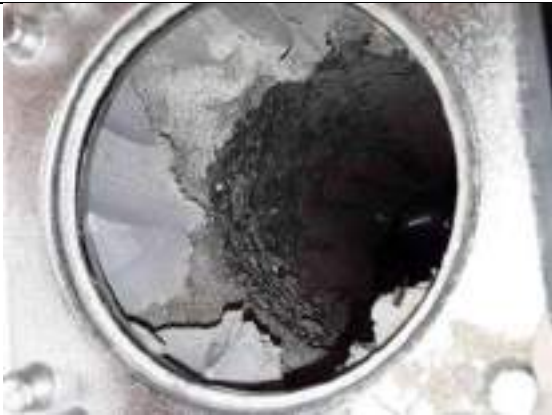
<p>Exhaust not operational.</p> <p>HARPER OBSERVATION AND COMMENTS - RESOLVED</p>
<p>U G05.8</p>	<p>Bathroom</p>	<p>Floor waste</p>	<p>See section 8.12 of this report</p> <p>Works not completed with due care and skill.</p> <p>Inadequate substrate preparation</p>

<p>Adhesion failure of waterproofing in drain.</p>

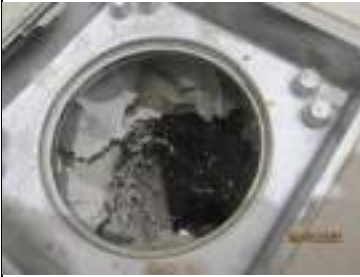
<p>HARPER OBSERVATION AND COMMENTS – DISAGREE, WATERPROOFING ADHESION IS SATISFACTORY.</p>

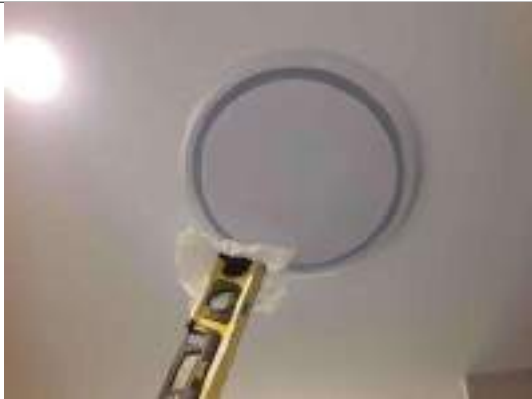
<p>Mechanical exhaust not operational.</p> <p>HARPER OBSERVATION AND COMMENTS – RESOLVED</p>
<p>U G05.12</p>	<p>Bathroom</p>	<p>Vanity</p>	<p>Incomplete work. Edging missing</p>

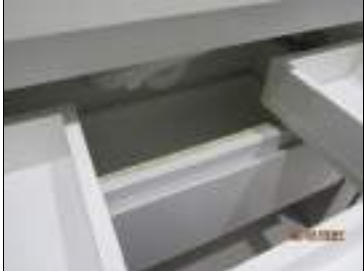
<p>Exposed mellamine edges.</p>

<p>HARPER OBSERVATION AND COMMENTS – OUTSTANDING, HOWEVER ITEM HAS NO IMPACT ON USE OR MATERIALS.</p>

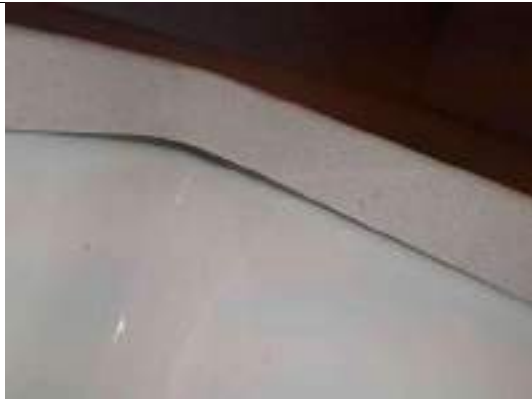
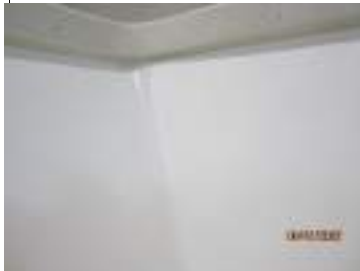
<p>U G05.13</p> <p>HARPER OBSERVATION AND COMMENTS – RESOLVED</p>	<p>Ensuite</p>	<p>Vanity (Sink)</p>	<p>Water entering concealed space is a breach of FP1.7 of the BCA.</p>

<p>Void to under mount sink.</p>

<p>HARPER OBSERVATION AND COMMENTS - RESOLVED</p>
<p>U G05.14</p>	<p>Ensuite</p>	<p>Mechanical exhaust</p>	<p>See section 8.25 of this report</p>

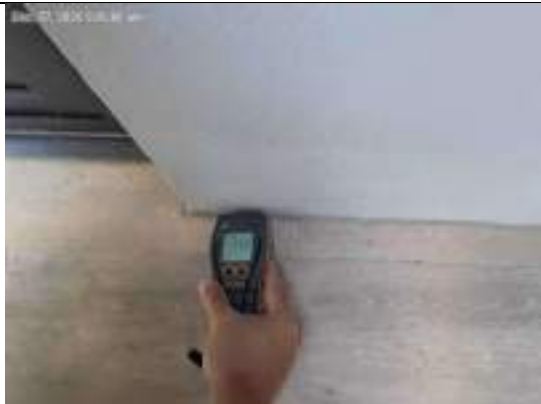
U G05.25	Balcony - South (Mitchell Avenue)	Hebel cladding (West wall)	Note.

<p>Base reading to Hebel of 14.2%</p> <p>HARPER COMMENTS AND OBSERVATIONS – CONCUR, NOTED.</p>
U G05.26	Balcony - South (Mitchell Avenue)	Floor waste	No waterproofing as required by AS4654.2.

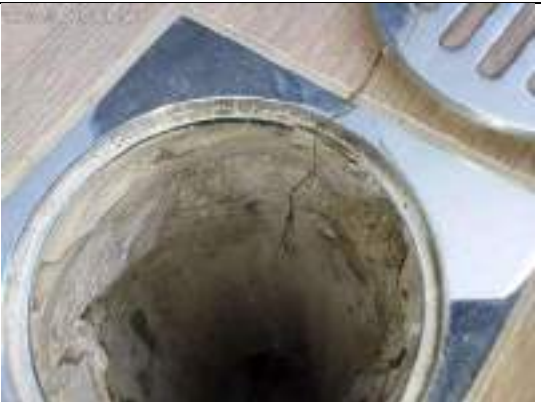
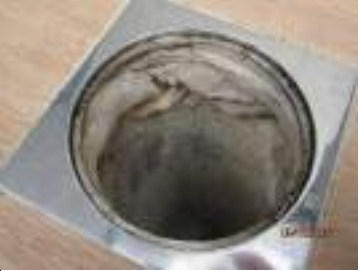
<p>No visible waterproofing has been turned down the floor waste.</p>

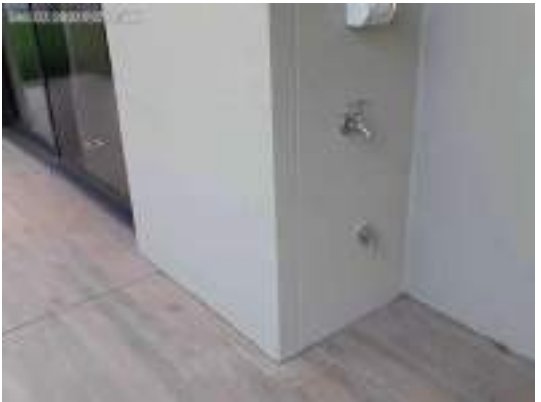
U G05.27	Balcony - South (Mitchell Avenue)	Hebel cladding	See section 8.6 of this report

<p>No drainage provision to facade.</p>

<p>HARPER OBSERVATION AND COMMENTS – OUTSTANDING REFER ITEM 5-GO5 SECTION 10 HARPER DEFECT SCHEDULE</p>

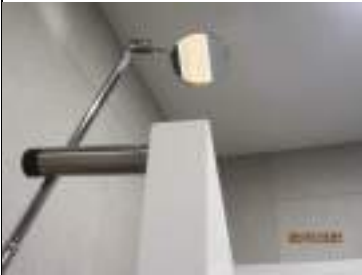
Top of door has not been sealed HARPER COMMENTS AND OBSERVATIONS – OUTSTANDING REFER ITEM 1-304SECTION 10 HARPER DEFECT SCHEDULE

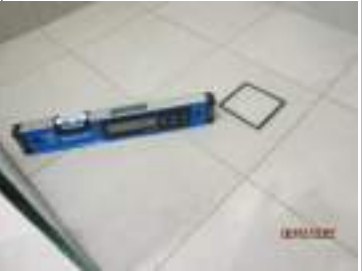
<p>Water is ponding</p>

<p>HARPER OBSERVATION AND COMMENTS - OUTSTANDING, SUFFICIENT FALL IN TILE SURFACE, WATER IS PONDING DUE TO DRAINAGE INLET EDGE IS HIGHER THAN TILE SURFACE</p>
U 304.8	Ensuite	Mechanical exhaust	See section 8.25 of this report.

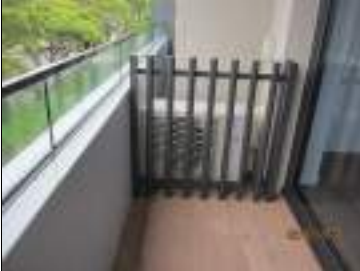
Cladding does not have a drainage provision.

HARPER COMMENTS AND OBSERVATIONS – UNABLE TO TEST DUE TO RAIN AND RESTRICTED ACCESS.
----------	-----------	-------------	----------------------------------	--	---

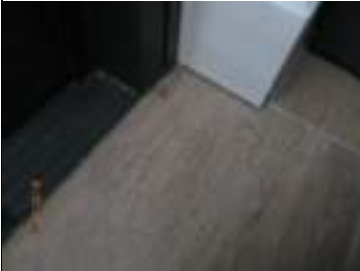
Unit 306						
U 306.1	Lounge	Sliding door threshold	See section 8.3 of this report		 	<p>A. No waterstop. B. Sliding door installed in contact with cement.</p>

<p>HARPER COMMENTS AND OBSERVATIONS – CONCUR, OUTSTANDING</p> <p>REFER ITEM C-1 SECTION 10 HARPER DEFECT SCHEDULE</p>
U 306.2	Laundry	Clothes dryer	Works have not been completed with due care and skill.		 	<p>Instead of shortening the length of the cable, a twist tie has been used to retain the extra length of cable.</p>   <p>HARPER OBSERVATIONS AND COMMENTS – CLOTHES DRY REMOVED.</p>

C-1	Door installation – Waterstop and weatherproof flashing	Scope of Remedial Works	Claim for Costs	Notes
	<p>The Author has observed that no water stop has been provided to the doors to all units.</p> <p>The Author noted that the defect was identified in Section 8.3 of the Construction Adviser (Giaouris) Report.</p> <p>The Author concurs with Giaouris view that the installation has not been carried out in accordance</p>	<p>Allow to:</p> <p>Apply following rectification methodology to each unit and door identified in Table C-1-1</p> <ol style="list-style-type: none"> 1. Provide site supervision. <p>Supervisor to coordinate access and facilitate the works throughout the</p>	<p>Co-ordination and Supervision - Refer to allowance in summary of costs at end of this Scott schedule.</p> <p>Labour to cover and protect adjacent surfaces 1manx1hr@\$60perhr/\$60</p>

The doors identified by the Author in **Table C-1-1** of this item in relation to the defective works should be rectified to comply with requirements of the NCC and AS4654.2.

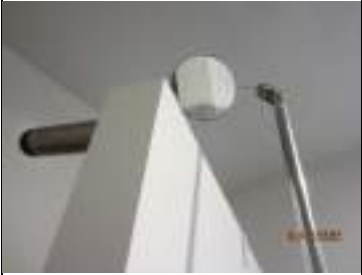
Top of door has not been sealed

HARPER OBSERVATIONS AND COMMENTS – RESOLVED

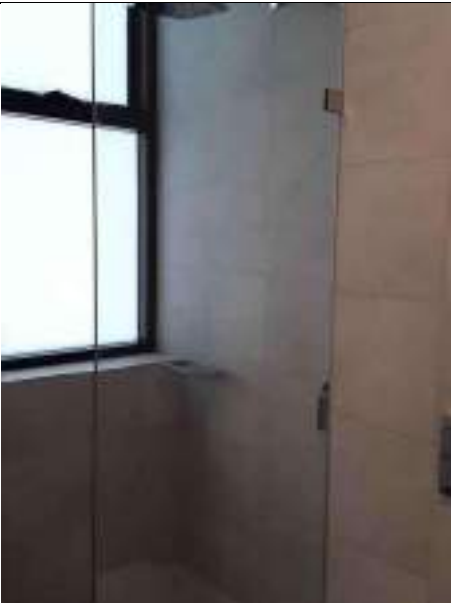
U 306.5	Bathroom	Shower screen	Breach of AS/NZS 2208. Works are not fit for purpose

Glass not identifiable as safety glass. HARPER OBSERVATIONS AND COMMENTS – CERTIFICATION PROVIDED BY SUPPLIER.
U 306.6	Bathroom	Top of door	See section 8.16 of this report	 	Top of door has not been sealed

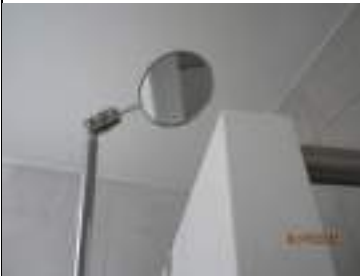
HARPER OBSERVATIONS AND COMMENTS – RESOLVED

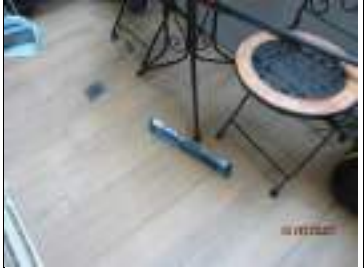
<p>A. No waterstop. B. Sliding door installed in contact with cement. C. Efflorescence.</p>

<p>HARPER OBSERVATIONS AND COMMENTS – NO EFFLORESCENCE PRESENT REFER ITEM C-1 SECTION 10 HARPER DEFECT SCHEDULE</p>
<p>U 306.13</p>	<p>Main bedroom balcony</p>	<p>Sliding door threshold</p>	<p>See section 8.3 of this report</p>

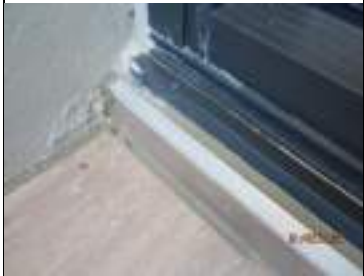
<p>Tile installed proud of subsill not behind as detailed by AS4654.2.</p>

<p>HARPER OBSERVATIONS AND COMMENTS – OUTSTANDING, HOWEVER DOOR DRAINAGE IS NOT OBSTRUCTED AND METAL TILE TRIM FINISH IS SATISFACTORY.</p>

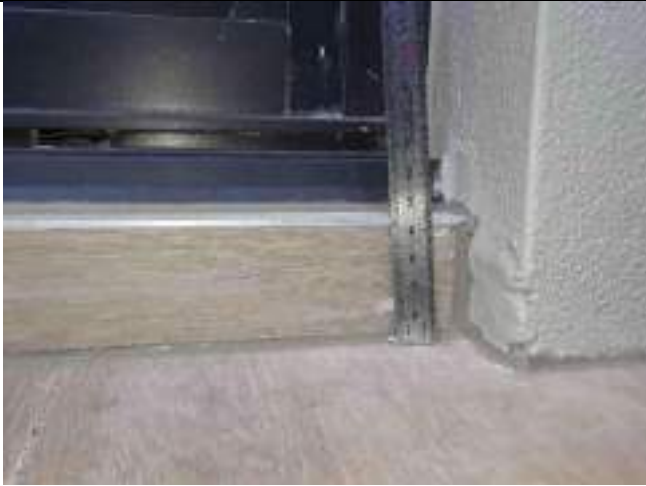
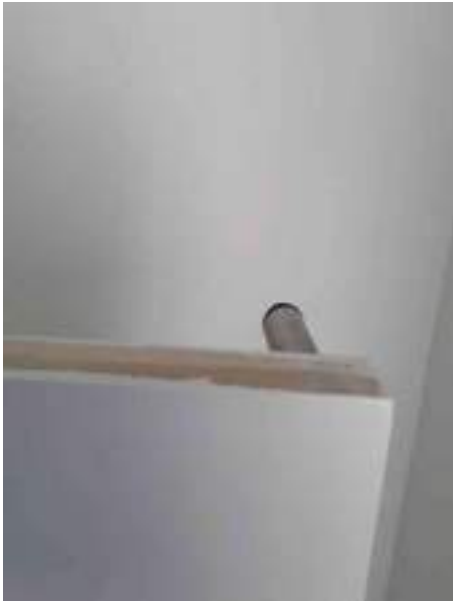
U 306.21	Bedroom 2	Top of door	See section 8.16 of this report .

<p>Top of door has not been sealed.</p> <p>HARPER OBSERVATIONS AND COMMENTS – RESOLVED</p>

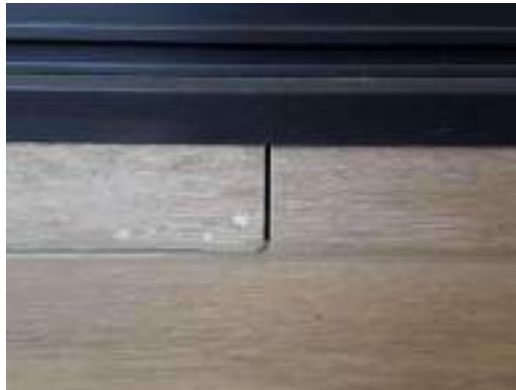
U 306.24	Balcony	Sliding door threshold	Incomplete work.

<p>Gap in tiles will allow moisture to enter rear of tiles.</p>   <p>HARPER OBSERVATIONS AND COMMENTS –RESOLVED</p>
U 306.25	Balcony	Floor waste	See section 8.6 of this report	<p>HARPER OBSERVATIONS AND COMMENTS - HEBEL IS LOCATED WITHIN BALCONY ENVELOPE AND NOT FULLY EXPOSED TO WEATHER, SO NO REQUIREMENT FOR DRAINAGE PIPE TO STORMWATER INLET.</p>

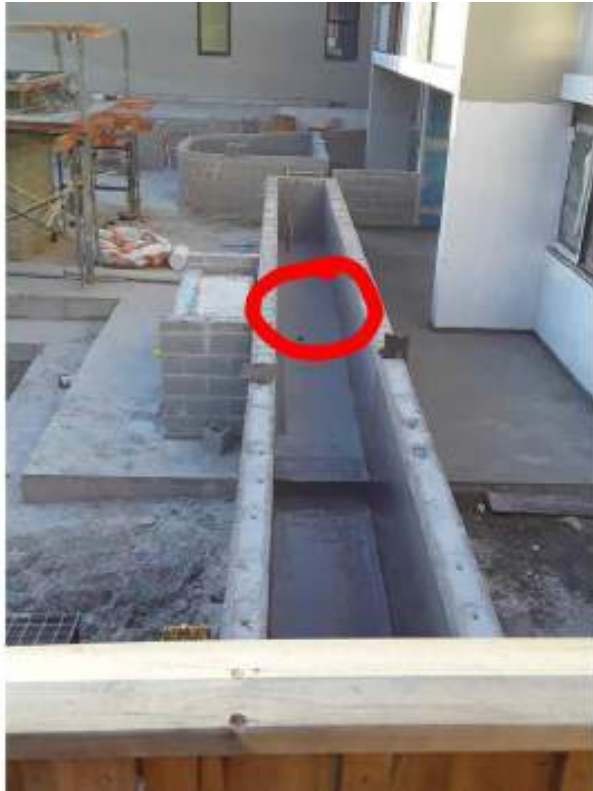
C 38 – North facade, planter box

Water is ponding in base of planter.

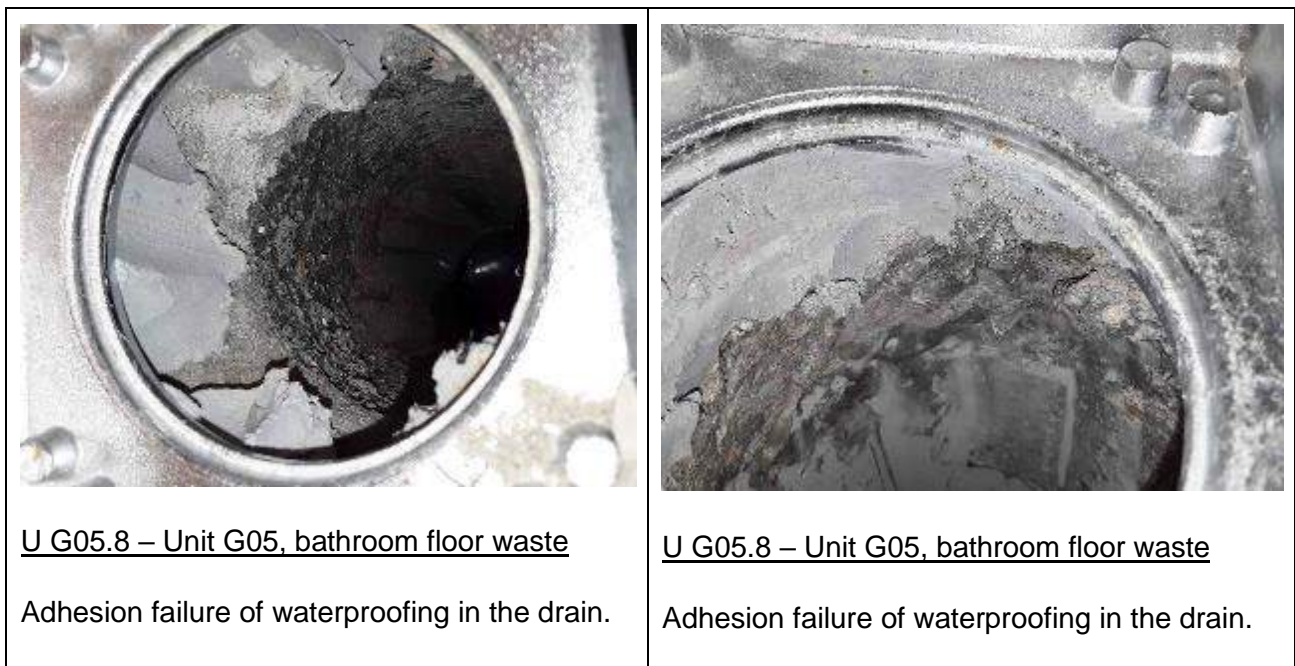
DEFECT NO.	LOCATION	AREA	BREACH	DEFECT DESCRIPTION
U G05.8	Bathroom	Floor waste	Breach of F 1.7 of the BCA. Breach of AS 3740. Works are not fit for purpose.	Adhesion failure of waterproofing in the drain.

8.12.3.1 Adhesion failure; and

8.12.7 Adhesion failure and insufficient membrane termination is in breach of AS3740, which is a further breach of F 1.7 of BCA.

8.12.10 Remove failed downturned membrane;

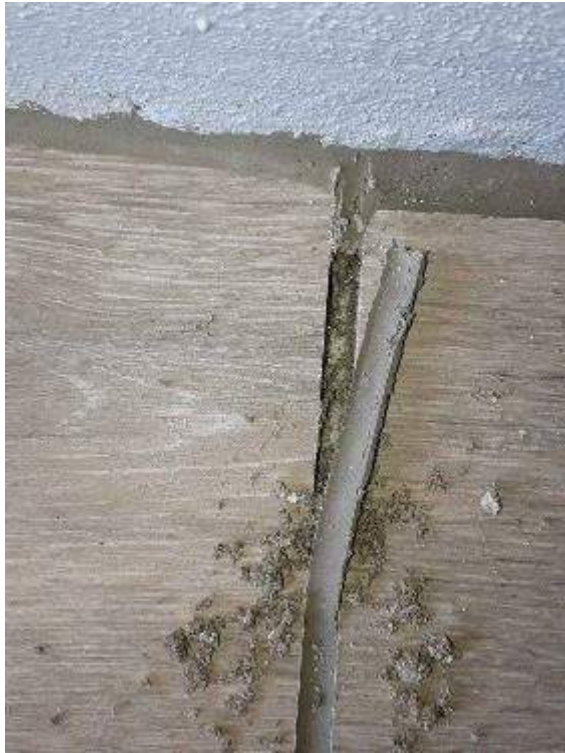
U 304.19 – Unit 304 balcony, control joints

Expansion joint does not continue through the tile screed.

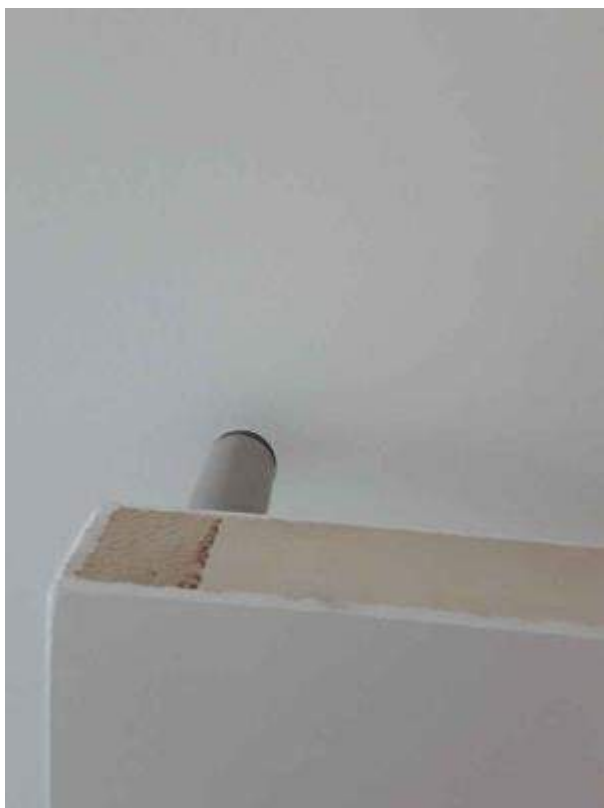
U G05.18 – Unit G05, bedroom 2 top of the door

Top of the door has not been sealed.	Top of the door has not been sealed.
--------------------------------------	--------------------------------------

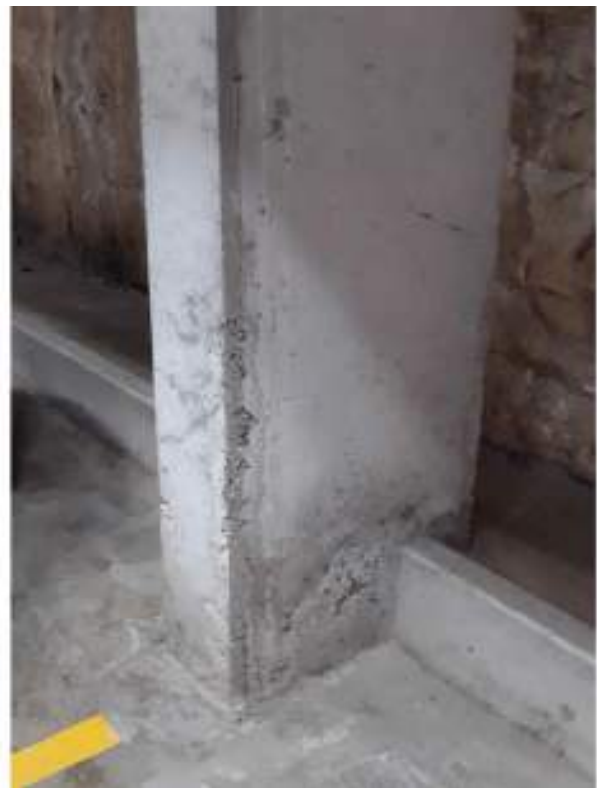
C 101 – Basement 1 –visitor parking bay

Insufficiently vibrated concrete.

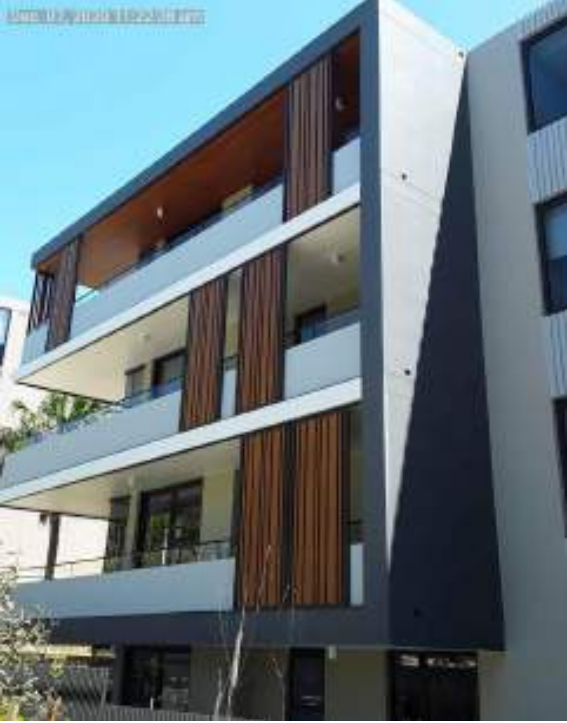
<p><u>C 50 – South facade, cladding</u></p> <p>Eaves to be tested for combustibility.</p>

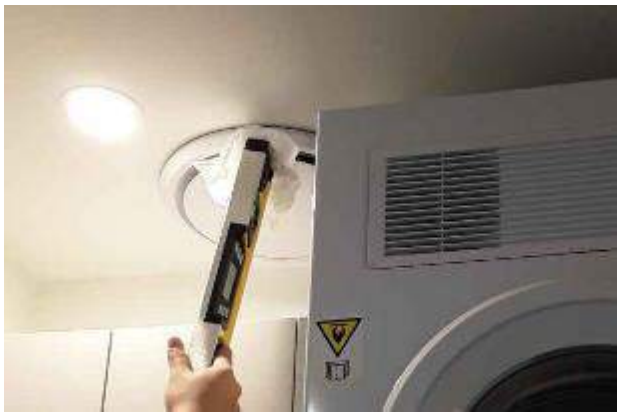
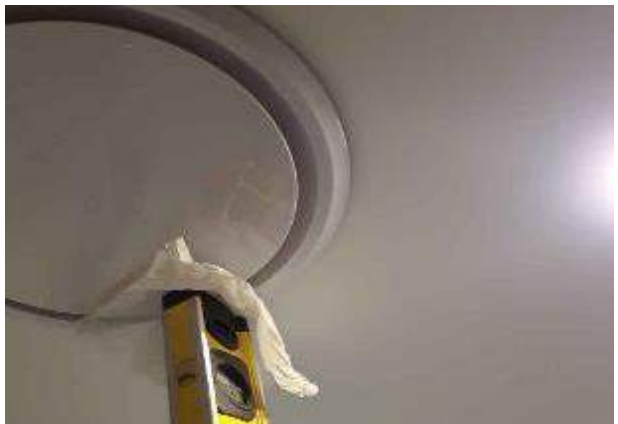
<p><u>U G05.7 - Unit G05 laundry, mechanical exhaust</u></p> <p>Mechanical exhaust not operational.</p>	<p><u>U 304.8 - Unit 304 ensuite, mechanical exhaust</u></p> <p>Mechanical exhaust not operational.</p>
