HOMESAFE INSPECTIONS

COMBINED BUILDING AND PEST INSPECTION

215 Oyster Bay Rd
Oyster Bay, NSW 2225

04/10/2023

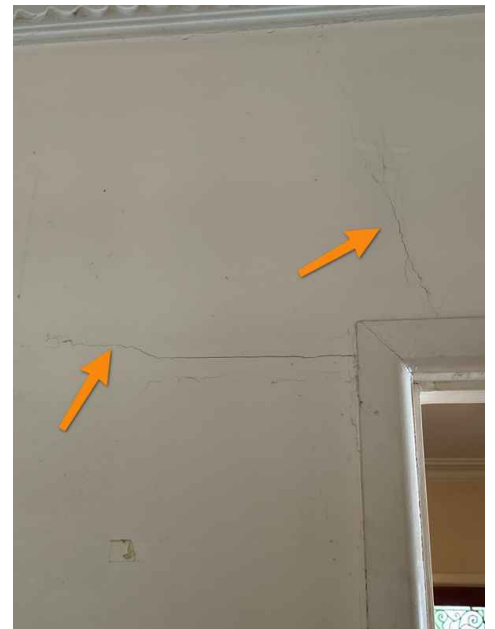
12.4.1 Walls

MINOR SETTLEMENT CRACKS

Contact a qualified professional.

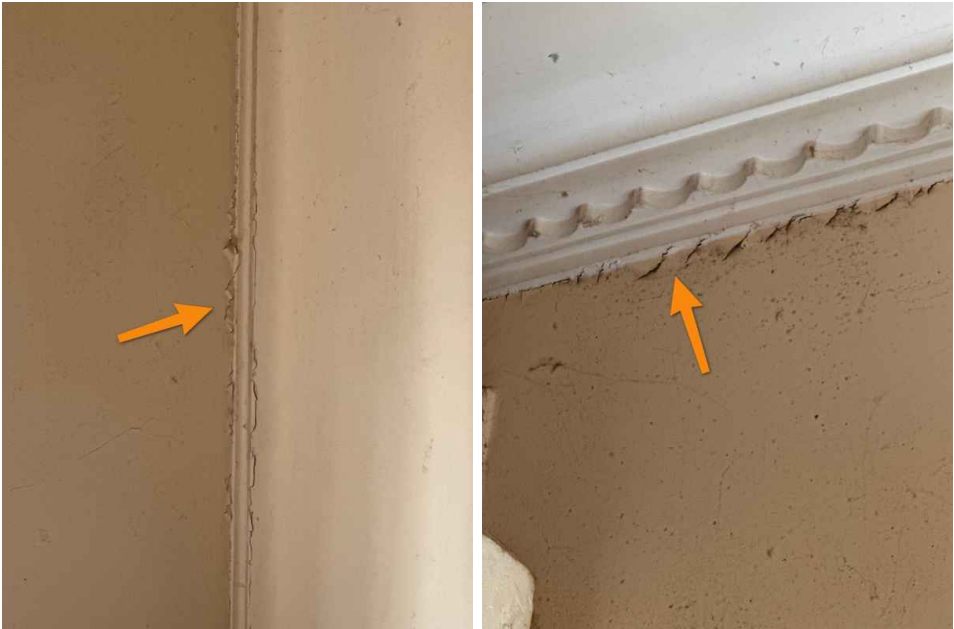
12.4.2 Walls

PAINT DETERIORATION

Contact a qualified painting contractor.

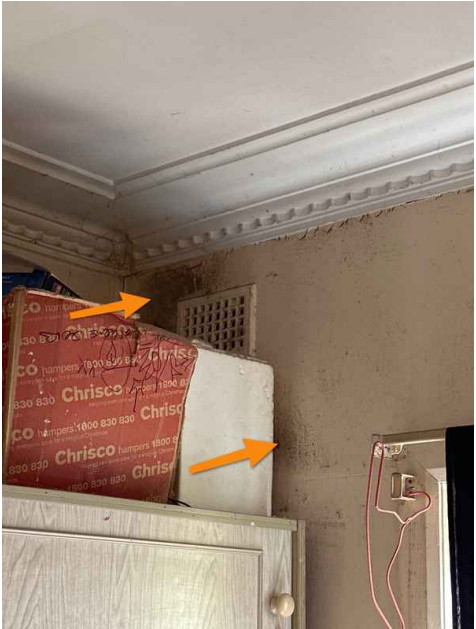
12.4.3 Walls

POSSIBLE MOULD

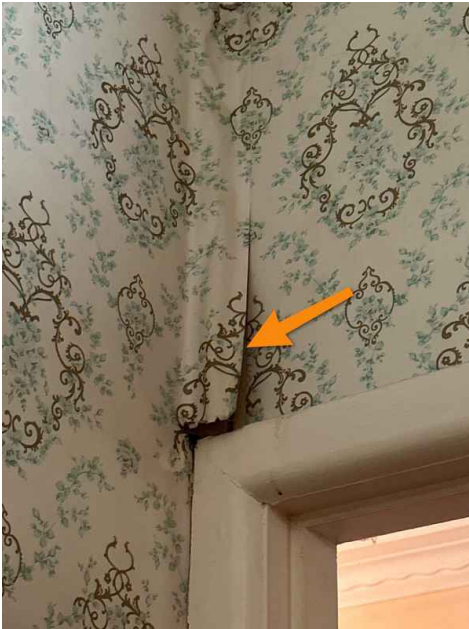
14.4.1 Walls

WALL PAPER DETERIORATION

Contact a qualified professional.

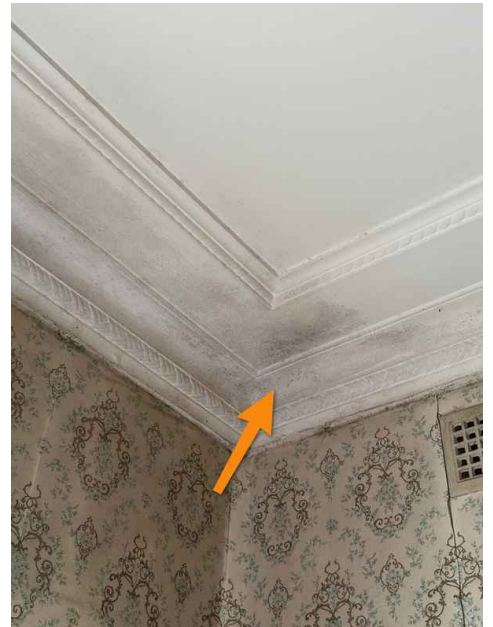
14.5.1 Ceilings

POSSIBLE MOLD

Recommendation

Contact a qualified mold inspection professional.

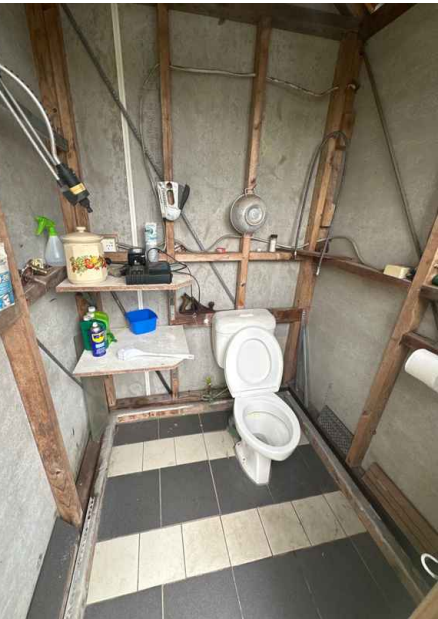
General View

General view at the time of inspection

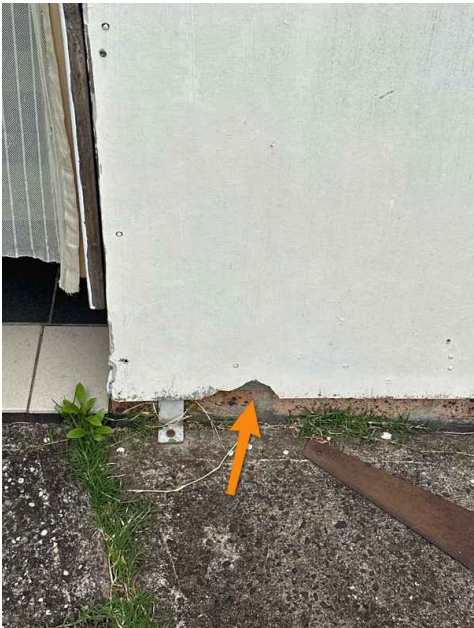
IMPACT DAMAGE

Impact damage noted. Patch and paint will generally suffice, however, see a qualified plasterer for further advice

Recommendation

Contact a qualified professional.

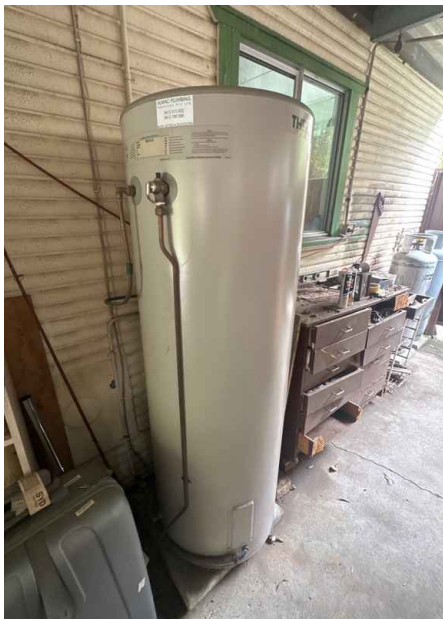
Hot Water Unit: General view of hotwater system

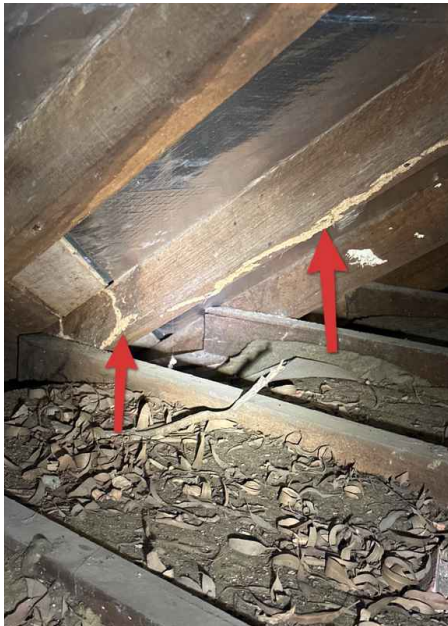
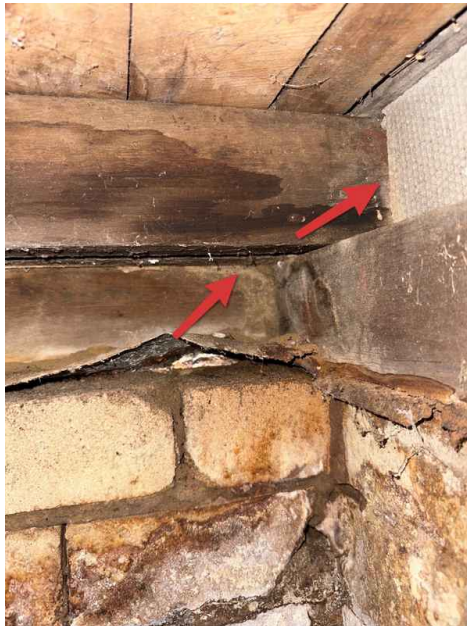
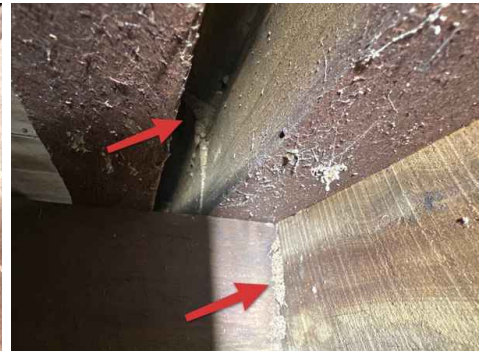
Termite damage and/or workings were found mainly in but not limited to

Roof void, Subfloor, Shed

Termite damage/workings are not confined to these areas and further damage may also be located in concealed areas.

**Was any evidence of timber damage visible**

Yes

Where evidence of termite activity was found in the grounds then the risk to buildings is very high. A treatment to eradicate the termites and to protect the building(s) should be carried out. Where the evidence of termite workings was found in the grounds or the building(s) then the risk of a further attack is high. If visible evidence of dormant/inactive termite activity was sighted at the time of inspection a real possibility exists that termite damage does exist.

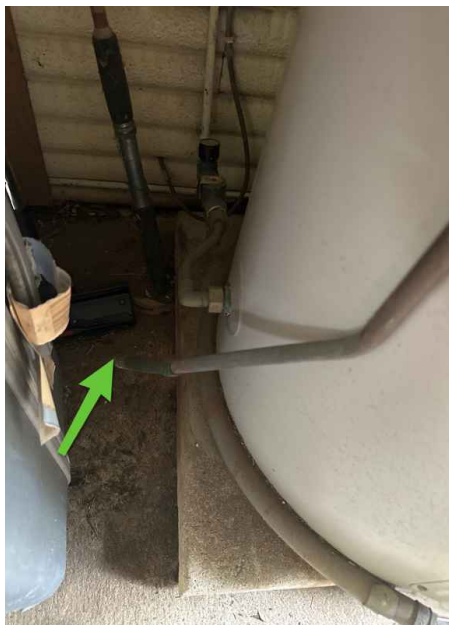
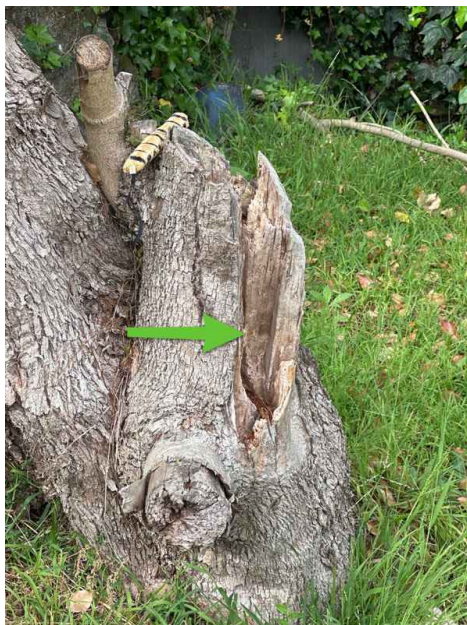
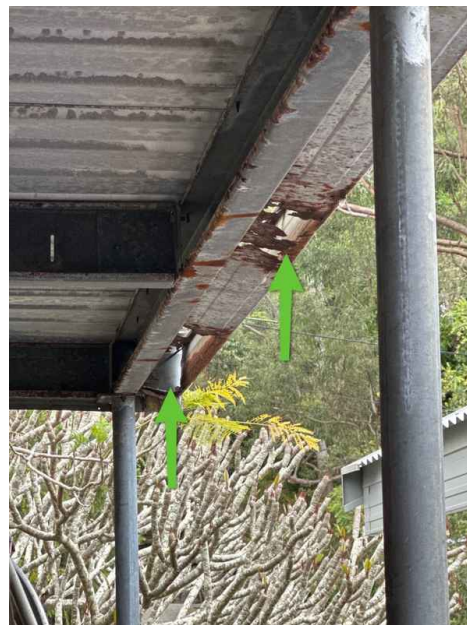
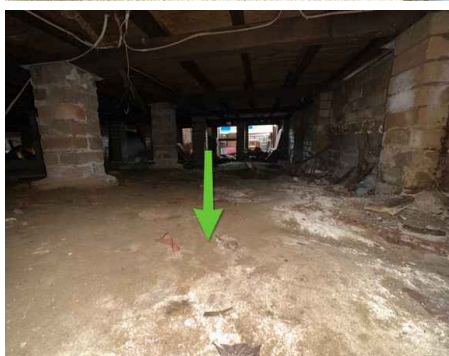
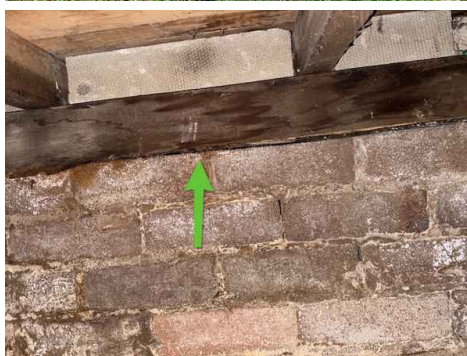
Hot Water Overflow, Timber Debris, Damp Subfloor Soil, Tree/Leafy Environment, Timber Sleepers, Tree Stumps, Rusty ant caps, Mulch & Garden Beds Next to House, Old Form Work, Inadequate subfloor ventilation

Conductive conditions are areas that promote termite activity. The above areas are recommended that repairs be completed to help minimise the risk of termite attacks.

**Are trees close to home - Yes**

Trees are in close proximity to the dwelling and within the termite foraging area. These are a favourable influence for termite infestation and I recommend you liaise with neighbours to have trees regularly checked and if on your site, organise regular inspections for termite infestation.
