HOMESAFE INSPECTIONS

## BUILDING & PEST INSPECTION

87 Ingrid Rd  
Kareela, NSW 2232

15/03/2024

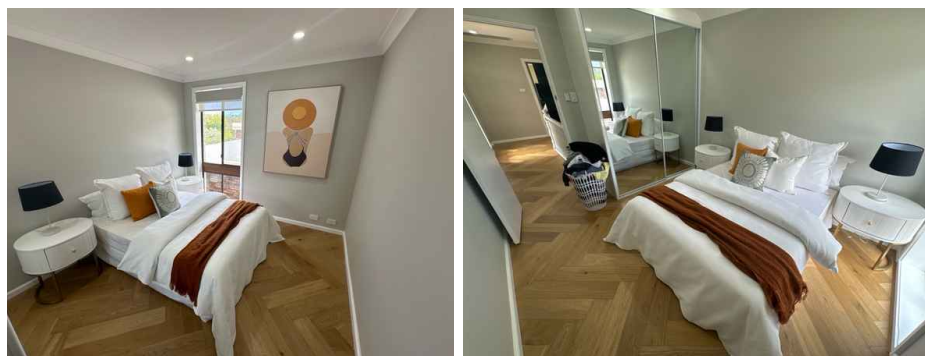
General view at the time of inspection

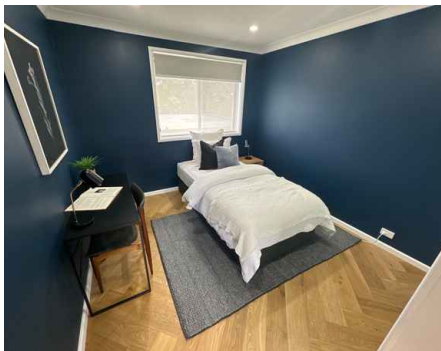
General view at the time of inspection

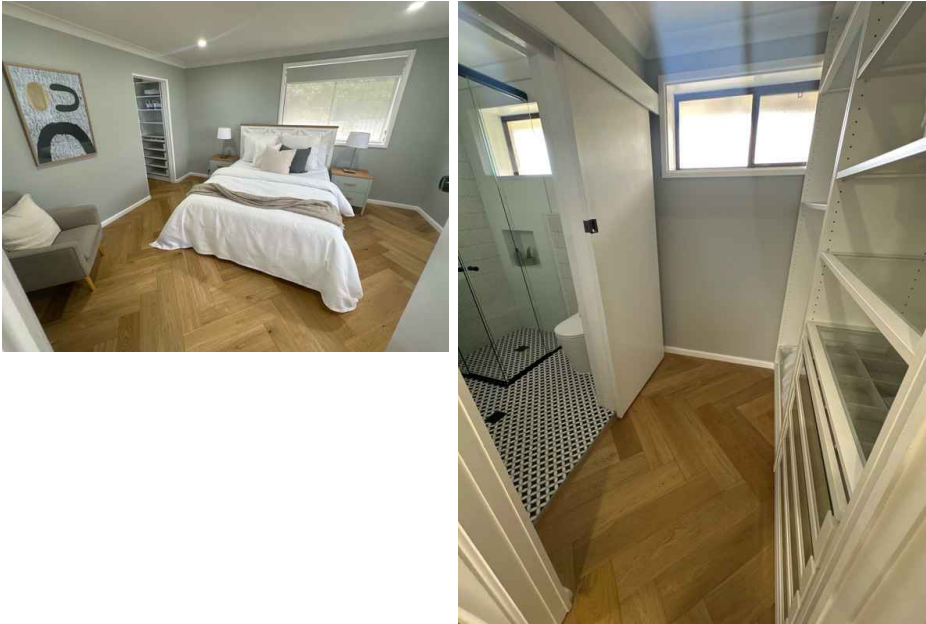
General view at the time of inspection

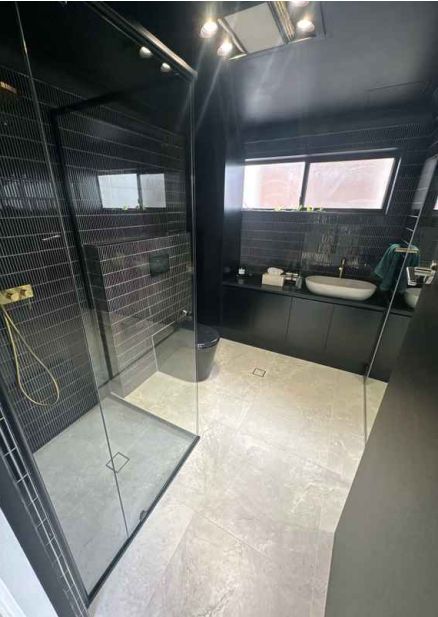
General view at the time of inspection

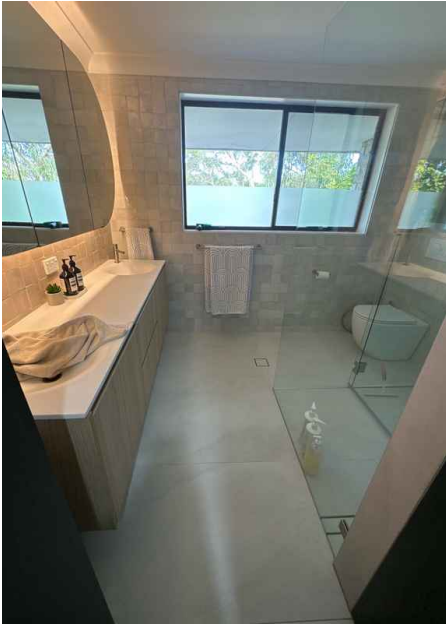
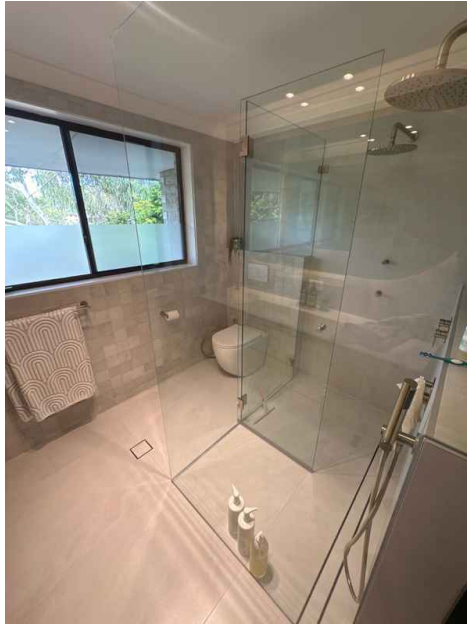
General view at the time of inspection

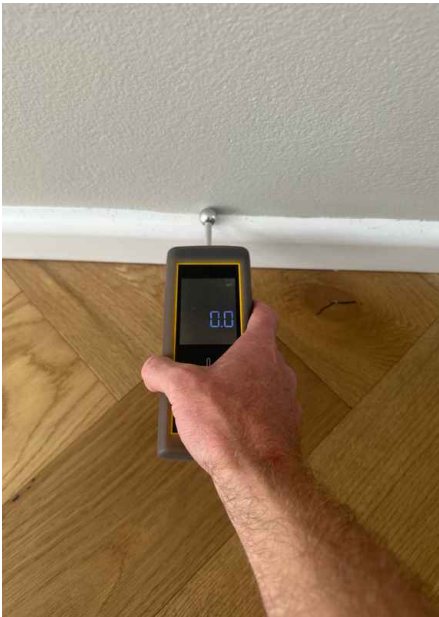
**Shower & Bath: Was there high moisture readings to the walls adjacent to the shower recess**

No

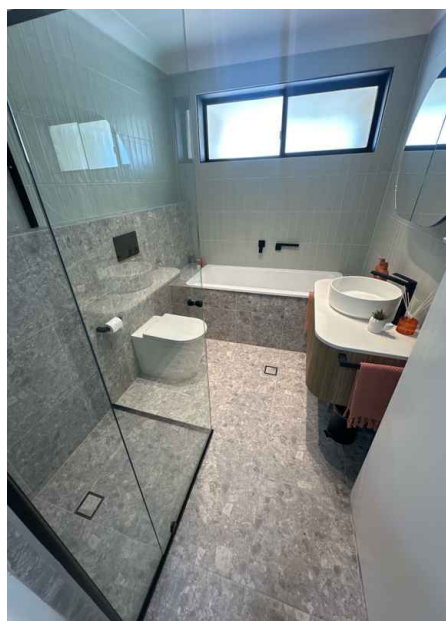
General view at the time of inspection

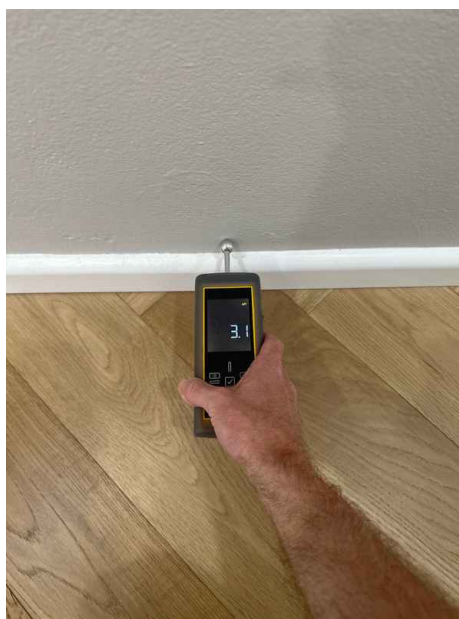
#### Shower & Bath: Was there high moisture readings to the walls adjacent to the shower recess

No

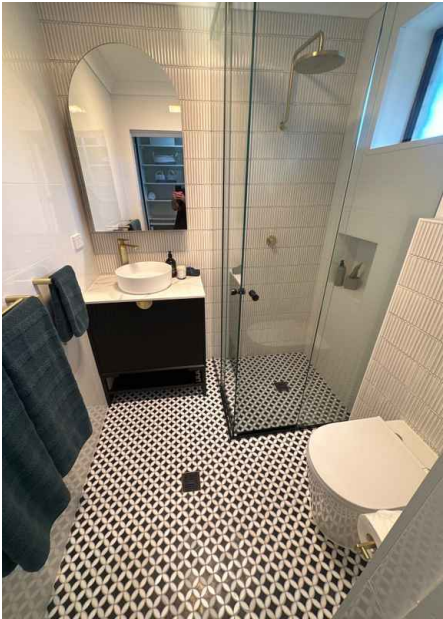
General view at the time of inspection

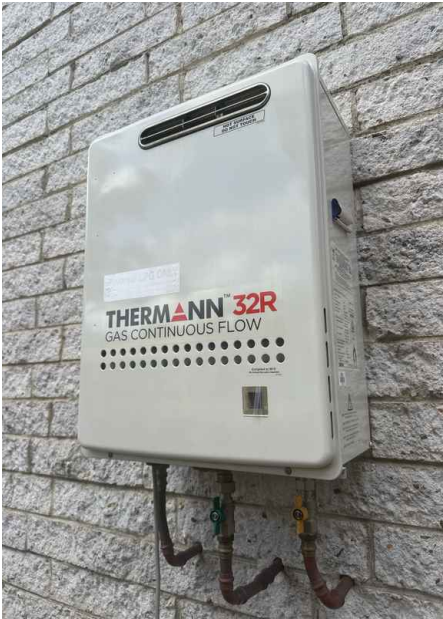
Hot Water Unit: General view of hotwater system
