HOMESAFE INSPECTIONS

BUILDING & PEST INSPECTION

83 Ninth Ave
Loftus, NSW 2232

28/02/2024

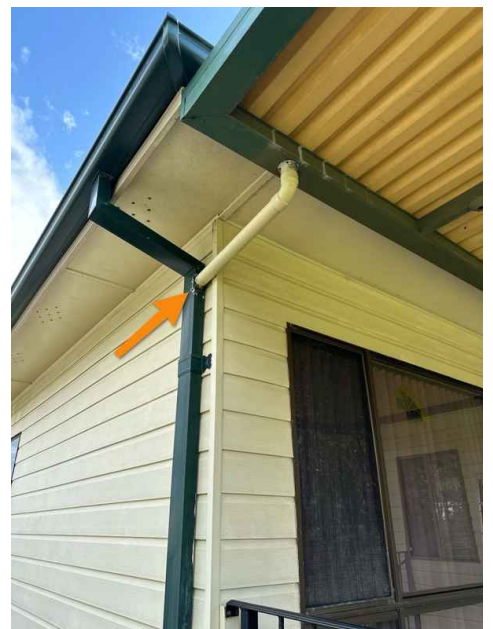
LEAKING

Evidence of leaking down pipe joins.

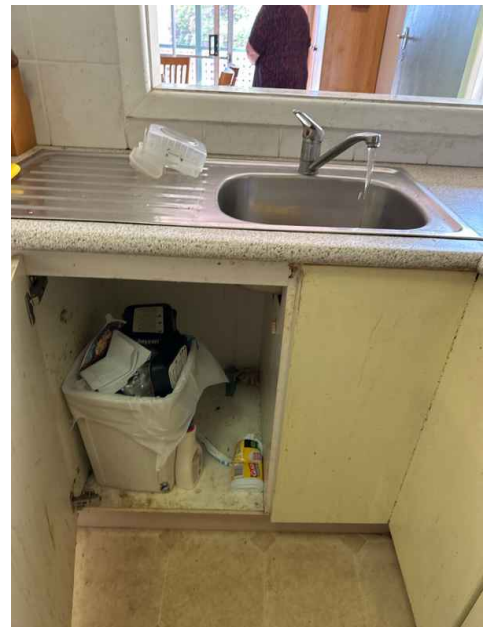
OWNER POSSESSIONS

There are owner's possessions, items in cupboards/under sink & personal belongings present which is preventing a thorough inspection of some areas of the Kitchen from being undertaken.

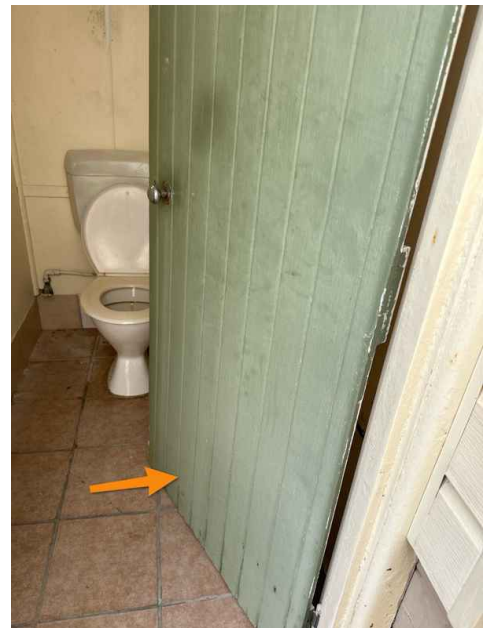
17.4.1 Floor

CRACKED FLOOR TILES

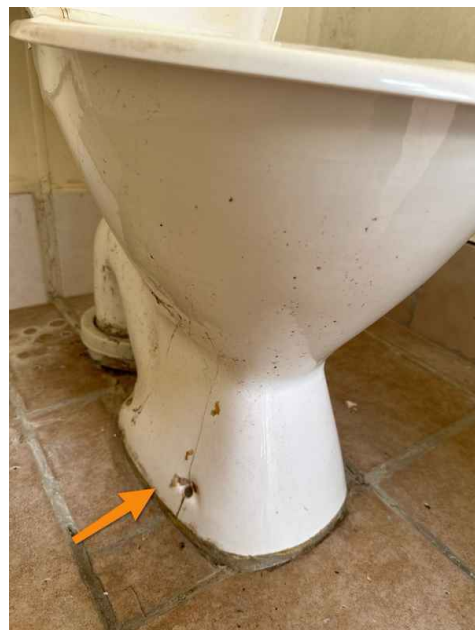
DAMAGED

Toilet has been damaged. Replacement could be likely in the future.

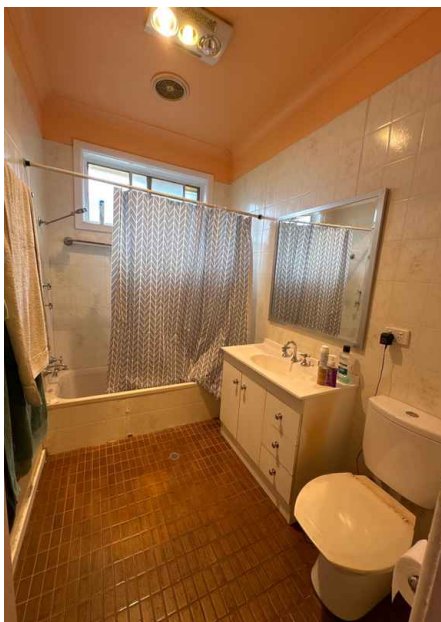
General View

General view at the time of inspection

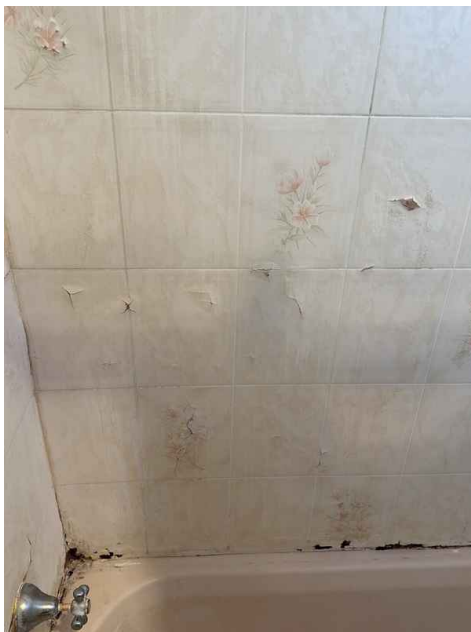
18.3.1 Walls

WALL LINING DETERIORATION

Wall lining is not tiles and has deteriorated. Strip and re-tile.

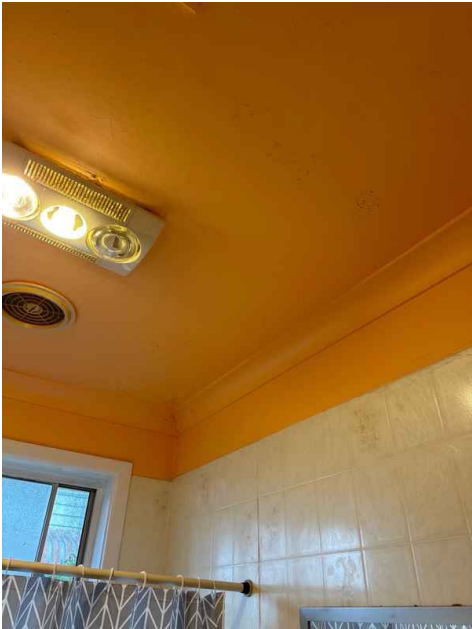
18.5.1 Ceiling

POSSIBLE MOLD

There are possible signs of fungi growth on ceiling. It is unknown if this is a safety hazard. Recommend a qualified mold inspector evaluate.

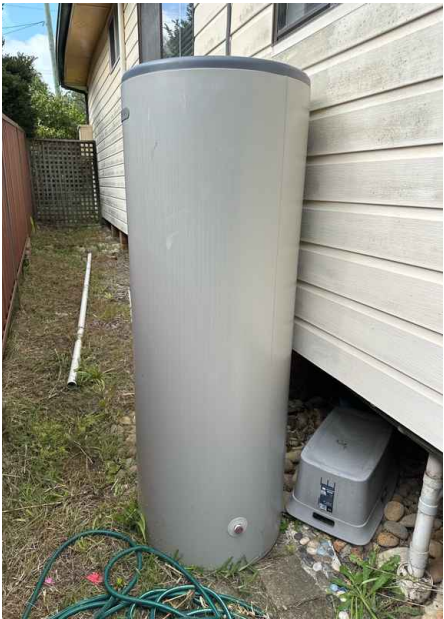
Hot Water Unit: General view of hotwater system

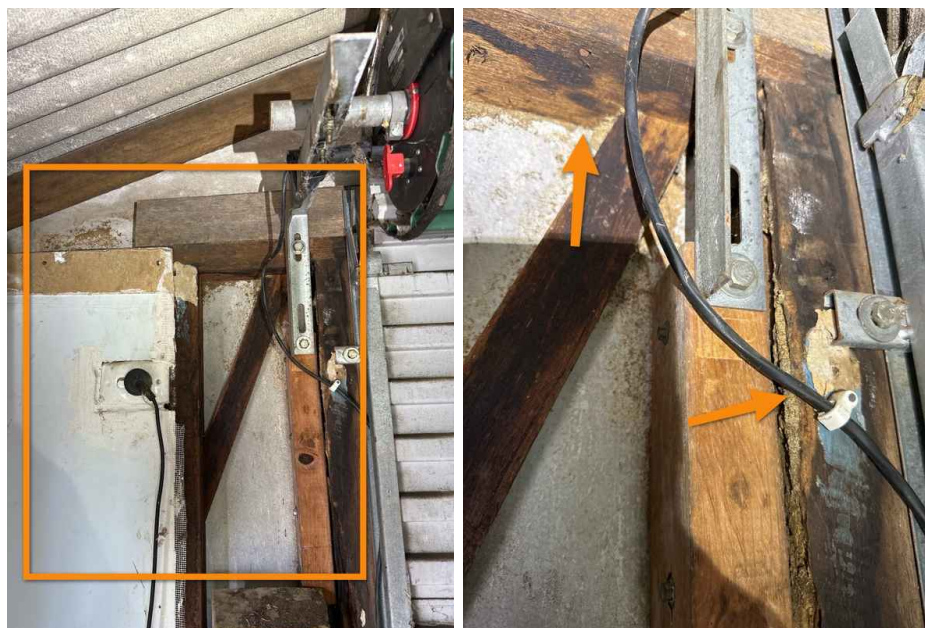
Termite damage and/or workings were found mainly in but not limited to

Garage/Carport

Termite damage/workings are not confined to these areas and further damage may also be located in concealed areas.
