HOMESAFE INSPECTIONS

## BUILDING & PEST INSPECTION

119 Glencoe St  
Sutherland, NSW 2232

05/04/2024

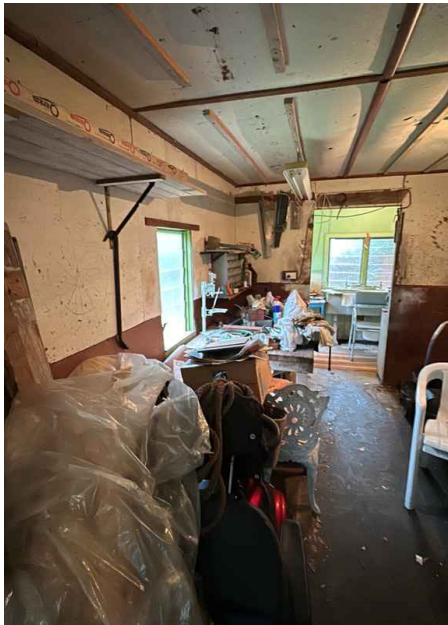
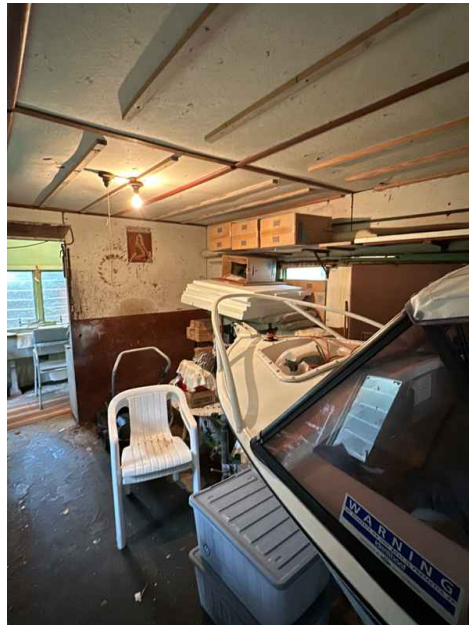
#### General view of Garage/Carport

General aging and/or denting and/or wear and tear or the previous patching is evident on the ceiling linings.

Down pipe/s not connected to storm water discharge - Down pipes not connected to storm water have the potential to cause differential settlement to the footings, cause rising damp and is also conducive to termite infestation.

Recommendation  
Contact a qualified plumbing contractor.

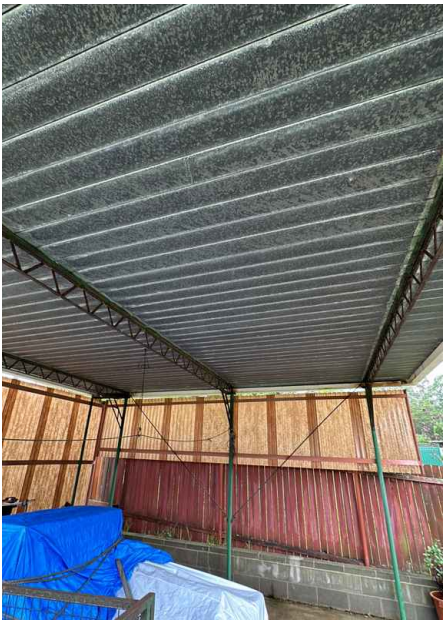
General view of Garage/Carport

Gutter rust/penetrations - The gutter has excessive rust where leaking will occur.

The carport frame is showing signs of rust and needs maintenance  
Recommend scaling back all metal treating and painting to preserve

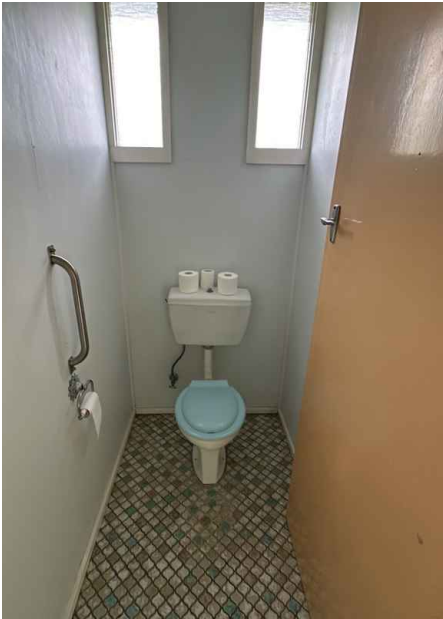
General view of Powder Room at the time of inspection

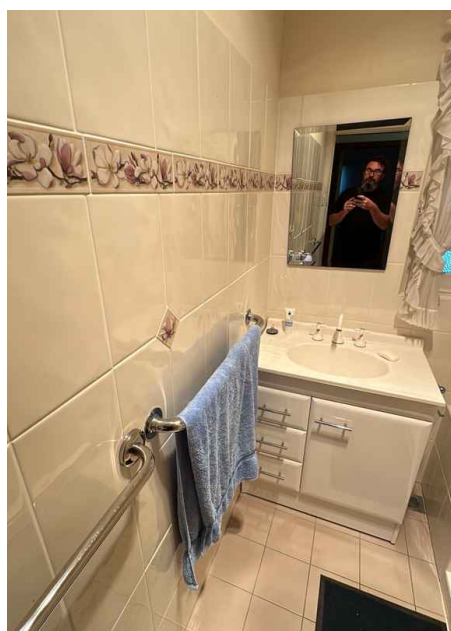
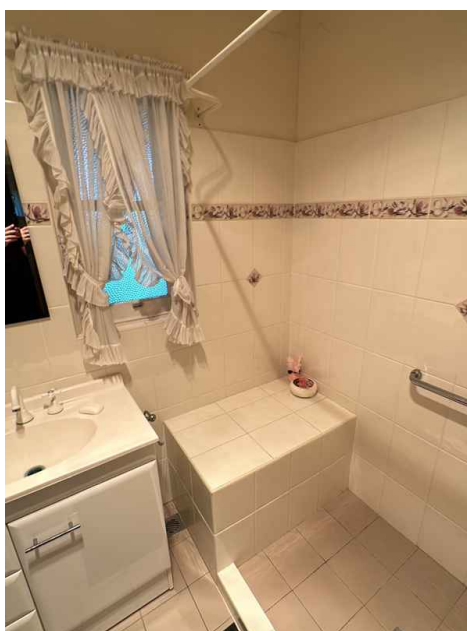
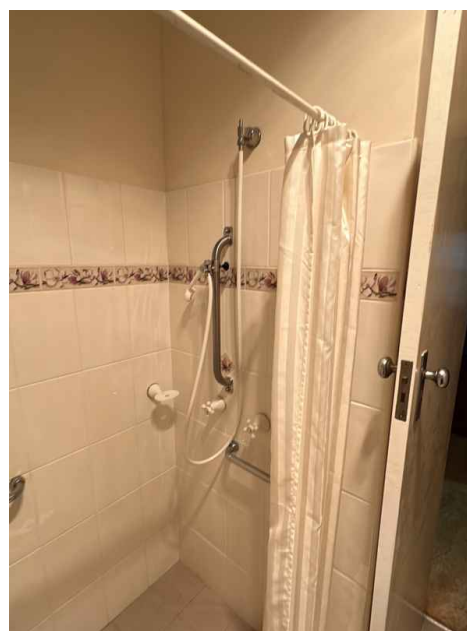
General view at the time of inspection

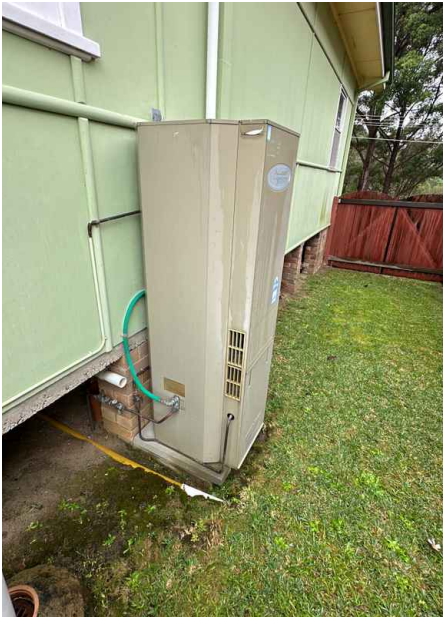
Hot Water Unit: General view of hotwater system
